# Follow Up Report: #21-301

## July 14<sup>th</sup>, 2021 – Cyclone Separator Process Water Spill

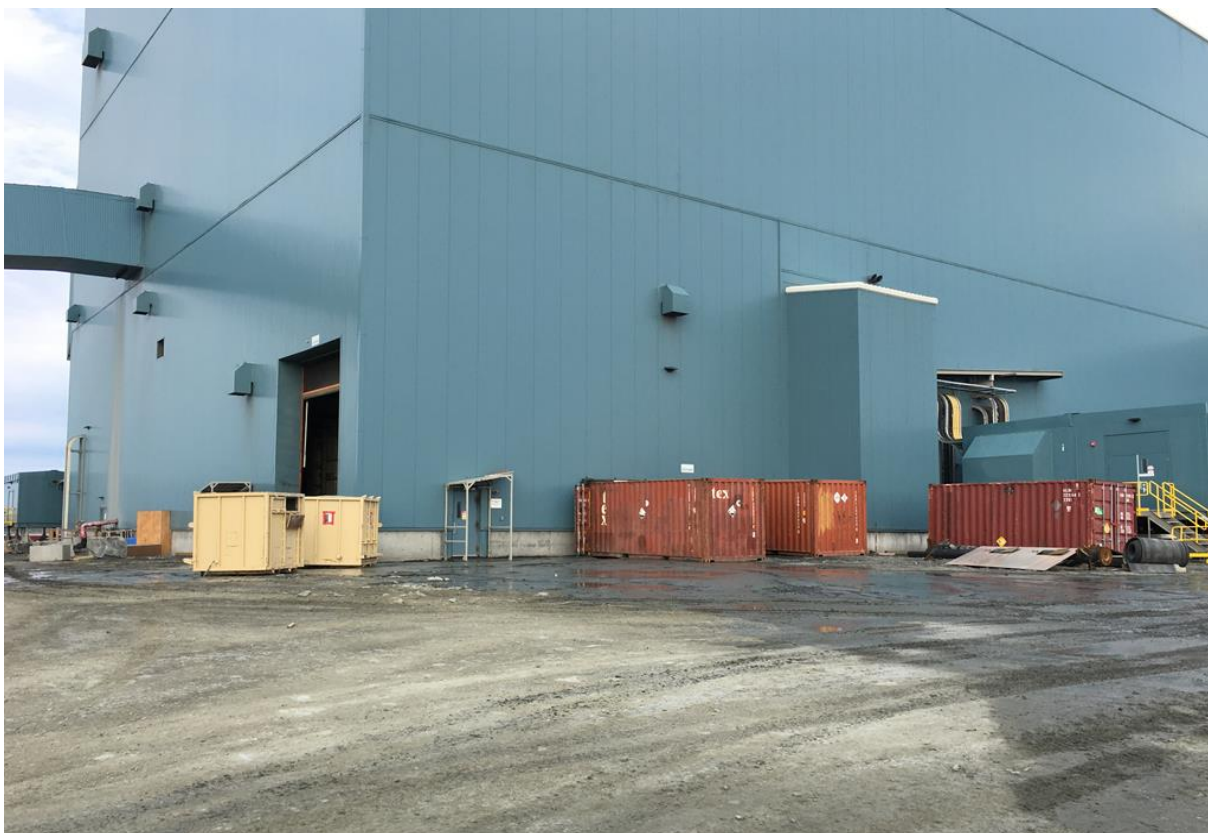
At approximately 6:00 am, July 14<sup>th</sup>, 2021, a blockage in the cyclone system within the process plant occurred preventing cyclone slurry (solid and water mix) from passing through the cyclone unit. The system backed up causing cyclone slurry to overflow to the floor of the process plant. Approximately 20m<sup>3</sup> of cyclone slurry flowed outside of the building, onto the industrial pad. The spill volume was estimate based on the area and depth of the spilled material.

**Figure 2:** Cyclone slurry flow outside process plant.

The plant was shut down to stop the release. The Cyclone slurry, which spilled to the process plant floor, as well as contaminated material outside of the process building was cleaned up immediately. All material collected was reprocessed through the mill. The affected area was cleared with heavy equipment.

A blockage within the cyclone went unnoticed by the control room operator, causing the system to become overwhelmed before the operator could stop the inflow. Cyclone slurry overflowed into the sump, which did not have capacity to contain the volume of overflow. The sump then overflowed, and slurry flowed out of the building.

To prevent recurrence, modifications to the trash screen sump containment will be made to allow any overflow material to be contained within the Grinding area containment and sump. The grinding area containment has significant capacity to contain this type of release in the future.
