Follow Up Report: #21-492

December 8, 2021 – 100L Sewage Water

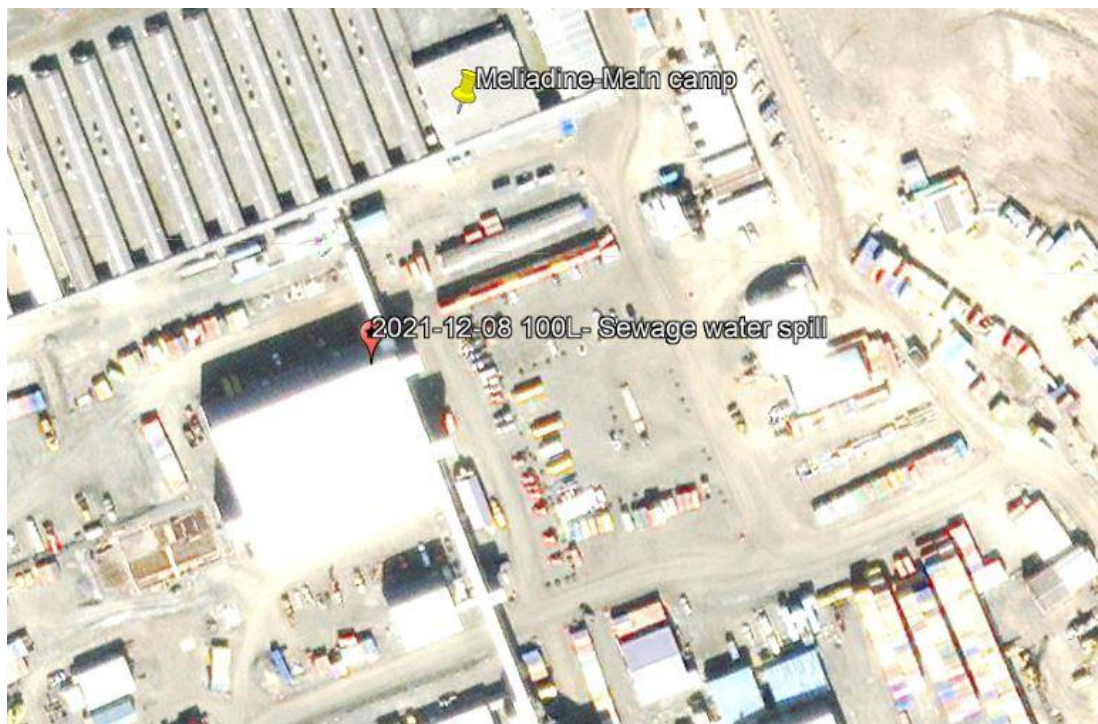
Figure 1: 100L Sewage spill location

The coordinates of this spill source (lift station) are 63° 2'21"N, 92°13'41"W. No water bodies were impacted by this spill. All water released was contained within the industrial pad.
