Follow Up Report: #2022019

January 25th, 2022 – Thickener Water Spill

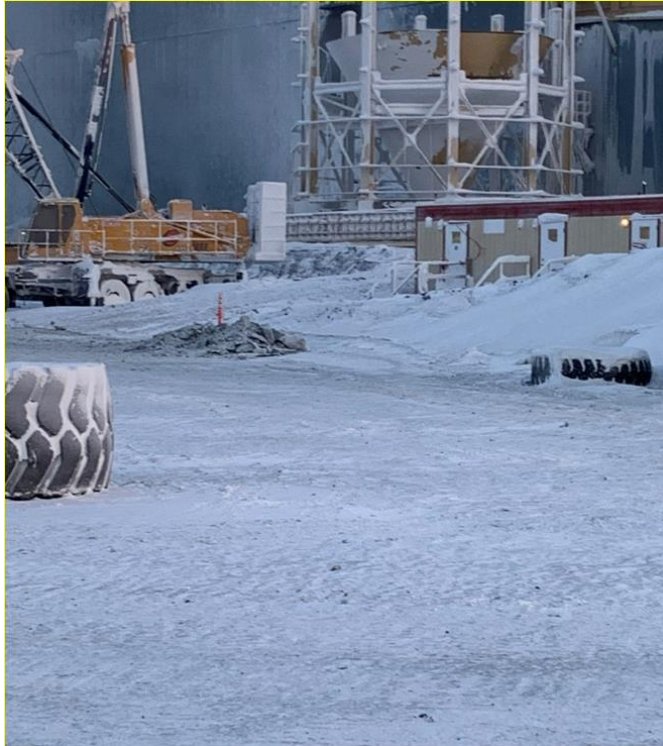
Figure 2: Final clean up.

The plant was shut down to stop the release. Berms were created to contain the spill and minimize the impacted area. A sample was collected for analysis. An excavator, loader and haul truck were used to clean up the spilled material. All material collected will be placed in the process plant sump where it will be returned to the process plant system.
