## Follow Up Report: #2022036

### January 30, 2022 Oil Contaminated Waste Water Spill

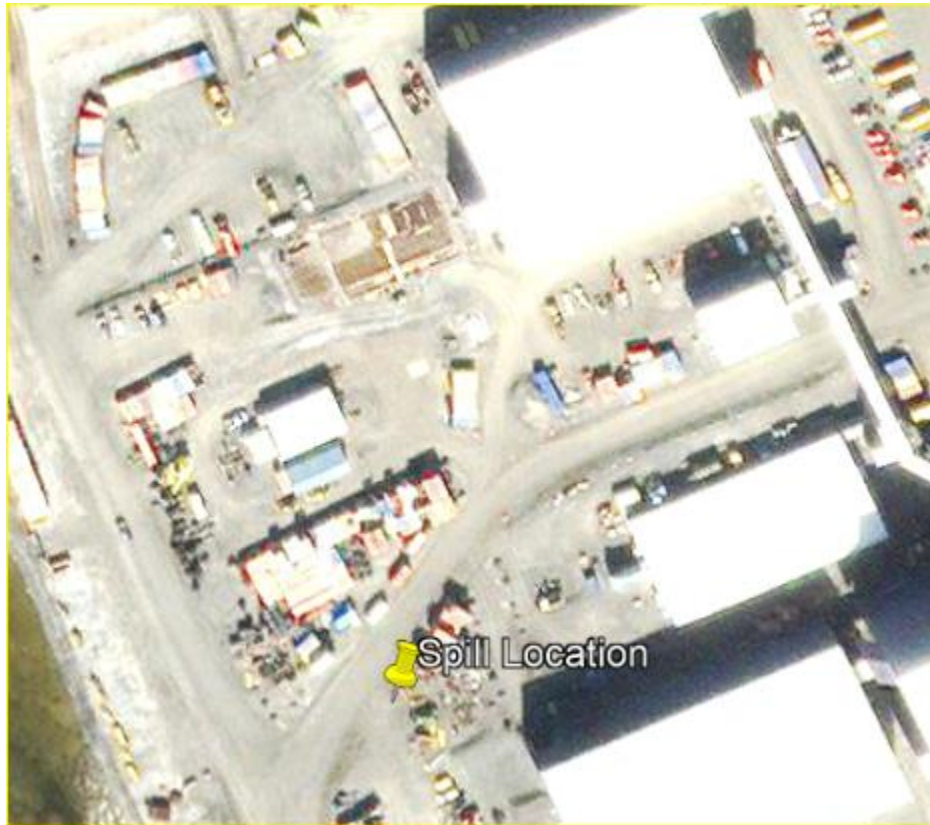
No water bodies were impacted by this spill. The closest natural water body (G2 lake) is 600 m from the spill location. The coordinates of the spill are 63° 2'14"N, 92°13'37"W (Figure 2).

**Figure 2:** Location of spill outside the MSB maintenance shop

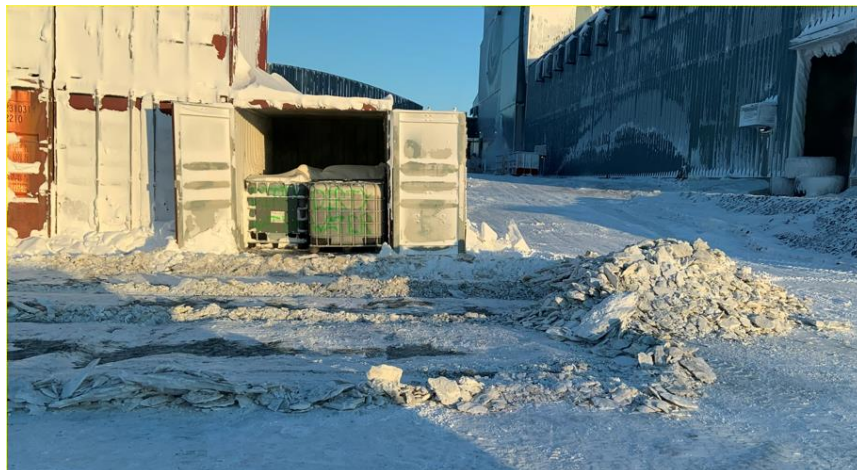
**Figure 3:** Initial cleanup process. Stockpile material later taken to the contaminated snow cell.

Frozen condition and the flat surface kept the spill contained to the local area as shown in Figure 1. The spill was cleaned up using a skid steer and the contaminated snow was disposed of in the contaminated snow cell.
