Follow Up Report: #2022057

February 27, 2022 – 25 L Sewage

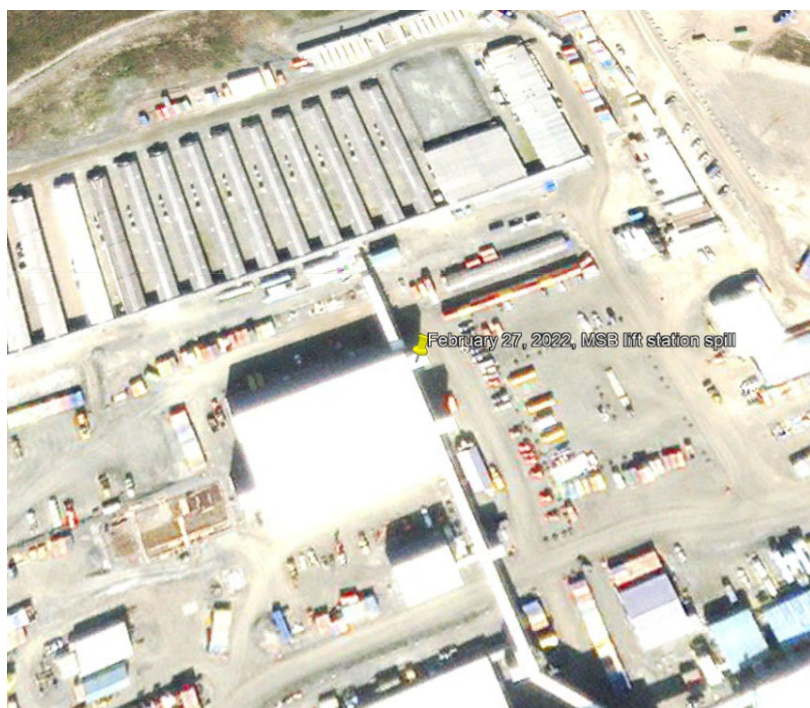
Figure 1: Location of the MSB lift station spill

At approximately 10:00 on February 27, 2022, 25L of sewage was spilled at the Multi Service Building (MSB) lift station when the vacuum truck hose was disconnected.

The coordinates of this spill are 63° 2' 21"N, 92° 13' 40"W. No water bodies were impacted by this spill. The closest water body (G2) is approximately 500 m north.

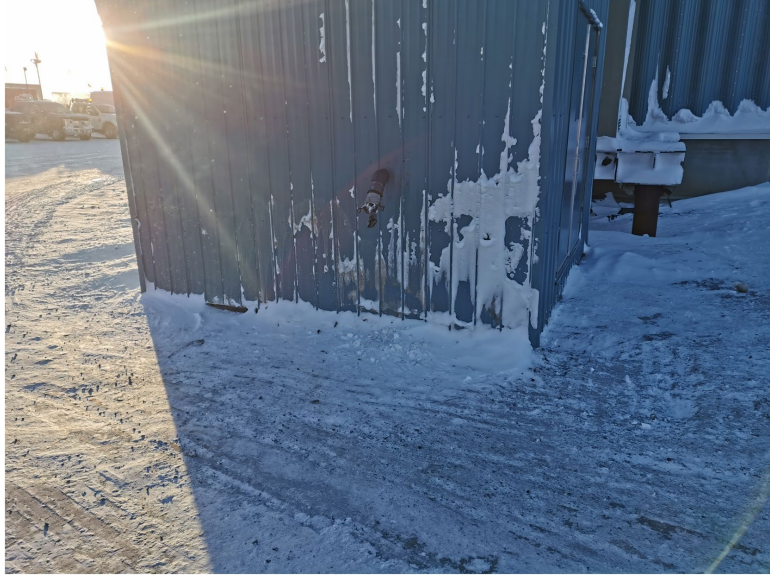
Figure 2: MSB lift station spill clean up

The spill was contained to the local area. The topography of the area and the freezing conditions prevented the sewage from migrating off site, facilitating spill recovery. Frozen contaminated material was collected and placed in drums to be returned to the sewage treatment system at a later date.

Due to COVID-19 related staff reorganization, the regular vacuum truck operating crew wasn't on site at the time of the incident and the temporary vacuum truck operator did not follow the proper sequence during the vacuum truck unloading.

The vacuum truck operational procedure was recently reviewed to include usage of a drip bucket while on and off loading and a copy has been laminated and placed in the vacuum truck for ease of reference.

This procedure was reviewed with the vacuum truck operator working at the time of the spill and will be reviewed with regular operators as they come back to site before they operate the vacuum truck.
