Follow Up Report: #2022097

March 25th 2022, Emulsion Spill

The following information refers to spill 2022097 reported by Agnico Eagle Mines Limited March 25th, 2022, and is being provided in accordance with:

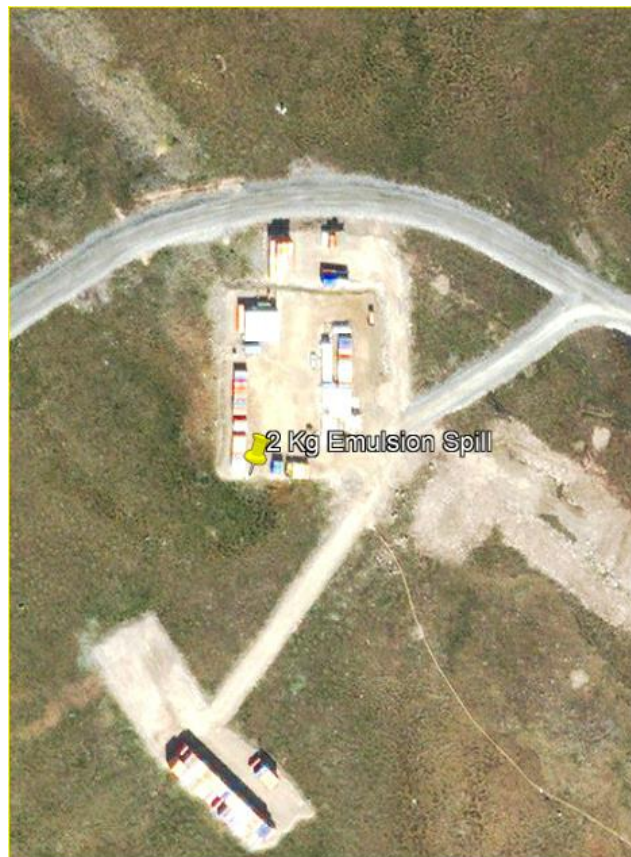
On March 25th at approximately 14:00, an estimated 2 kg of emulsion was identified during snow removal operations on the emulsion pad.

No water bodies were impacted by this spill. The closest natural water body (G9) is 365 m from the spill location. The coordinates of the spill are 63° 2'38.33"N, 92°15'24.59"W (Figure 1).

Figure 1: Location of 2kg emulsion spill

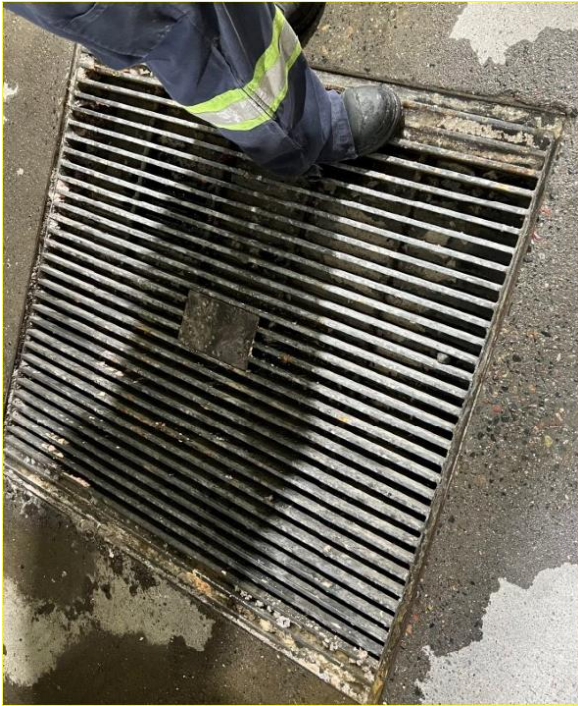
Figure 3: Dyno Equipment Shop collection sump

Emulsion plant personnel collected all impacted snow and ice and placed it in the Dyno Equipment Shop to thaw. The melted material was collected in the floor sump and transferred to a tote for disposal as hazardous waste.
