Follow Up Report: #2022148

April 25th, 2022 – 25 L Sewage

The following information refers to an incident #2022148 reported by Agnico Eagle Mines Limited April 26th, 2022, and is being provided in accordance with:

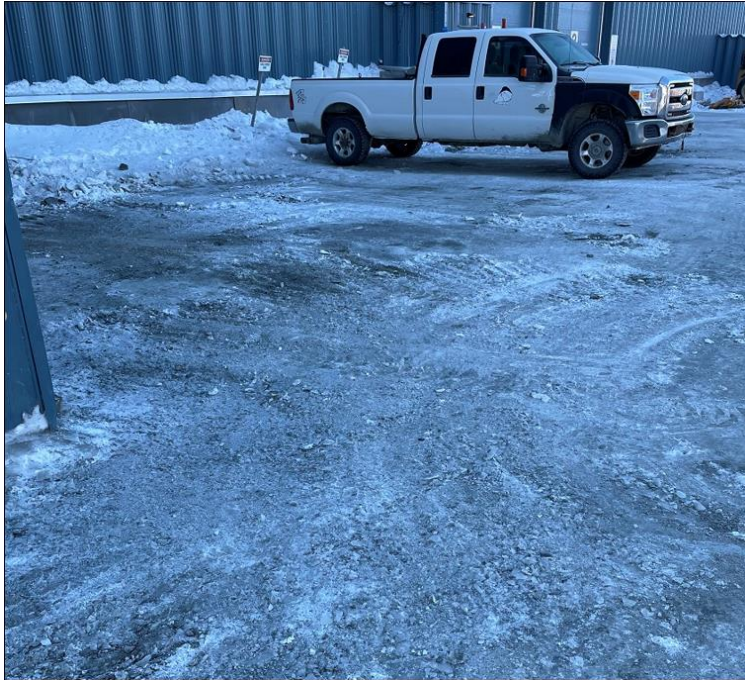
Figure 2: MSB lift station spill cleanup

The spill was contained to Lift station building and the local area. The freezing conditions prevented the sewage from migrating, facilitating spill recovery. Frozen contaminated material was in an open area allowing the material to be collected with a loader and placed in a drum and disposed of after the frozen material has melted.

While transferring the content of the vacuum truck into the MSB lift station, the operator inadvertently used a broken CamLock connector to connect the hose to the lift station. The sewage vacuum hose became dislodged releasing sewage inside the MSB lift station and to the ground outside the life station.

- the defective CamLock fitting was replaced;
- a threaded coupler that has less tendency to fail as there are no movable latches has been ordered and will replace the current latching style of CamLock fitting when they arrive;
- whip check cables have been installed to reduce hose movement during sewage transfer.
