## **Re.: Follow-up Report: Spill #2022411– Release of 300 L of wash bay solids at the Meliadine Gold Project**

### **Description of Incident**

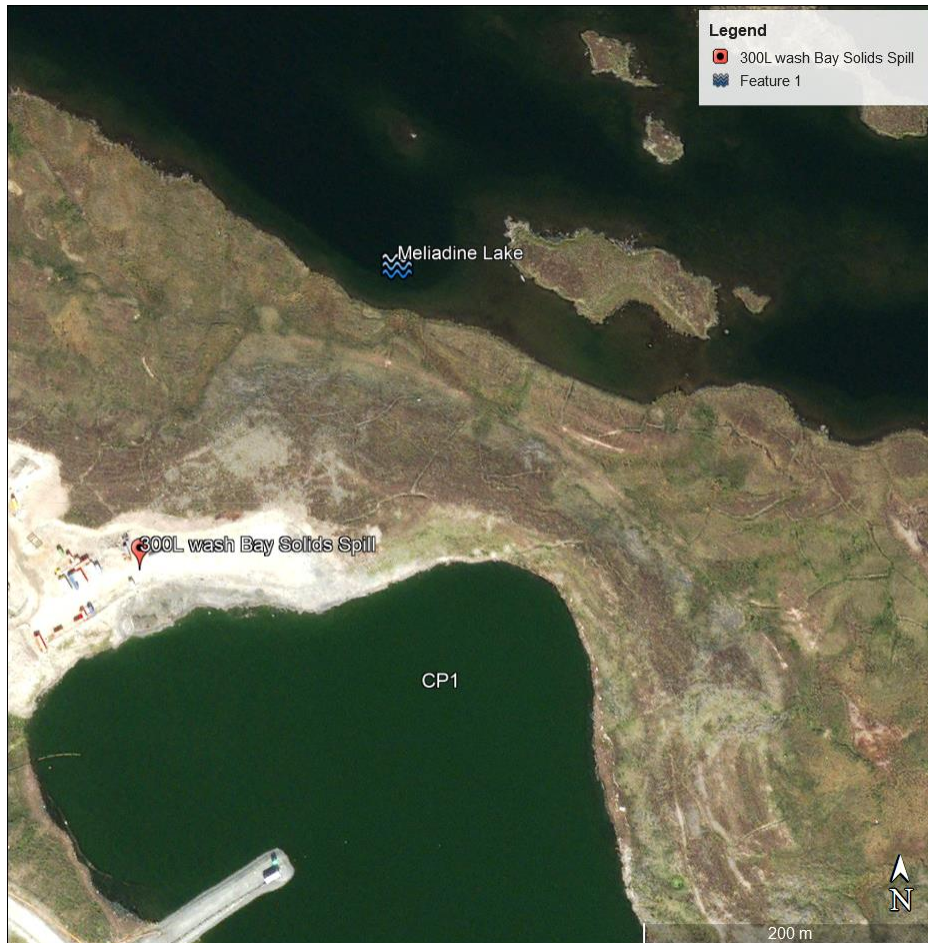
**Figure 1:** Location of wash bay solids spill and proximity to water bodies.

On August 9<sup>th</sup>, 2022, at approximately 9:00 pm, an estimated 300 L of wash bay solids was spilled on the industrial pad during the transfer of solids from the vehicle wash bay to a haul truck. No water bodies were impacted by this spill. The closest water body (Meliadine Lake) is approximately 265 meters east, as seen in Figure 1.

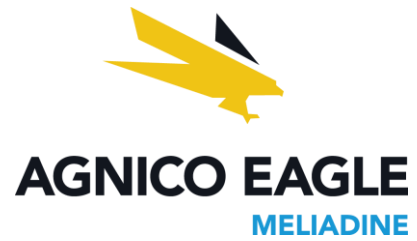
**Photo 1:** Wash bay solids spill

Upon discovery of the spill, a vacuum truck was used to recover the wash bay solids and remediate the impacted area. The recovered material was placed in Landfarm A as per the Landfarm Management Plan.

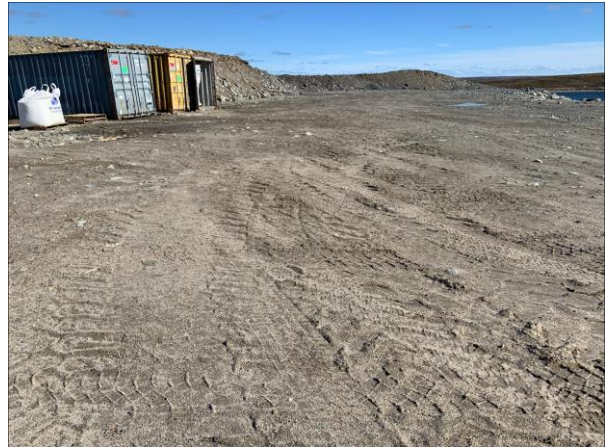
**Photo 2:** Wash bay solids spill remediation
