Re.: Follow-up Report Spill #2022475 – Release of 5 L of Untreated Sewage at the Meliadine Gold Project

Description of Incident

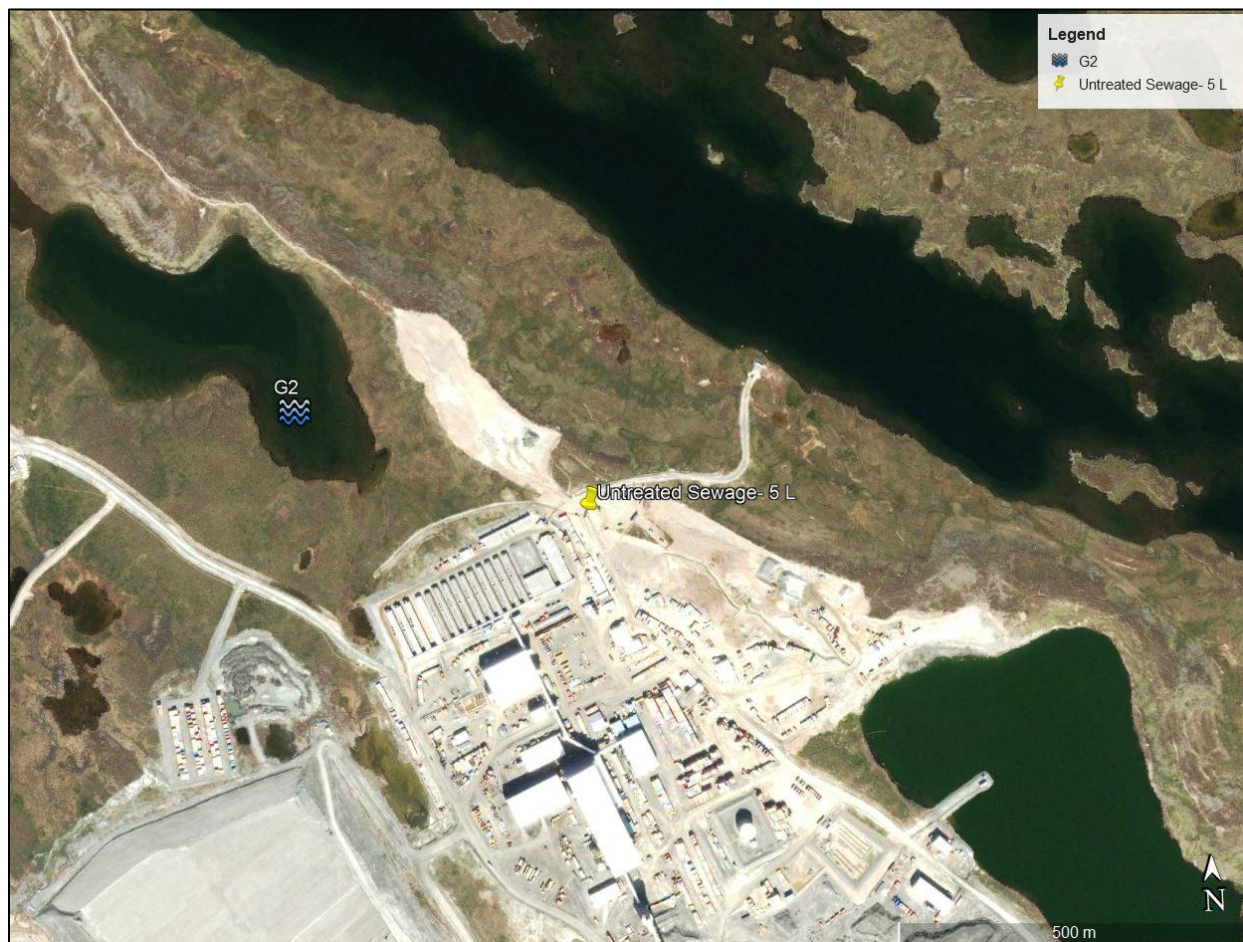
Figure 1: Location of sewage spill and proximity to water bodies.

On September 23rd, 2022, at approximately 2:00 pm, an estimated 5 L of untreated sewage was spilled on the industrial pad due a sewage transfer line not being fully drained when storing it back on the vacuum truck. No water bodies were impacted by this spill. The closest water body (G2) is approximately 316 meters northwest, as seen in Figure 1.

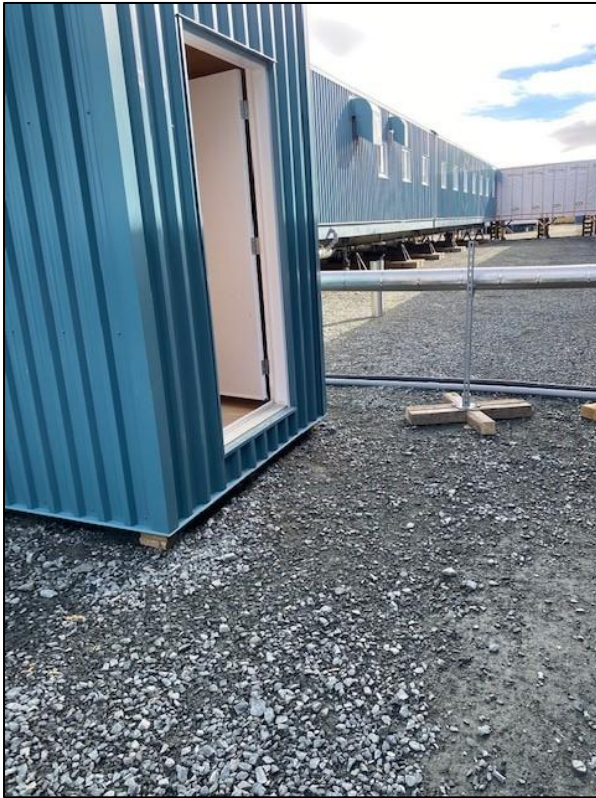
Photo 1: Wing 16 lift station (spill location)

The vacuum truck was used to recover the free liquid and transfer into the lift station. The impacted surface area was hand excavated and an estimated 5 kg of material was brought to Landfarm A as per the Landfarm Management Plan.

- New piece of equipment and worker was unfamiliar with its operation.
- Previous operator of equipment did not fully empty the line.

- Vacuum truck procedure will be reviewed with all employees.
- Supervisors will meet with new operators to remind them of the importance of not rushing.
- Vacuum truck procedure will be available in the new vacuum truck for reference.
