RAILWAY DESIGN INFORMATION

NORTH RAILWAY TERRAIN ANALYSIS

Engineering Report Civil Engineering Site Assessment of North Railway Alignment

Baffinland Iron Mines Corporation

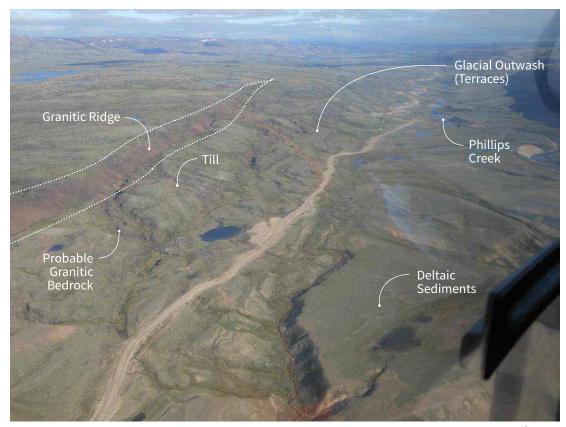
Photo 1

Photograph 1 shows an aerial view of the Tote Road and the granitic ridge between approximately CH 2+500 (foreground) and 10+000 (background). The Tote road is situated on glacial outwash terraces (frozen gravelly sand), which are highly undulating as illustrated by the winding road alignment.

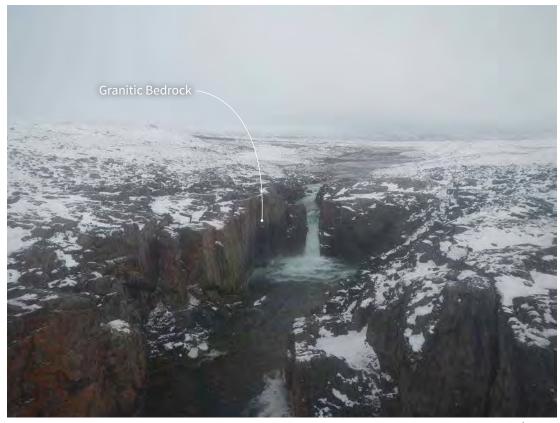
Photographs 4 and 5 show the upstream and downstream reaches of Phillips Creek near the waterfall located at CH 10+800. See also Figure 3-1. These photographs (i.e., 4 and 5) show outcropping granitic bedrock in Phillips Creek and ice rich soils situated immediately east of the creek. Between CH 0+000 and 12+000, similar granitic outcrops occur periodically between Philips Creek and the granitic ridge. Referring to Drawing H352035-GEOSKT-229-292-000, Sheet 1 of 4, there are several pre-existing permitted granitic quarries within this segment of the railway as denoted by the diamond (*) symbols.

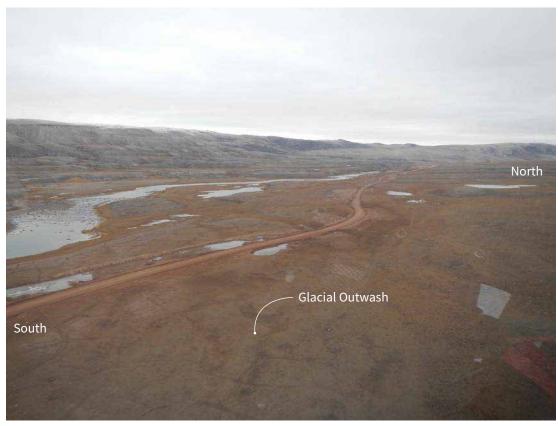
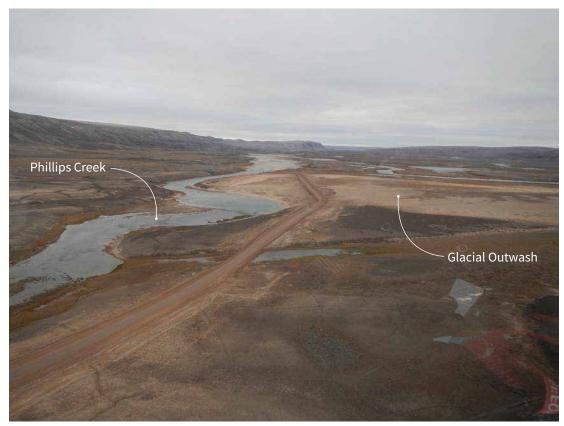
Photographs 6, 7 and 8 show the north approach to Bridge No. 1, Bridge No. 1, and the south approach to Bridge No. 1, respectively. Notably, the terrain is flat with regularly occurring small water bodies, which are usually indicative of ground ice. In this area, the soils comprise mainly sand with trace to some gravel, and variable silt content.

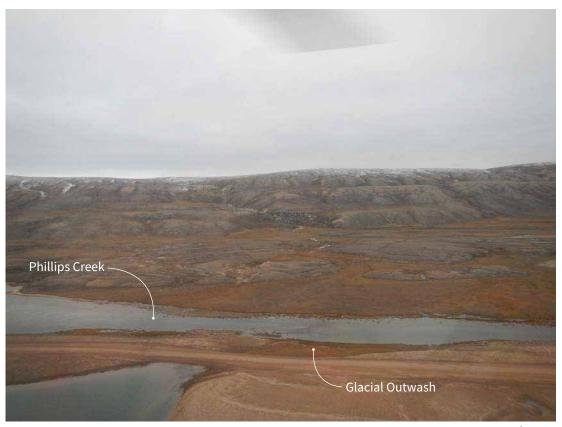
Photo 9

Photographs 9 to 19 illustrate the two contrasting terrain units that effectively dominate the geology between CH 10+000 and 46+000, i.e., the gray till and tan to reddish brown outwash gravelly sand deposits. Referring to Photograph 10, several ridges occur in the till to the east of the existing Tote Road. These ridges typically indicate the presence of shallow sedimentary bedrock (i.e. limestone beds) located just below the ground surface. The noses of the beds are typically exposed in the occasional creek beds that flow east to west during summer toward Phillips Creek. In some areas, these ridges may be indicative of ground ice as highlighted in Photograph 12.

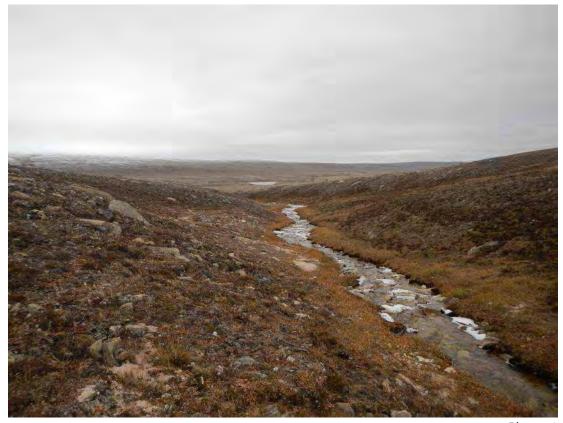
Photo 13

Photograph 13 shows a typical creek bed. The creek gradient is relatively flat and the flows, when present, are typically along the top of underlying limestone or sandstone beds (i.e. bedrock). Photograph 14 shows a general view of the till plain.

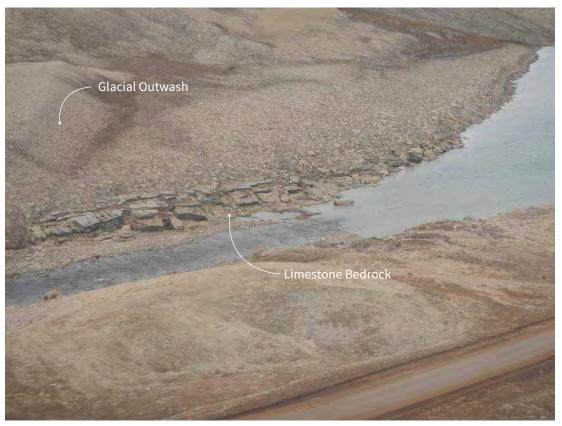
Photo 16

Photograph 16 shows exposed sedimentary bedrock in the Phillips Creek stream bed. At this location, taking into account the relief and flat lying nature of the bedrock, the depth to bedrock under the Tote Road is in the order of 5 to 10 m.

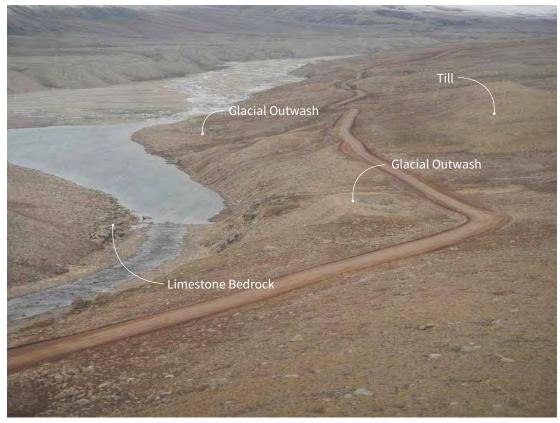
Photo 17

Photographs 15, 17, and 18 all show views of the outwash terrain. As noted above, the surface soils comprise sands and gravelly sands with occasional cobbles.

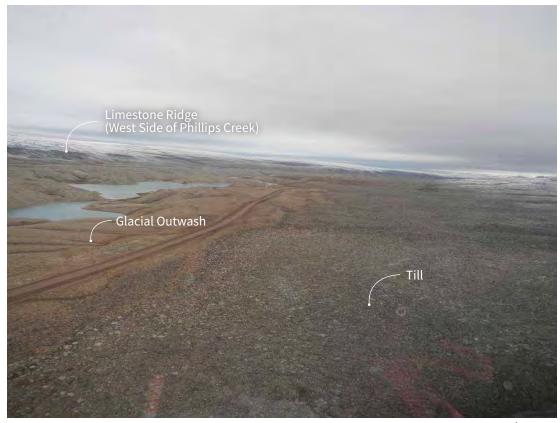
Photo 19

Photograph 19 illustrates the contact between the glacial outwash and till terrain units at CH 46+000. As noted above, these two units can be easily differentiated by their colour and fines content; notably, the till is generally gray and comprises 30 to 50 percent silt particles; whereas, the sand and gravelly sand is tan coloured and relatively clean.

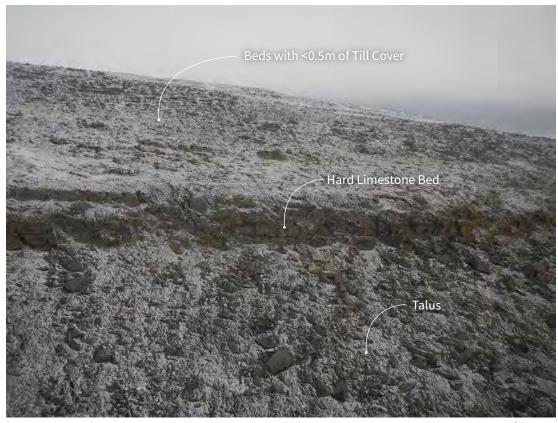
Photo 21

Over this stretch of the alignment, there is an exposed limestone ridge or mesa running parallel to and approximately 500 m east of the Tote Road. The bedrock ridge occurs between approximately el 750 to el 850 ft and is shown in Photographs 21 (CH 54+200), Photo 22 (CH 57+800) and Photo 26 (CH 52+000 to 58+000). The limestone bed associated with this ridge is more prevalent on the west side of Phillips Creek as shown in Photographs 15, 18, 19, 20 and 24. It is noted that there is possible ground ice at CH 45+000 (see Photograph 20), which is not delineated on the public domain geologic maps for this area. The reader is referred to Appendix C for aerial photographs and an estimate of the extent of ice rich soil.

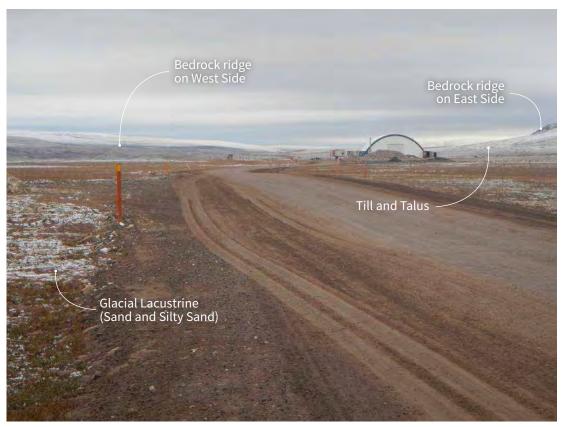
Lastly, between CH 55+200 and 59+200, Tote Road traverses a flat plain consisting of sand and silty sands deposited in a shallow water proglacial lake environment. Photos 23, 24 and 25 are representative of the terrain at this portion of the alignment.

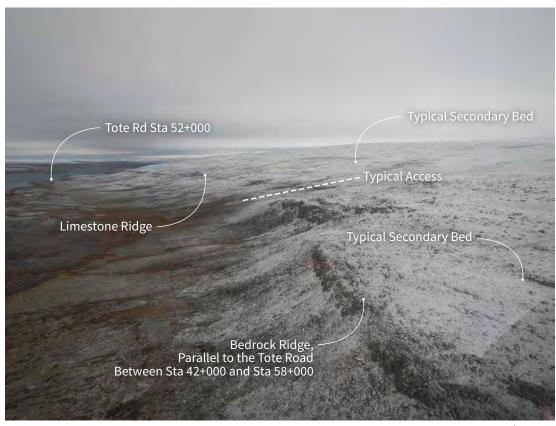
Photo 26

Photograph 26 shows a good perspective of the exposed limestone ridge between CH 52+000 and CH 59+200. The ridge is a prime candidate for quarry development.

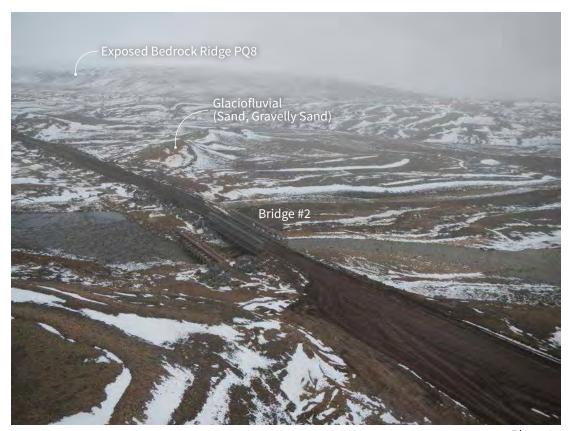
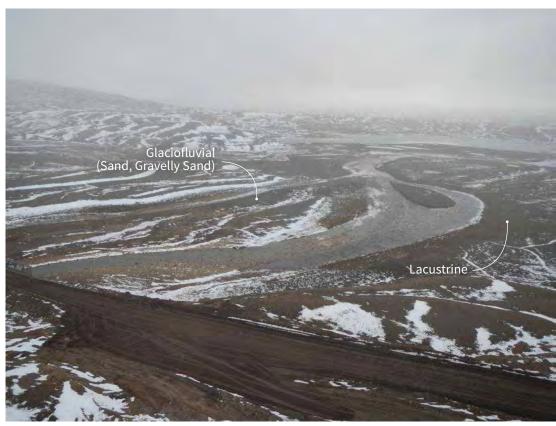
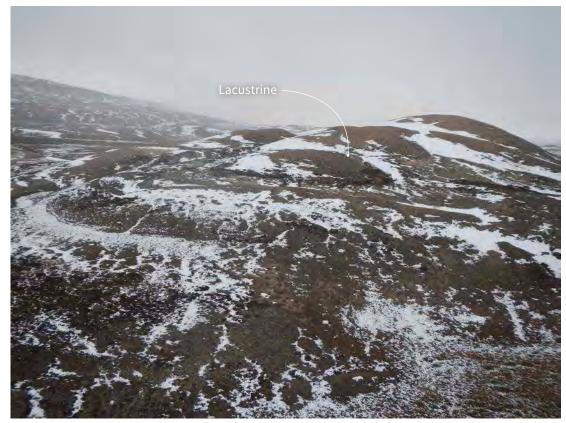
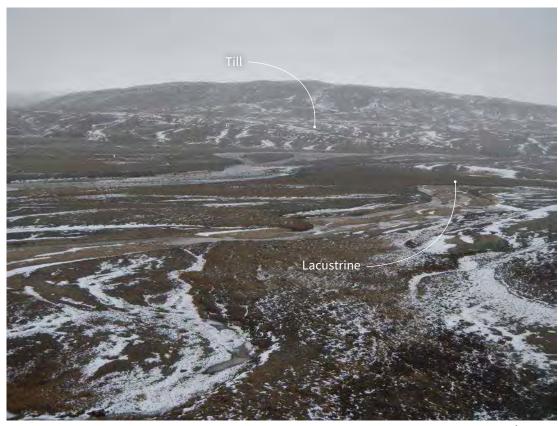
Photographs 27 to 30, inclusive, show views of Bridge No. 2 and the lake bed deposits located west of the bridge. The primary soil type is silt and sand or silty sand.

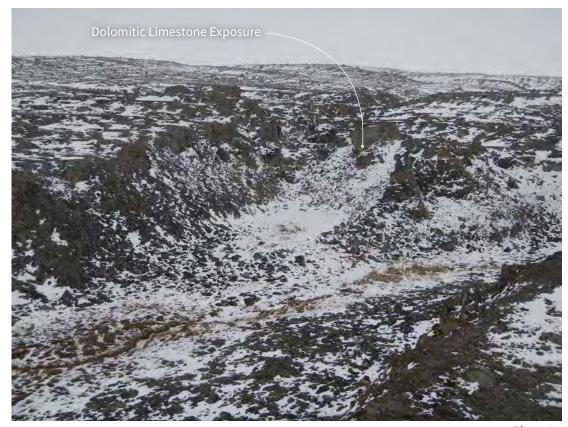
Photo 31

Photographs 31 and 34 show the exposed dolomitic limestone ridge at CH 64+200 of the rail alignment (Note: East side of the valley). This is the same bedrock unit that is present between CH 42+000 and CH 59+200 on the east and west sides of Phillips Creek and it is prevalent throughout most of the central portion of the rail route. At this location, the bedrock is fairly blocky due to ice jacking and it is covered by a thin discontinuous veneer of glacial till of approximately 1 m thickness or less.

In summary, the author believes that photographs 31, 33, 34, 35, 36 and 37 should be indicative of the conditions at PQ07, PQ08 and PQ09.

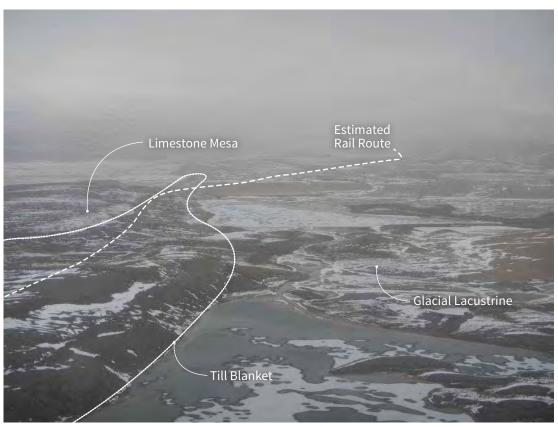
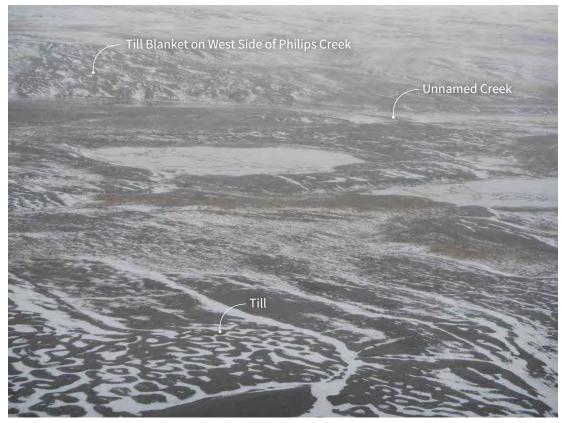
Photographs 32 and 33 show the glacial till blanket in the unnamed creek valley, as well as the lacustrine terrain to the north near the Tote Road Bridge No. 2.

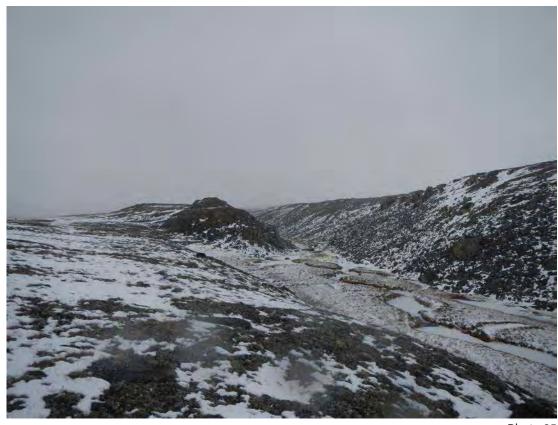
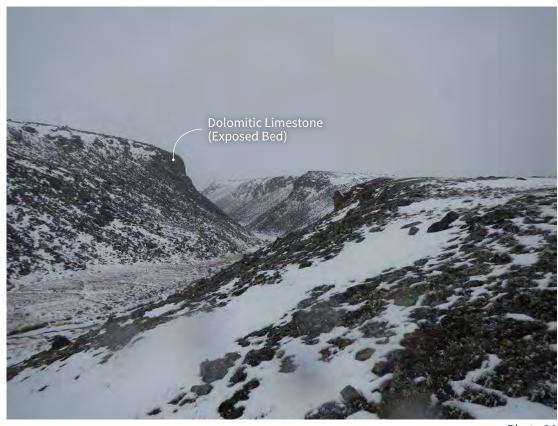
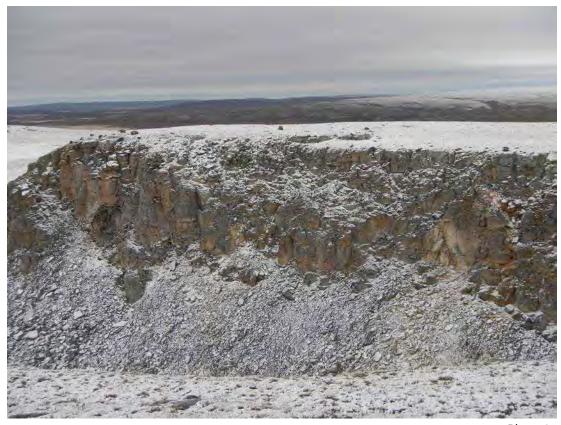
Photographs 35, 36 and 37 show the limestone ridge at CH 66+000 (i.e. between El. 750 ft and 850 ft). Initially, this was thought to be a quarry location for the rail alignment when the alignment was located east of the unnamed creek; however, it is representative of the expected conditions on the west side at PQ09 (See H352034-GEOSKT-229-292-0002, Sheet 3 of 4).

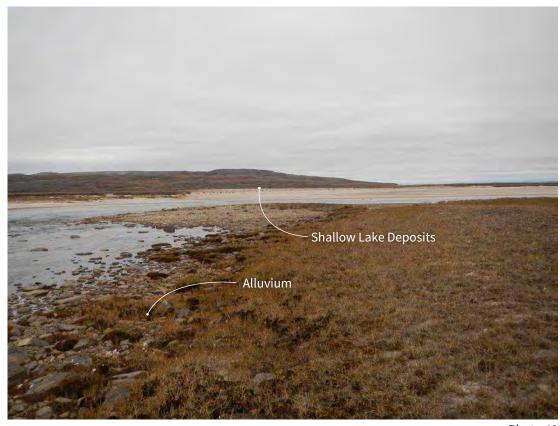
Photo 40

The proposed railway crosses the unnamed creek from the west side to the east side between CH 70+000 and 72+600. The left bridge approach is situated on a gently sloping till blanket; Photographs 40 and 41 illustrate the till blanket (east side). The terrain transitions to a broad and flat alluvial plain approximately 300 m west of the bridge crossing. The alluvium comprises sand and gravel with cobbles and is illustrated on Photograph 40. Between CH 71+300 and 72+600, the alignment transitions to a glacial lacustrine deposit comprising medium fine sand, which is also shown in Photograph 40. This deposit is wet with numerous small surface water bodies, which again is normally associated with thermal karst and ground ice.

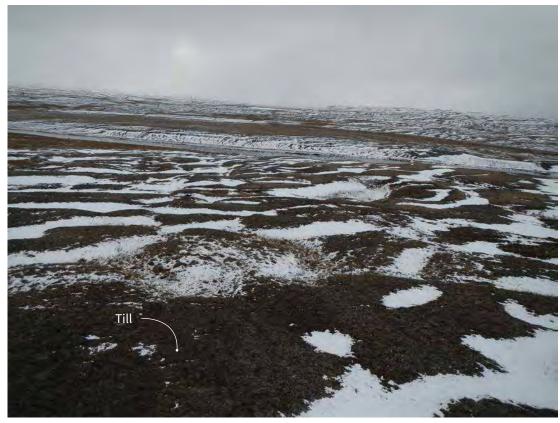
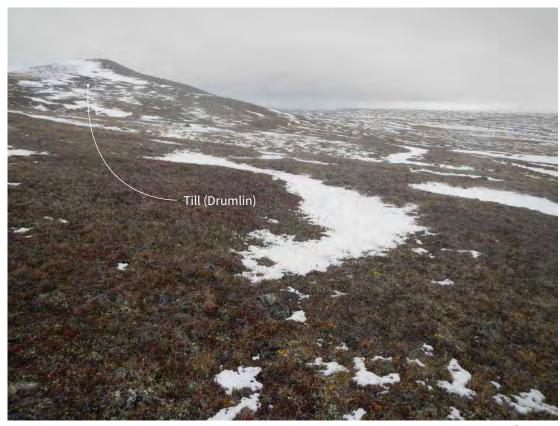
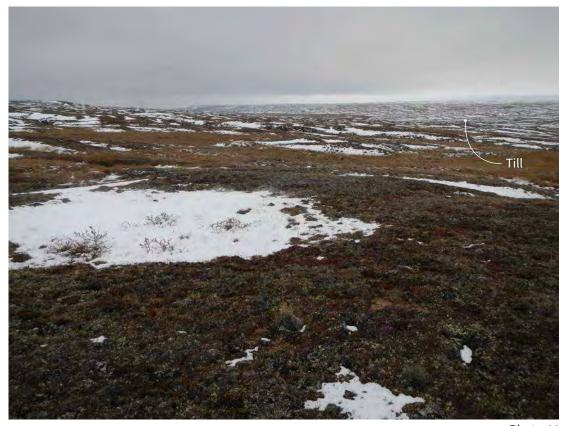
Photographs 41 to 44 show the general till terrain. Photograph 45 shows the prominent bedrock ridge that is situated about 1.5 km north of the rail and emerges starting at CH 80+000 (see Photograph 45).

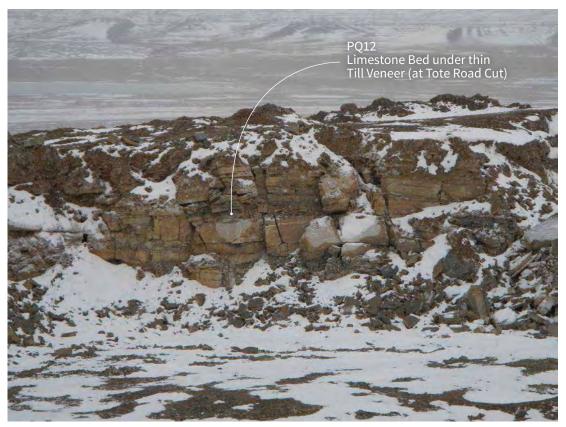
Photo 47

The bedrock is very shallow at numerous locations particularly adjacent to the Tote Road. For example, Photograph 47 shows a road cut made in 2016 to reduce grades on the Tote Road. The bedrock at this location is very shallow and the till cover is less than 0.3 m thick. This has been identified as a potential quarry location, See PQ12, as noted in Section 4 of this report.

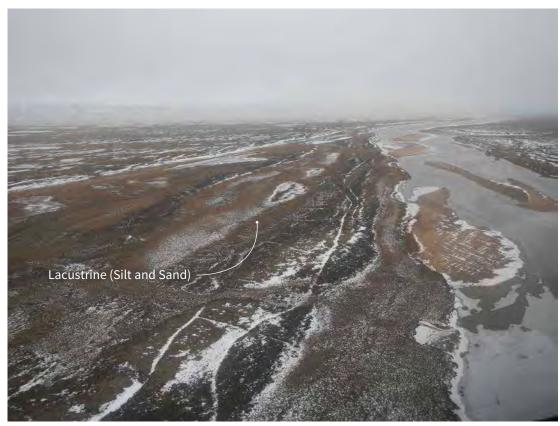
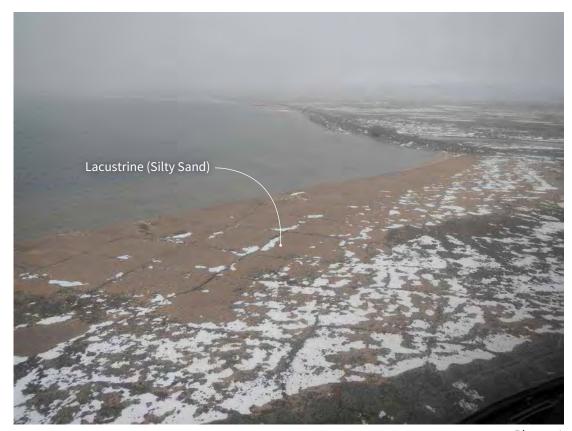
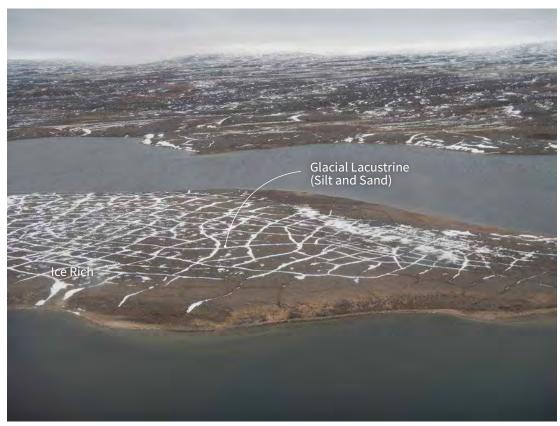
Photographs 46, 48, 49, 55, and 56 show the glacial lacustrine terrain, which comprises predominantly flat ice rich sandy silt to silty sand.

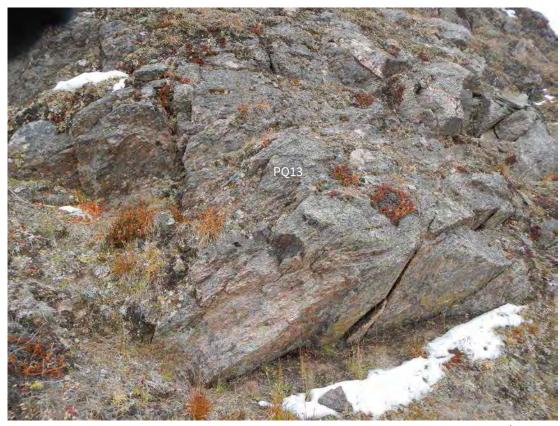
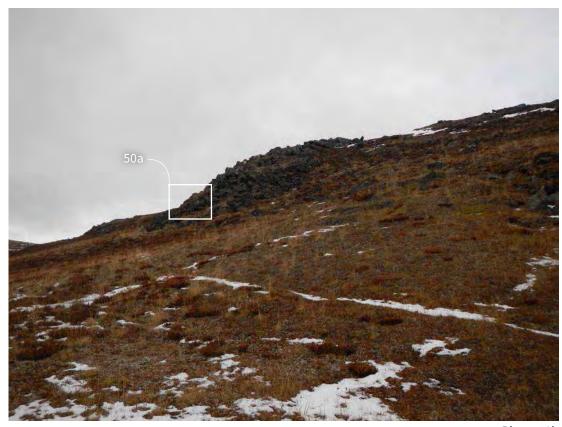
Photo 50a

There is an excellent quarry site situated just over 1 km north of the rail alignment and labeled PQ13 on Drawing H352034-GEOSKT-229-292-0002. The potential quarry site is a hill of granitic rock and is shown on Photographs 50 and 52. As an alternate to PQ13, there is also an exposed Diabase Dyke situated another 1.5 km north of PQ13. The dyke is shown in Photographs 51a and b.

PQ13, **PQ14**, **and PQ15**: Most of these potential quarry sites consist of granitic bedrock with a thin veneer of gravelly sand or sand overlying the rock. These quarries should be suitable for producing rockfill as well as ballast and there should be more than enough material to meet the project needs. The overburden thickness at PQ14 is not known and could be too thick to allow easy development. As noted in Section 3, there is a diabase dyke situated 1.5 km north of PQ13 and at PQ15. The diabase is very hard and would be an excellent site for ballast production. The hardness of the diabase will make it difficult to quarry and crush, and given the reasonably good quality of the granitic borrow sources, utilizing the dyke is probably not necessary.

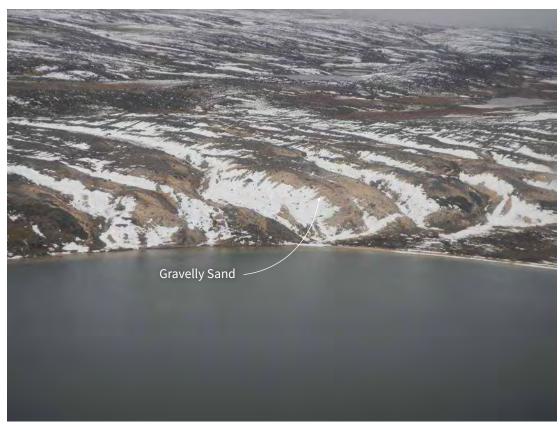
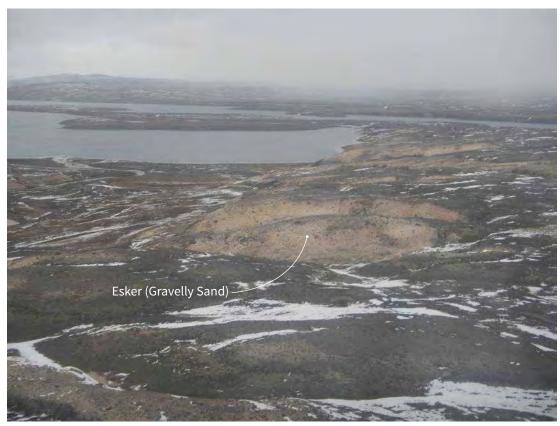
Photographs 57 and 58 show the esker terrain, which consists of mainly gravelly sand.

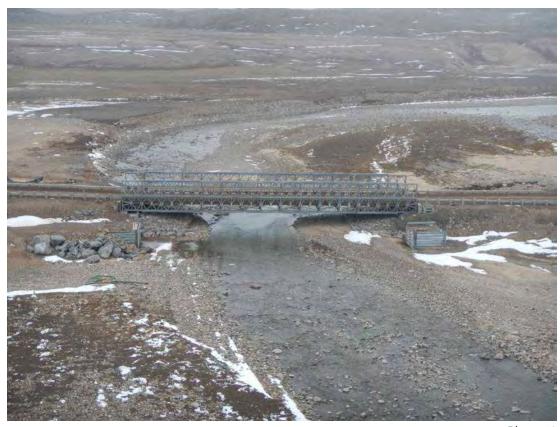
Photo 59

Photographs 59 and 60 show the Tote Road Bridge No. 4, which is situated on the sand and gravel alluvial plain associated with the unnamed creek.

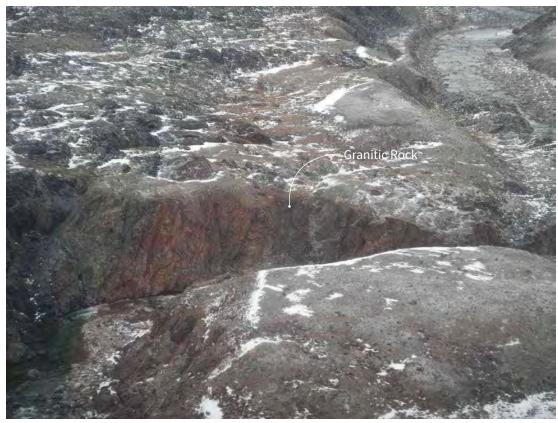
Photo 61

The rail alignment has been moved north of Bridge No. 4 into the rocky terrain in order to generate rockfill from cut-fill earthworks. Photograph 61 illustrates the predominant terrain for the rail alignment.
