Phase 2 Milne Rail Corridor Aquatic Habitat Assessment

**Baffinland Iron Mines
Mary River Project**

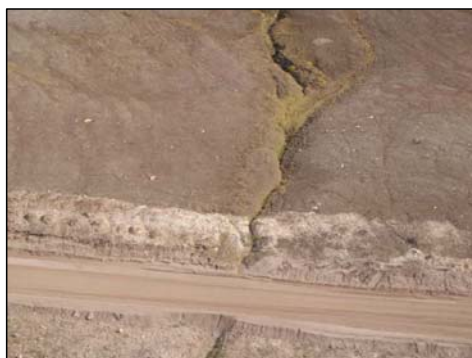
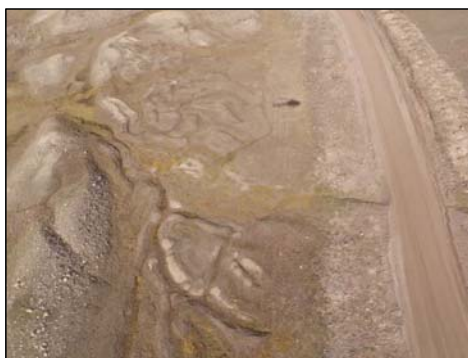
Figure 2. Aerial views of CV-20-2 during fall (A) and (B).

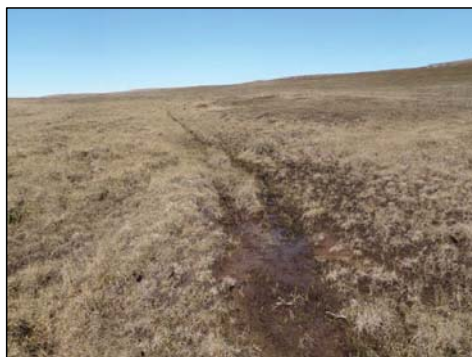
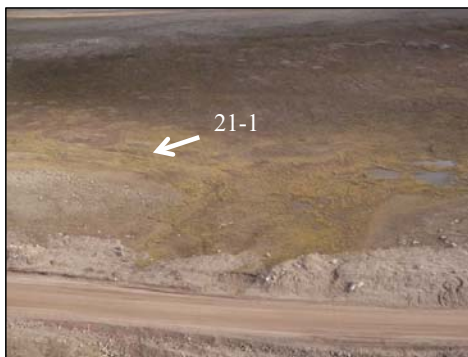
This site was nearly dry in 2018. In addition, there was no defined channel and multiple soft barriers to fish movement (subsurface flow) and no connection to overwintering habitat. There is no fish habitat at this crossing.

Figure 1. Views of CV-21-1 at the rail crossing during summer (A) and aerially during fall (B).

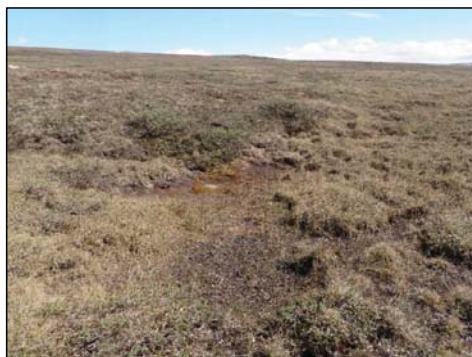
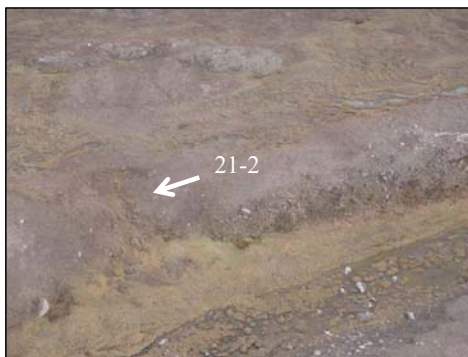
This site was nearly dry in 2018. In addition, there was no defined channel and multiple soft barriers to fish movement (subsurface flow) and no connection to overwintering habitat. There is no fish habitat at this crossing.

Figure 1. Views of CV-21-2 at the rail crossing during summer (A) and aerially during fall (B).

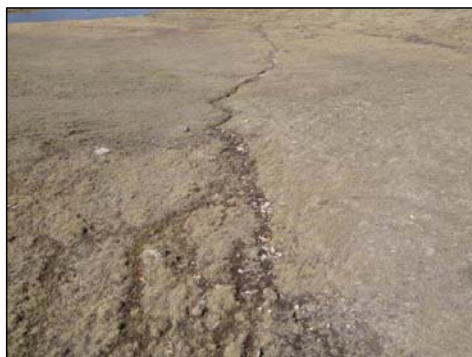
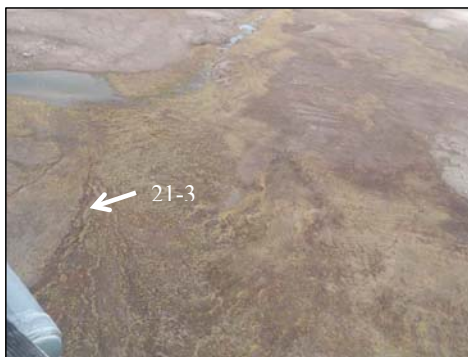
This site was nearly dry in 2018. In addition, there were multiple soft barriers to fish movement (subsurface flow) and no connection to overwintering habitat. There is no fish habitat at this crossing.

Figure 1. Views of CV-21-3 at the rail crossing during summer (A) and aerially during fall (B).

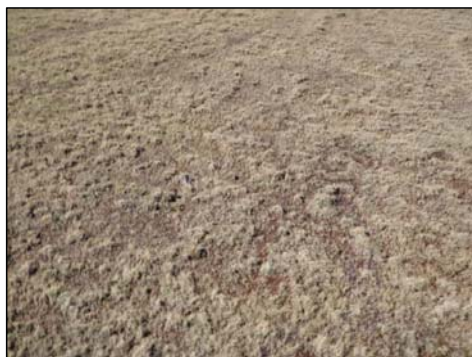
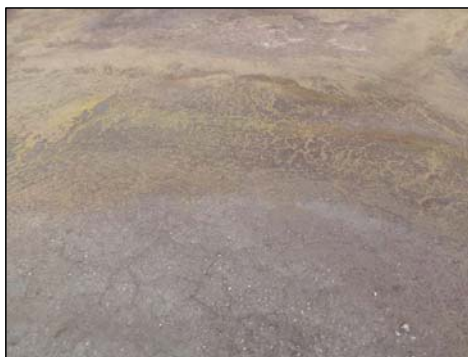
This site was nearly dry in 2018. In addition, there was no defined channel and multiple soft barriers to fish movement (subsurface flow) and no connection to overwintering habitat. There is no fish habitat at this crossing.

Figure 1. Views of CV-21-4 at the rail crossing during summer (A) and aerially during fall (B).

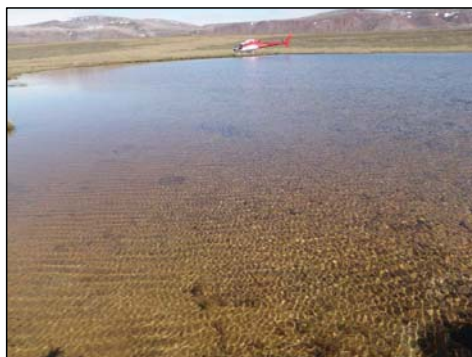
This is a small, shallow (< 1 m maximum depth), isolated pond. Fish were not captured or observed in 2018. Depths are insufficient for overwintering and there is no access from other waterbodies. There is no fish habitat at this crossing.

Figure 1. Views of CV-22-1 at the rail crossing during summer (A) and (B), and aerially during fall (C).

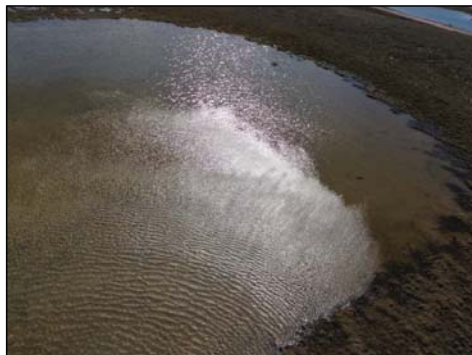
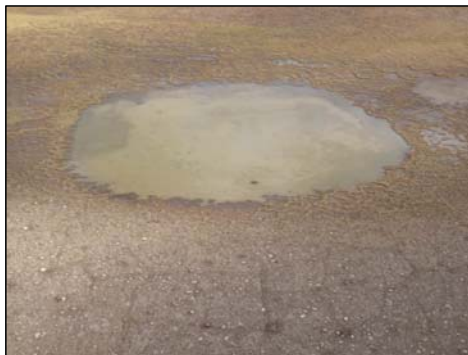
This is a small, shallow (< 1 m maximum depth), isolated pond, similar to CV-22-1. Depths are insufficient for overwintering and there is no access from other waterbodies. There is no fish habitat at this crossing.

Figure 1. Views of CV-22-2 at the rail crossing during summer (A) and aerially during fall (B).

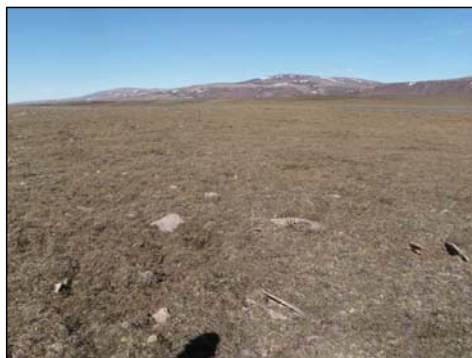
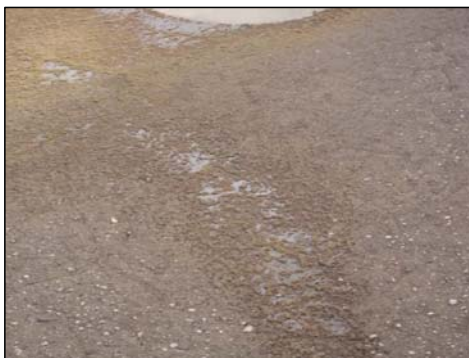
This was a dry low point during summer and nearly dry during fall. There is no access from other waterbodies. There is no fish habitat at this crossing.

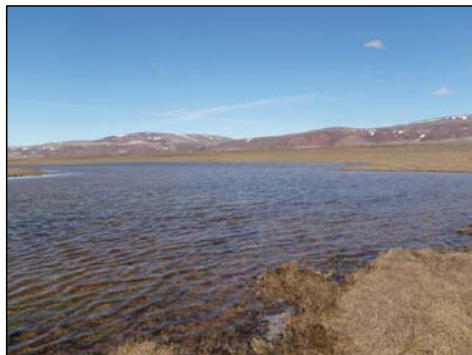
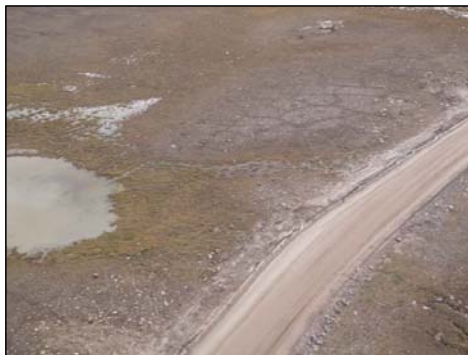
This is a small, shallow (< 1 m maximum depth), isolated pond. Overwintering is not possible in this pond and there is no access from other waterbodies. There is no fish habitat at this crossing.

Figure 1. Views of CV-22-4 at the rail crossing during summer (A) and aerially during fall (B).

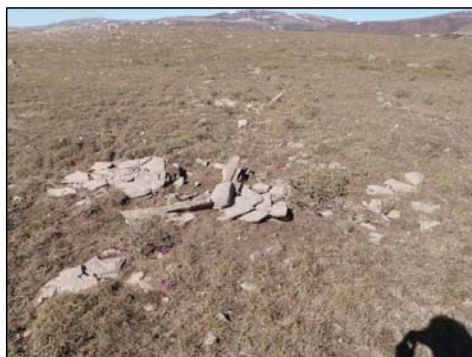
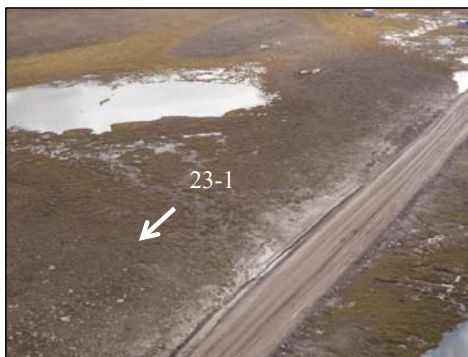
This was a dry low point during summer and nearly dry during fall. There are no connections to overwintering habitat under any flow scenario. There is no fish habitat at this crossing.

Figure 1. Views of CV-23-1 at the rail crossing during summer (A) and aerially during fall (B).

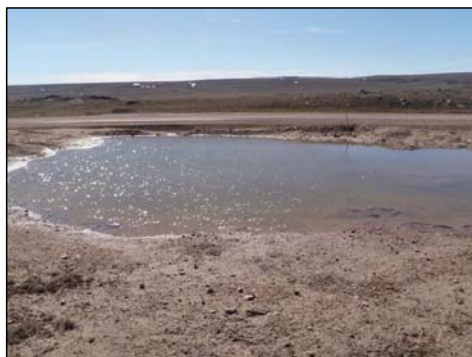
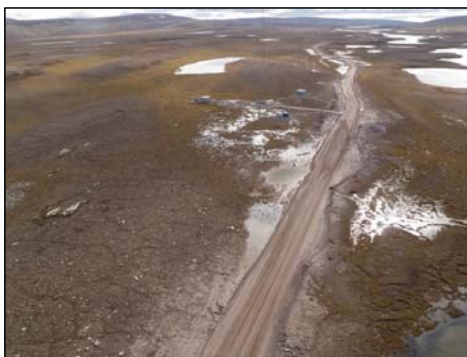
Water in this area is typically dispersed across the tundra in a very shallow film, but it also pools up against the upstream side of the Tote Road. Flows are often subsurface and there is a vertical barrier at the confluence with Phillips Creek. There is no fish habitat at this crossing.

Figure 1. Views of CV-23-2 at the rail crossing during summer (A) and aerially during fall (B).

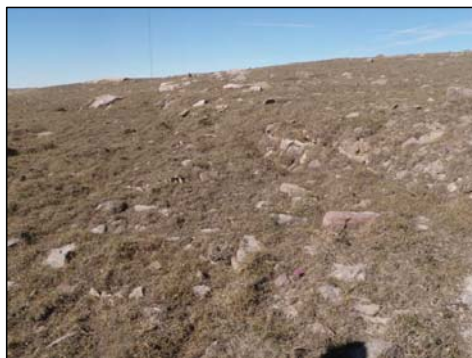
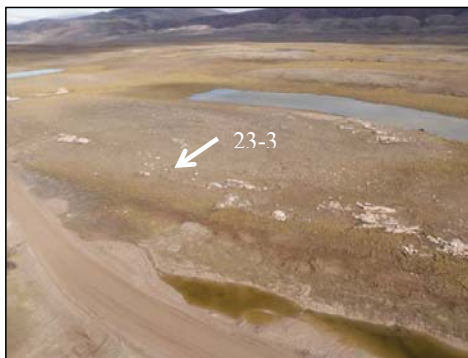
This was a dry spot in 2018. There is no fish habitat at this crossing.

Figure 1. Views of CV-23-3 at the rail crossing during summer (A) and aerially during fall (B).

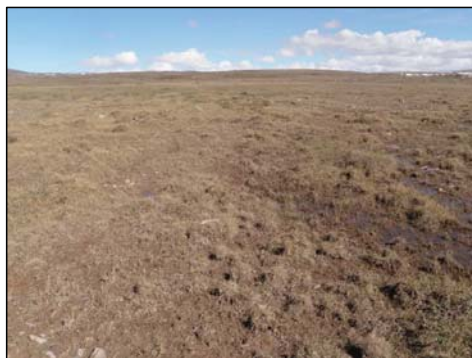
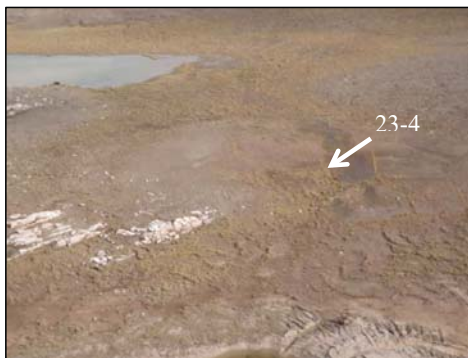
This was a dry or nearly dry low point in 2018. There is no fish habitat at this crossing.

Figure 1. Views of CV-23-4 at the rail crossing during summer (A) and aerially during fall (B).

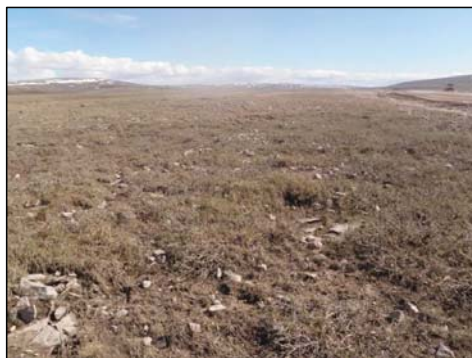
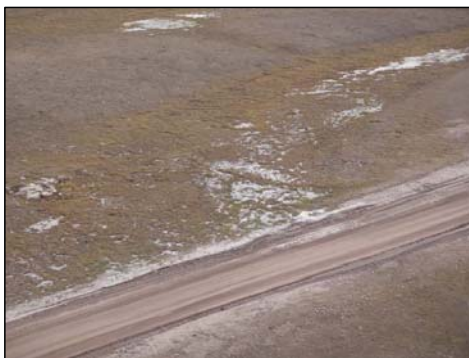
This was a dry or nearly dry low point in 2018. There is no fish habitat at this crossing.

Figure 1. Views of CV-24-1 at the rail crossing during summer (A) and aerially during fall (B).

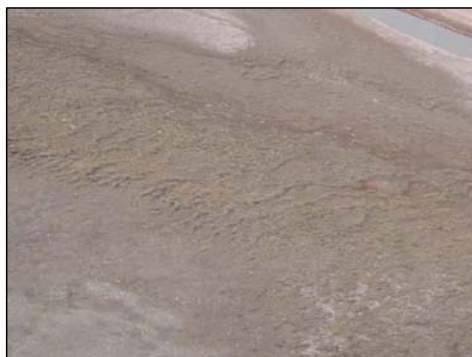
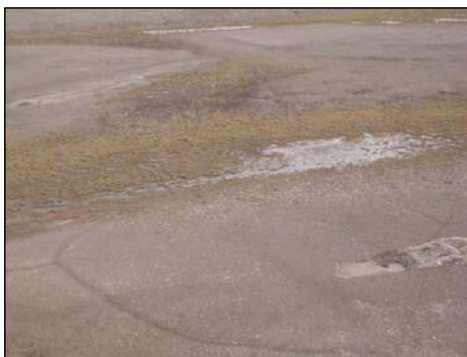
This is a dry or nearly dry marshy terrestrial spot with no connections to other waterbodies and multiple upstream and downstream soft barriers (subsurface flow). There is no fish habitat at this crossing.

Figure 1. Aerial views of CV-24-3 at the rail crossing during summer (A) and fall (B).

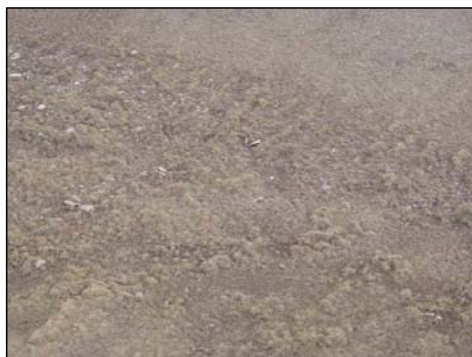
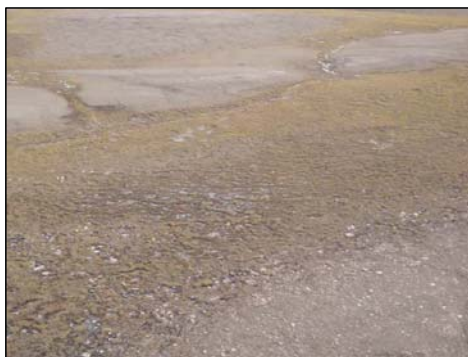
This is a dry or nearly dry marshy terrestrial spot with no connections to other waterbodies and multiple upstream and downstream soft barriers (subsurface flow). This is part of the same system as several other crossings. There is no fish habitat at this crossing.

Figure 1. Aerial views of CV-25-1 at the rail crossing during summer (A) and fall (B).

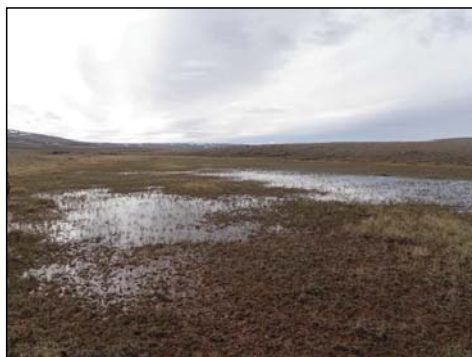
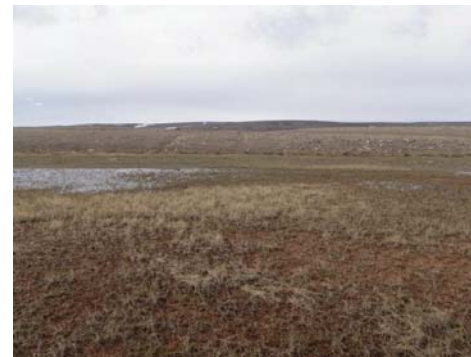
This is a marshy terrestrial spot with no connections to other waterbodies and multiple upstream and downstream soft barriers (no surface water). This is part of the same system as several other nearby crossings. There is no fish habitat at this crossing.

Figure 1. Views of CV-25-2 at the rail crossing during summer looking upstream (A) downstream (B) and across (C).

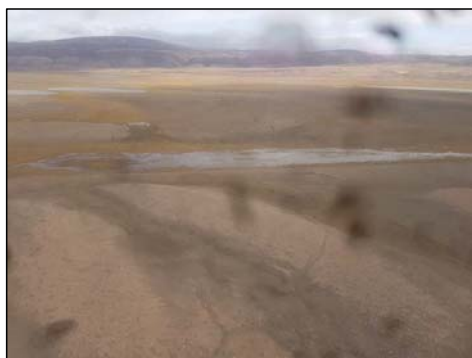
A
Figure 2. Aerial view of CV-25-2 during fall.

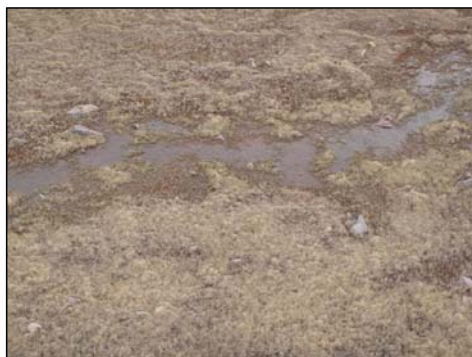
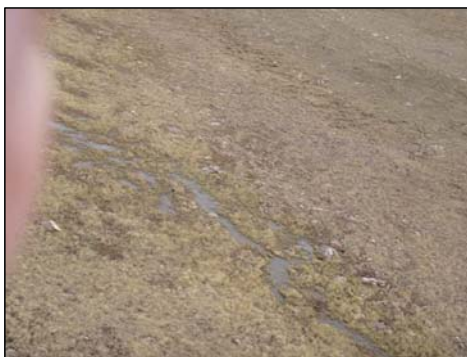
This is a marshy terrestrial spot with no connections to other waterbodies and multiple upstream and downstream soft barriers (no surface water). This is part of the same system as several other nearby crossings. There is no fish habitat at this crossing.

Figure 1. Aerial views of CV-25-3 at the rail crossing during summer (A) and (B), and fall (C).

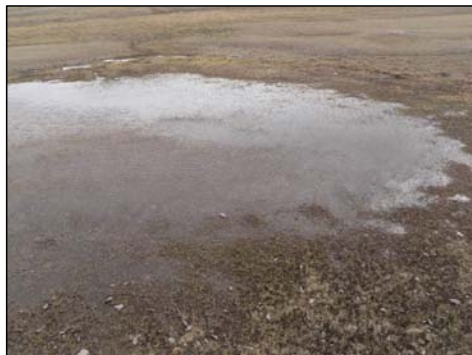
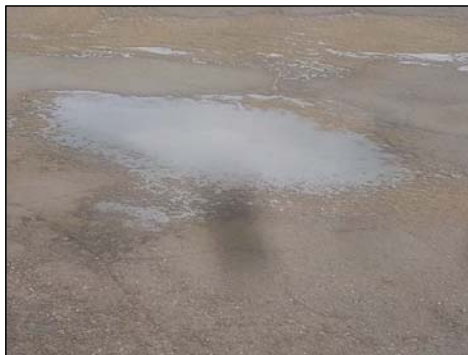
This is a small, shallow pond that is part of a marshy terrestrial complex with no connections to overwintering waterbodies and multiple upstream and downstream soft barriers (no surface water). This is part of the same system as several other nearby crossings. There is no fish habitat at this crossing.

Figure 1. Aerial views of CV-26-1 at the rail crossing during summer (A) and fall (B).

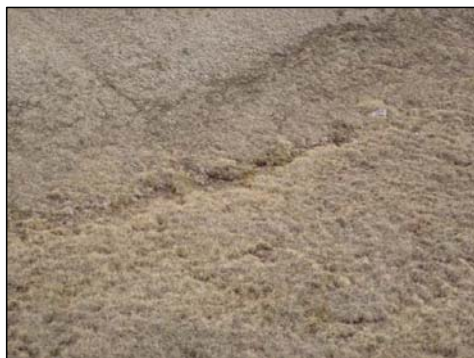
A

This was a dry low point in 2018. There is no fish habitat at this crossing.

Figure 1. Aerial view of CV-26-3 at the rail crossing during summer (A).

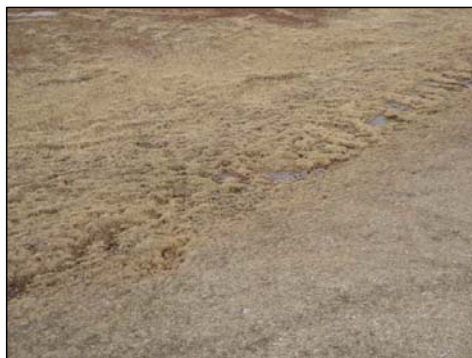
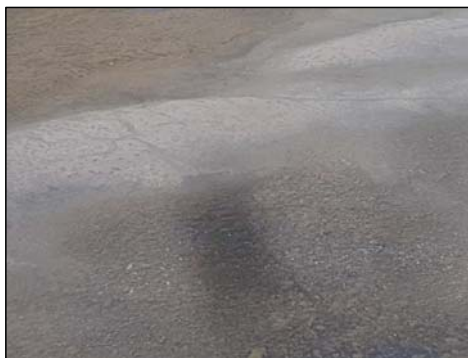
A

This was a nearly dry low point in 2018. There is no fish habitat at this crossing.

Figure 1. Aerial views of CV-26-4 at the rail crossing during summer (A) and fall (B).

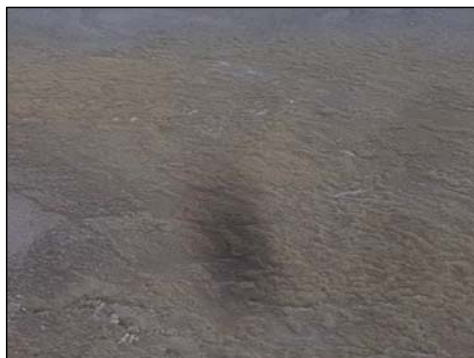
A

This was a nearly dry low point in 2018. There is no fish habitat at this crossing.

Figure 1. Aerial view of CV-26-5 at the rail crossing during fall (A).

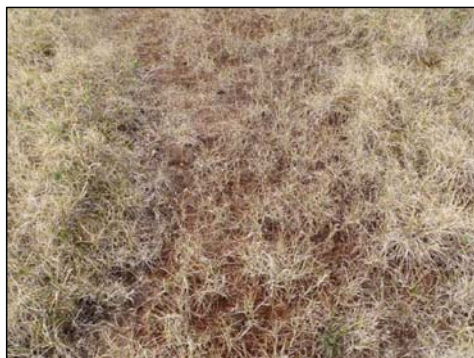
A

This was a nearly dry low point in 2018. There are no connections to other waterbodies under any flow scenarios. There is no fish habitat at this crossing.

Figure 1. Aerial view of CV-27-1 at the rail crossing during fall (A).

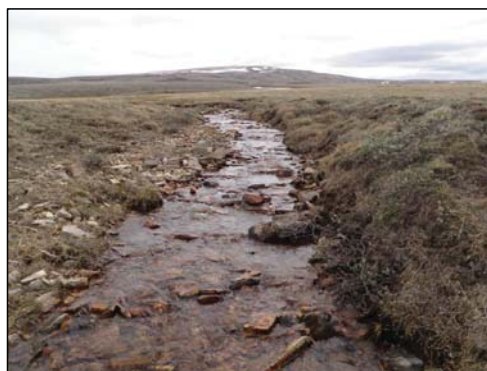
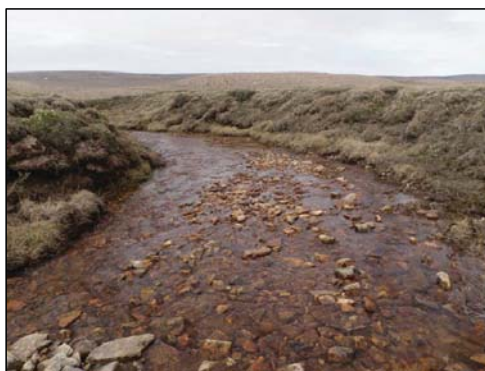
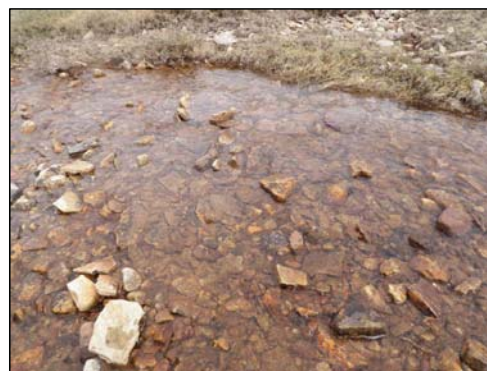
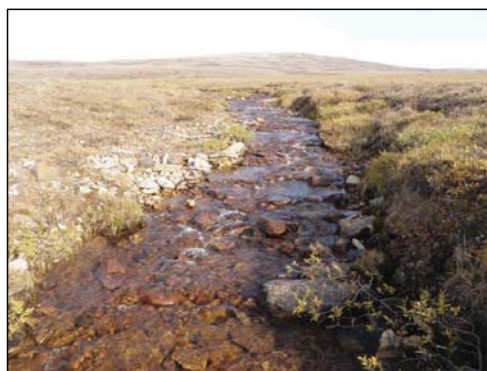
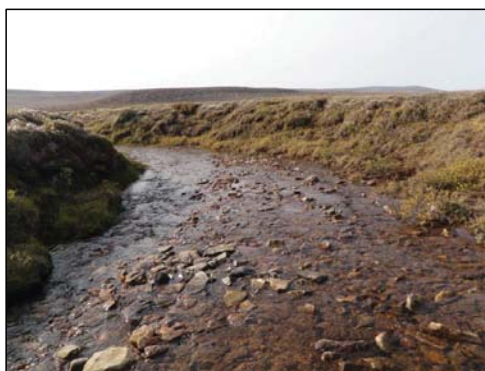
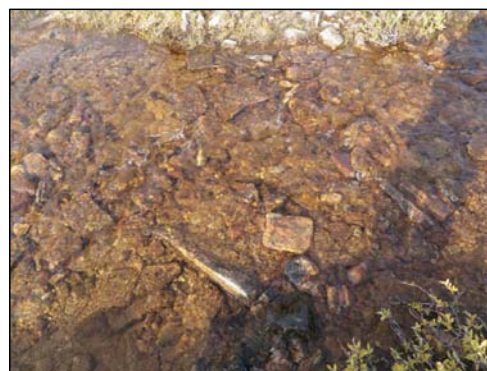
Figure 6. Summer (top) and fall (bottom) views of CV-27-2 at the rail crossing; (A) looking upstream; (B) looking downstream; and (C) looking across.

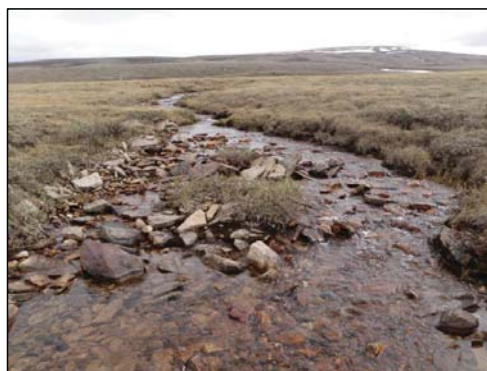
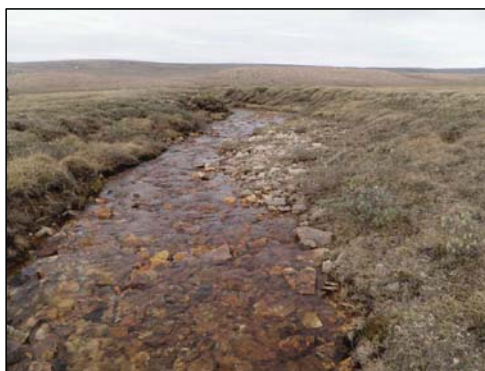
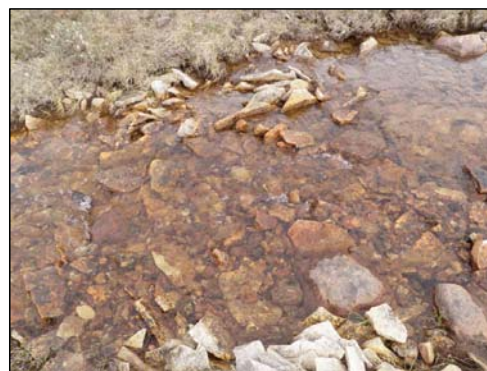
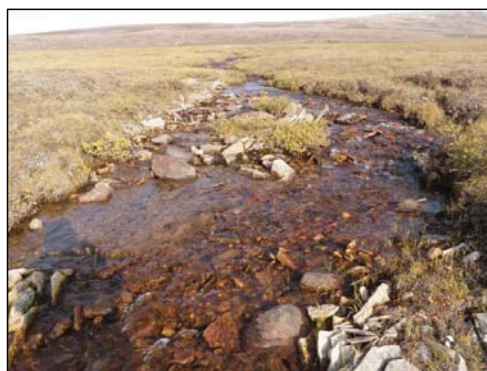
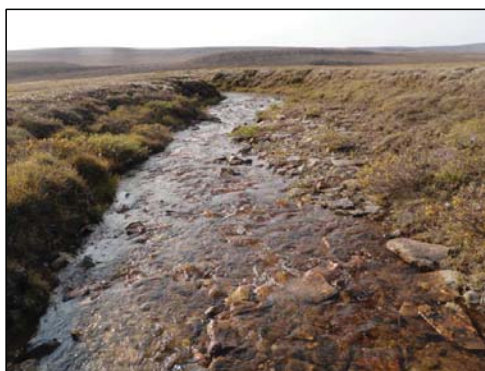
Figure 7. Summer (top) and fall (bottom) views of CV-27-2 at the 20 m upstream cross-section; (A) looking upstream; (B) looking downstream; and (C) looking across.

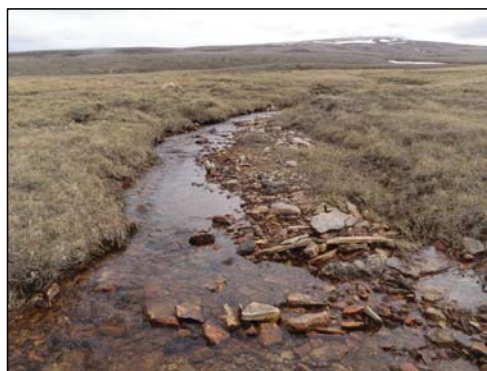
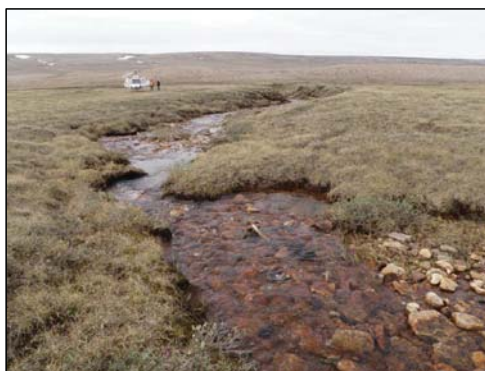
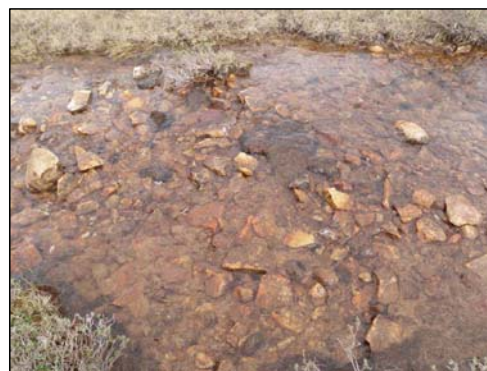
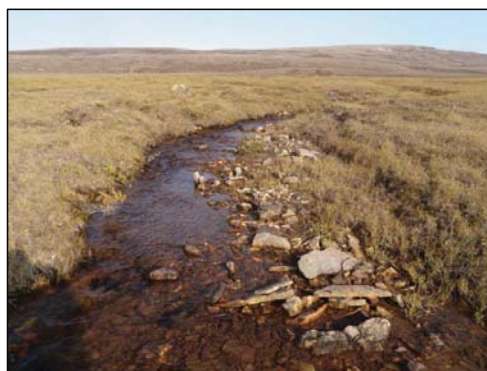
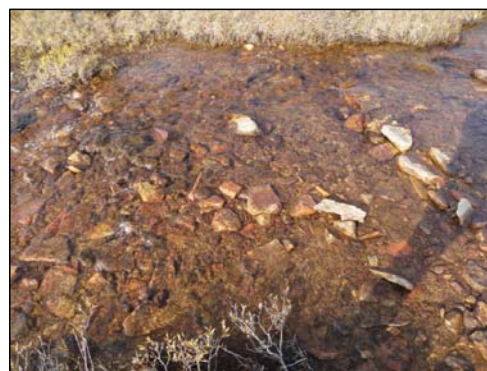
Figure 8. Summer (top) and fall (bottom) views of CV-27-2 at the 40 m upstream cross-section; (A) looking upstream; (B) looking downstream; and (C) looking across.

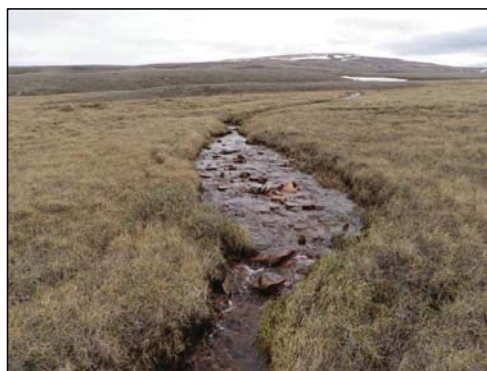
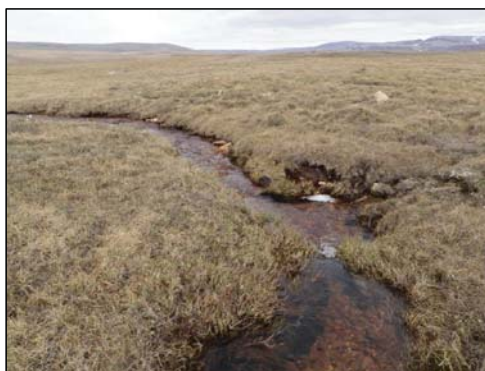
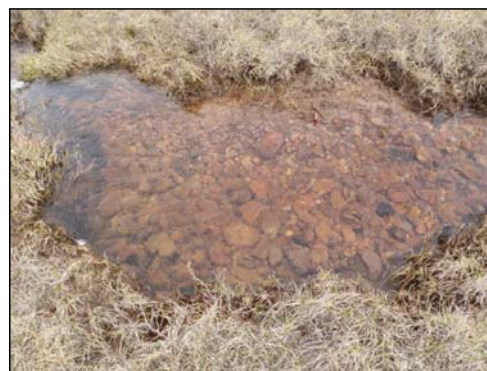
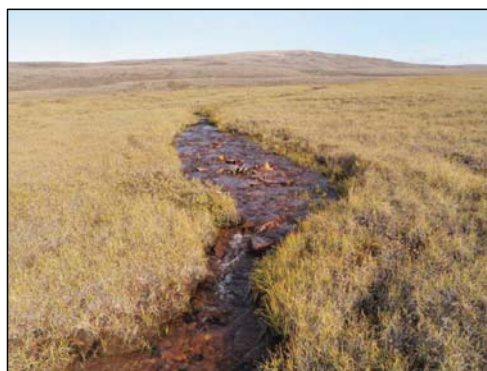
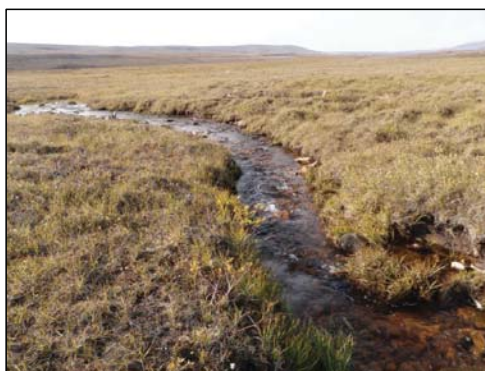
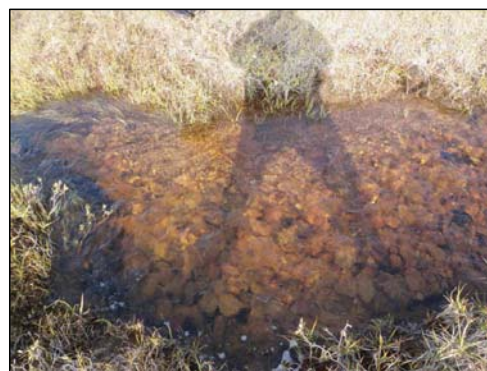
Figure 9. Summer (top) and fall (bottom) views of CV-27-2 at the 60 m upstream cross-section; (A) looking upstream; (B) looking downstream; and (C) looking across.

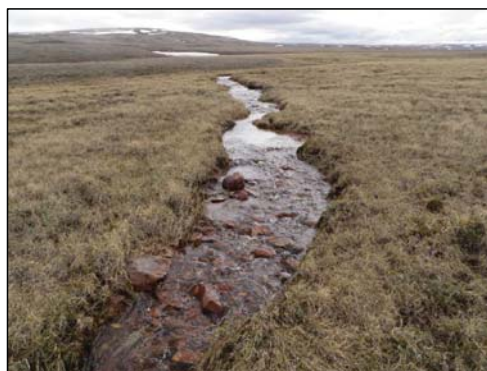
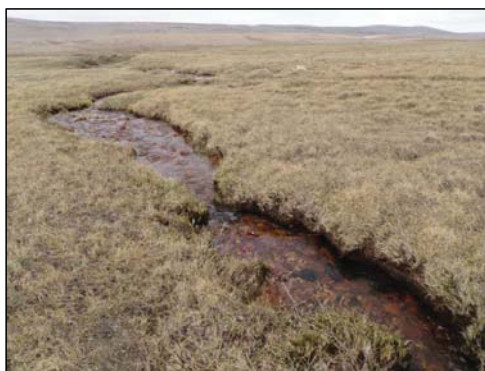
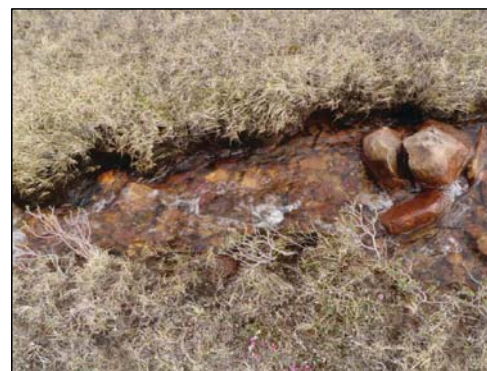
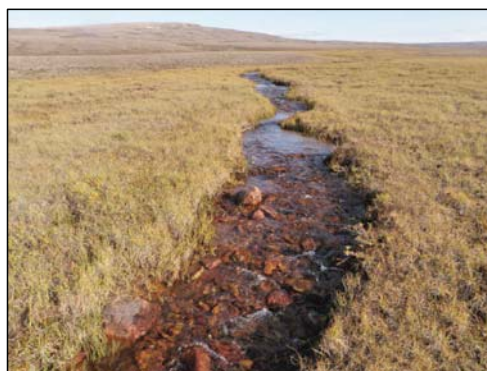
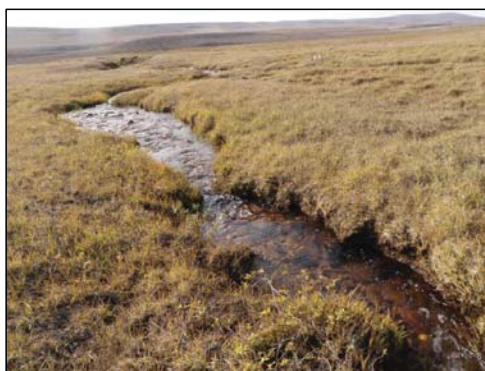
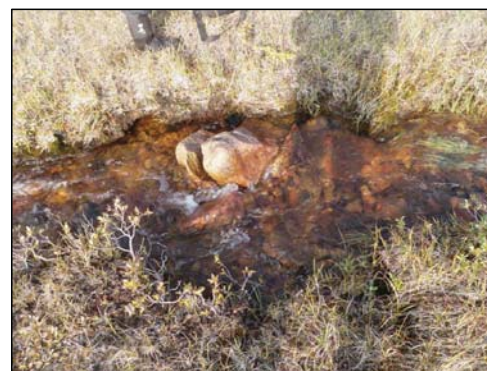
Figure 10. Summer (top) and fall (bottom) views of CV-27-2 at the 80 m upstream cross-section; (A) looking upstream; (B) looking downstream; and (C) looking across.

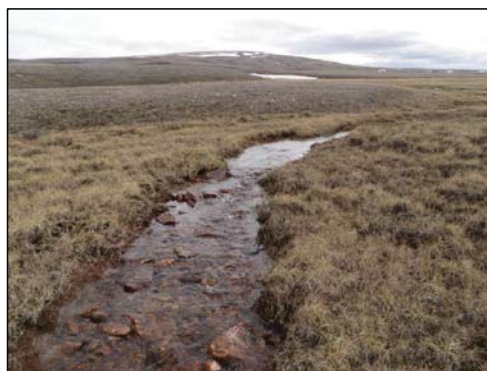
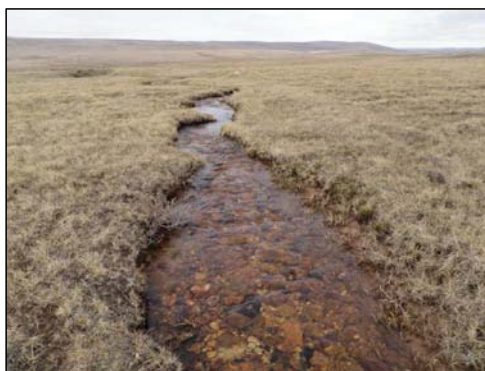
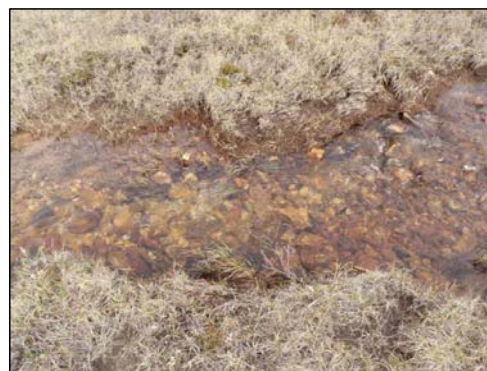
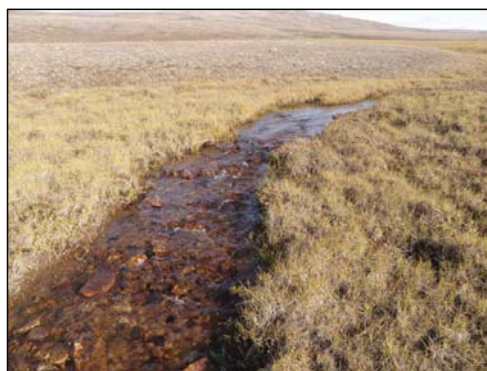
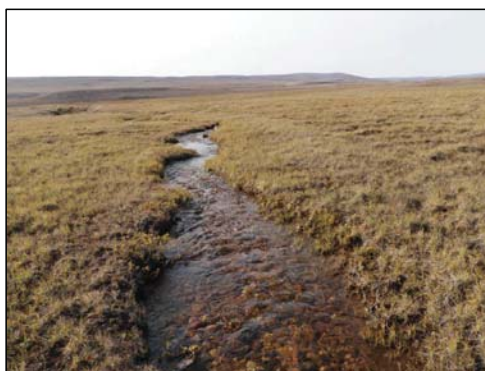
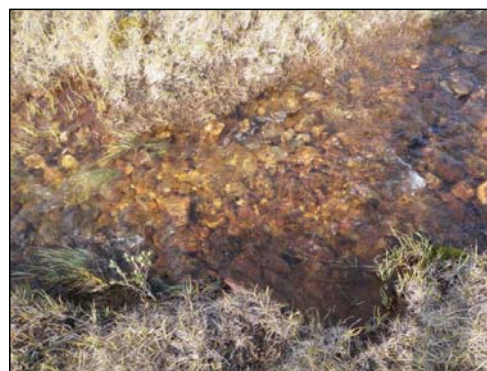
Figure 11. Summer (top) and fall (bottom) views of CV-27-2 at the 100 m upstream cross-section; (A) looking upstream; (B) looking downstream; and (C) looking across.

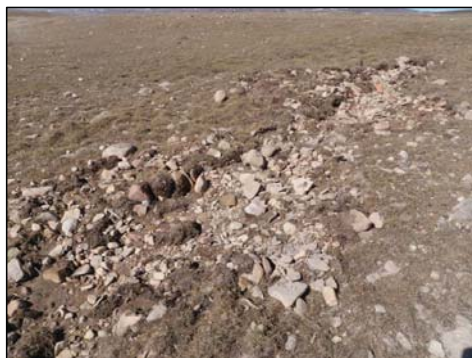
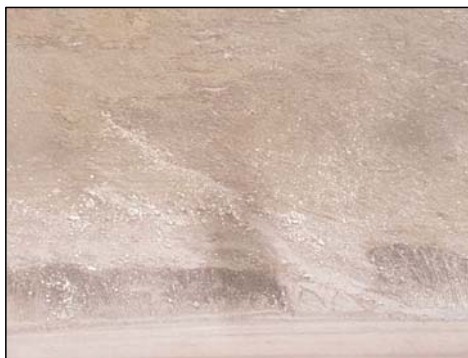
This was a dry low point in 2018. There is no fish habitat at this crossing.

Figure 1. Views of CV-27-3 at the rail crossing during summer (A) and aerially during fall (B).

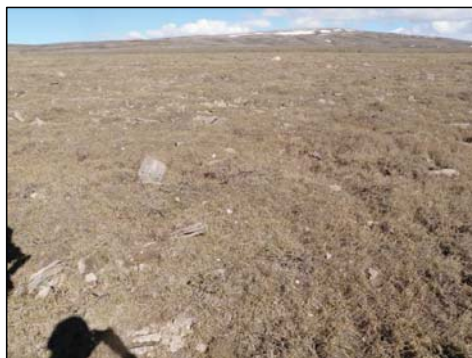
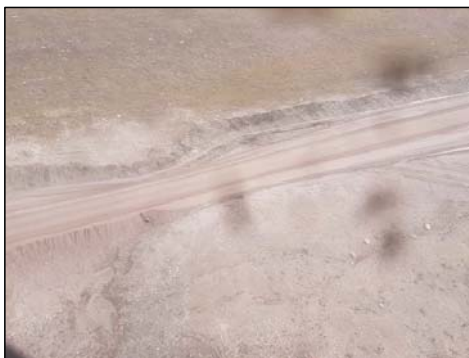
This was a dry low point in 2018. There is no fish habitat at this crossing.

Figure 1. Views of CV-27-4 at the rail crossing during summer (A) and aerially during fall (B).

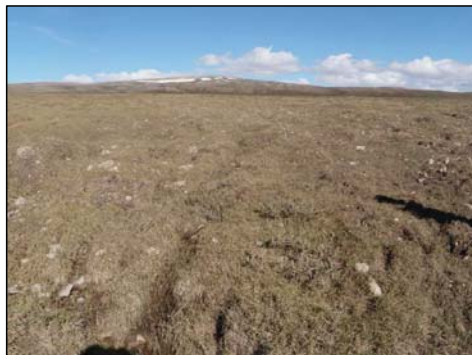
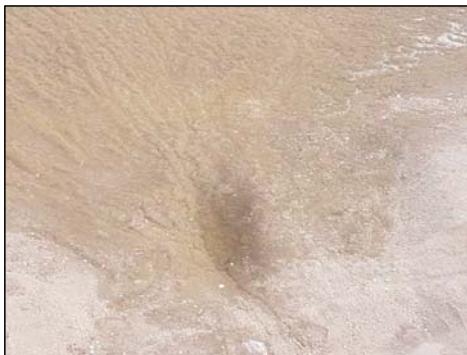
This was a nearly dry spot in 2018. Lack of water and multiple soft barriers downstream (no surface water, steep gradient) prevent fish access to the crossing. There is no fish habitat at this crossing.

Figure 1. Views of CV-27-5 at the rail crossing during summer (A) and aerially during fall (B).

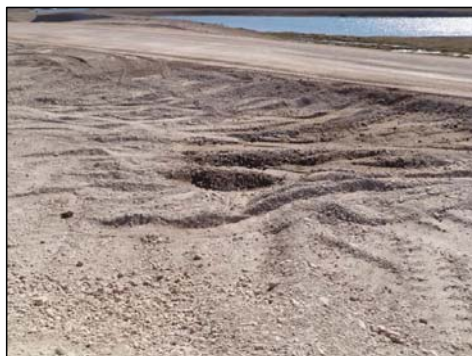
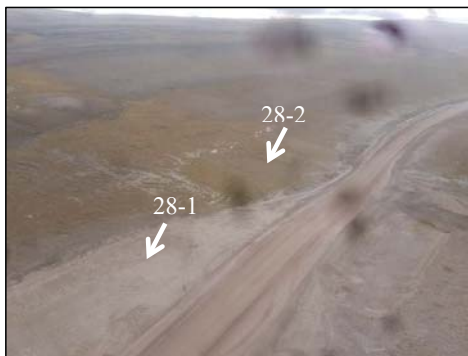
This was a dry low point in 2018. The area has already been disturbed by Tote Road activities. There is no fish habitat at this crossing.

Figure 1. Views of CV-28-1 at the rail crossing during summer (A) and aerially with nearby 28-2, during fall (B).

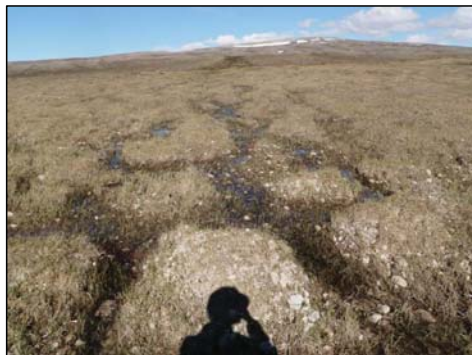
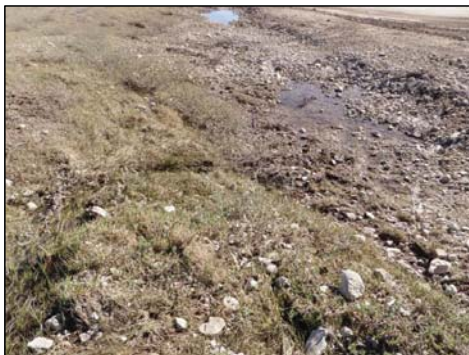
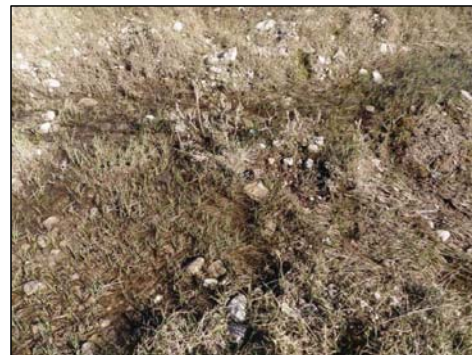
This was a marshy terrestrial area with some surface flows in 2018. There are multiple soft barriers downstream of the crossing with no fish access from Phillips Creek. There is no fish habitat at this crossing.

Figure 1. Views of CV-28-2 at the rail crossing during summer, looking upstream (A) downstream (B) and across (C).

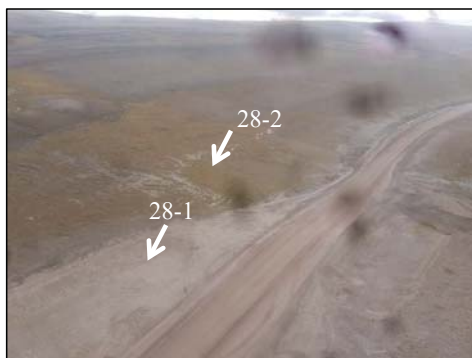
Figure 2. Aerial view of CV-28-2 and nearby 28-1 during fall.

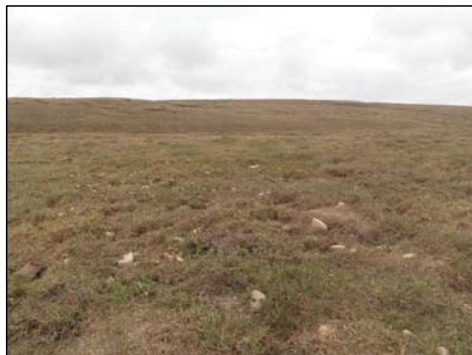
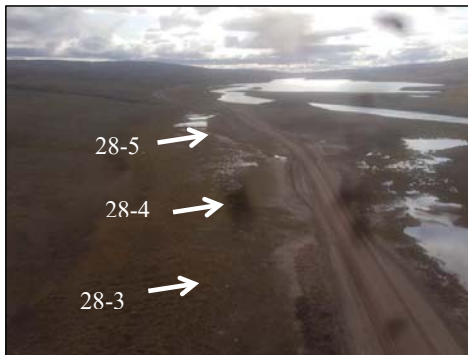
This was a dry to nearly dry low point during 2018. It is part of the same marshy terrestrial area as 28-4 and 28-5 characterized by disconnected patches of shallow surface water and no connection to larger waterbodies. There is no fish habitat at this crossing.

Figure 1. Views of CV-28-3 at the rail crossing during summer (A) and aerially, with 28-4 and 28-5, during fall (B).

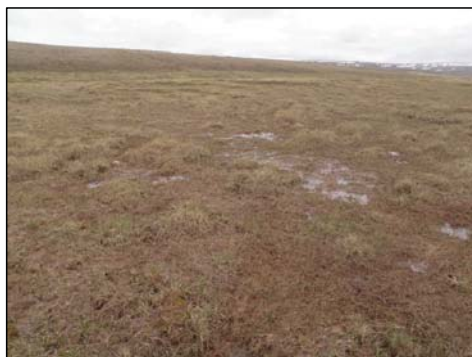
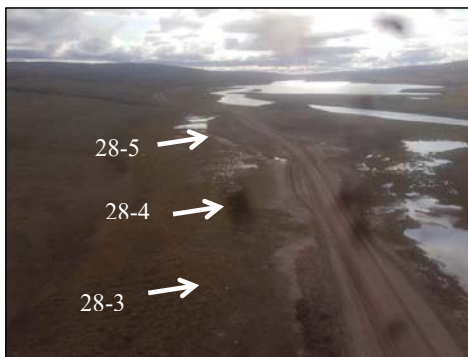
This was a dry to nearly dry low point during 2018. It is part of the same marshy terrestrial area as 28-3 and 28-5 characterized by disconnected patches of shallow surface water and no connection to larger waterbodies. There is no fish habitat at this crossing.

Figure 1. Views of CV-28-4 at the rail crossing during summer (A) and aerially, with 28-3 and 28-5, during fall (B).

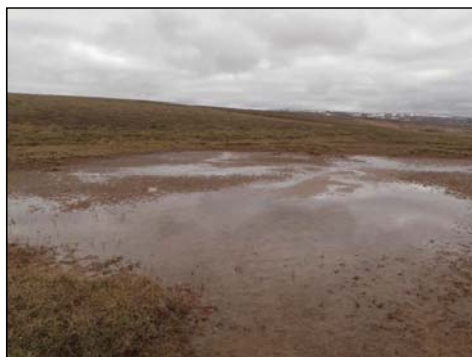
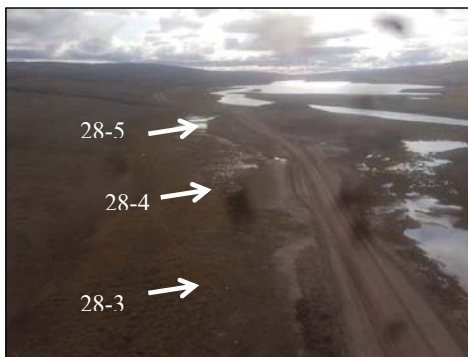
This was a barely wetted pond in 2018. It is part of the same marshy terrestrial area as 28-3 and 28-4 characterized by disconnected patches of shallow, fishless surface water and no connection to larger waterbodies. There is no fish habitat at this crossing.

Figure 1. Views of CV-28-5 at the rail crossing during summer (A) and aerially, with 28-3 and 28-4, during fall (B).

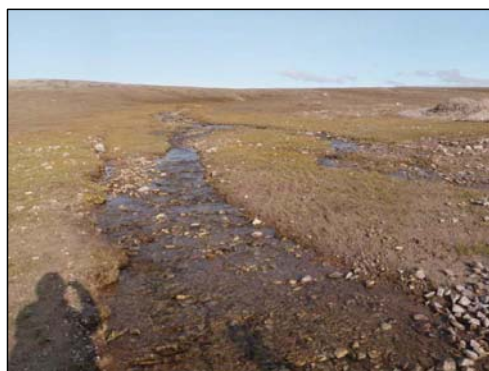
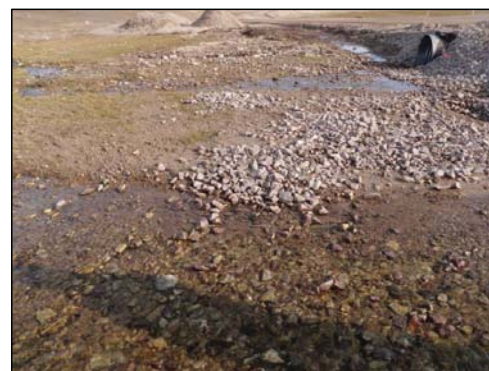
Figure 1. Summer (top) and fall (bottom) views of CV-28-6 at the 60 m downstream cross-section; (A) looking upstream; (B) looking downstream; and (C) looking across.

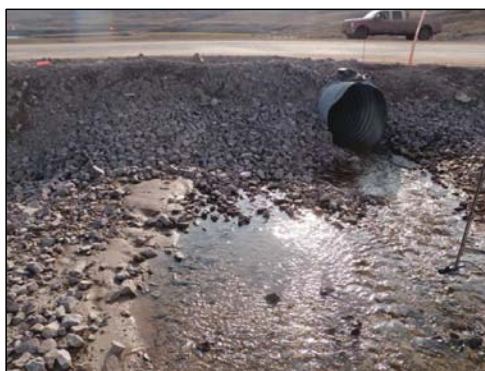
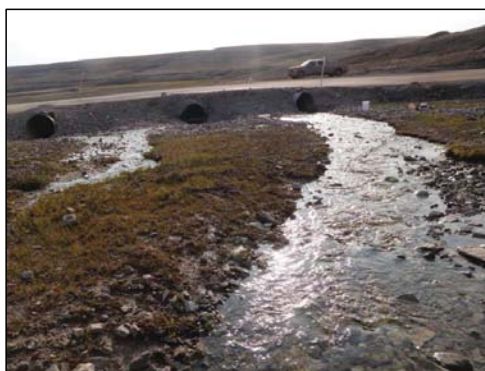
Figure 2. Summer (top) and fall (bottom) views of CV-28-6 at the 40 m downstream cross-section; (A) looking upstream; (B) looking downstream; and (C) looking across.

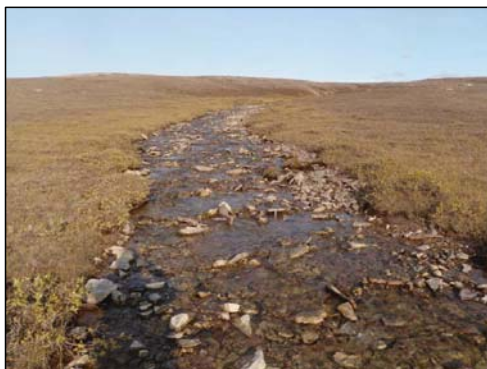
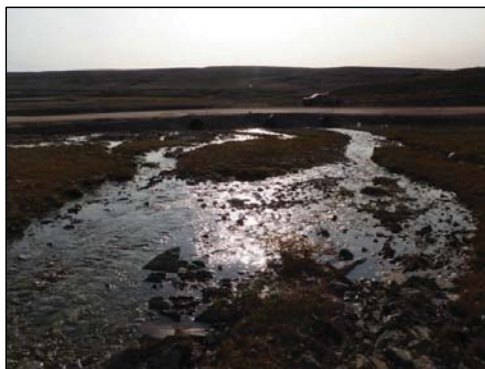
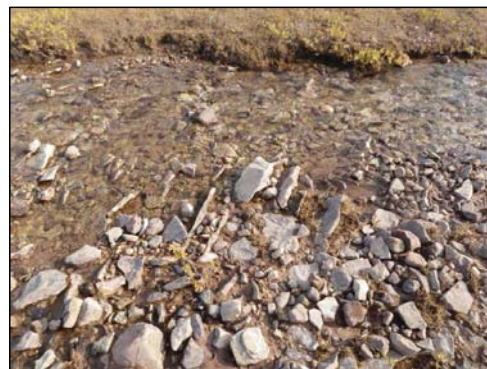
Figure 3. Summer (top) and fall (bottom) views of CV-28-6 at the 20 m downstream cross-section; (A) looking upstream; (B) looking downstream; and (C) looking across.

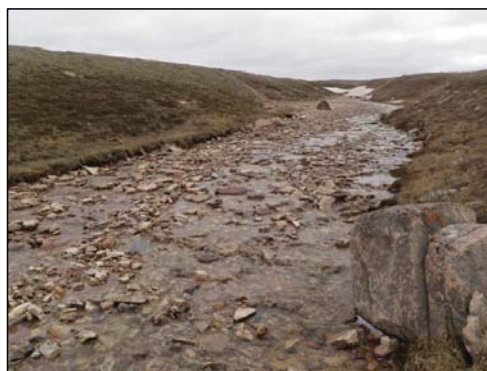
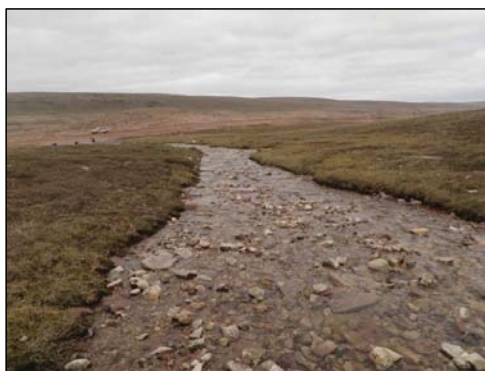
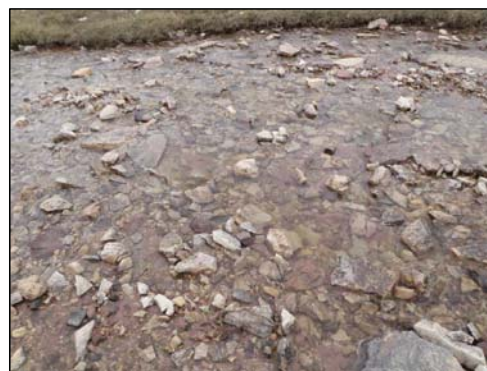
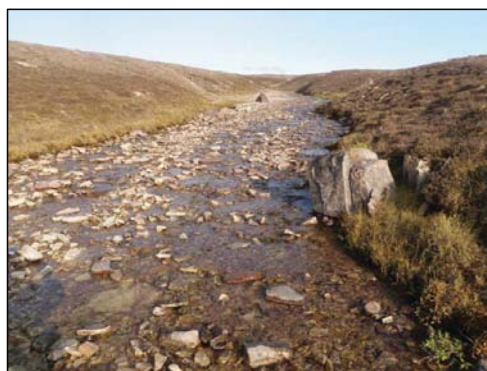
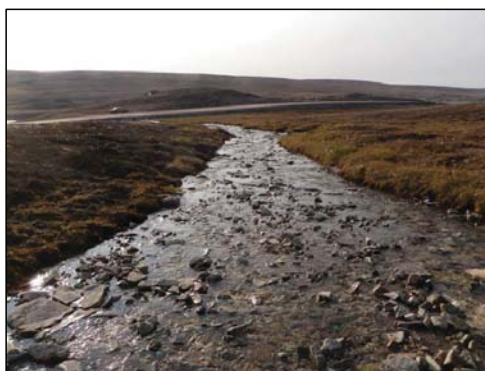
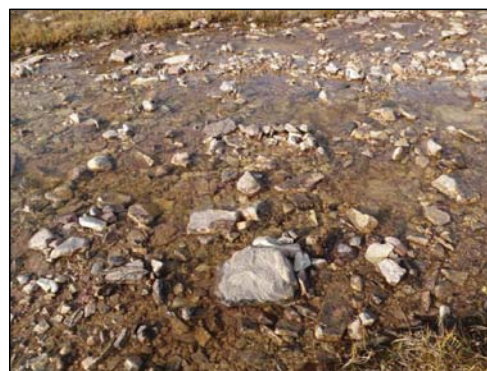
Figure 7. Summer (top) and fall (bottom) views of CV-28-6 at the 60 m upstream cross-section; (A) looking upstream; (B) looking downstream; and (C) looking across.

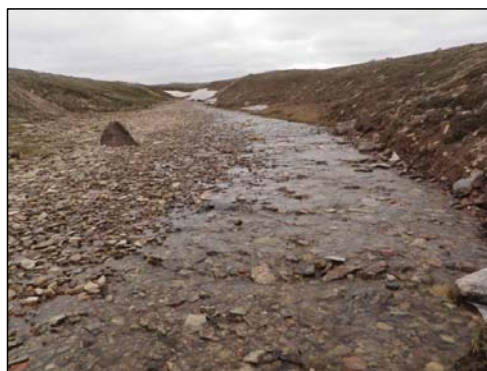
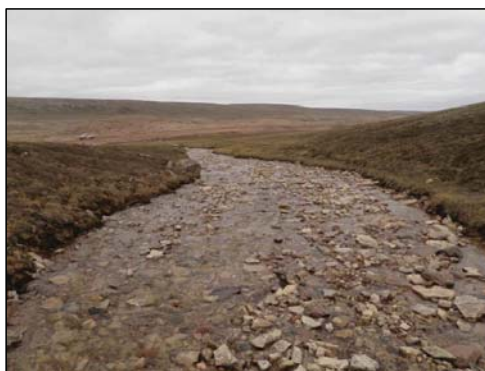
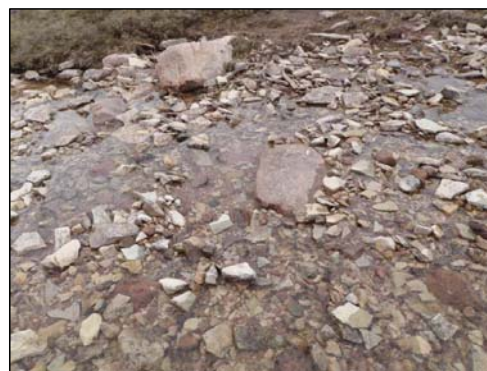
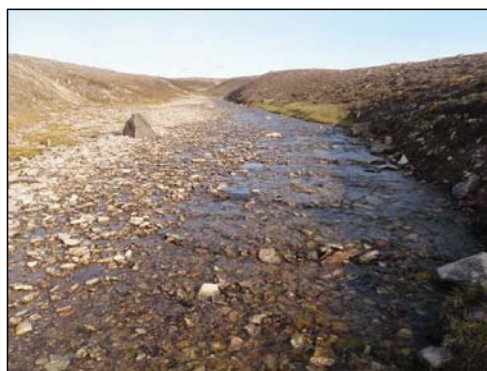
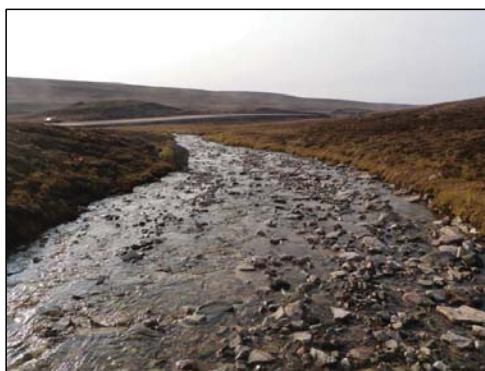
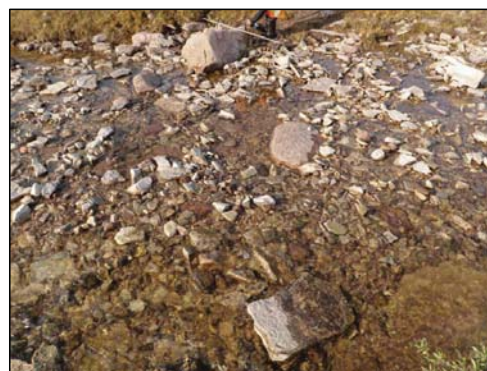
Figure 8. Summer (top) and fall (bottom) views of CV-28-6 at the 80 m upstream cross-section; (A) looking upstream; (B) looking downstream; and (C) looking across.
