Phase 2 Milne Rail Corridor Aquatic Habitat Assessment

**Baffinland Iron Mines
Mary River Project**

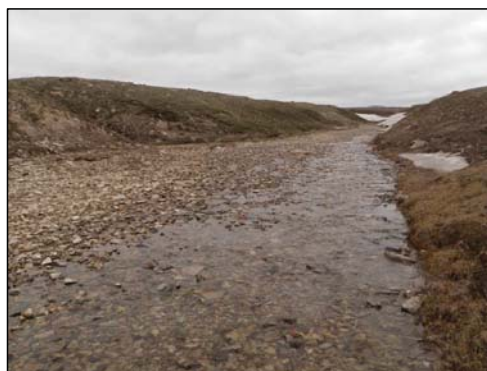
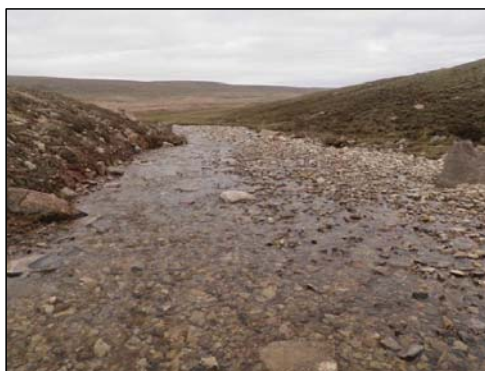
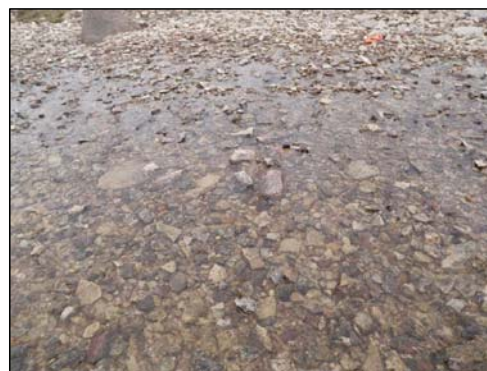
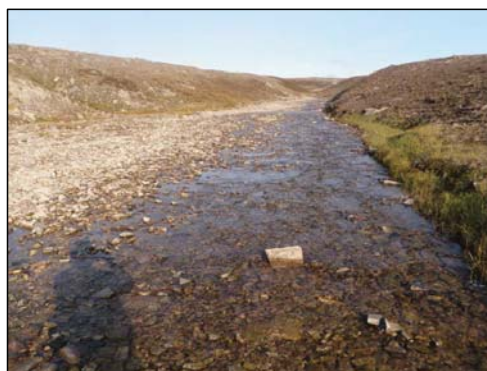
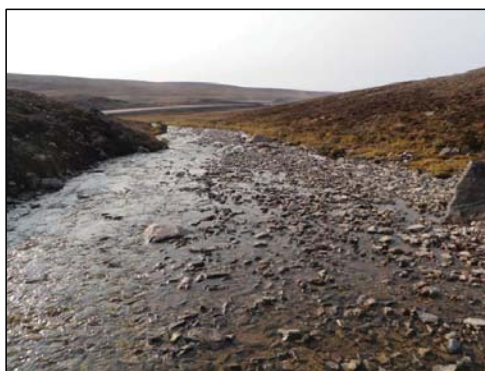
Figure 9. Summer (top) and fall (bottom) views of CV-28-6 at the 100 m upstream cross-section; (A) looking upstream; (B) looking downstream; and (C) looking across.

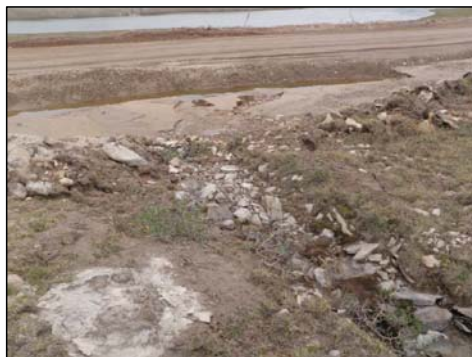
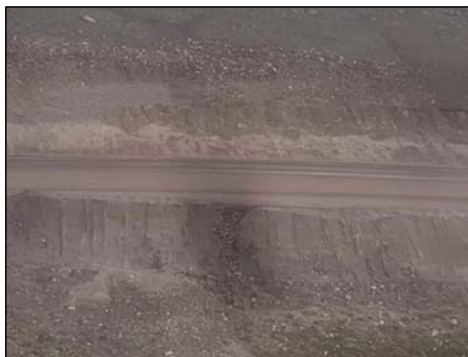
This was a mostly dry spot during 2018 with some ponding occurring alongside the Tote Road. Steep gradient and lack of surface flow prevent access from Phillips Creek downstream. There is no fish habitat at this crossing.

Figure 1. Views of CV-28-7 at the rail crossing during summer (A) and aerially during fall (B).

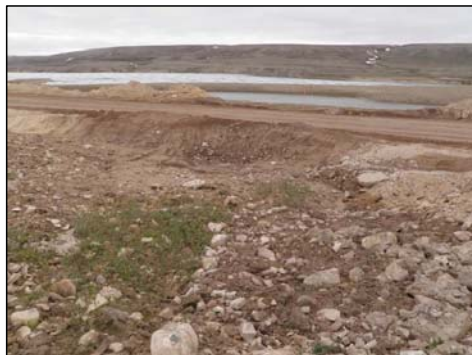
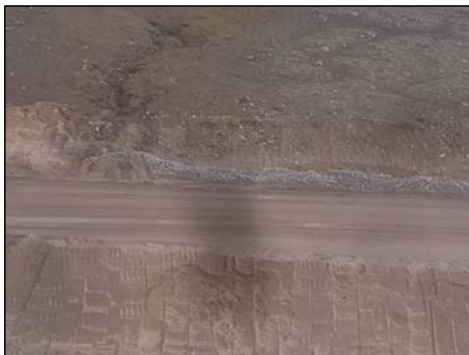
This was a mostly dry spot during 2018 with some ponding occurring alongside the Tote Road. Steep gradient and lack of surface flow prevent access from Phillips Creek downstream. There is no fish habitat at this crossing.

Figure 1. Views of CV-29-1 at the rail crossing during summer (A) and aerially during fall (B).

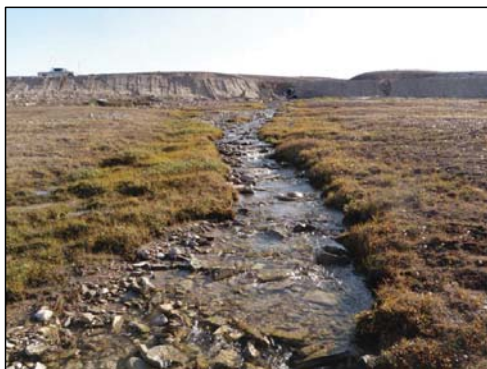
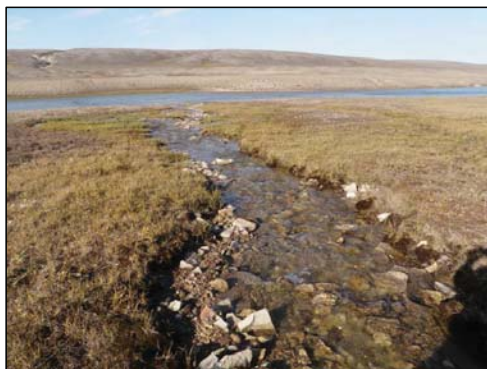
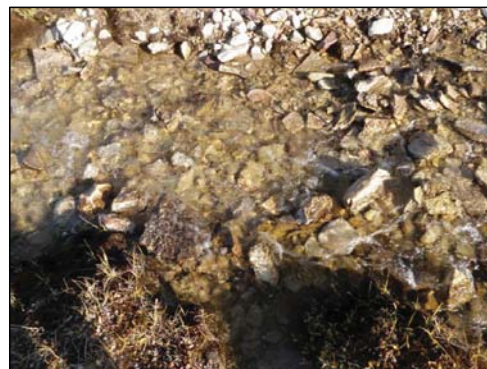
Figure 1. Summer (top) and fall (bottom) views of CV-29-2 at the 100 m downstream cross-section; (A) looking upstream; (B) looking downstream; and (C) looking across.

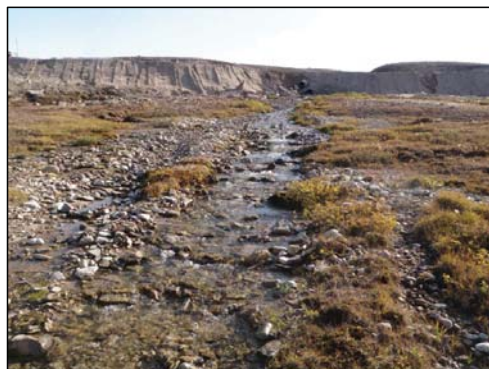
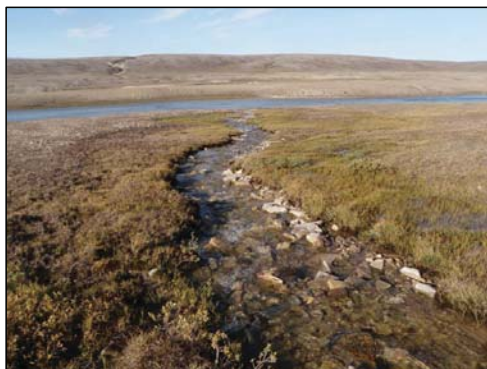
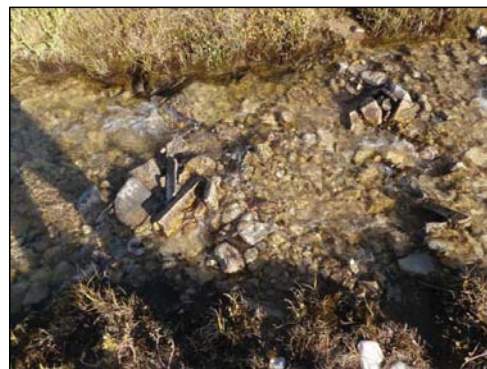
Figure 2. Summer (top) and fall (bottom) views of CV-29-2 at the 80 m downstream cross-section; (A) looking upstream; (B) looking downstream; and (C) looking across.

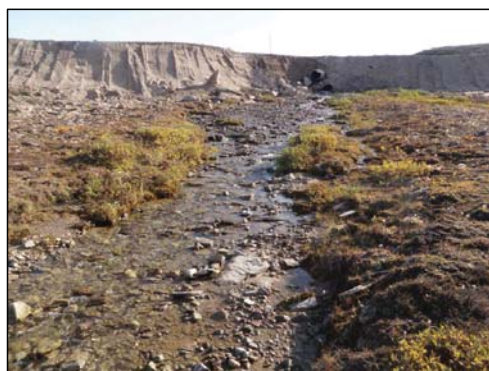
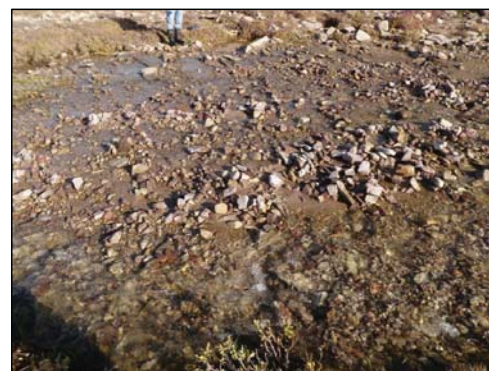
Figure 4. Summer (top) and fall (bottom) views of CV-29-2 at the 40 m downstream cross-section; (A) looking upstream; (B) looking downstream; and (C) looking across.

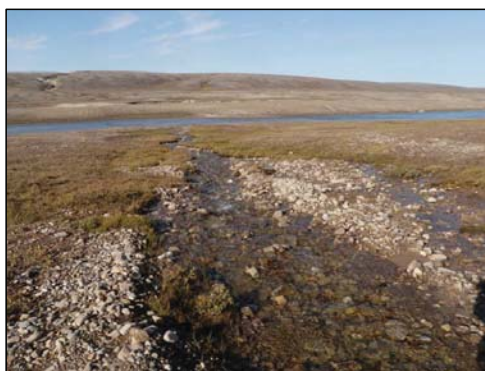
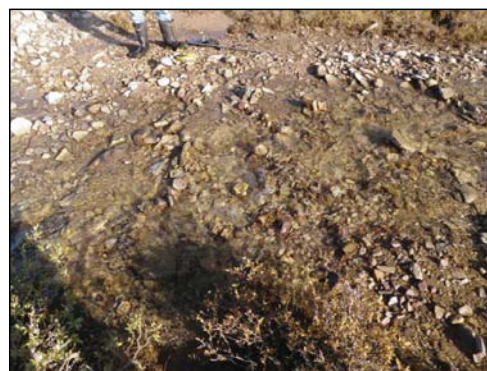
Figure 3. Summer (top) and fall (bottom) views of CV-29-2 at the 60 m downstream cross-section; (A) looking upstream; (B) looking downstream; and (C) looking across.

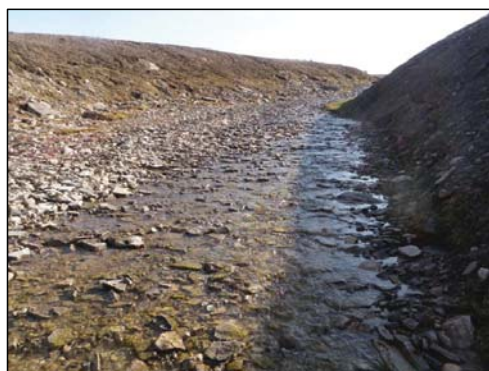
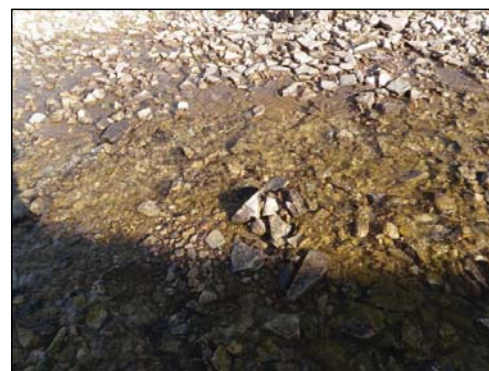
Figure 6. Summer (top) and fall (bottom) views of CV-29-2 at the 20 m upstream cross-section; (A) looking upstream; (B) looking downstream; and (C) looking across.

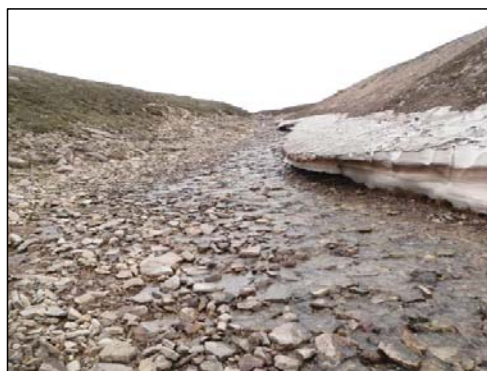
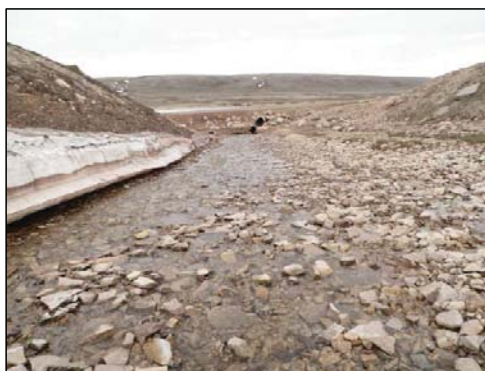
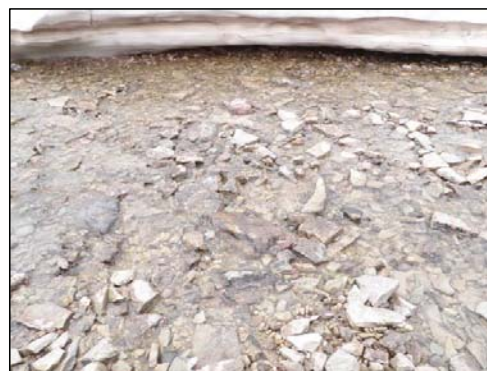
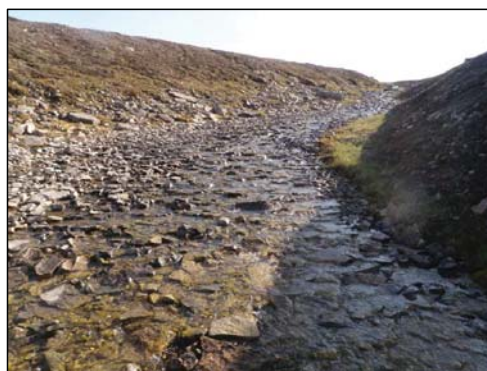
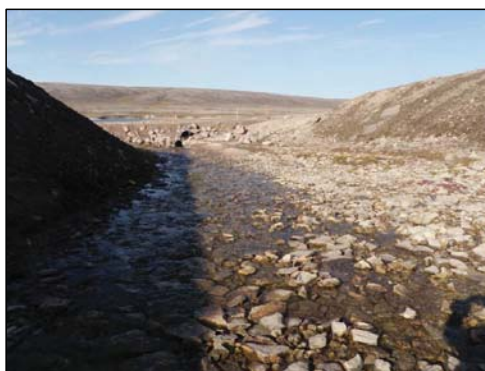
Figure 7. Summer (top) and fall (bottom) views of CV-29-2 at the 40 m upstream cross-section; (A) looking upstream; (B) looking downstream; and (C) looking across.

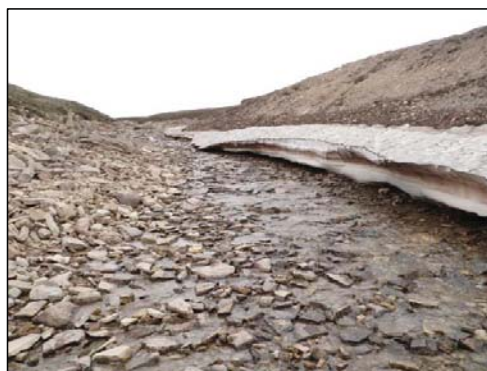
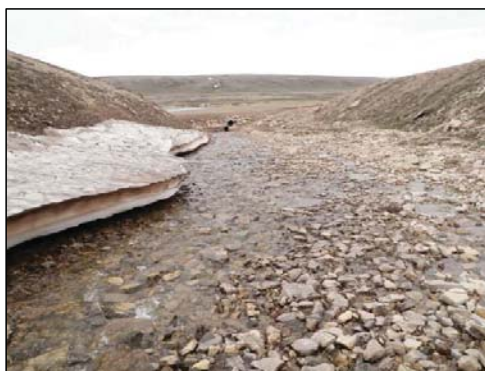
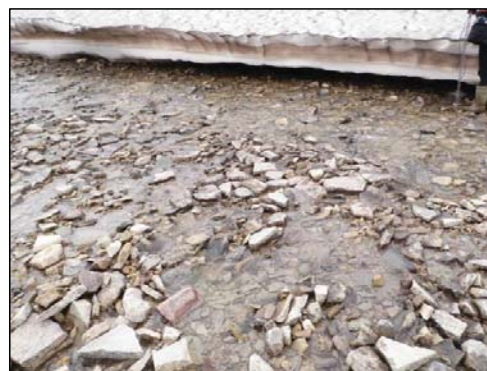
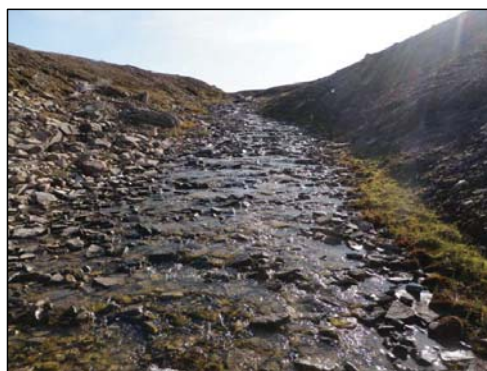
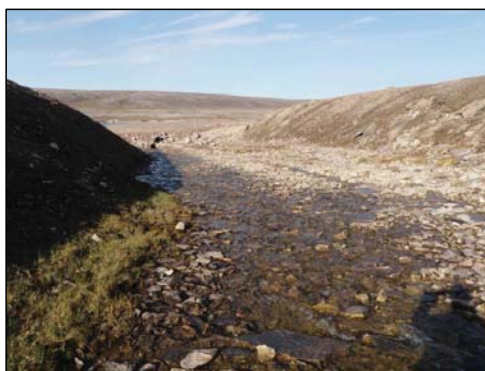
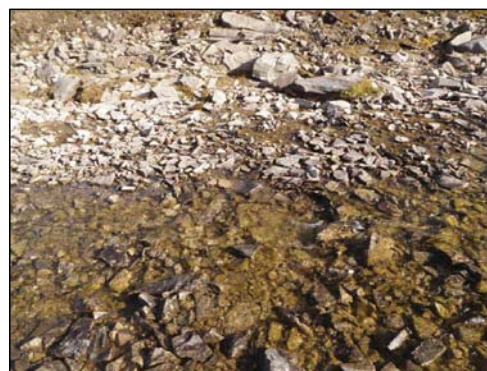
Figure 8. Summer (top) and fall (bottom) views of CV-29-2 at the 60 m upstream cross-section; (A) looking upstream; (B) looking downstream; and (C) looking across.

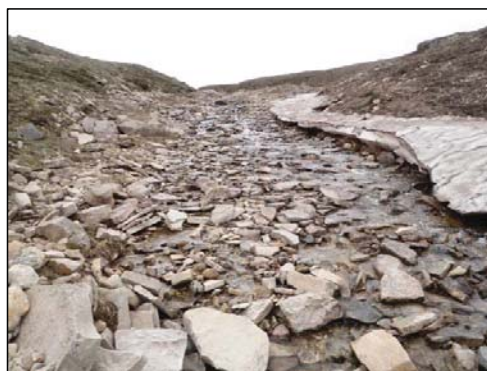
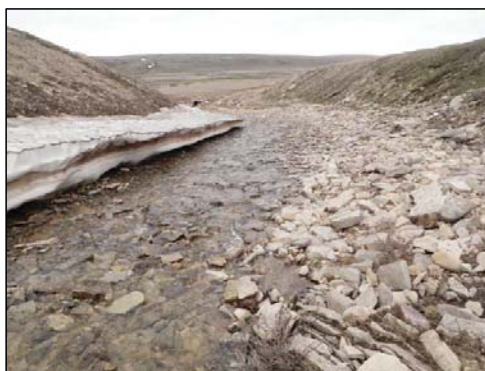
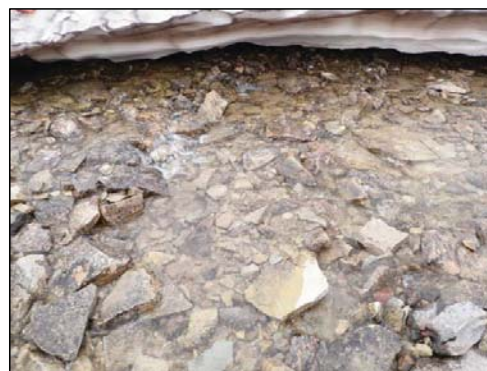
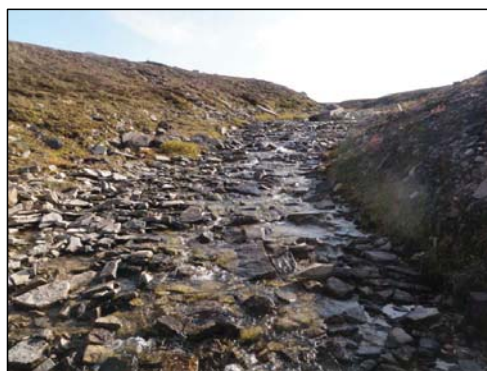
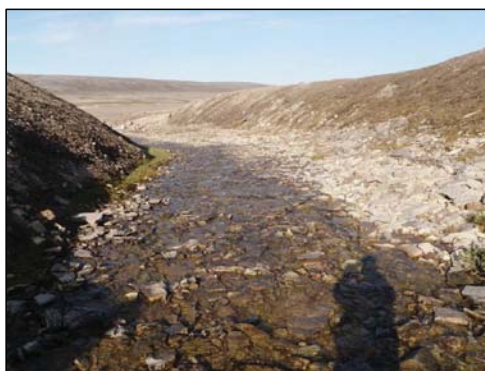
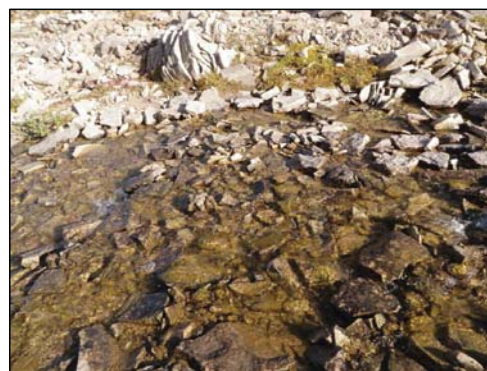
Figure 9. Summer (top) and fall (bottom) views of CV-29-2 at the 80 m upstream cross-section; (A) looking upstream; (B) looking downstream; and (C) looking across.

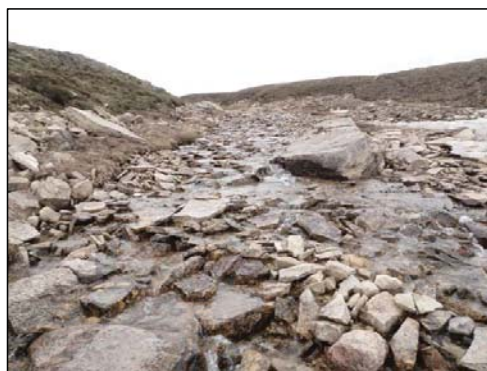
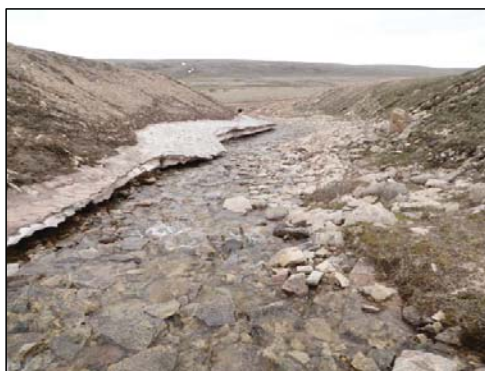
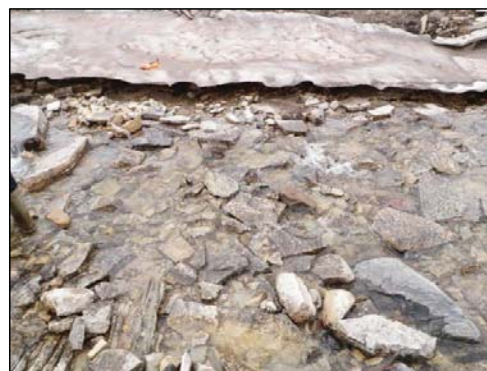
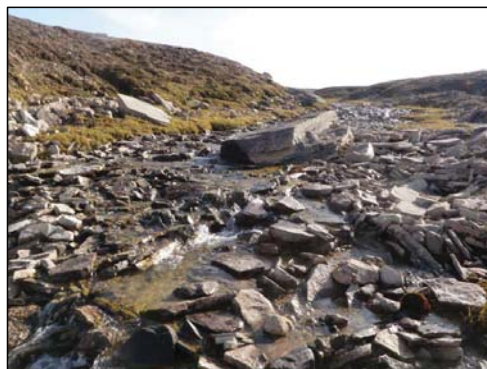
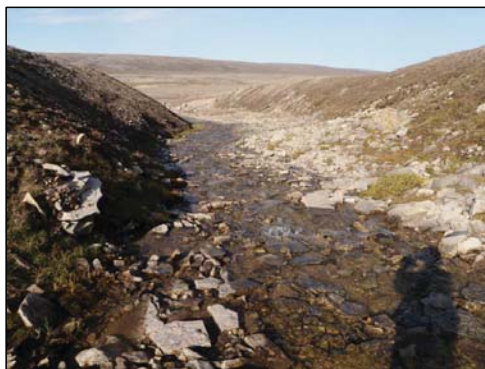
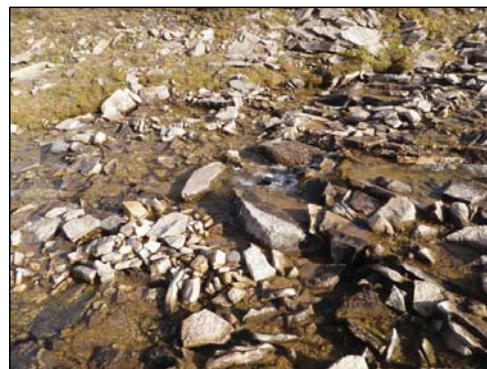
Figure 10. Summer (top) and fall (bottom) views of CV-29-2 at the 100 m upstream cross-section; (A) looking upstream; (B) looking downstream; and (C) looking across.

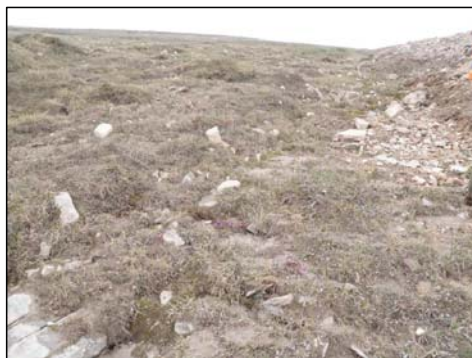
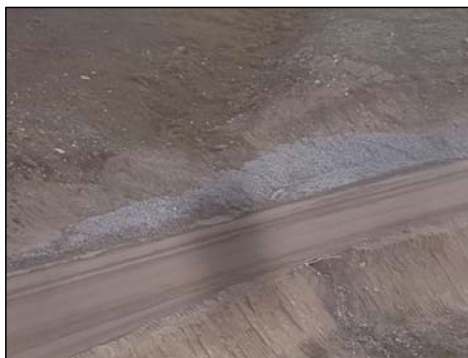
This was a dry, grassy valley in 2018. Steep gradient and lack of surface flow prevent access from Phillips Creek downstream. There is no fish habitat at this crossing.

Figure 1. Views of CV-29-3 at the rail crossing during summer (A) and aerially during fall (B).

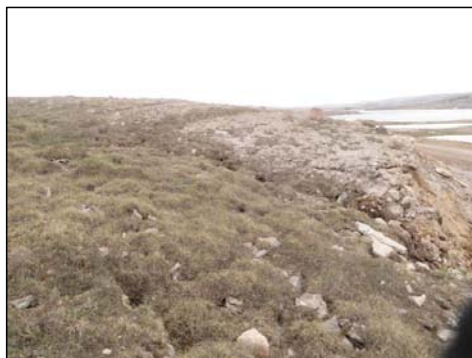
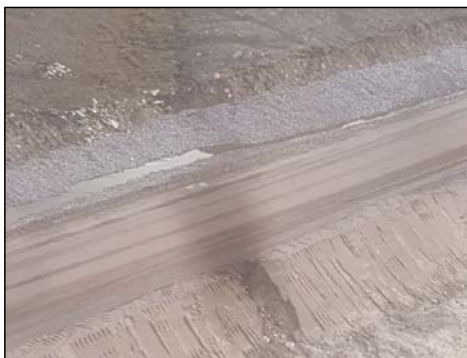
This was a dry, grassy valley in 2018. Steep gradient and lack of surface flow prevent access from Phillips Creek downstream. There is no fish habitat at this crossing.

Figure 1. Views of CV-29-4 at the rail crossing during summer (A) and aerially during fall (B).

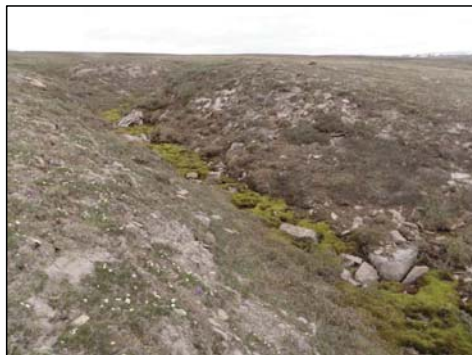
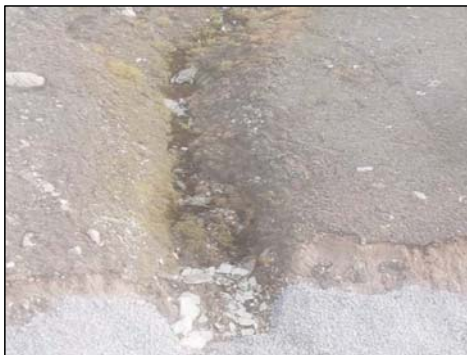
This was a nearly dry, grassy valley in 2018. Steep gradient and lack of surface flow prevent access from Phillips Creek downstream over all flow regimes. There is no fish habitat at this crossing.

Figure 1. Views of CV-29-5 at the rail crossing during summer (A) and aerially during fall (B).

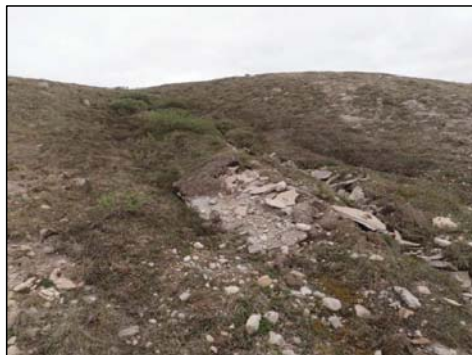
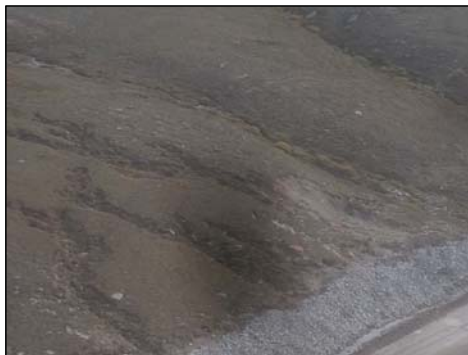
This was a dry, grassy, rocky hillside in 2018. Steep gradient and lack of surface flow prevent access from Phillips Creek downstream over all flow regimes. There is no fish habitat at this crossing.

Figure 1. Views of CV-30-1 at the rail crossing during summer (A) and aerially during fall (B).

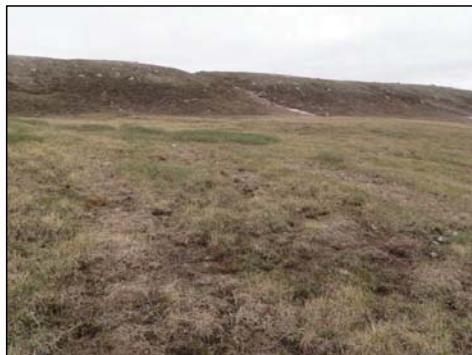
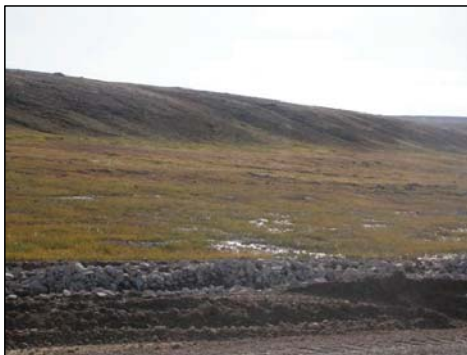
This was a dry or nearly dry, grassy hillside in 2018. Steep gradient and lack of a channel or surface flow prevent access from Phillips Creek downstream over all flow regimes. There is no fish habitat at this crossing.

Figure 1. Views of CV-30-2 at the rail crossing during summer (A) and fall (B).

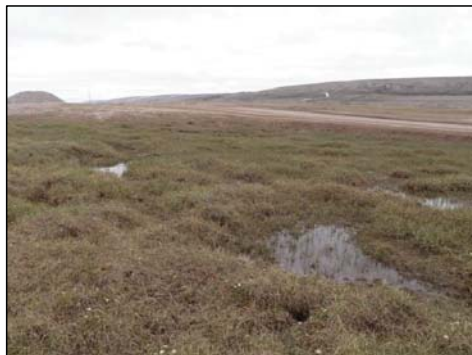
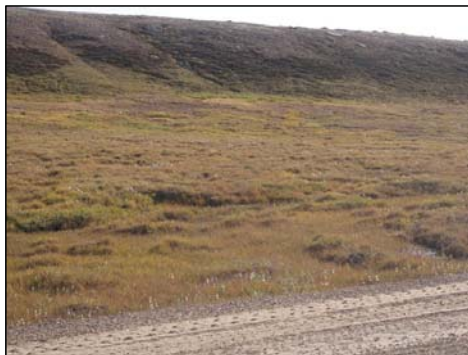
This was a nearly dry, grassy hillside in 2018. Steep gradient and lack of surface flow and connectivity prevent access from Phillips Creek downstream over all flow regimes. There is no fish habitat at this crossing.

Figure 1. Views of CV-30-3 at the rail crossing during summer (A) and fall (B).

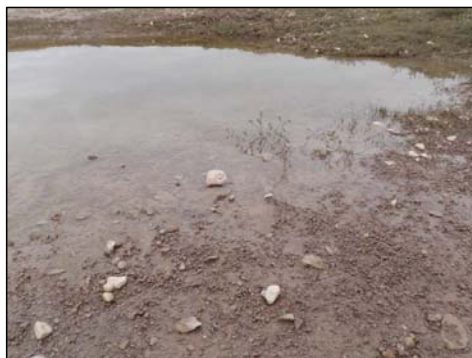
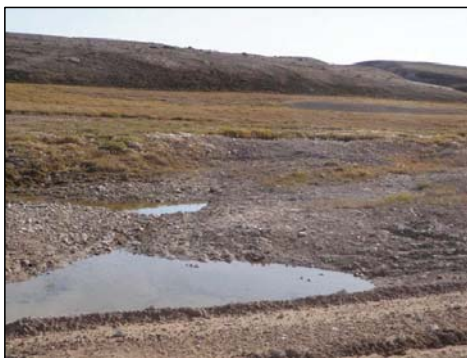
This was a Tote Road ditch pond with very little water in 2018. This site is not connected to any other waterbody. There is no fish habitat at this crossing.

Figure 1. Views of CV-30-4 at the rail crossing during summer (A) and fall (B).

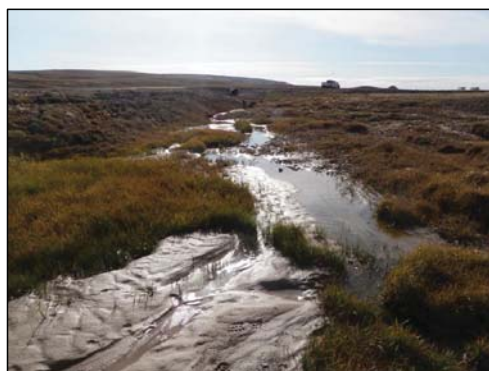
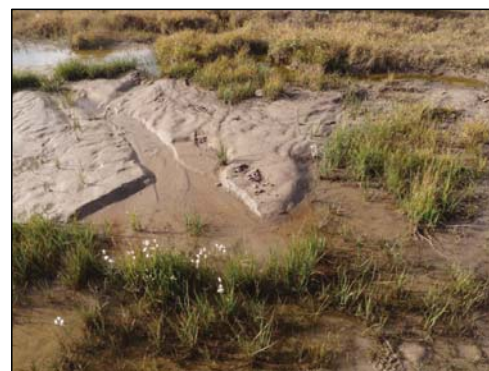
Figure 1. Summer (top) and fall (bottom) views of CV-30-5 at the 100 m downstream cross-section; (A) looking upstream; (B) looking downstream; and (C) looking across.

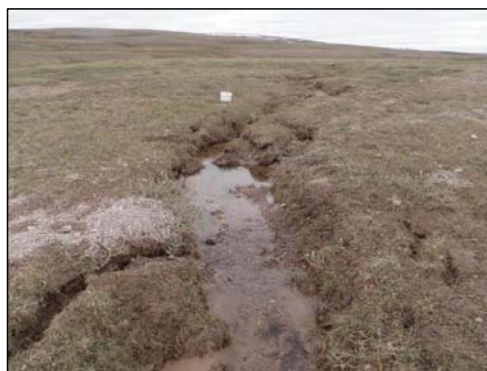
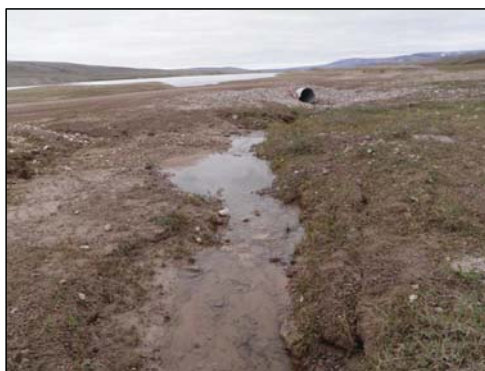
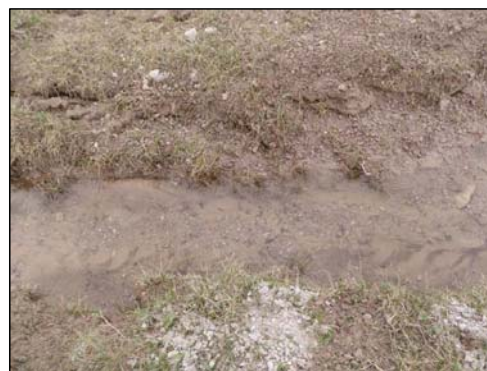
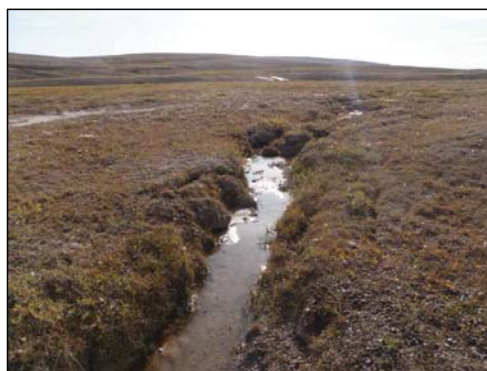
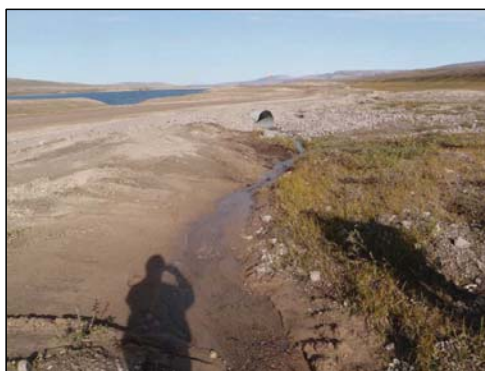
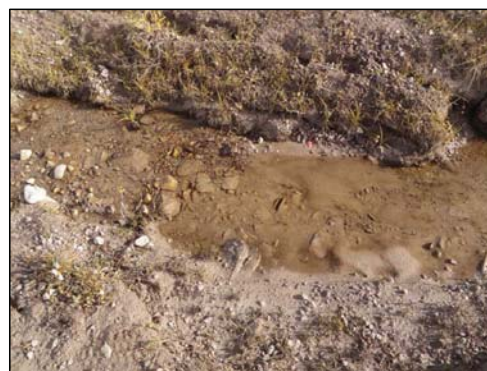
Figure 2. Summer (top) and fall (bottom) views of CV-30-5 at the rail crossing; (A) looking upstream; (B) looking downstream; and (C) looking across.

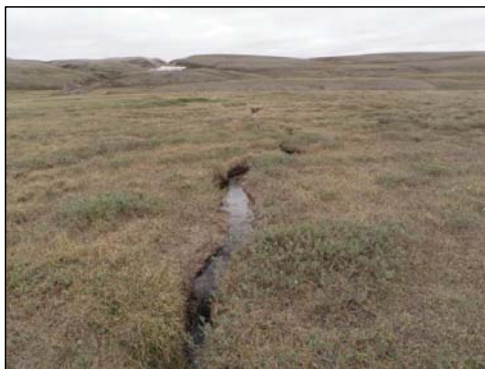
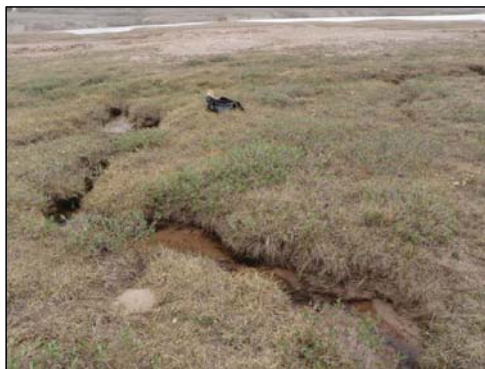
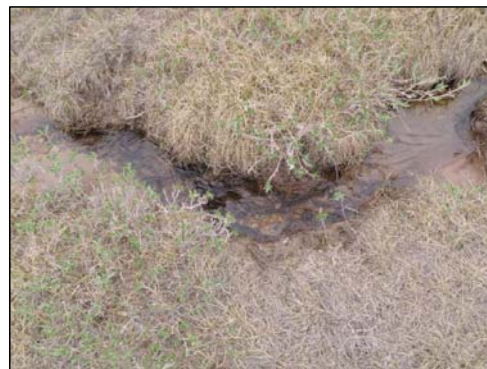
Figure 3. Summer (top) and fall (bottom) views of CV-30-5 at the 40 m upstream cross-section; (A) looking upstream; (B) looking downstream; and (C) looking across.

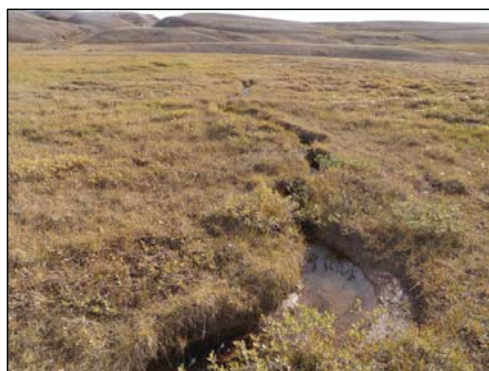
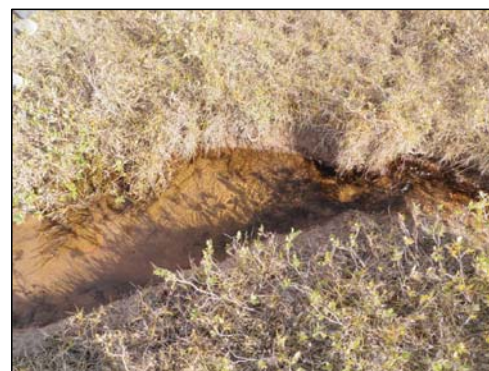
Figure 4. Summer (top) and fall (bottom) views of CV-30-5 at the 50 m upstream cross-section; (A) looking upstream; (B) looking downstream; and (C) looking across.

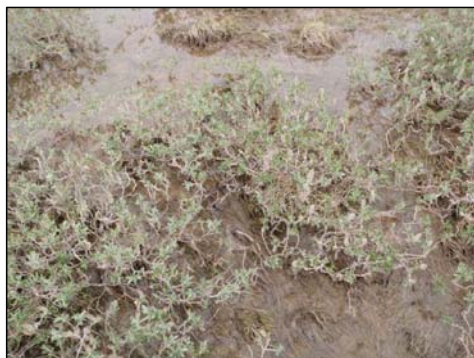
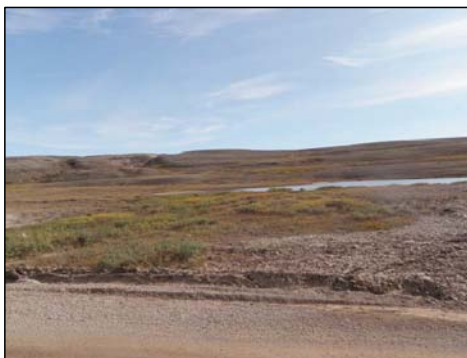
This was shallow, marshy habitat adjacent to a fishless pond. This site is not connected to any other waterbody. There is no fish habitat at this crossing.

Figure 1. Views of CV-30-6 at the rail crossing during summer (A) and fall (B).

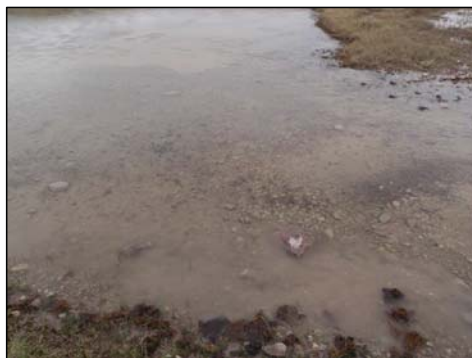
This is a shallow, isolated, fishless pond. Fish were not captured or observed during the July survey. There is no fish habitat at this crossing.

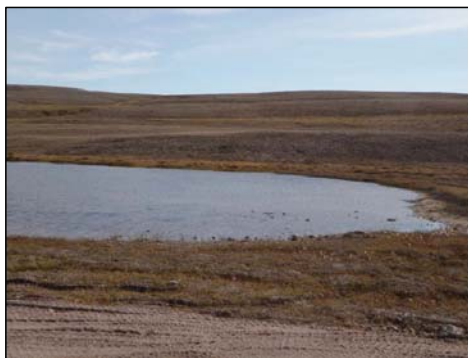
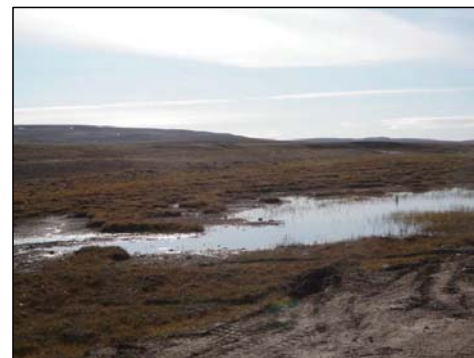
Figure 1. Views of CV-30-7 at the rail crossing during summer (A) and fall (B) and (C).

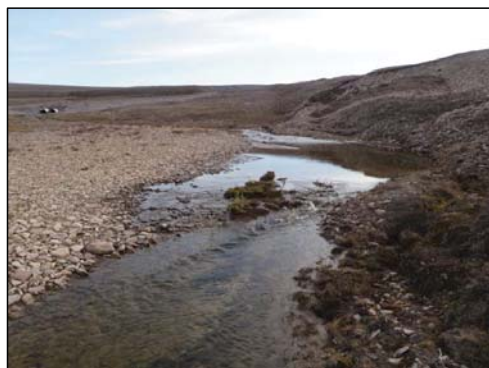
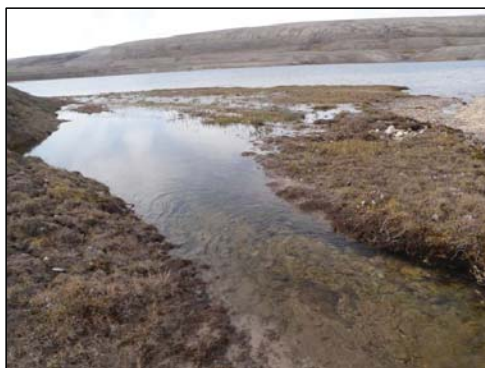
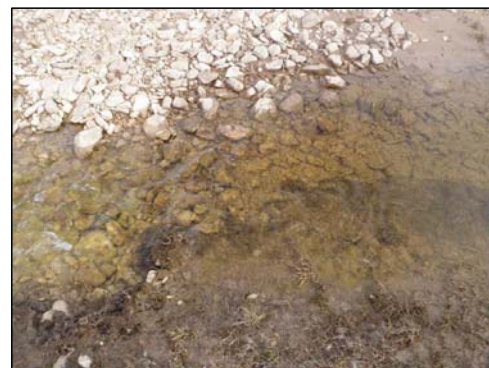
Figure 1. Summer (top) and fall (bottom) views of CV-31-1 & CV-31-2 at the 100 m downstream cross-section; (A) looking upstream; (B) looking downstream; and (C) looking across.

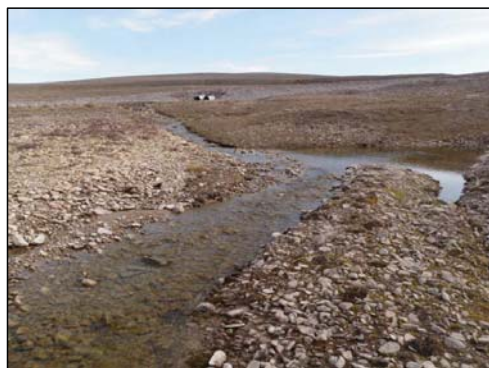
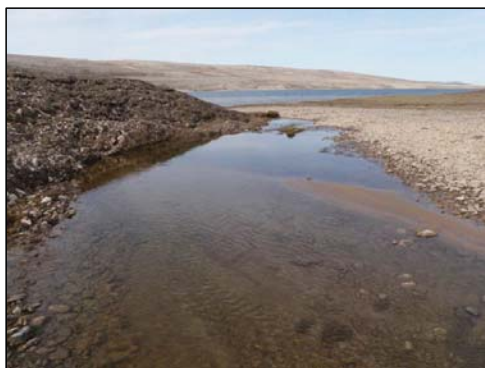
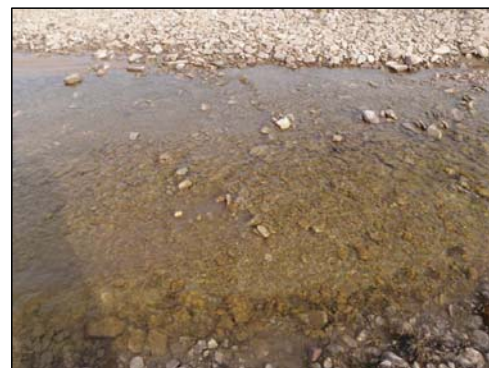
Figure 2. Summer (top) and fall (bottom) views of CV-31-1 & CV-31-2 at the 80 m downstream cross-section; (A) looking upstream; (B) looking downstream; and (C) looking across.

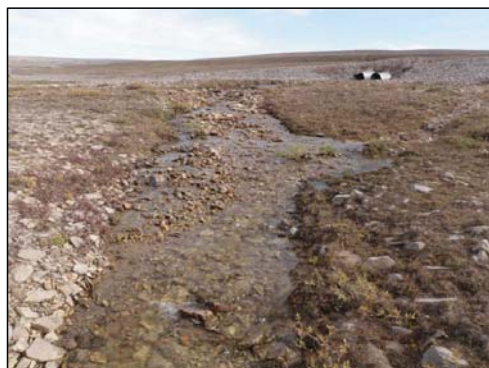
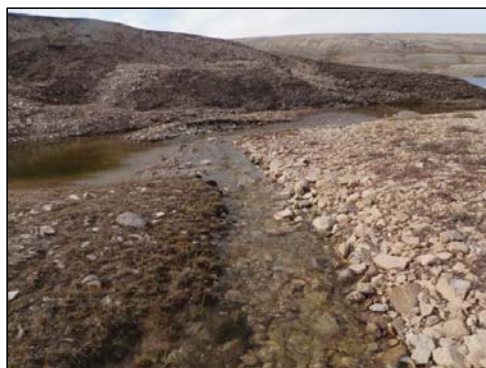
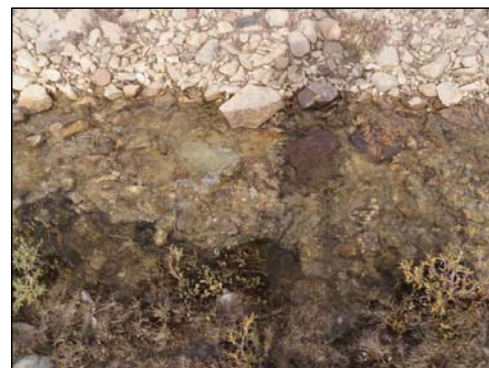
Figure 3. Summer (top) and fall (bottom) views of CV-31-1 & CV-31-2 at the 60 m downstream cross-section; (A) looking upstream; (B) looking downstream; and (C) looking across.

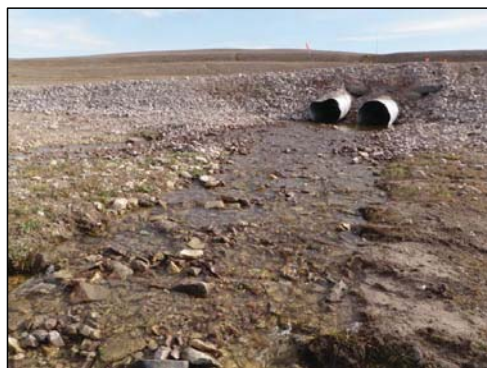
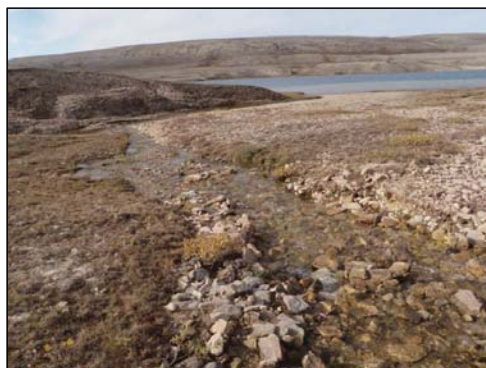
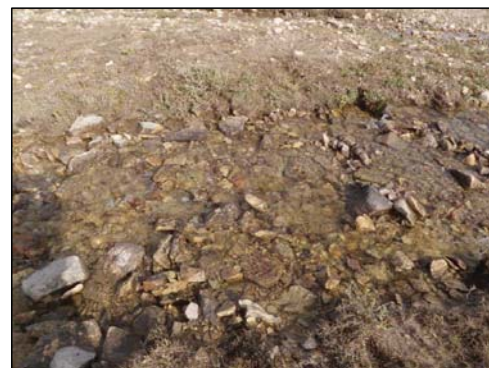
Figure 4. Summer (top) and fall (bottom) views of CV-31-1 & CV-31-2 at the 40 m downstream cross-section; (A) looking upstream; (B) looking downstream; and (C) looking across.

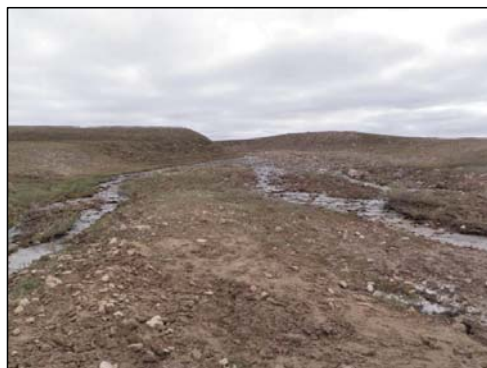
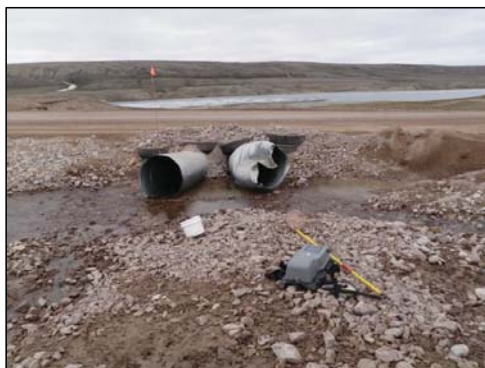
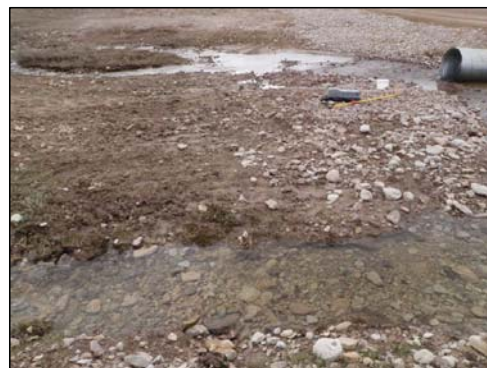
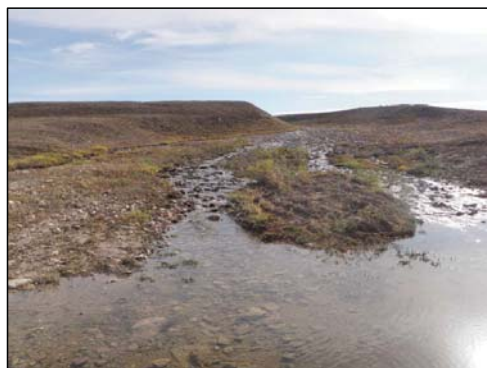
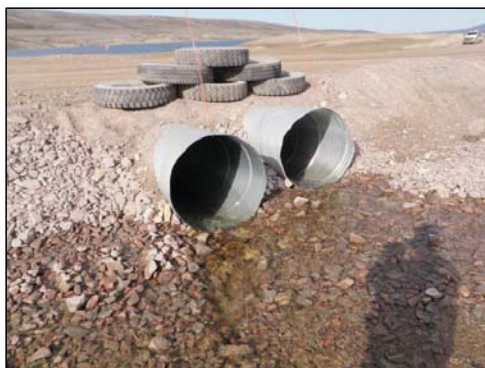
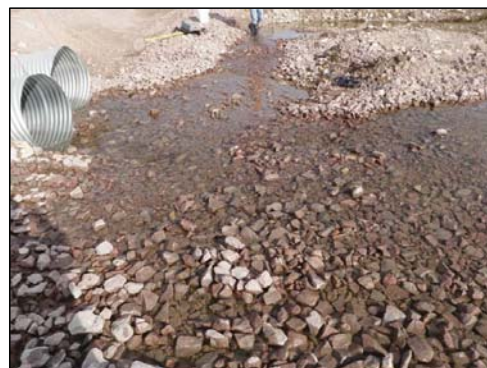
Figure 5. Summer (top) and fall (bottom) views of CV-31-1 & CV-31-2 at the rail crossing; (A) looking upstream; (B) looking downstream; and (C) looking across.

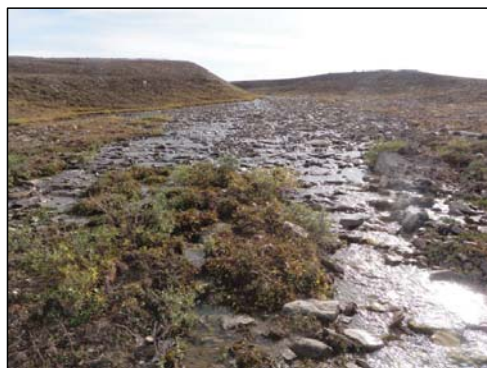
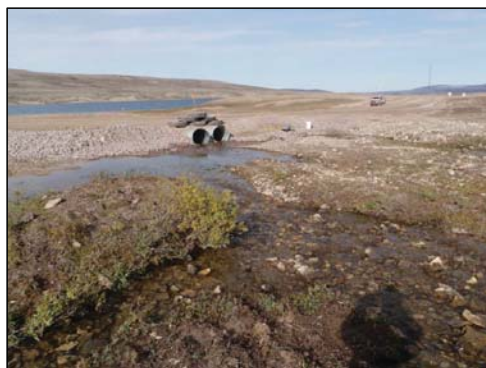
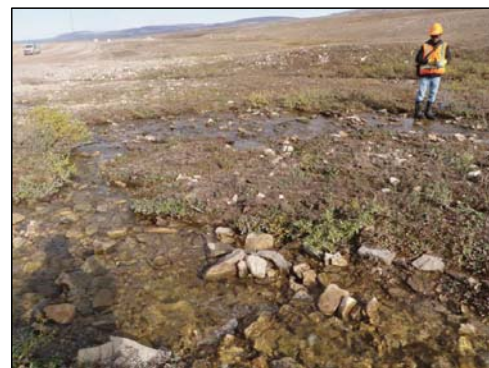
Figure 6. Summer (top) and fall (bottom) views of CV-31-1 & CV-31-2 at the 20 m upstream cross-section; (A) looking upstream; (B) looking downstream; and (C) looking across.

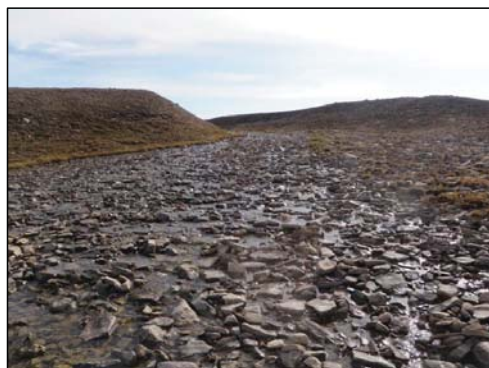
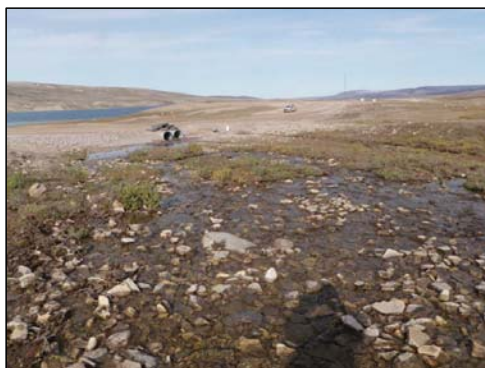
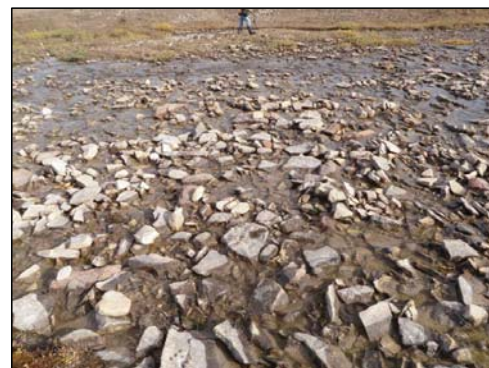
Figure 7. Summer (top) and fall (bottom) views of CV-31-1 & CV-31-2 at the 40 m upstream cross-section; (A) looking upstream; (B) looking downstream; and (C) looking across.

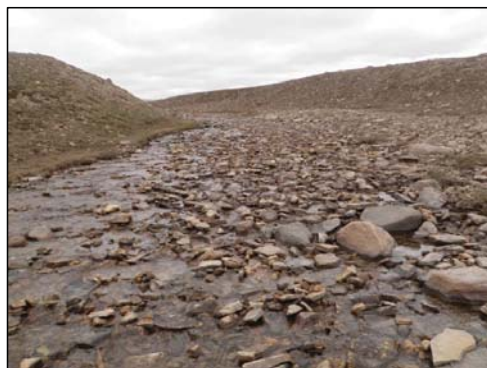
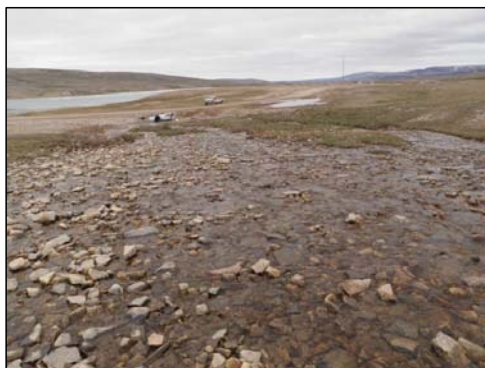
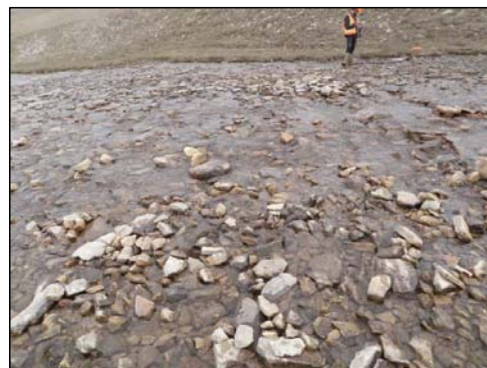
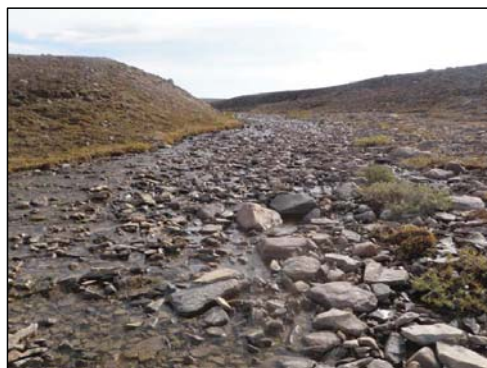
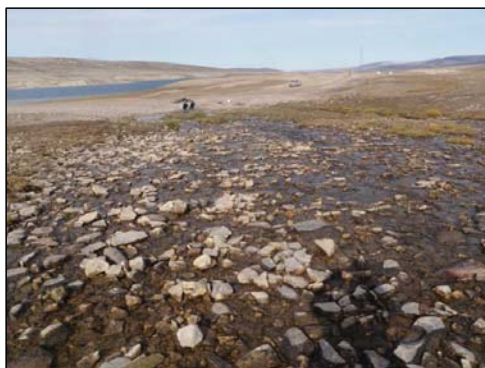
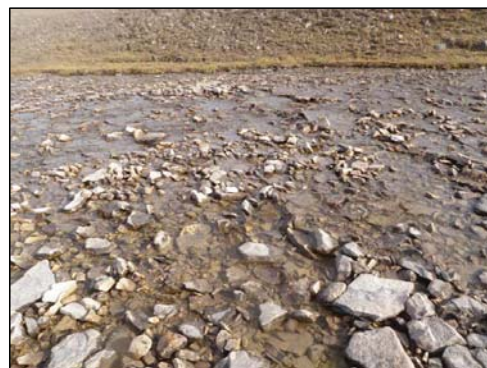
Figure 8. Summer (top) and fall (bottom) views of CV-31-1 & CV-31-2 at the 60 m upstream cross-section; (A) looking upstream; (B) looking downstream; and (C) looking across.

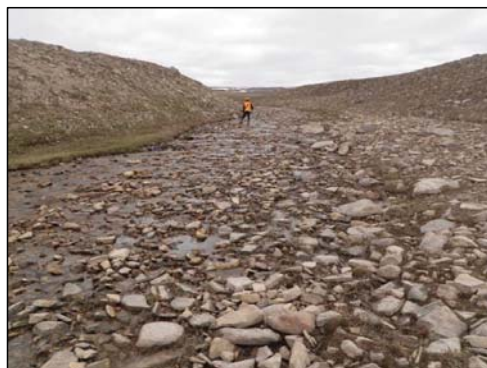
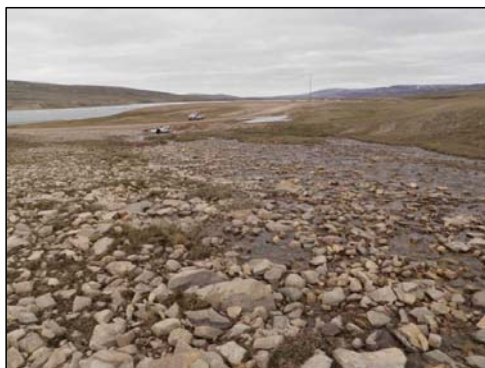
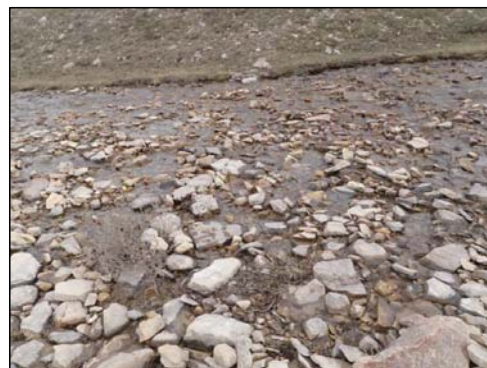
Figure 9. Summer (top) and fall (bottom) views of CV-31-1 & CV-31-2 at the 80 m upstream cross-section; (A) looking upstream; (B) looking downstream; and (C) looking across.

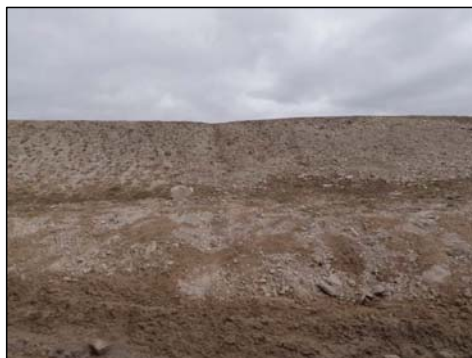
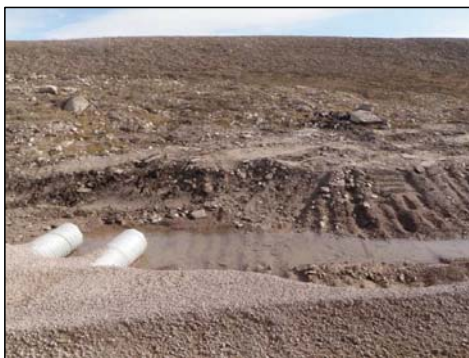
This was a dry hillside in 2018 with some ponding where it meets the Tote Road. There is no fish habitat at this crossing.

Figure 1. Views of CV-31-3 at the rail crossing during summer (A) and fall (B).

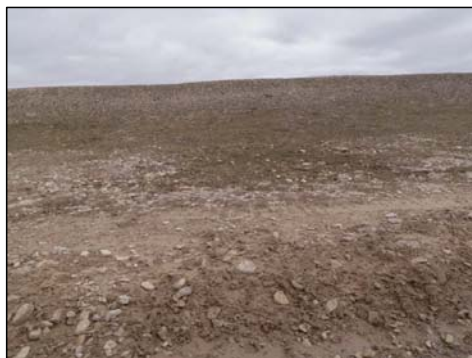
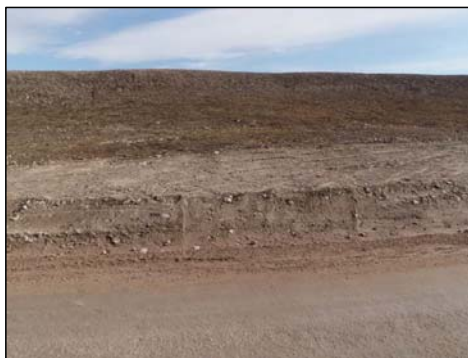
This was a dry hillside in 2018. There is never fish habitat at this crossing.

Figure 1. Views of CV-31-4 at the rail crossing during summer (A) and fall (B).

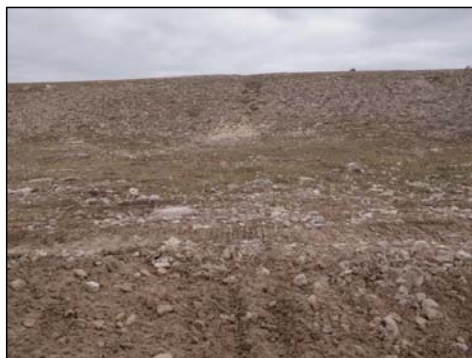
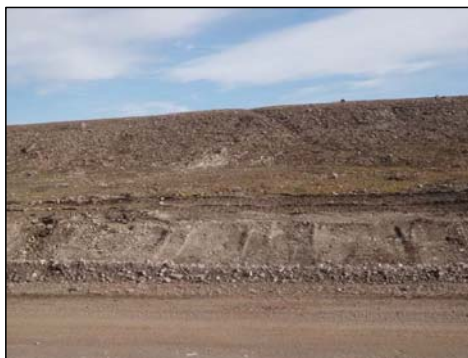
This was a dry hillside in 2018. There is never fish habitat at this crossing.

Figure 1. Views of CV-32-1 at the rail crossing during summer (A) and fall (B).

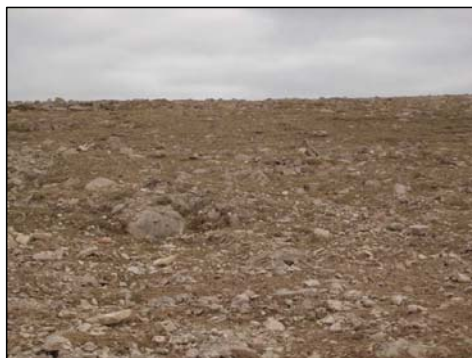
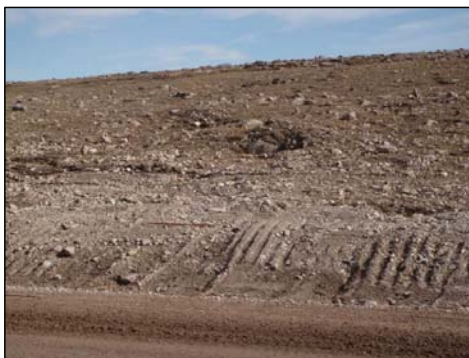
This was a dry hillside in 2018. There is never fish habitat at this crossing.

Figure 1. Views of CV-32-2 at the rail crossing during summer (A) and fall (B).
