Phase 2 Milne Rail Corridor Aquatic Habitat Assessment

**Baffinland Iron Mines
Mary River Project**

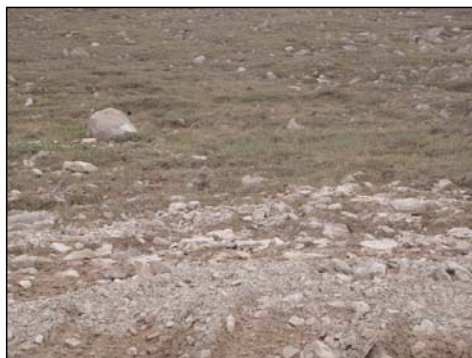
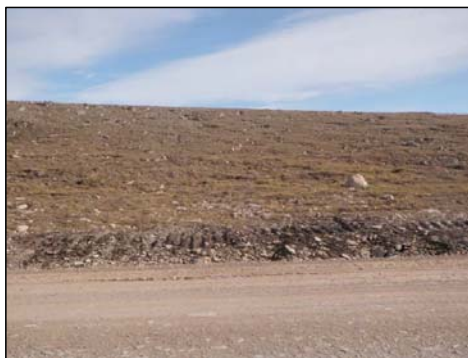
This was a dry hillside in 2018. There is never fish habitat at this crossing.

Figure 1. Views of CV-32-3 at the rail crossing during summer (A) and fall (B).

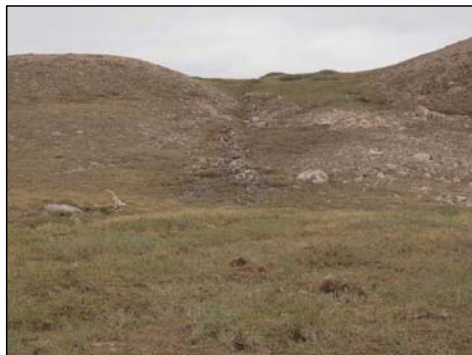
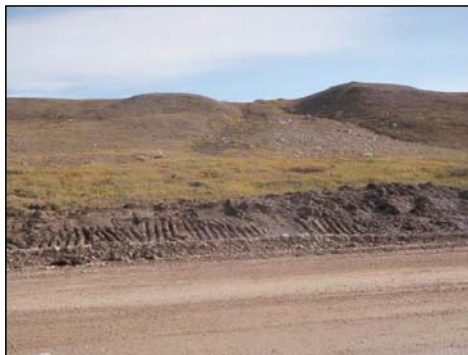
This was a nearly dry, rocky depression on a hillside in 2018. Surface water was not maintained and there was no connectivity with other waterbodies. There is never fish habitat at this crossing.

Figure 1. Views of CV-32-4 at the rail crossing during summer (A) and fall (B).

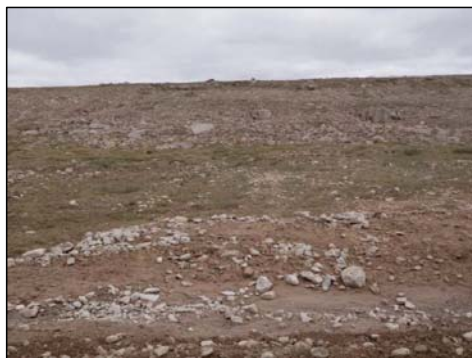
This was a dry hillside in 2018. There is never fish habitat at this crossing.

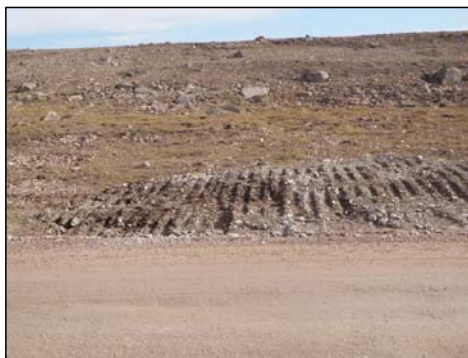
Figure 1. Views of CV-33-1 at the rail crossing during summer (A) and fall (B).

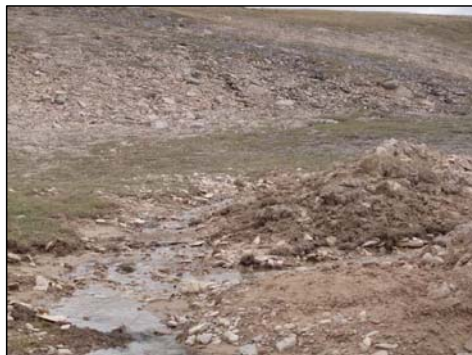
This was a small trickle of water flowing over mostly terrestrial habitat and forming a pond at the Tote Road in 2018. There was no connection to Phillips Creek downstream. There is never fish habitat at this crossing.

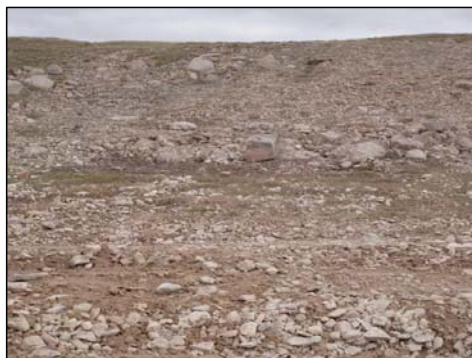
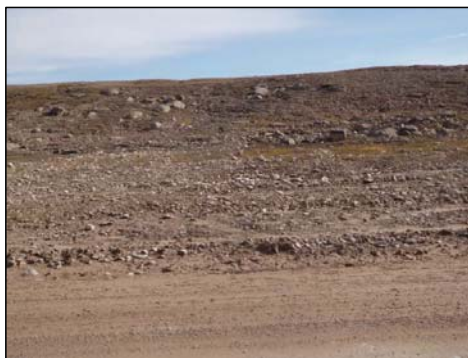
This was a dry hillside in 2018. There is never fish habitat at this crossing.

Figure 1. Views of CV-33-3 at the rail crossing during summer (A) and fall (B).

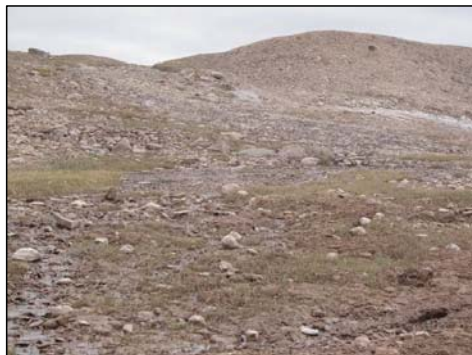
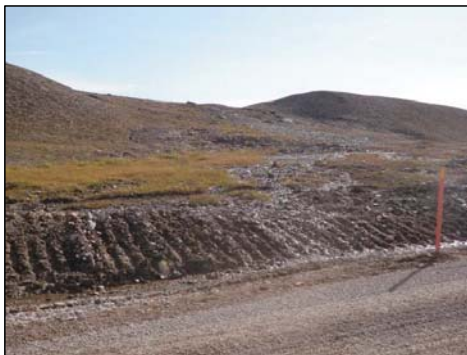
This was a thin layer of water flowing over rocks and terrestrial vegetation in 2018. There was insufficient water and no access from Phillips Creek. There is never fish habitat at this crossing.

Figure 1. Views of CV-33-4 at the rail crossing during summer (A) and fall (B).

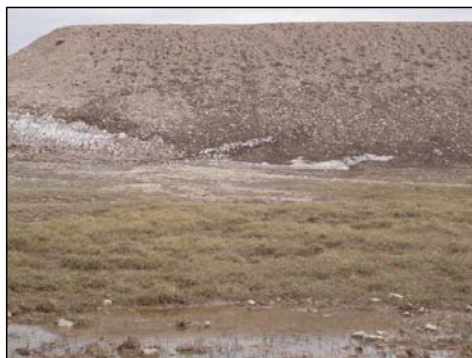
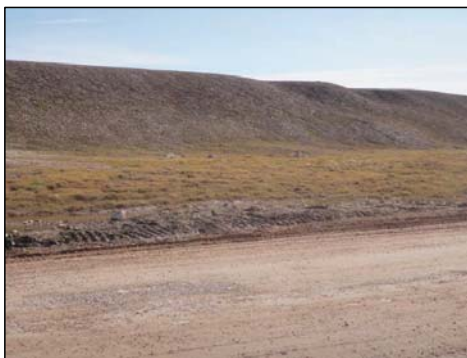
This was a nearly dry hillside with some downstream pond formation at the Tote Road, but no connection with fish-bearing waterbodies. There is never fish habitat at this crossing.

Figure 1. Views of CV-33-5 at the rail crossing during summer (A) and fall (B).

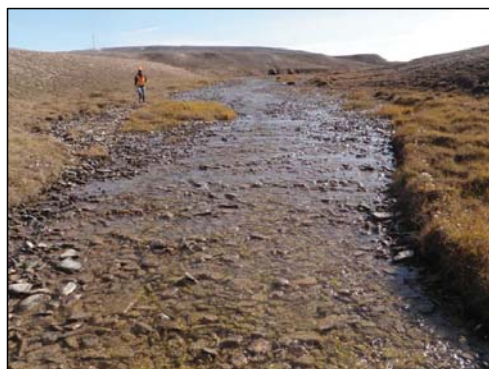
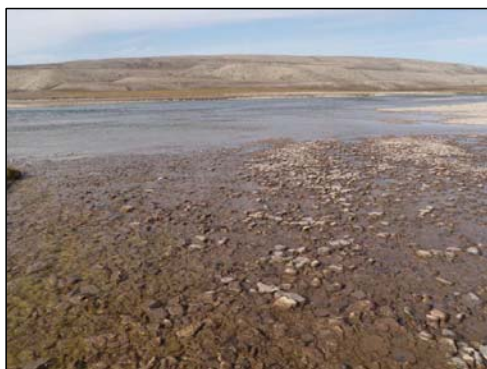
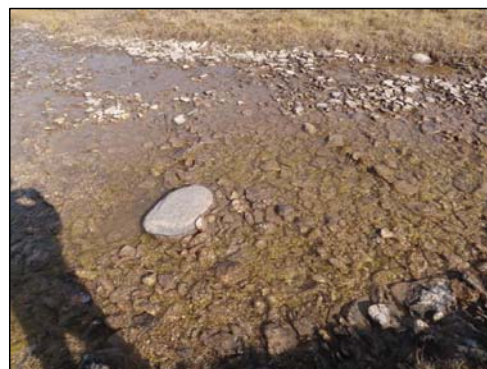
Figure 1. Summer (top) and fall (bottom) views of CV-33-6 at the 100 m downstream cross-section; (A) looking upstream; (B) looking downstream; and (C) looking across.

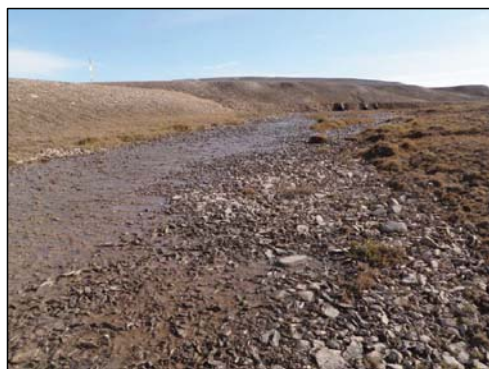
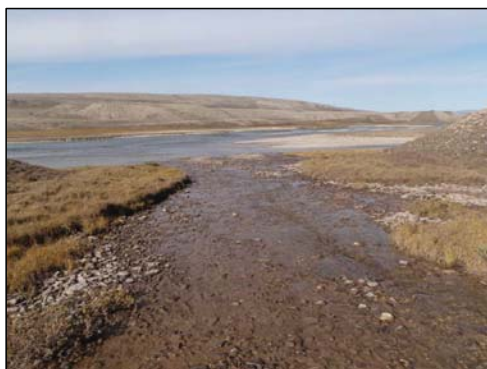
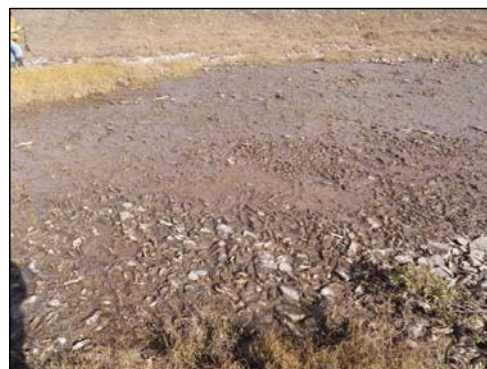
Figure 2. Summer (top) and fall (bottom) views of CV-33-6 at the 80 m downstream cross-section; (A) looking upstream; (B) looking downstream; and (C) looking across.

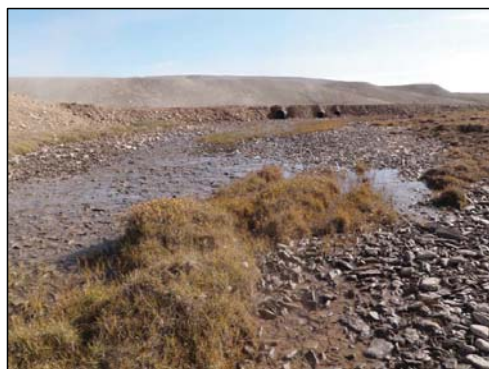
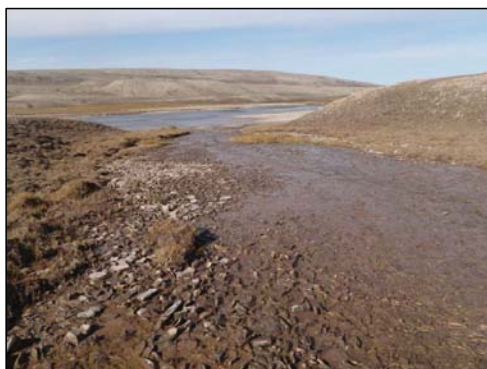
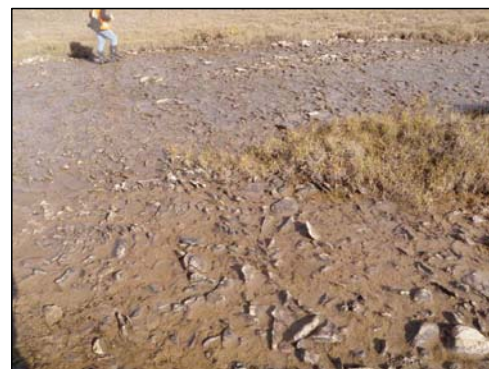
Figure 3. Summer (top) and fall (bottom) views of CV-33-6 at the 60 m downstream cross-section; (A) looking upstream; (B) looking downstream; and (C) looking across.

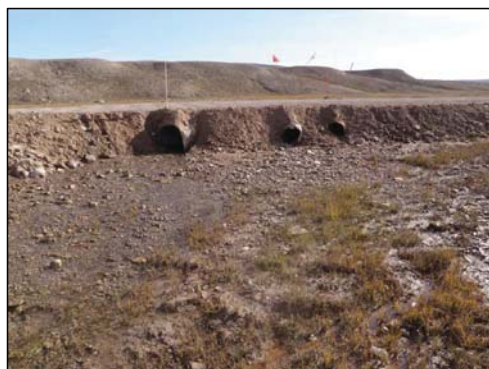
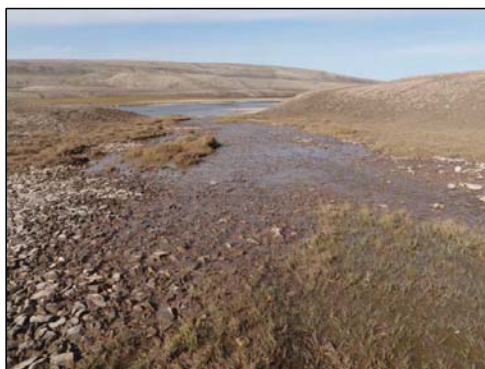
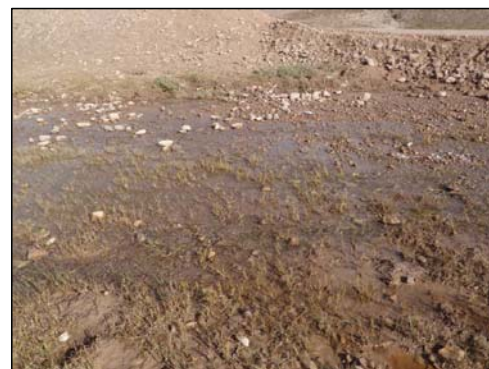
Figure 4. Summer (top) and fall (bottom) views of CV-33-6 at the 40 m downstream cross-section; (A) looking upstream; (B) looking downstream; and (C) looking across.

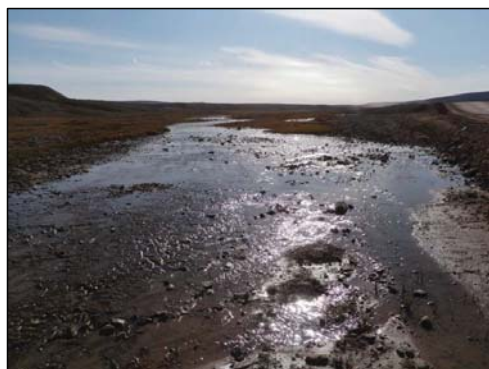
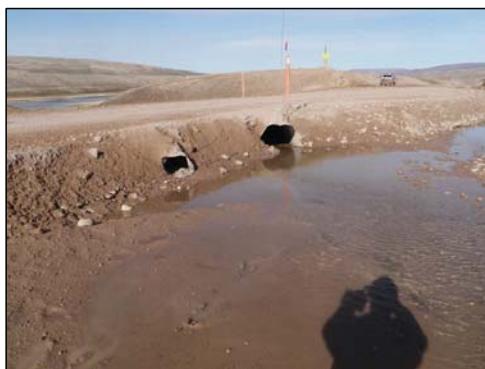
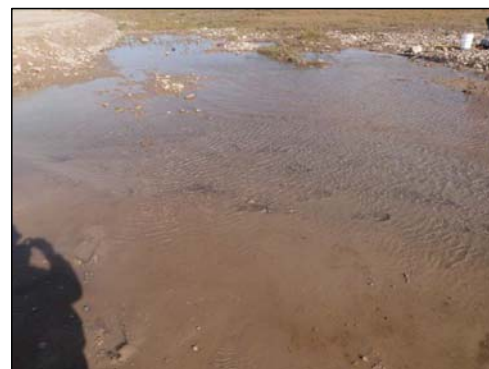
Figure 5. Summer (top) and fall (bottom) views of CV-33-6 at the 20 m downstream cross-section; (A) looking upstream; (B) looking downstream; and (C) looking across.
