Phase 2 Milne Rail Corridor Aquatic Habitat Assessment

Crossing ID: CV-33-6

Dates Surveyed: 5 July & 25 August, 2018

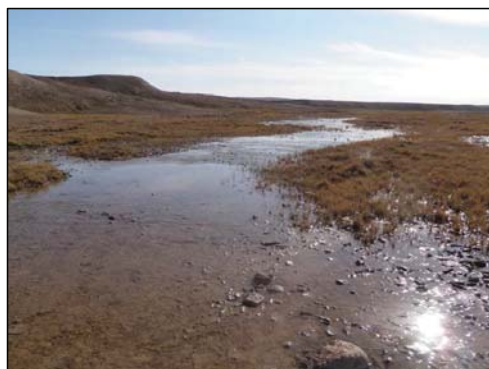
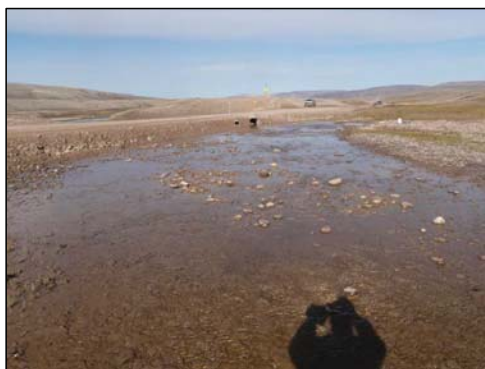
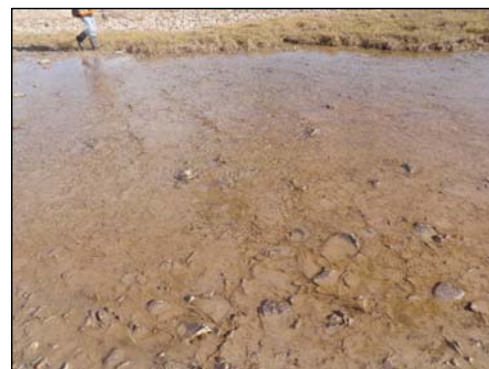
Figure 7. Summer (top) and fall (bottom) views of CV-33-6 at the 20 m upstream cross-section; (A) looking upstream; (B) looking downstream; and (C) looking across.

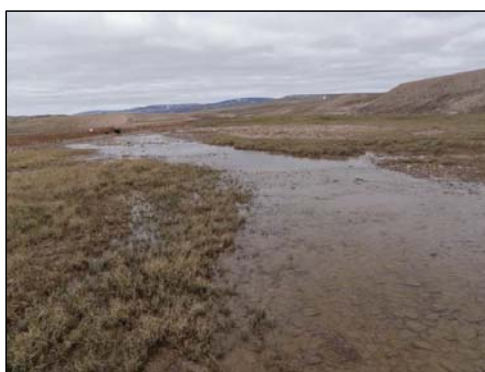
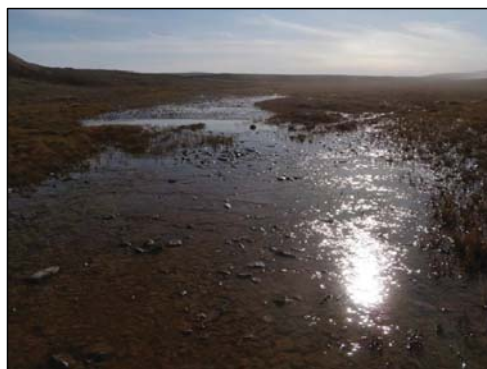
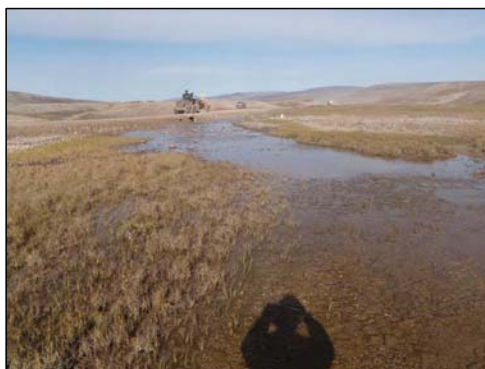
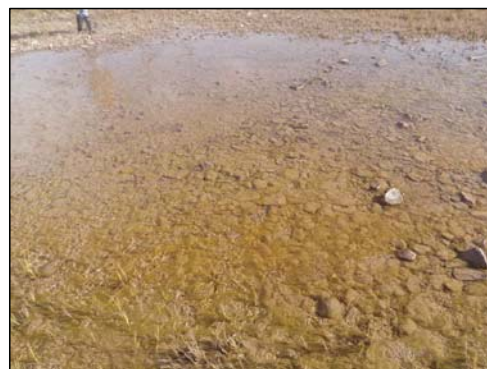
Figure 8. Summer (top) and fall (bottom) views of CV-33-6 at the 40 m upstream cross-section; (A) looking upstream; (B) looking downstream; and (C) looking across.

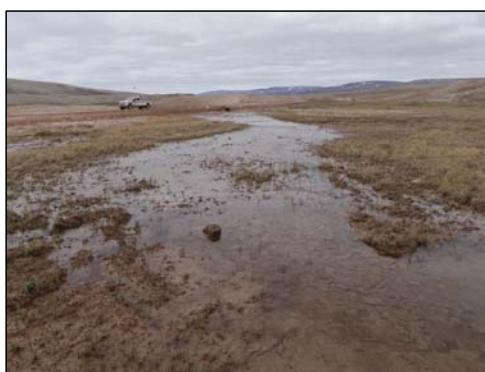
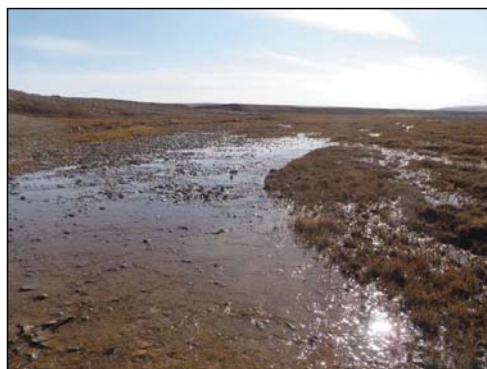
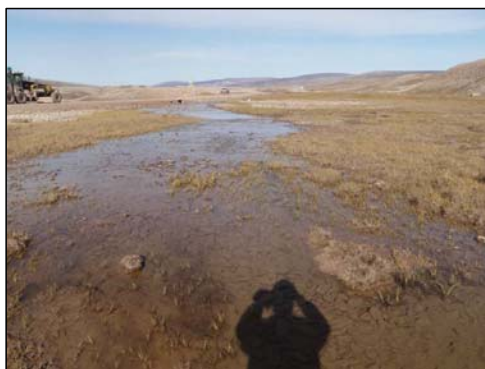
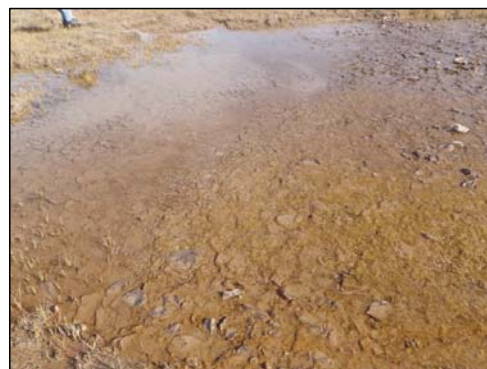
Figure 9. Summer (top) and fall (bottom) views of CV-33-6 at the 60 m upstream cross-section; (A) looking upstream; (B) looking downstream; and (C) looking across.

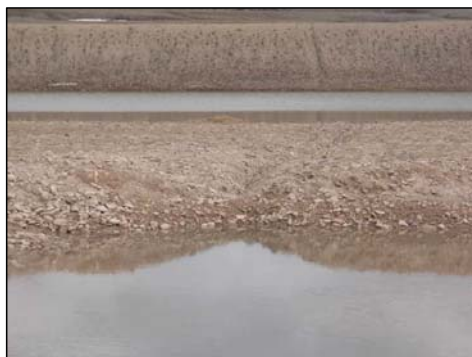
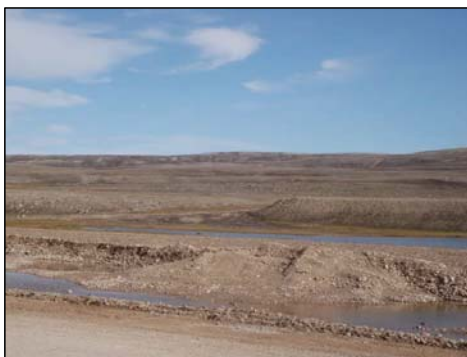
This was a small, shallow, isolated pond at the edge of the Tote Road. It was fishless and would remain unconnected to other waterbodies under all flow regimes. There is never fish habitat at this crossing.

Figure 1. Views of CV-33-7 (pond in the foreground) at the rail crossing during summer (A) and fall (B).

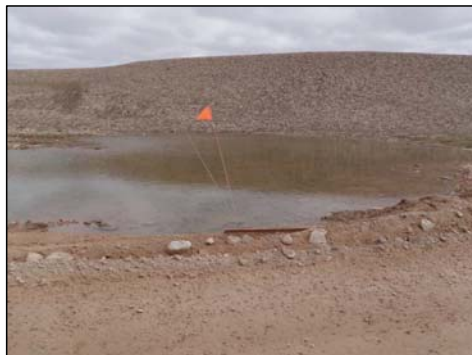
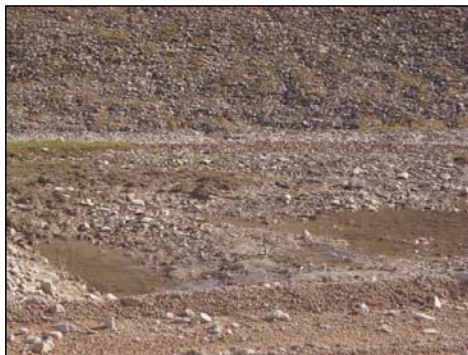
This was a small, shallow, isolated pond that has formed alongside the Tote Road. It was fishless and not connected to other waterbodies . There is never fish habitat at this crossing.

Figure 1. Views of CV-34-1 (pond and adjacent inflow) at the rail crossing during summer (A) and fall (B).

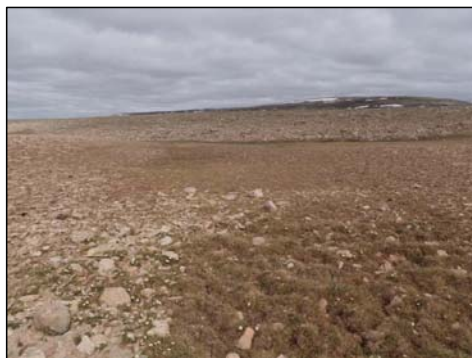
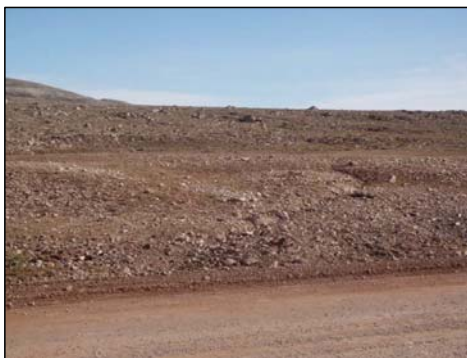
This was a dry depression in 2018. There is never fish habitat at this crossing.

Figure 1. Views of CV-34-2 at the rail crossing during summer (A) and fall (B).

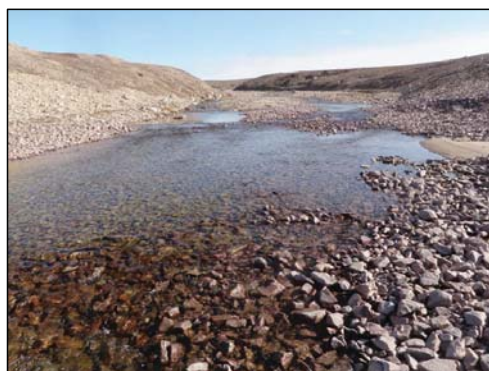
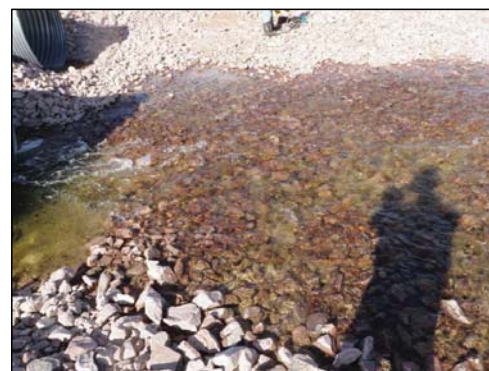
Figure 1. Summer (top) and fall (bottom) views of CV-35-2 at the 40 m downstream cross-section; (A) looking upstream; (B) looking downstream; and (C) looking across.

This rail crossing is immediately upstream of CV-099 on the Tote Road. Provides important rearing habitat for several size classes of juvenile char throughout the open water season.

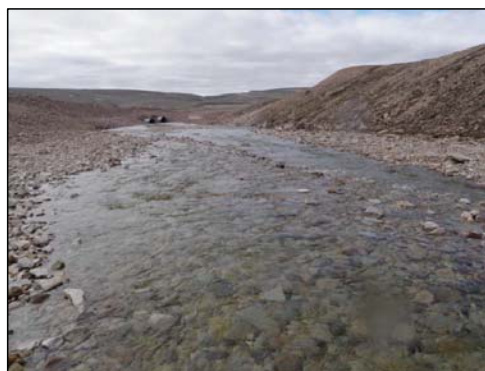
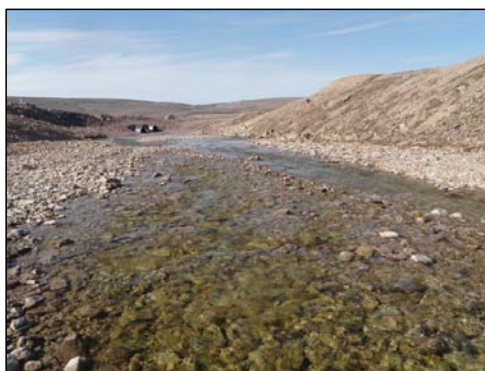
Figure 7. Summer (top) and fall (bottom) views of CV-35-2 at the 80 m upstream cross-section; (A) looking upstream; (B) looking downstream; and (C) looking across.

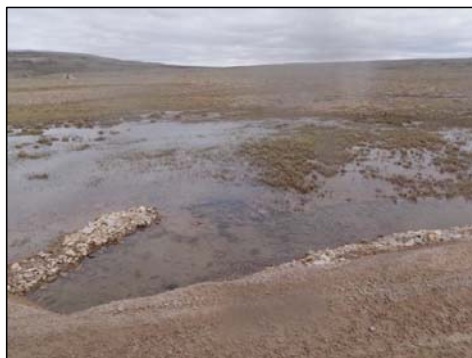
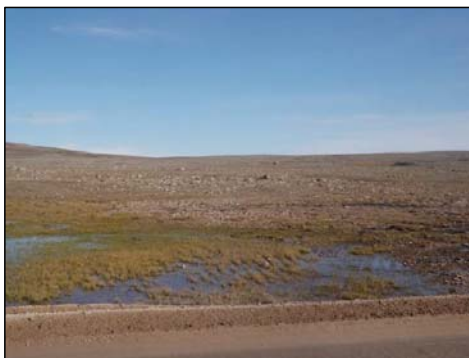
This was a small, shallow marshy spot in 2018. There were no fish and no connections to other waterbodies. There is never fish habitat at this crossing.

Figure 1. Views of CV-35-4 at the rail crossing during summer (A) and fall (B).

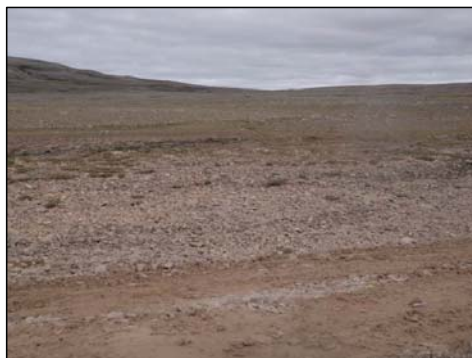
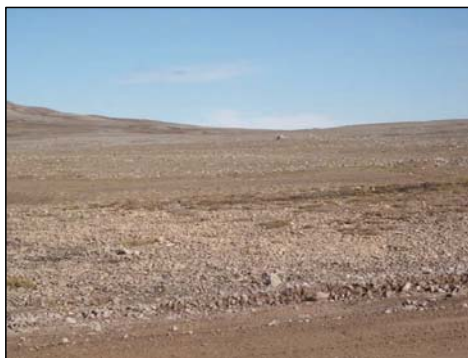
This was a dry low point in 2018. There is never fish habitat at this crossing.

Figure 1. Views of CV-35-5 at the rail crossing during summer (A) and fall (B).

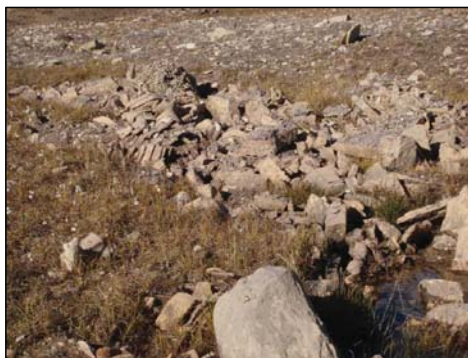
Figure 1. Views of CV-37-1 at the rail crossing during summer (A) and fall (B).

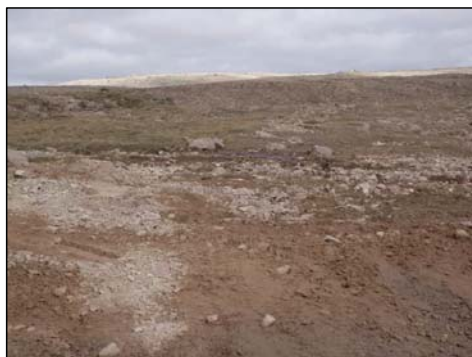
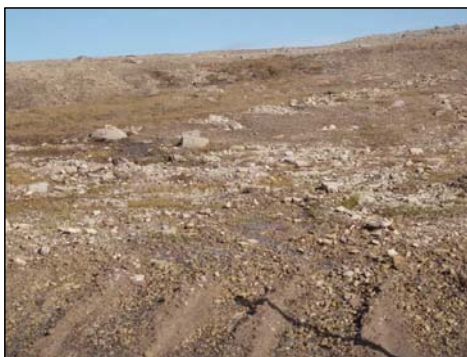
Figure 1. Views of CV-38-1 at the rail crossing during summer (A) and fall (B).

This was a small trickle of water flowing over terrestrial habitat in 2018. Surface flows were not maintained downstream and there was no connectivity with other waterbodies. There is never fish habitat at this crossing.

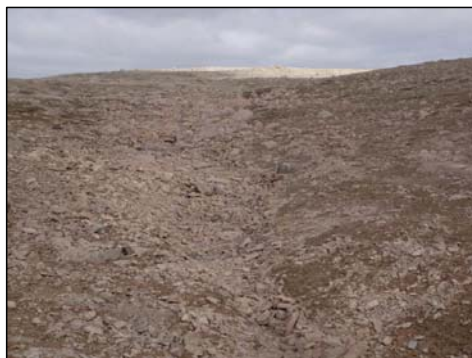
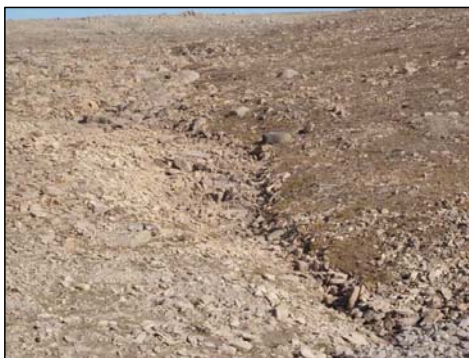
Figure 1. Views of CV-38-2 at the rail crossing during summer (A) and fall (B).

This was a dry, rocky, hillside depression in 2018. There is never fish habitat at this crossing.

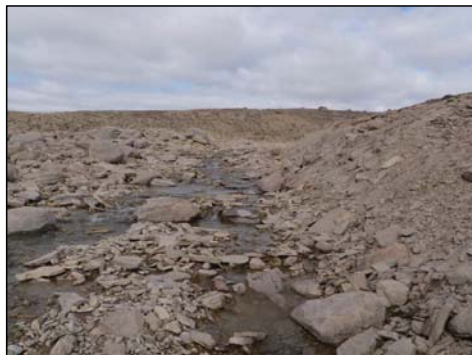
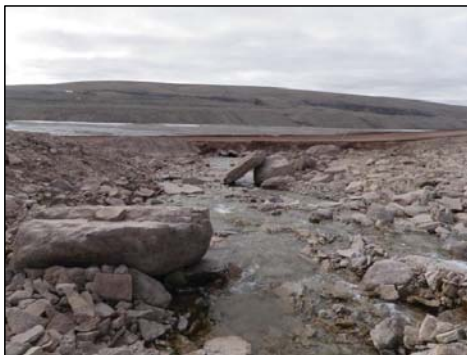
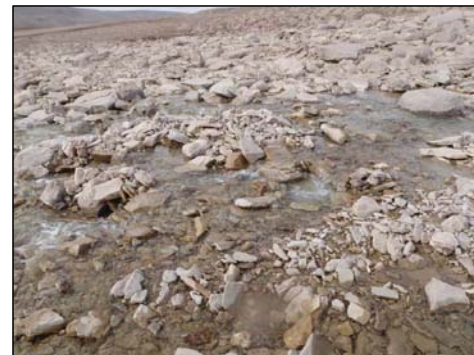
Figure 1. Views of CV-38-3 at the rail crossing during summer, looking upstream (A) downstream (B) and across (C).

This stream maintains sufficient flows and depths for fish use throughout the open-water period. However, a large, impassable, vertical barrier (waterfall) was previously identified approximately 30 m downstream of the Tote Road. Fish are present downstream of this waterfall, but they cannot access habitat near the rail crossing.

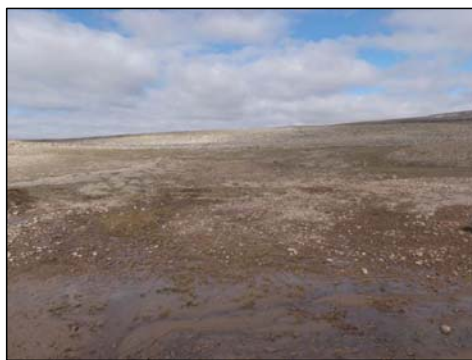
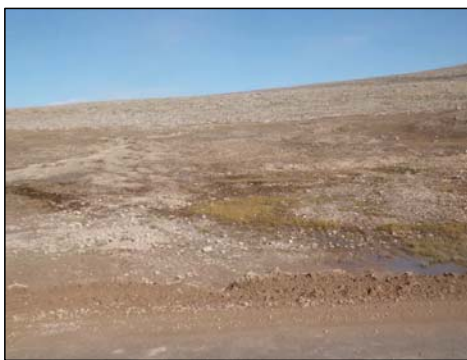
Figure 1. Views of CV-39-1 at the rail crossing during summer (A) and fall (B).

This was moist terrestrial habitat with some ponding at the Tote Road. There is never fish habitat at this crossing.

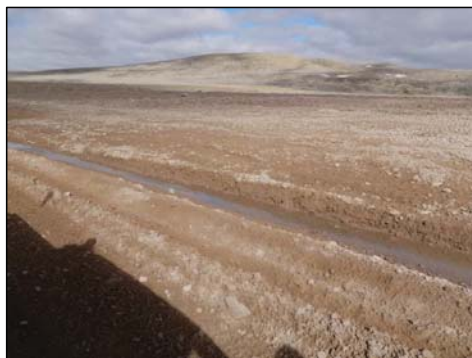
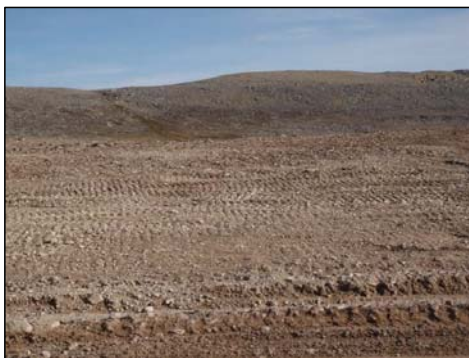
Figure 1. Views of CV-40-1 at the rail crossing during summer (A) and fall (B).

This was a ditch pond alongside the Tote Road. There is never fish habitat at this crossing.

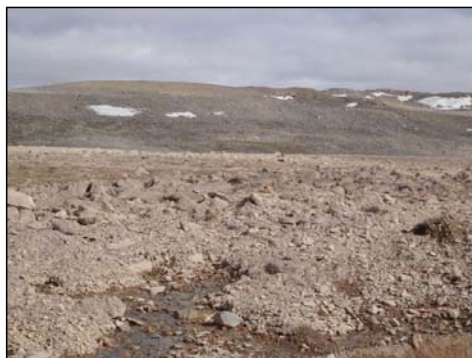
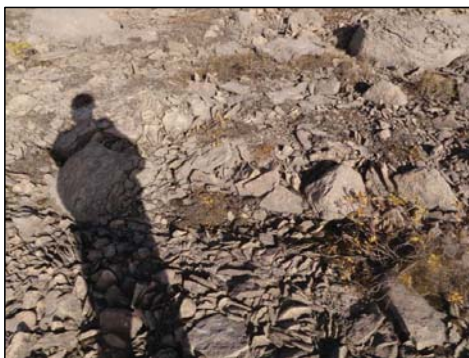
Figure 1. Views of CV-40-2 at the rail crossing during summer (A) and fall (B).

This was a small amount of water flowing among and under a field of rocks. There was no connection to other waterbodies. There is never fish habitat at this crossing.

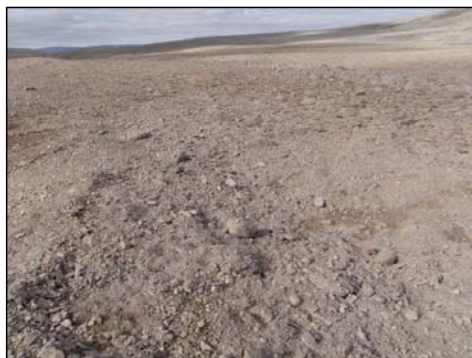
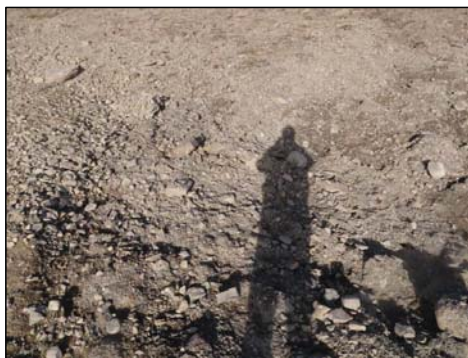
Figure 1. Views of CV-40-3 at the rail crossing during summer (A) and fall (B).

This was a dry depression full of rocks. There is never fish habitat at this crossing.

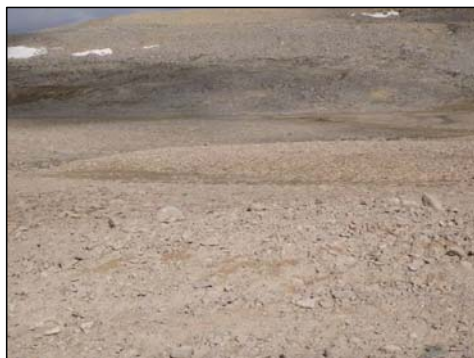
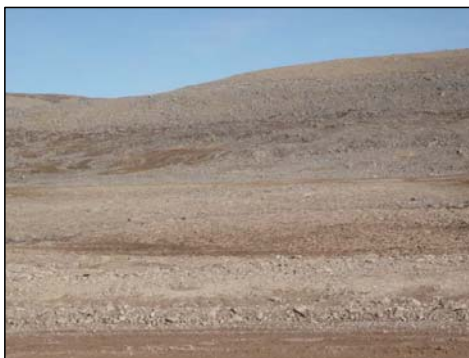
Figure 1. Views of CV-40-4 at the rail crossing during summer (A) and fall (B).

This was a dry low point in 2018. There is never fish habitat at this crossing.

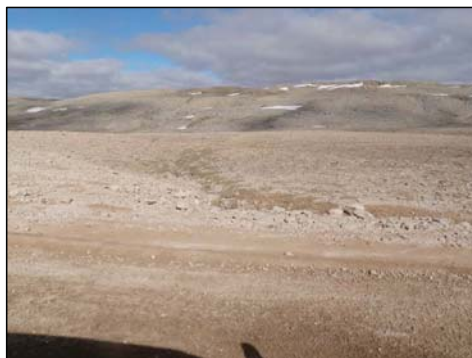
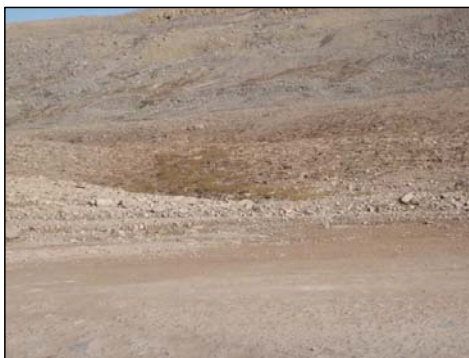
Figure 1. Views of CV-41-1 at the rail crossing during summer (A) and fall (B).

This was a dry, grassy depression on a hillside in 2018. There is never fish habitat at this crossing.

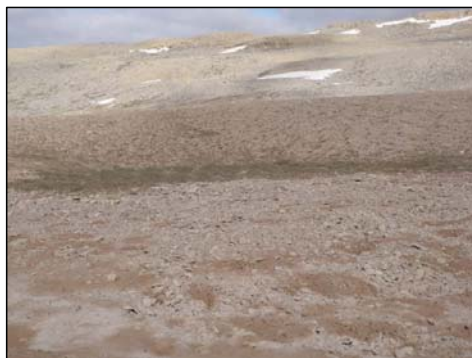
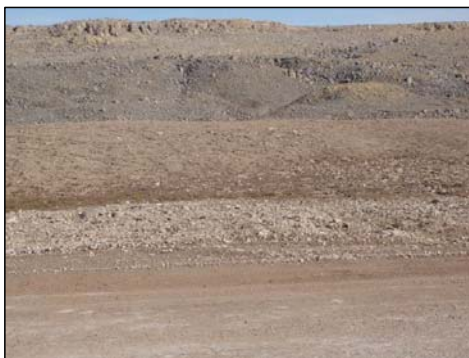
Figure 1. Views of CV-41-2 at the rail crossing during summer (A) and fall (B).

This was a dry, grassy depression on a hillside in 2018. There is never fish habitat at this crossing.

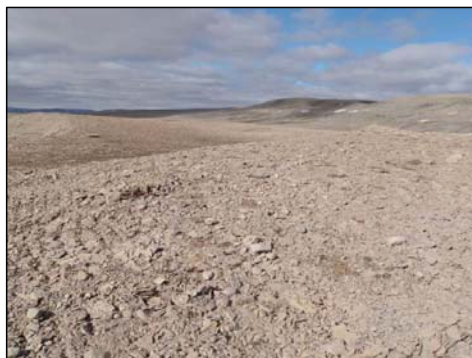
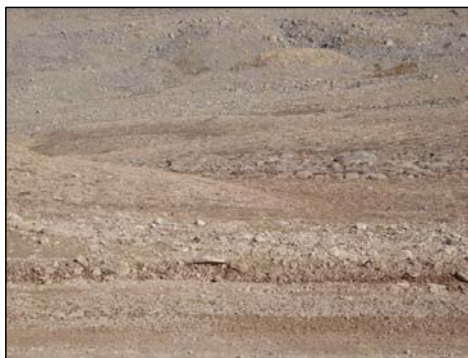
Figure 1. Views of CV-41-3 at the rail crossing during summer (A) and fall (B).

This was a dry, rocky hillside in 2018. There is never fish habitat at this crossing.

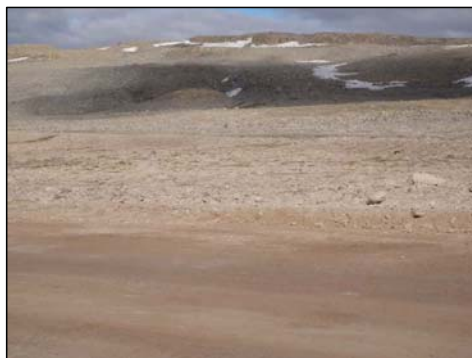
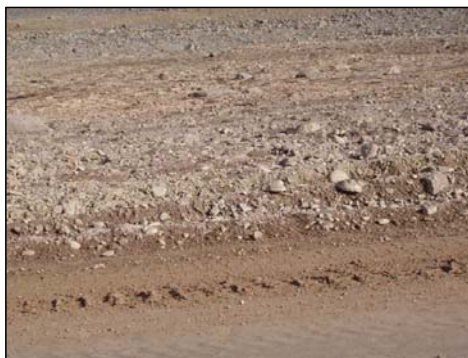
Figure 1. Views of CV-41-4 at the rail crossing during summer (A) and fall (B).

This was a dry, rocky low point in 2018. There is never fish habitat at this crossing.

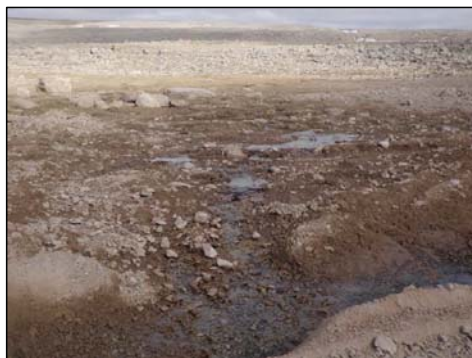
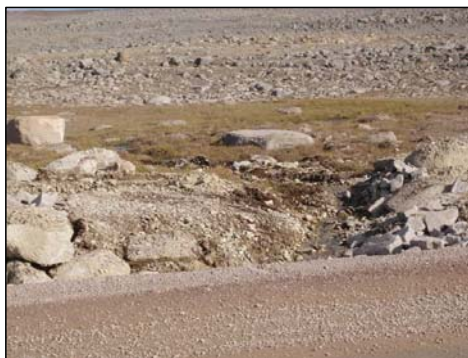
Figure 1. Views of CV-42-1 at the rail crossing during summer (A) and fall (B).

This was a thin trickle of water in 2018. Lack of surface flow in some areas and no connectivity to Phillips Creek prevent all fish access. There is never fish habitat at this crossing.

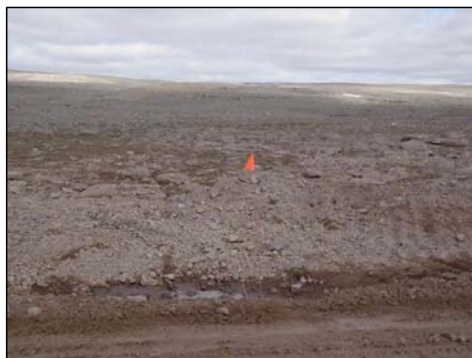
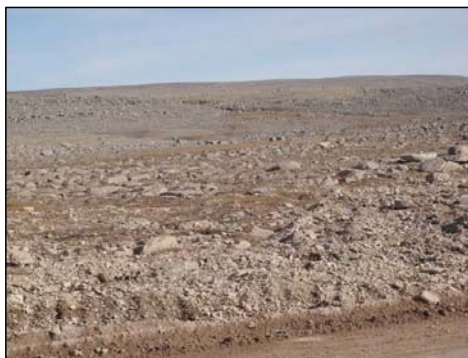
Figure 1. Views of CV-42-2 at the rail crossing during summer (A) and fall (B).

This was a dry depression in 2018. There is never fish habitat at this crossing.

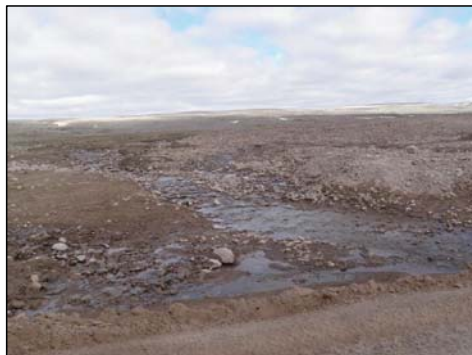
This site had very low flows in both seasons surveyed in 2018. In addition, there are multiple soft barriers (subsurface flow and steep gradient) downstream of the crossing preventing access from Phillips Creek. There is never fish habitat at this crossing.

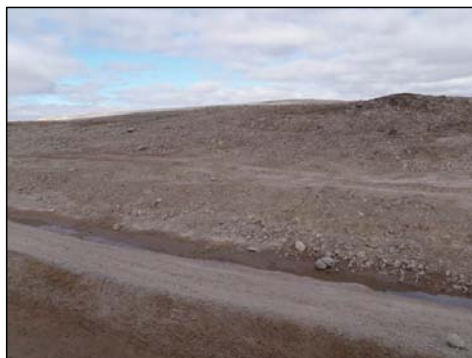
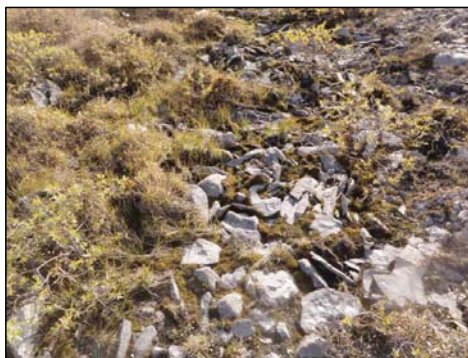
Figure 1. Views of CV-43-2 at the rail crossing during summer (A) and fall (B).

This was a dry, rocky low point in 2018. There is never fish habitat at this crossing.

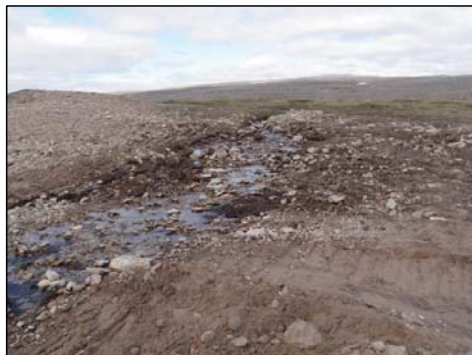
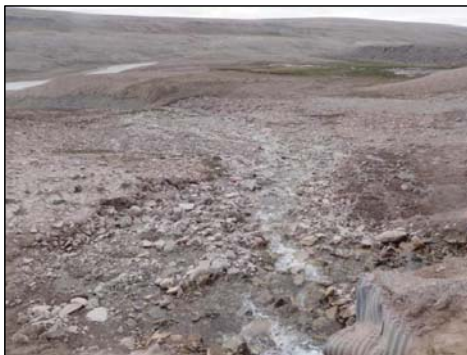
This stream maintained sufficient flows and depths throughout the open-water period in 2018. However, there is a large, impassable vertical drop downstream of the Tote Road preventing fish access from Phillips Creek under all flow conditions. There is never fish habitat at this crossing.

Figure 1. Views of CV-43-3 at the rail crossing (A) and downstream of the Tote Road, showing the vertical drop (B). Note that 43-4 joins with 43-3 upstream of the Tote Road.

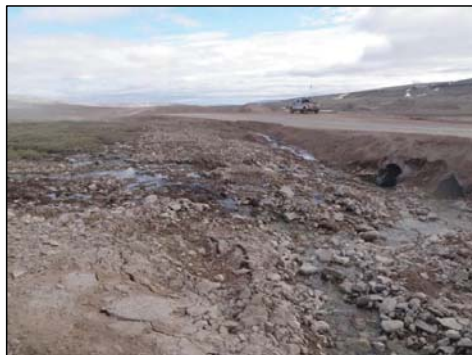
A

This stream maintained sufficient flows and depths throughout the open-water period in 2018. However, there is a large, impassable vertical drop downstream of the Tote Road preventing fish access from Phillips Creek under all flow conditions. There is never fish habitat at this crossing.

Figure 1. Views of CV-43-4 at the rail crossing (A) and downstream of the Tote Road, showing the vertical drop (B). Note that 43-3 joins with 43-4 upstream of the Tote Road.

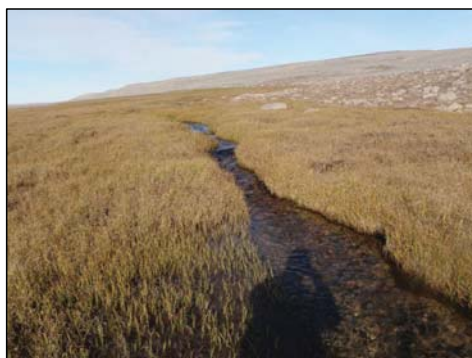
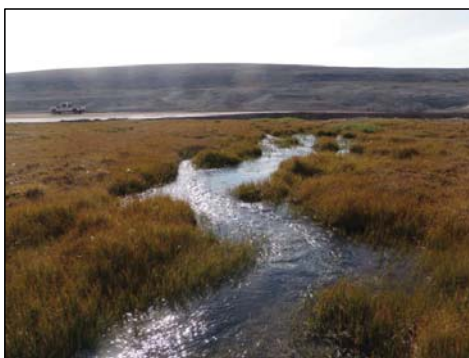
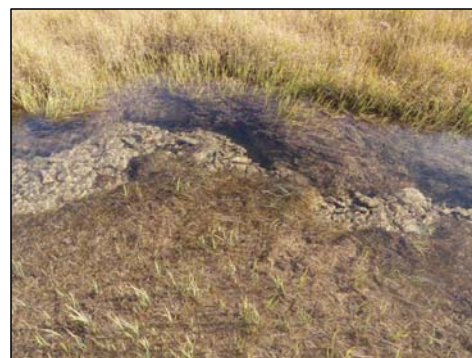
Figure 2. Views of CV-43-4 at the rail crossing during fall, looking upstream (A) downstream (B) and across (C).

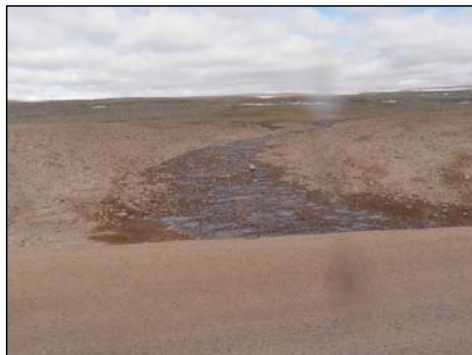
A

This stream maintained a small volume of flow throughout the open-water period in 2018. However, insufficient depths and steep vertical gradient downstream of the Tote Road prevent fish access from Phillips Creek. There is never fish habitat at this crossing.

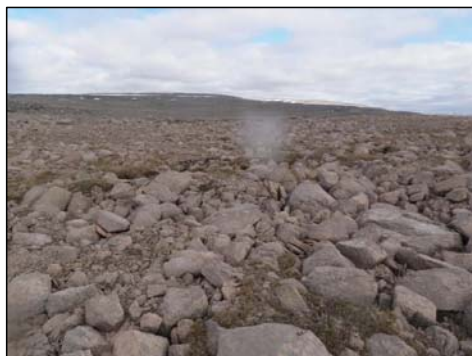
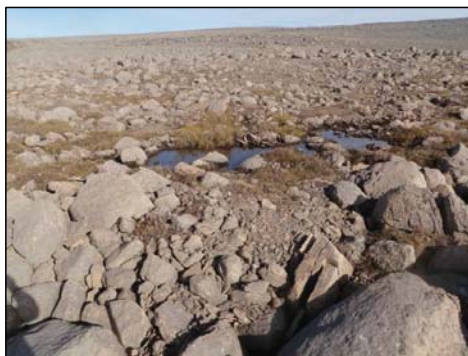
This was a boulder field with small, unconnected puddles in 2018. There is never fish habitat at this crossing.

Figure 1. Views of CV-44-1 at the rail crossing during summer (A) and fall (B).

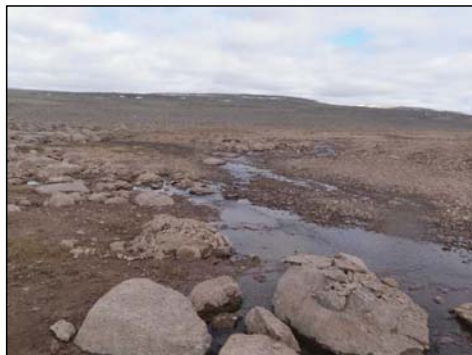
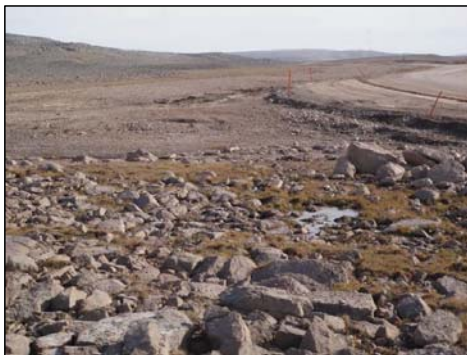
This maintained minimal flows during the open-water period in 2018. Downstream of the Tote Road is an impassable vertical barrier that prevents fish access to the rail site under all flow conditions. There is never fish habitat at this crossing.

Figure 1. Views of CV-44-2 at the rail crossing during summer (A) and fall (B).

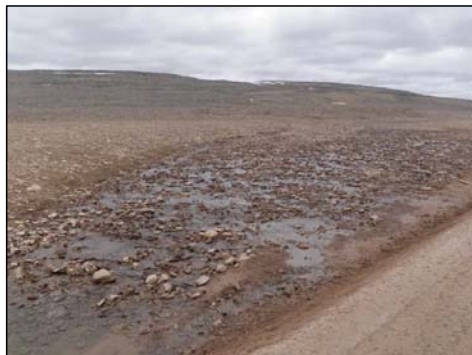
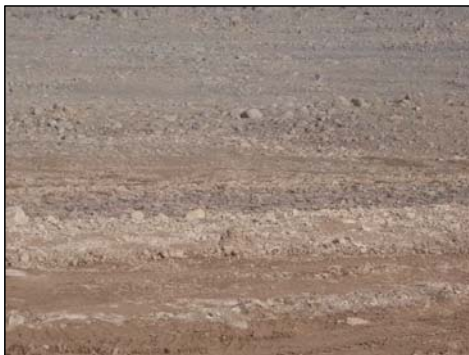
Figure 1. Views of CV-44-3 at the rail crossing during summer (A) and fall (B).

This stream had a small amount of water flowing during summer, but was dry during fall, 2018. Downstream of the Tote Road is an impassable vertical barrier that prevents fish access to the rail site under all flow conditions. There is never fish habitat at this crossing.

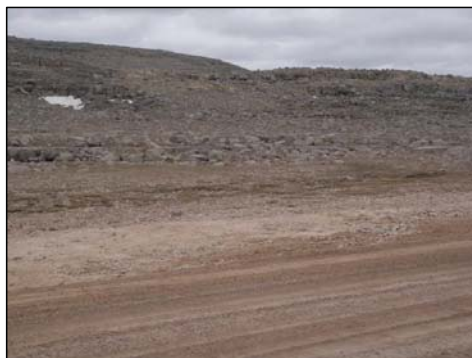
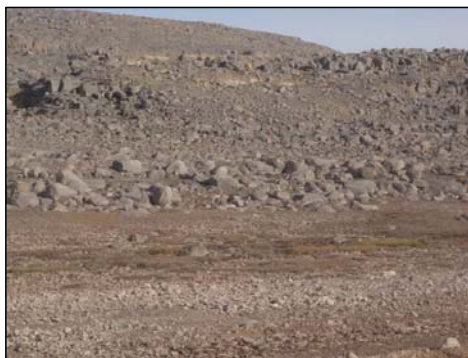
This was a dry, low point in 2018. There is never fish habitat at this crossing.

Figure 1. Views of CV-45-1 at the rail crossing during summer (A) and fall (B).

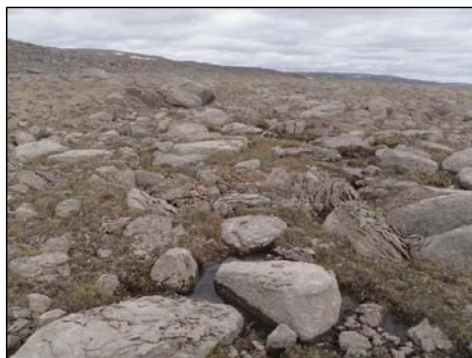
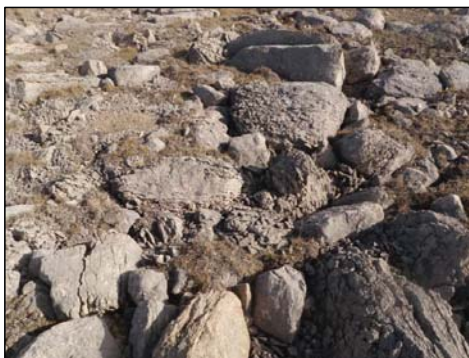
This was a nearly dry, boulder field in 2018. There is never fish habitat at this crossing.

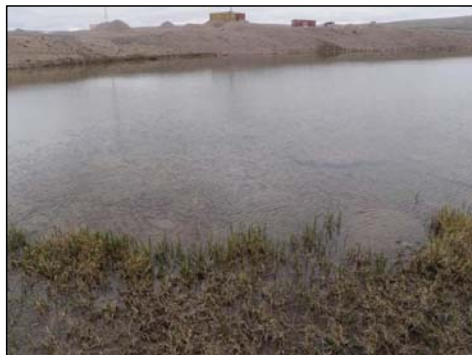
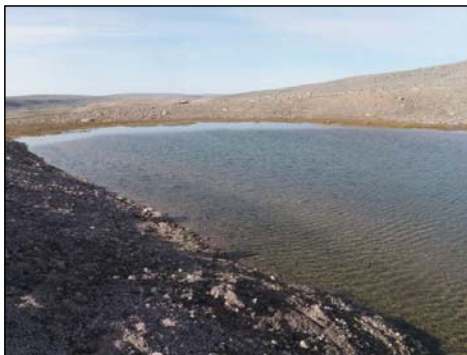
This was a small, shallow (< 1 m) pond with no connection to Phillips Creek. Depth is insufficient for overwintering. Fish were not observed. There is never fish habitat at this crossing.

Figure 1. Views of CV-46-1a at the rail crossing during summer (A) and fall (B).

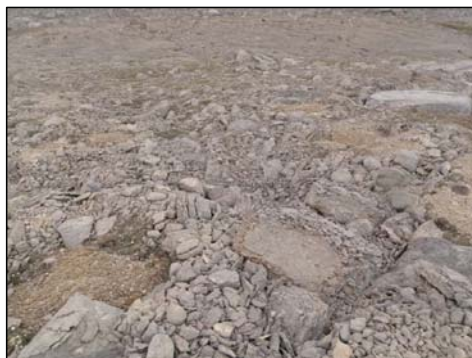
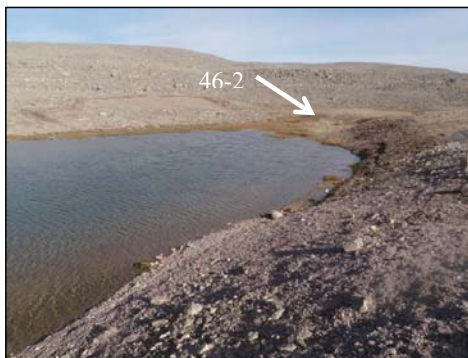
This was a dry depression adjacent to the CV-46-1a pond. There is never fish habitat at this crossing.

Figure 1. Views of CV-46-2 at the rail crossing during summer (A) and fall, with 46-1a in the foreground (B).

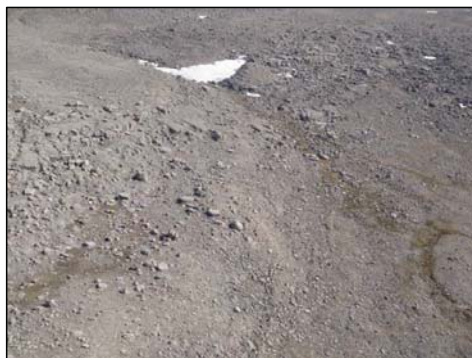
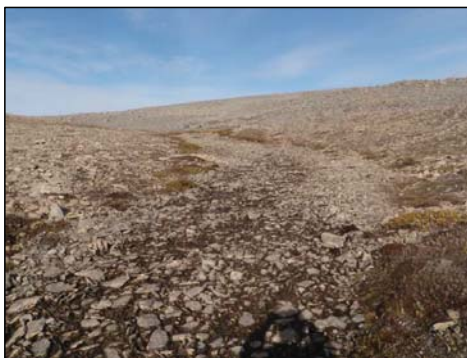
This was dry or nearly dry during the open-water period in 2018. There is no access from other waterbodies. There is never fish habitat at this crossing.

Figure 1. Views of CV-46-3 at the rail crossing during summer (A) and fall (B).

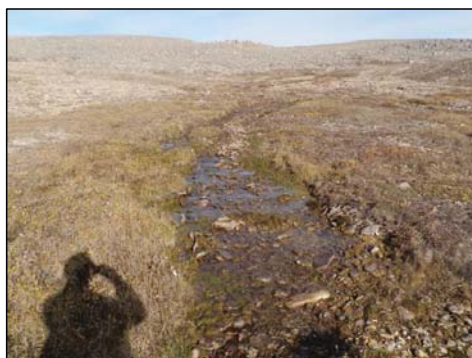
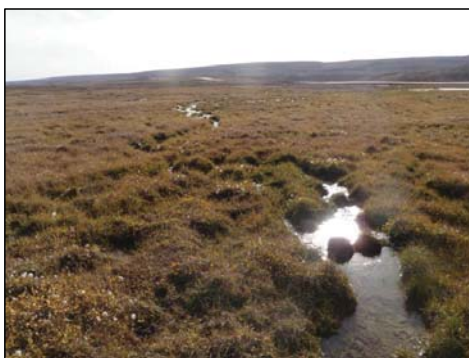
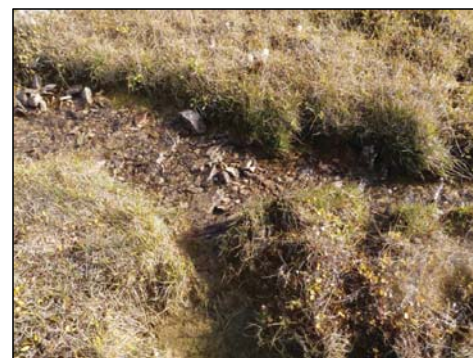
This stream maintained a small amount of flow throughout the open-water period in 2018. However, there is a steep barrier downstream of the Tote Road preventing fish access from Phillips Creek under all flow conditions. There is never fish habitat at this crossing.

Figure 2. Views of CV-46-4 at the rail crossing during fall, looking upstream (A) downstream (B) and across (C).

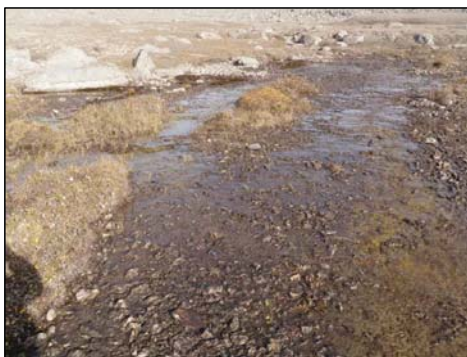
B

This stream maintained a small amount of flow throughout the open-water period in 2018. However, there is a steep barrier downstream of the Tote Road preventing fish access from Phillips Creek under all flow conditions. There is never fish habitat at this crossing.

Figure 1. Views of CV-46-6 at the rail crossing during summer (A) and fall (B). Note that these three crossings and 47-1b (not pictured) are all branches of the same stream.

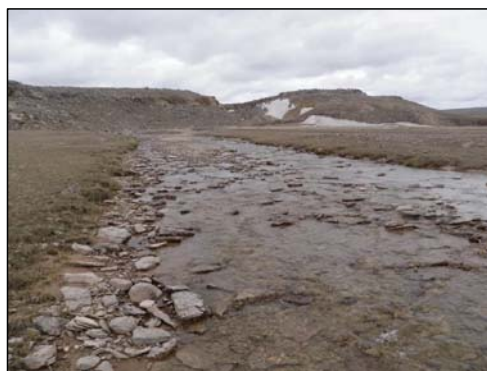
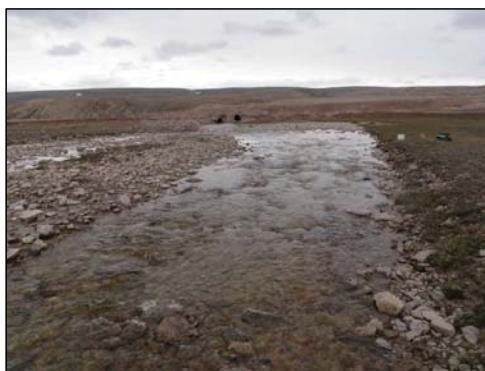
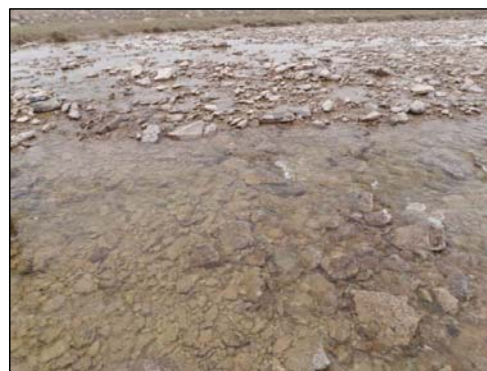
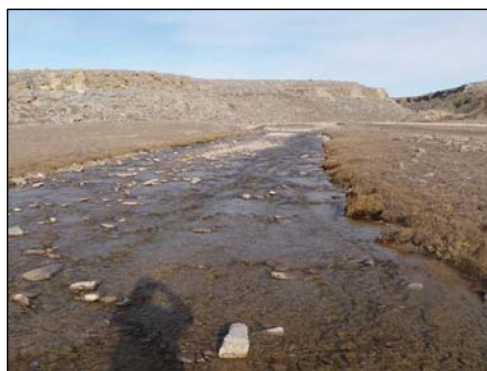
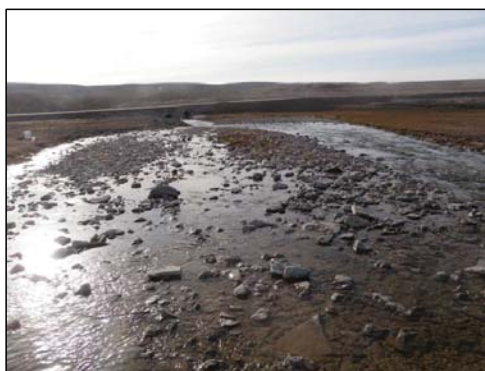
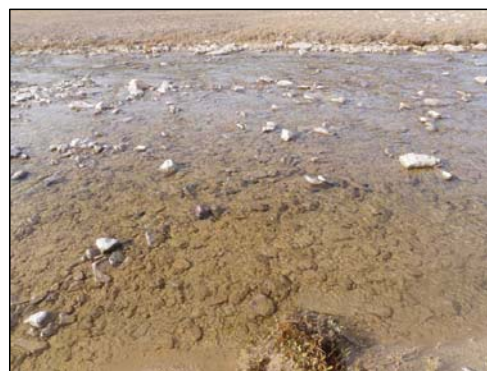
Figure 2. Summer (top) and fall (bottom) views of CV-47-1 at the 80 m downstream cross-section; (A) looking upstream; (B) looking downstream; and (C) looking across.

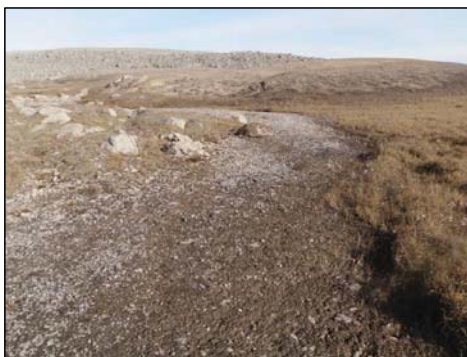
Figure 1. Views of CV-47-1a at the rail crossing during summer (A) and fall (B). Note that these three crossings and 47-1b (not pictured) are all branches of the same stream.

This stream was dry or nearly dry during the open-water period in 2018. In addition, there is a steep barrier downstream of the Tote Road (shared by other streams in this valley) preventing fish access from Phillips Creek under all flow conditions. There is never fish habitat at this crossing.

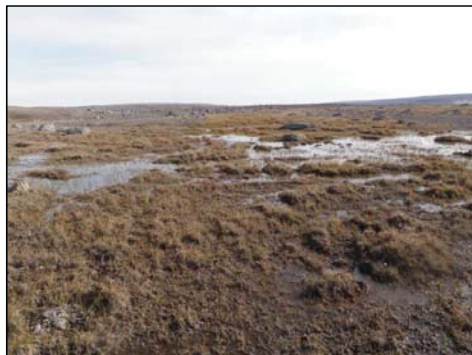
Figure 1. Views of CV-47-1b at the rail crossing during fall (A). Note that 47-1b and 46-4, 46-6, and 47-1a are all branches of the same stream.

This was marshy with little flow during the open-water period in 2018. In addition, there is a steep barrier downstream of the Tote Road (shared by other streams in this valley) preventing fish access from Phillips Creek under all flow conditions. There is never fish habitat at this crossing.

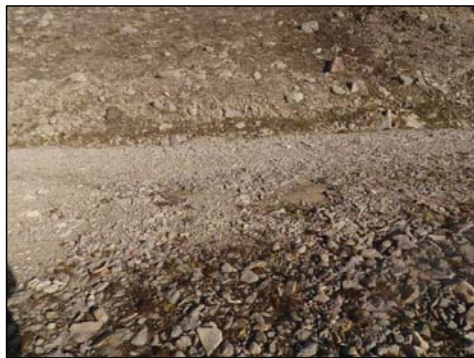
Figure 1. View of CV-47-3 at the rail crossing during fall.

This braid was dry during 2018 sampling, but is known to be wetted during period of very high flows (observed during annual Tote Road monitoring). Under such flow conditions, it may provide some rearing habitat.

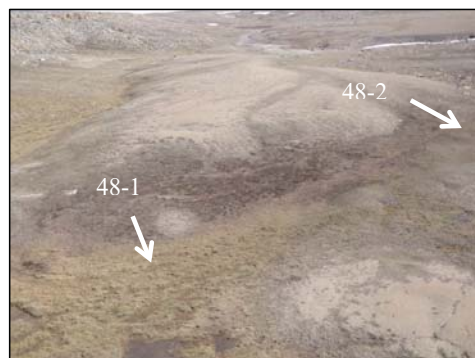
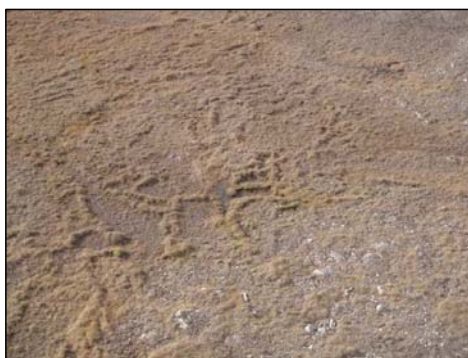
This was nearly dry marshy to dry during the open-water period in 2018. There were no connections to other waterbodies. There is never fish habitat at this crossing.

Figure 1. Views of CV-48-1 at the rail crossing, with nearby 48-2, during summer (A) and during fall (B).

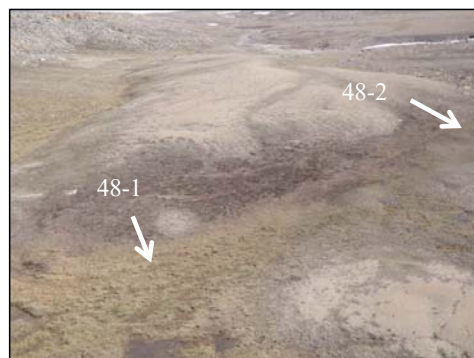
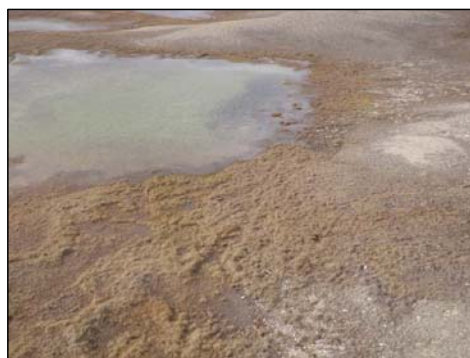
This was a marshy area with adjacent shallow, fishless pond. There were no connections to other waterbodies. There is never fish habitat at this crossing.

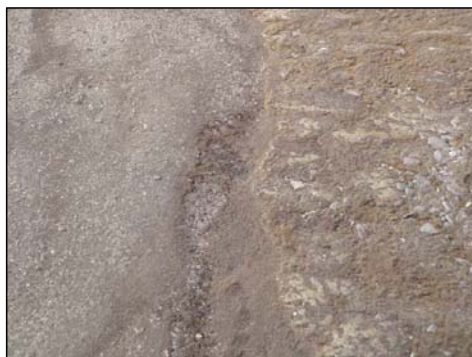
Figure 1. View of CV-48-3 at the rail crossing during fall.

This was a very steep, dry channel that joins with fish-bearing 48-4 downstream. However, the vertical barrier is impassable under all flow conditions. There is never fish habitat at this crossing.

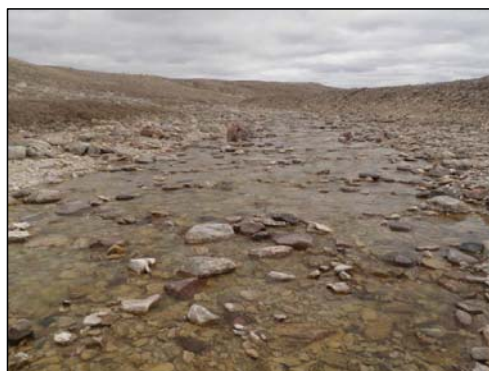
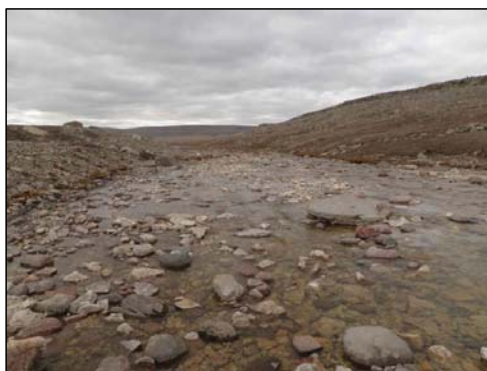
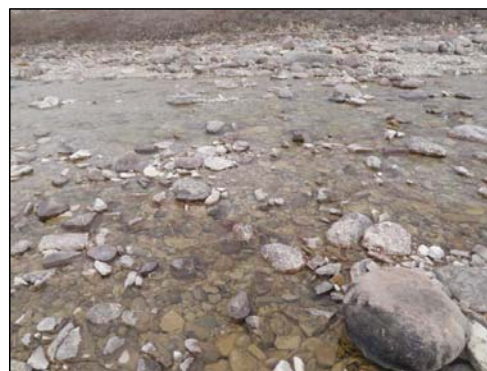
Figure 6. 100 m upstream cross-section view of CV-48-4; (A) looking upstream; (B) looking downstream; and (C) looking across.

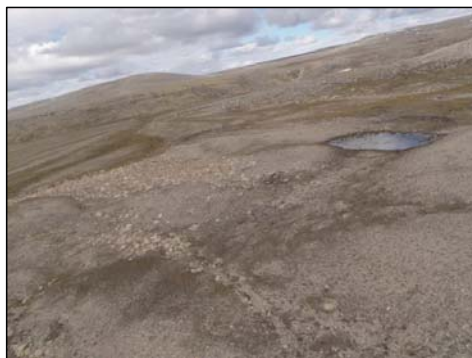
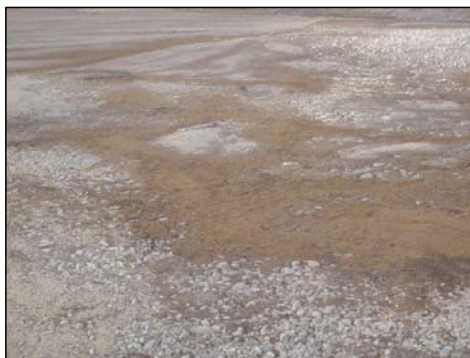
This was a nearly dry marshy area with occasional shallow, isolated ponds. There is never fish habitat at this crossing.

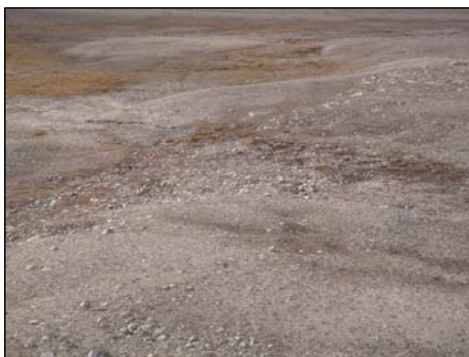
Figure 1. Aerial views of CV-49-2 at the rail crossing during summer (A) and fall (B).

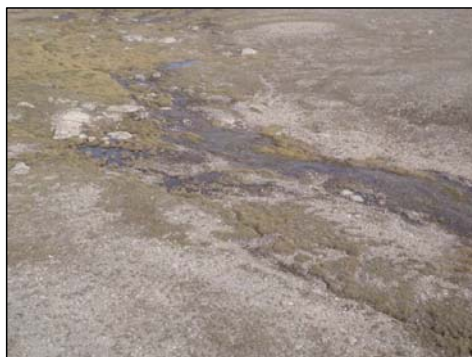
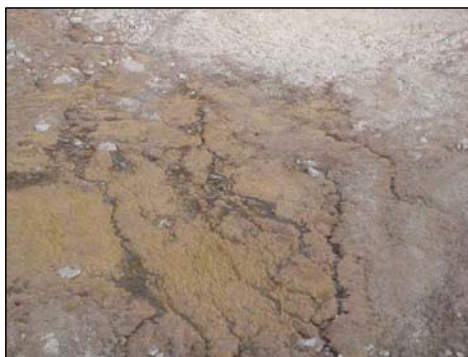
This crossing is in the same watershed as 49-2 and shares many characteristics. The Tote Road crossing (> 500 m downstream) is known to provide marginal fish habitat. Periods of very high water may allow access upstream of the soft barriers (subsurface water) between the road and rail. Fish use of this crossing would be rare, at best.

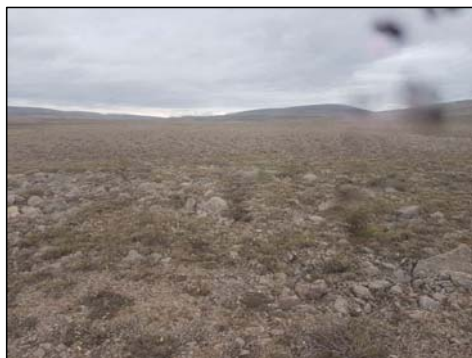
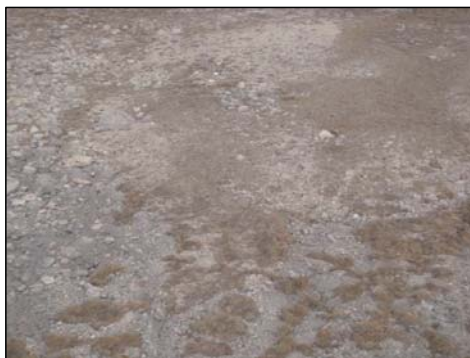
This was a dry low point. There is never fish habitat at this crossing.

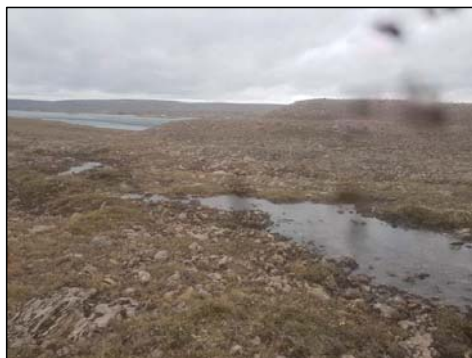
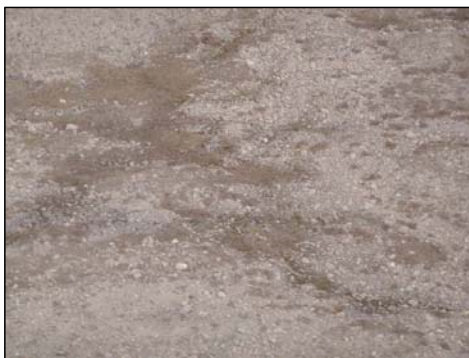
This site was a few isolated, shallow, fishless puddles during summer and nearly dry during fall. There is never fish habitat at this crossing.

Figure 1. Views of CV-50-2 at the rail crossing during summer (A) and fall (B).

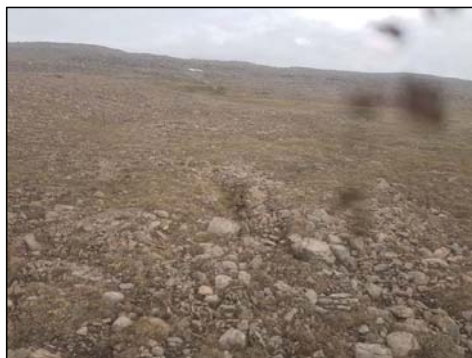
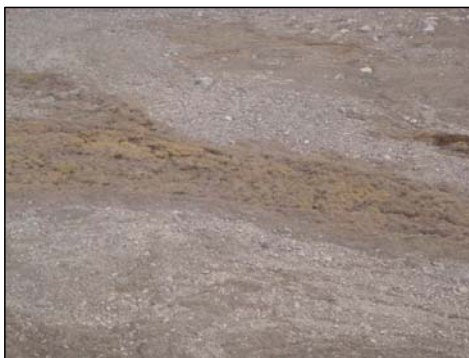
This was a nearly dry hillside. There is never fish habitat at this crossing.

Figure 1. Views of CV-50-3 at the rail crossing during summer (A) and fall (B).
