Phase 2 Milne Rail Corridor Aquatic Habitat Assessment

Crossing ID: CV-33-6

Dates Surveyed: 5 July & 25 August, 2018

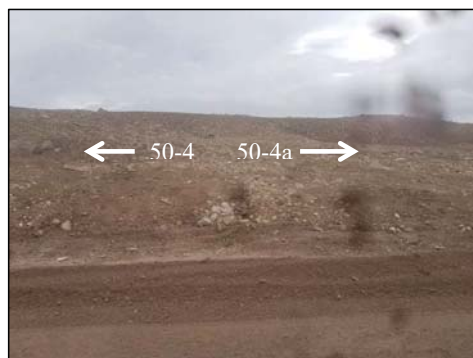
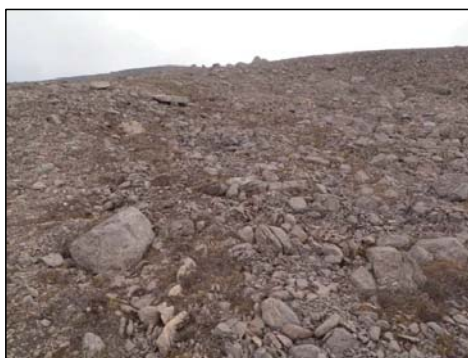
This was a dry hillside. There is never fish habitat at this crossing.

Figure 1. Views of CV-50-4 at the rail crossing during summer, with nearby 50-4a (A) and fall (B).

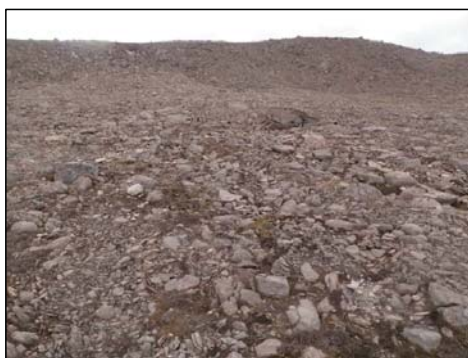
Figure 1. Views of CV-50-4a at the rail crossing during summer, with nearby 50-4 (A) and fall (B).

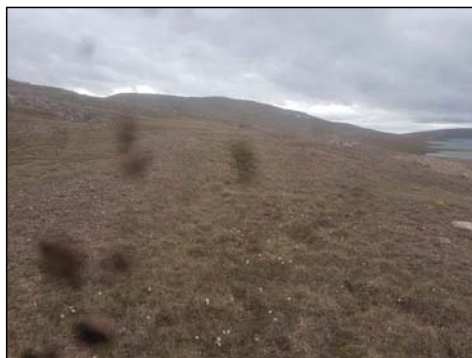
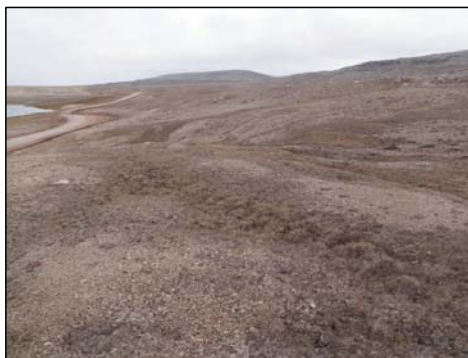
This was a dry hillside. There is never fish habitat at this crossing.

Figure 1. Views of CV-50-4b at the rail crossing during summer (A) and fall (B).

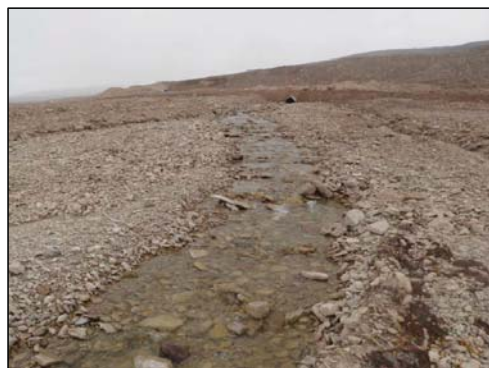
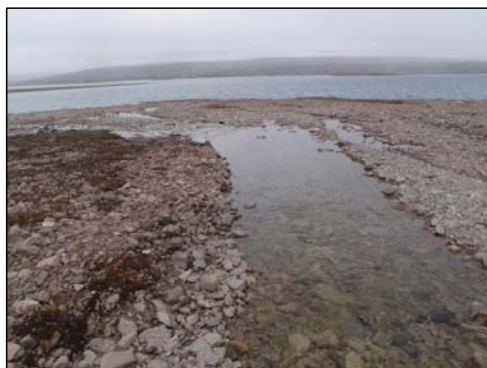
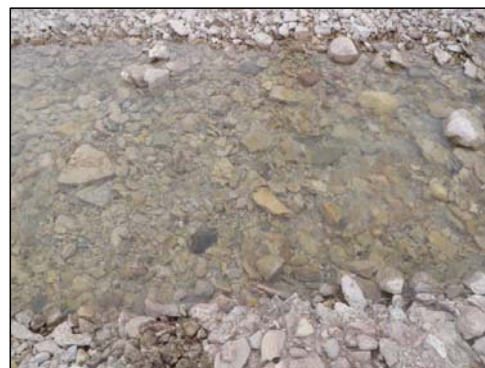
Figure 1. Summer (top) and fall (bottom) views of CV-50-6 at the 100 m downstream cross-section; (A) looking upstream; (B) looking downstream; and (C) looking across.

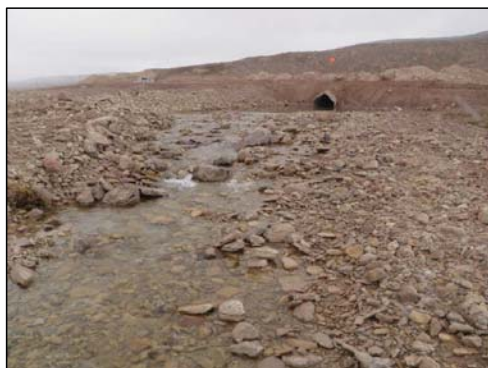
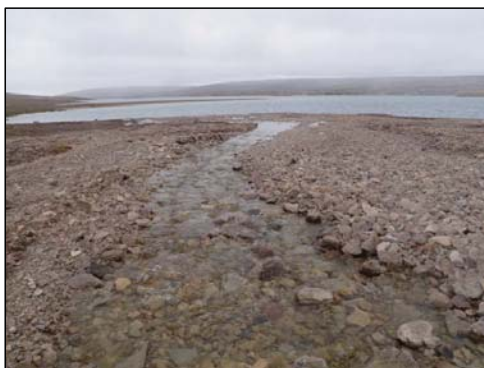
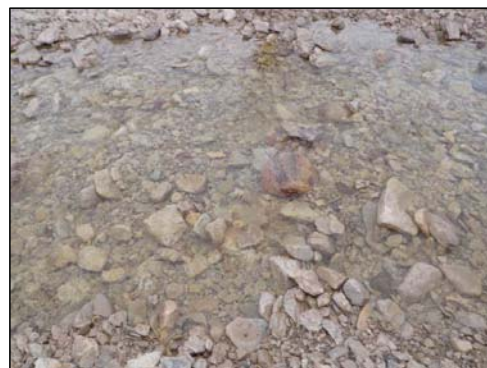
Figure 2. Summer (top) and fall (bottom) views of CV-50-6 at the 80 m downstream cross-section; (A) looking upstream; (B) looking downstream; and (C) looking across.

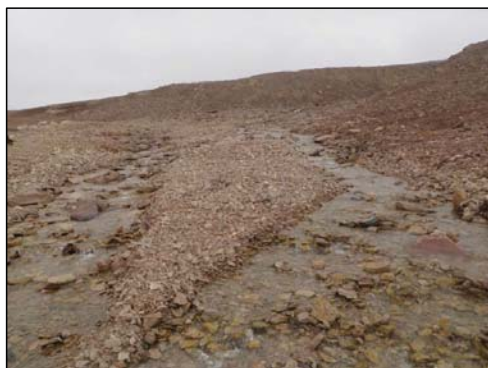
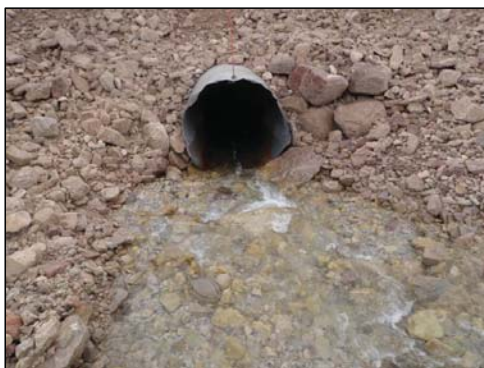
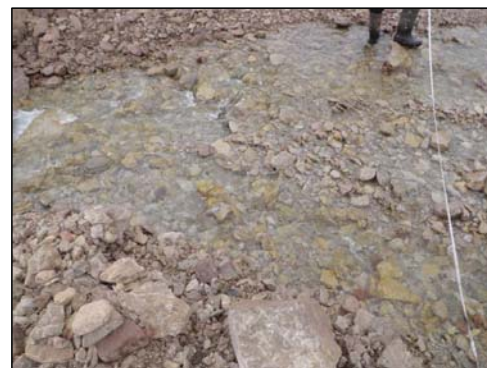
Figure 3. Summer (top) and fall (bottom) views of CV-50-6 at the 40 m downstream cross-section; (A) looking upstream; (B) looking downstream; and (C) looking across.

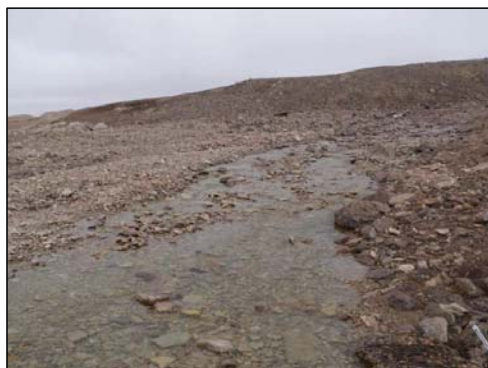
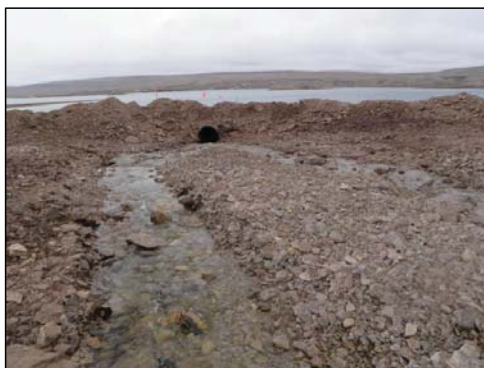
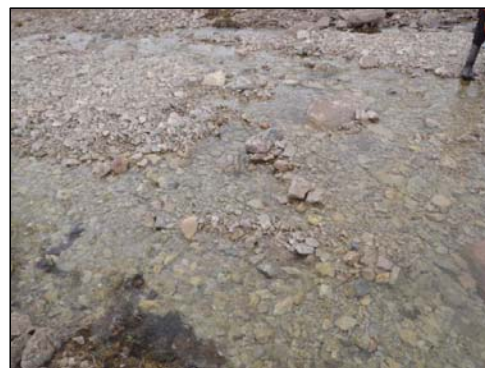
Figure 4. Summer (top) and fall (bottom) views of CV-50-6 at the 20 m downstream cross-section; (A) looking upstream; (B) looking downstream; and (C) looking across.

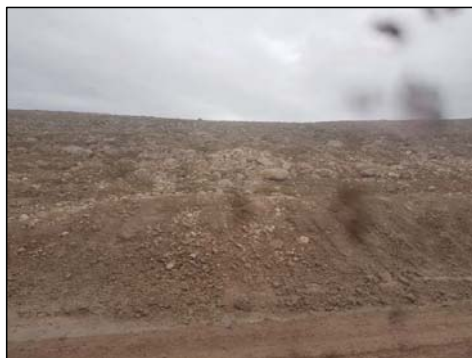
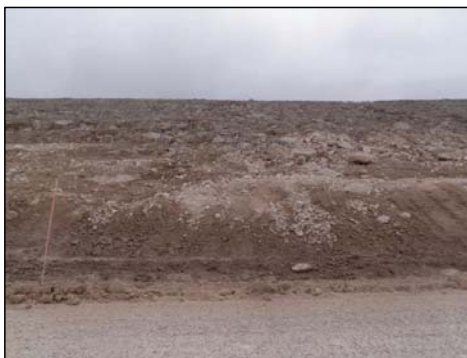
This was a dry hillside. There is never fish habitat at this crossing.

Figure 1. Views of CV-51-1 at the rail crossing during summer (A) and fall (B).

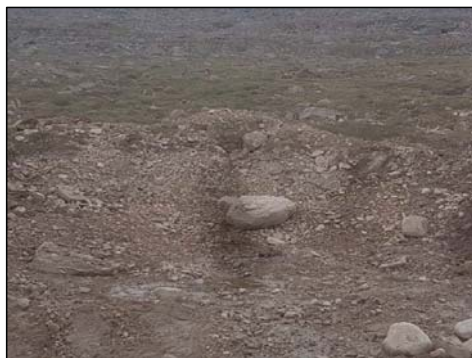
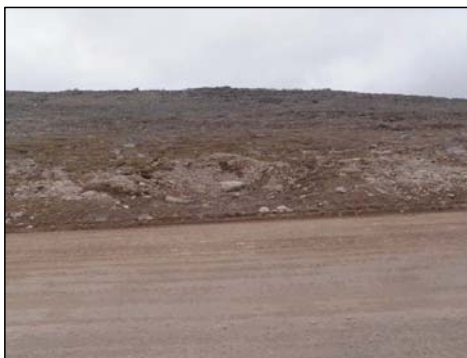
This was a dry hillside. There is never fish habitat at this crossing.

Figure 1. Views of CV-51-2 at the rail crossing during summer (A) and fall (B).

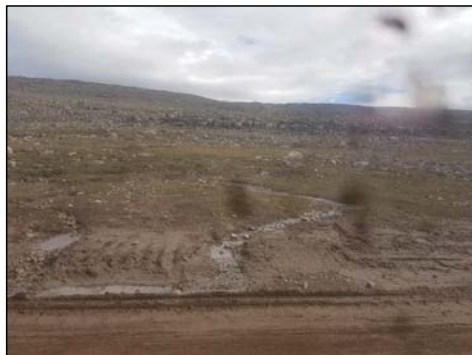
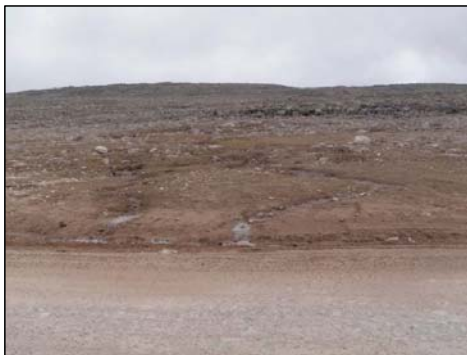
This site had very low water during 2018. In addition, there is no surface flow downstream of the Tote Road and no connectivity to overwintering habitat. There is never fish habitat at this crossing.

Figure 1. Views of CV-52-1 at the rail crossing during summer (A) and fall (B).

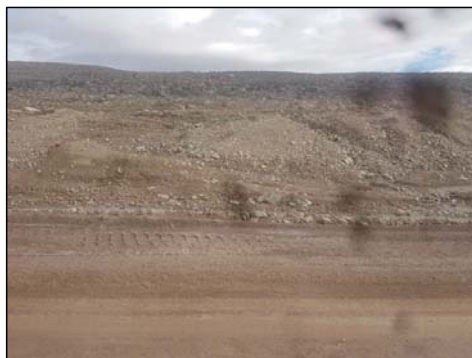
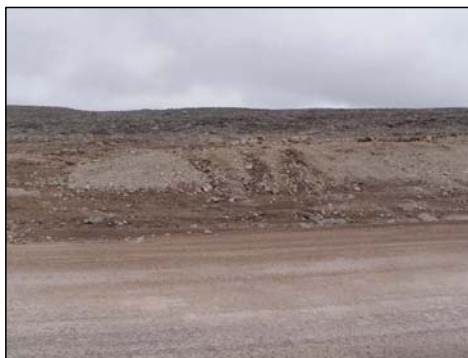
This was a nearly dry hillside with some ponding at the Tote Road. There is never fish habitat at this crossing.

Figure 1. Views of CV-52-2 at the rail crossing during summer (A) and fall (B).

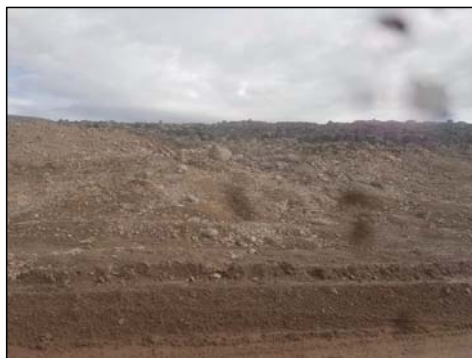
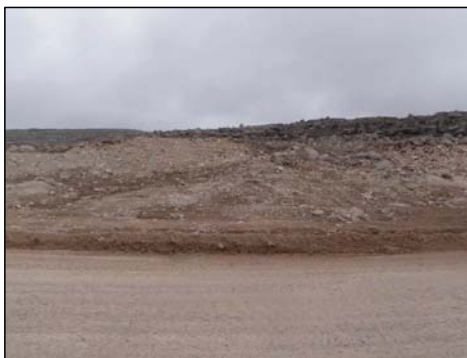
This was a dry hillside. There is never fish habitat at this crossing.

Figure 1. Views of CV-52-3 at the rail crossing during summer (A) and fall (B).

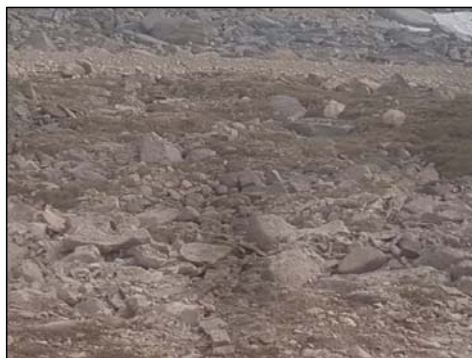
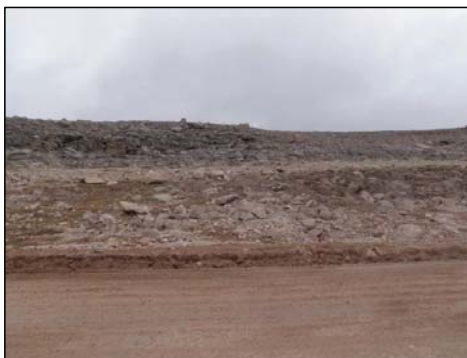
This was a dry hillside. There is never fish habitat at this crossing.

Figure 1. Views of CV-53-1 at the rail crossing during summer (A) and fall (B).

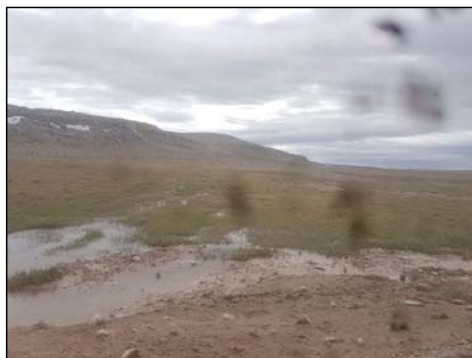
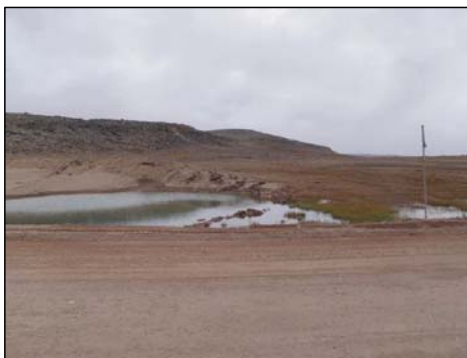
This was a small, shallow, fishless pond with no connections to other waterbodies. There is never fish habitat at this crossing.

Figure 1. Views of CV-53-2 at the rail crossing during summer (A) and fall (B).

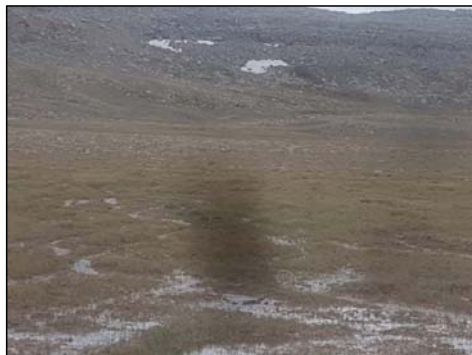
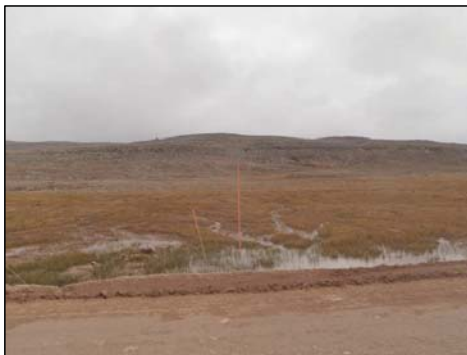
This was shallow, marshy habitat with multiple soft barriers downstream and no connection to overwintering habitat under any flow condition. There is never fish habitat at this crossing.

Figure 1. Views of CV-54-1 at the rail crossing during summer (A) and fall (B).
