Phase 2 Milne Rail Corridor Aquatic Habitat Assessment

Crossing ID: CV-62-1

**Baffinland Iron Mines
Mary River Project**

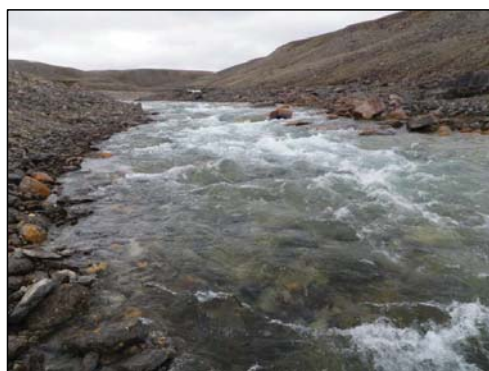
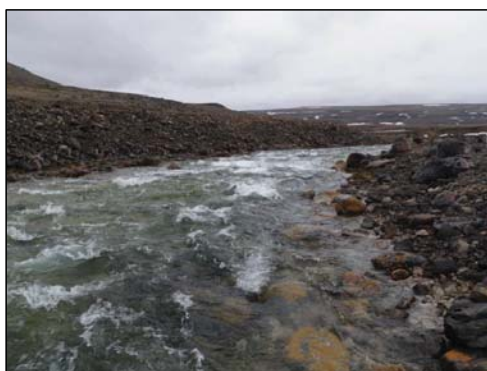
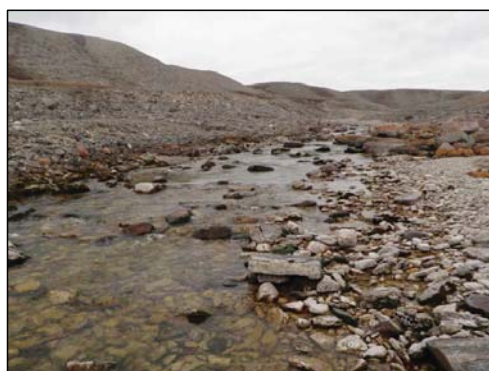
Figure 5. Summer (top) and fall (bottom) views of CV-62-1 at the 20 m downstream cross-section; (A) looking upstream; (B) looking downstream; and (C) looking across.

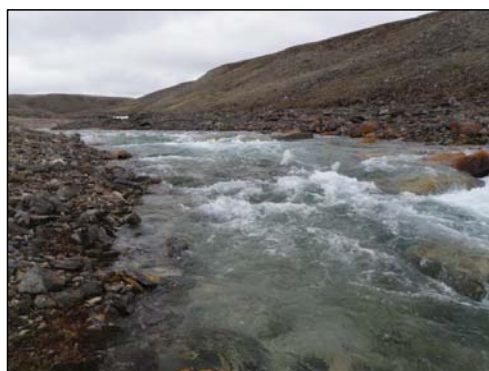
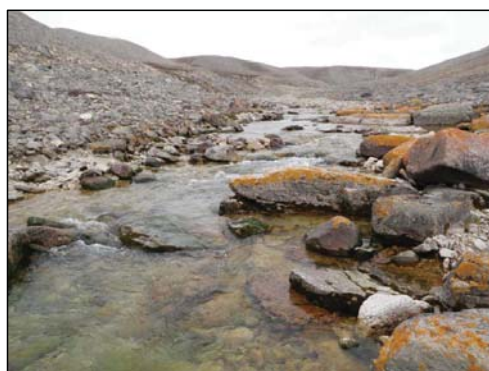
Figure 6. Summer (top) and fall (bottom) views of CV-62-1 at the rail crossing; (A) looking upstream; (B) looking downstream; and (C) looking across.

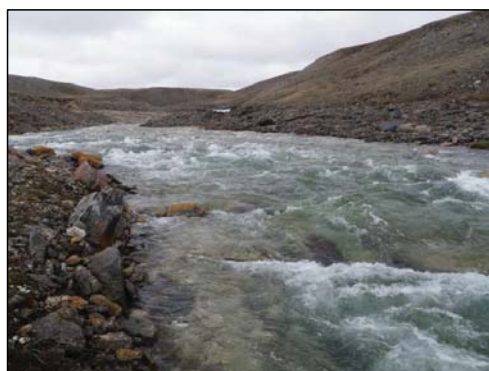
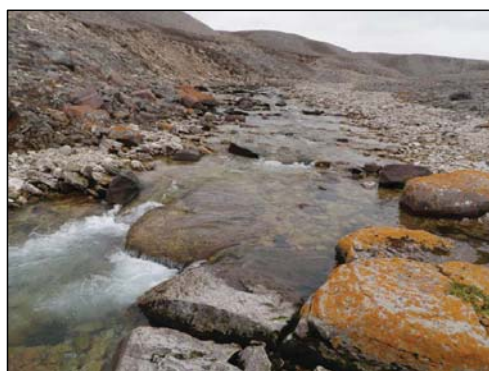
Figure 7. Summer (top) and fall (bottom) views of CV-62-1 at the 20 m upstream cross-section; (A) looking upstream; (B) looking downstream; and (C) looking across.

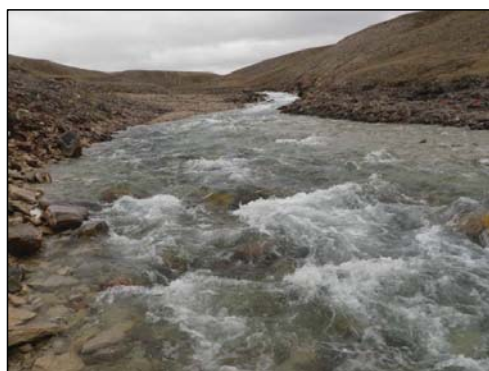
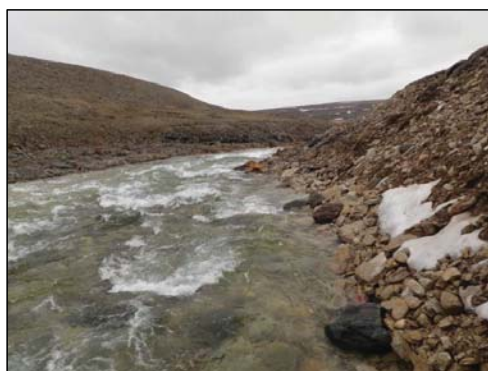
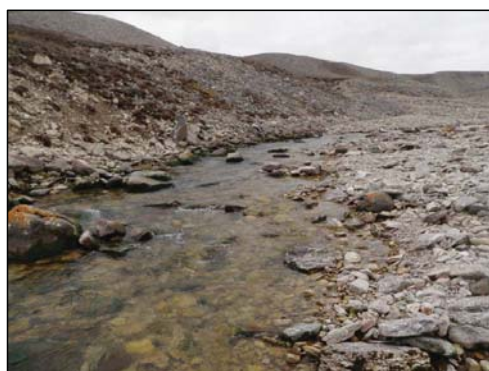
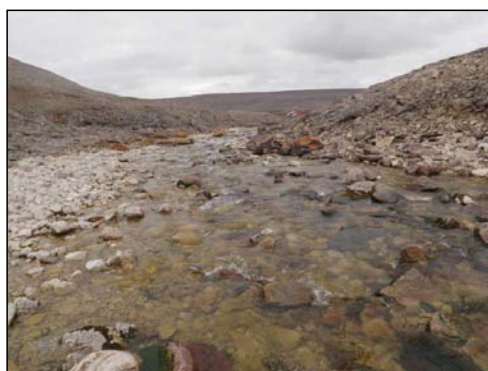
Figure 9. Summer (top) and fall (bottom) views of CV-62-1 at the 60 m upstream cross-section; (A) looking upstream; (B) looking downstream; and (C) looking across.

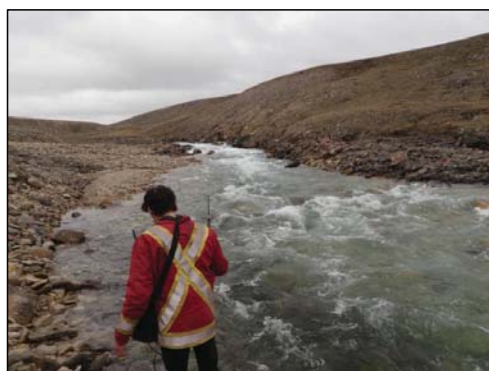
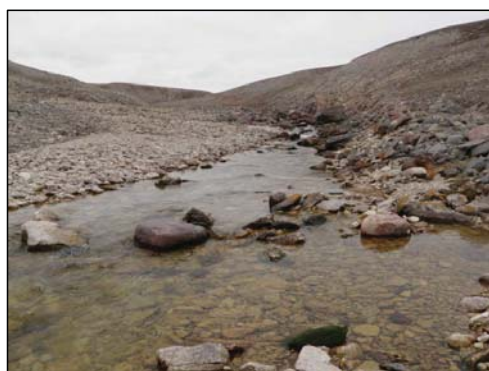
Figure 10. Summer (top) and fall (bottom) views of CV-62-1 at the 80 m upstream cross-section; (A) looking upstream; (B) looking downstream; and (C) looking across.

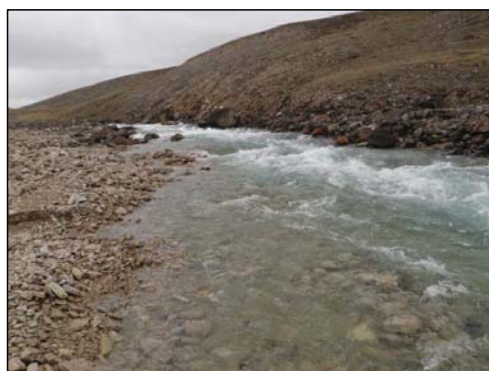
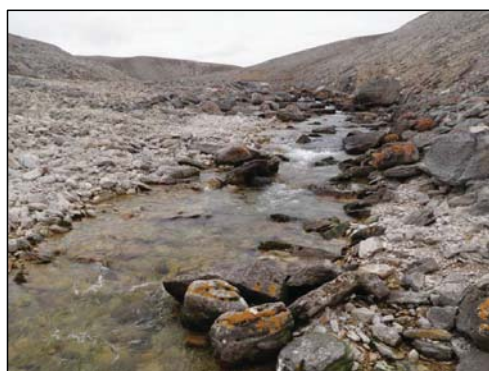
Figure 11. Summer (top) and fall (bottom) views of CV-62-1 at the 100 m upstream cross-section; (A) looking upstream; (B) looking downstream; and (C) looking across.

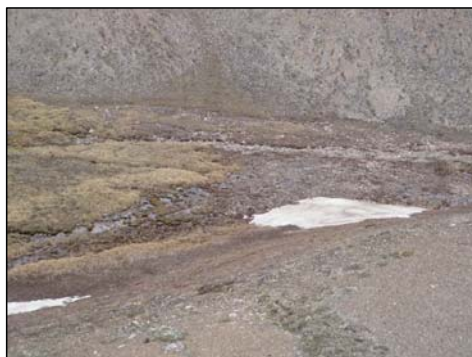
This crossing was very shallow in 2018 and steep (~15°). The channel widens downstream with very shallow (1 cm) and occasionally subsurface flows. These barriers to movement in 2018 likely prevent fish movements under most, if not all, flow conditions. Fish use of habitat at or near the crossing is unlikely.

Figure 1. Views of CV-62-2 at the rail crossing during summer (A), downstream (B), and the crossing during fall (C).

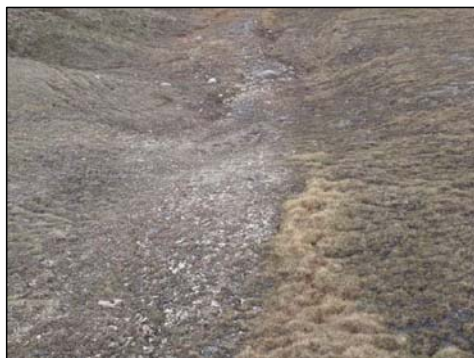
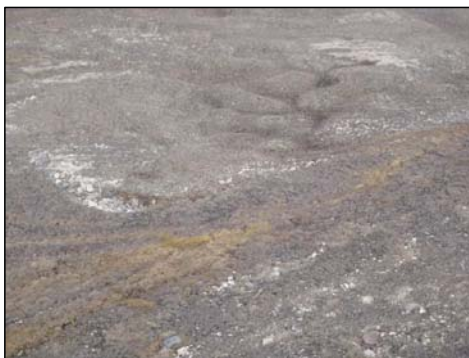
This crossing was dry in 2018 and steep. There are multiple potential soft barriers to movement even under very high flows. There is no fish use of habitat at the crossing.

Figure 1. Views of CV-62-3 at the rail crossing during summer (A) and fall (B).

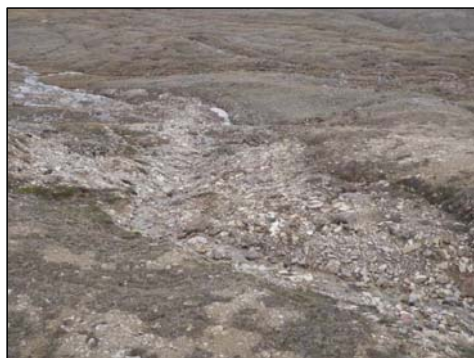
These are two branches of the same stream. Water was low in summer and nearly dry by fall, combined with a vertical drop barrier ~150 m downstream of the crossing, upstream access is prevented under any flow conditions. A subsurface flow barrier may exist at the downstream confluence. There is no fish use of habitat at the crossing.

Figure 1. Views of CV-62-6 (A) and 62-6b (B) during summer, and both crossings during fall (C).

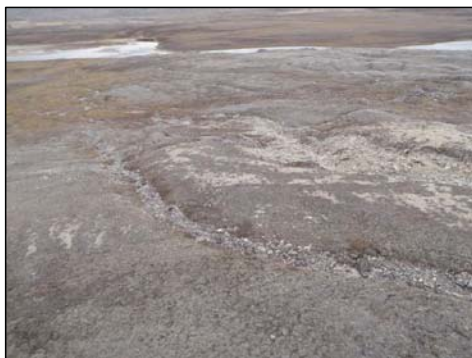
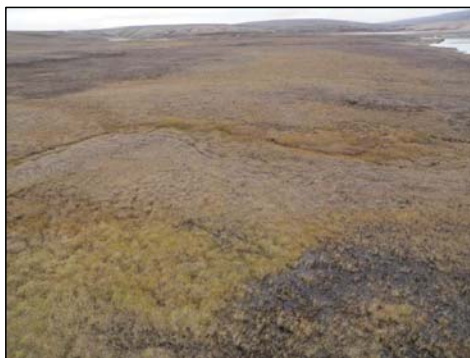
Figure 2. Views of CV-62-6 and 62-6b at the crossing during fall (A) and near the downstream confluence (B) showing loss of surface flow.

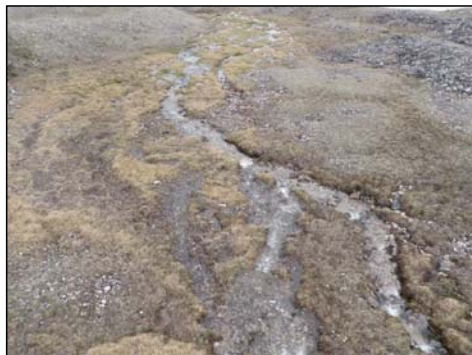
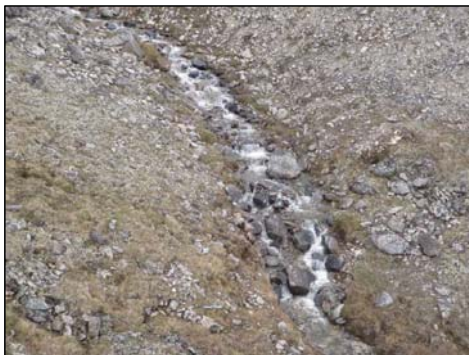
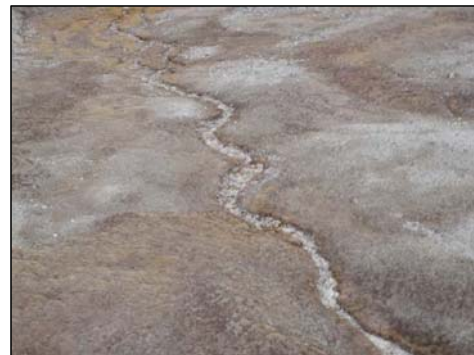
This crossing had flows during summer, but was nearly dry by fall 2018. There was an impassable vertical drop barrier 100 m downstream of the crossing. There is no fish use of habitat at the crossing.

Figure 1. Views of CV-63-1 at the crossing during summer (A), at the downstream barrier (B), and during fall looking upstream towards the crossing (C).

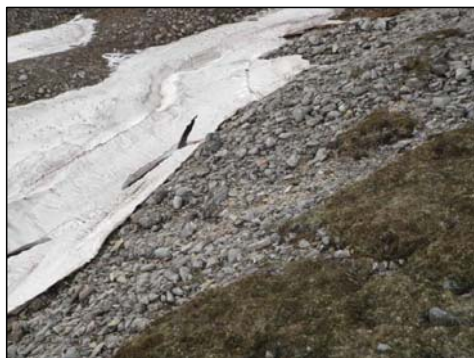
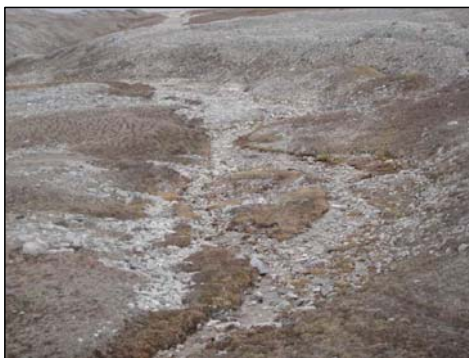
Figure 1. Views of CV-63-2 at the crossing during summer (A) and fall (B).

This crossing had similar habitat to CV-63-1 and shared the same impassable downstream barrier. There is no fish use of habitat at this crossing.

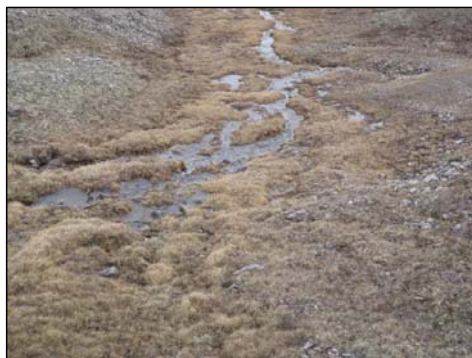
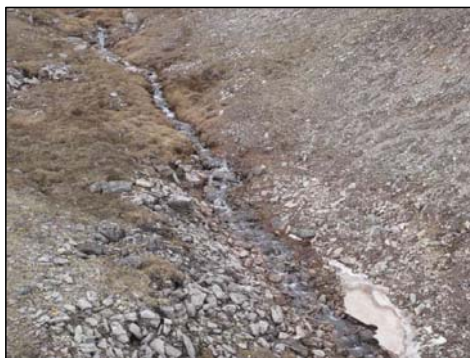
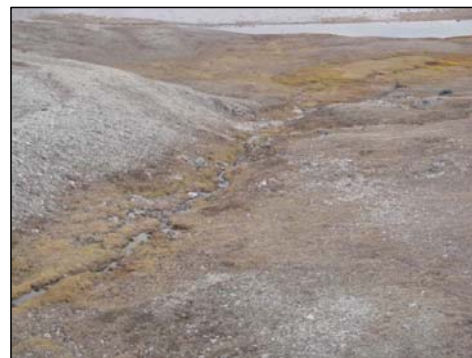
Figure 1. Views of CV-63-3 at the crossing during summer (A), at the downstream barrier (B), and at the crossing during fall (C).

This crossing was steep, but had sufficient water levels. However, there is an impassable vertical barrier 100 m downstream. There is no fish use of habitat at the crossing.

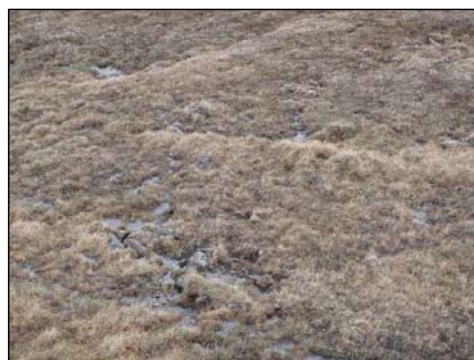
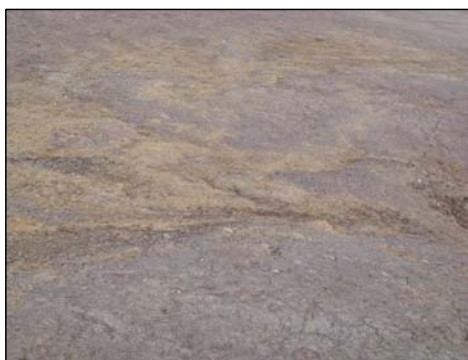
Figure 1. Views of CV-63-3a at the crossing during summer (A) and fall (B).

This crossing was nearly dry with no channel and was not connected to other waterbodies. There is no fish use of habitat at the crossing.

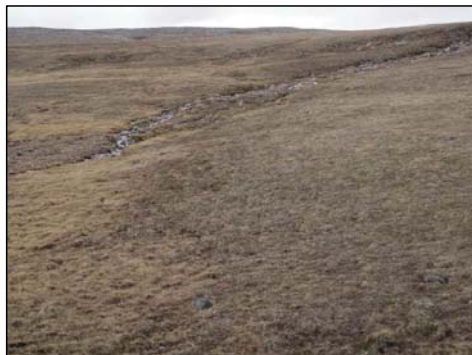
This crossing was very steep with low water levels in 2018. There were multiple subsurface flow barriers downstream of the crossing. The combined effects of all soft barriers likely prevent access under any flow condition. There is no fish use of habitat at the crossing.

Figure 1. Views of CV-63-4 at the crossing during summer (A) and fall (B).

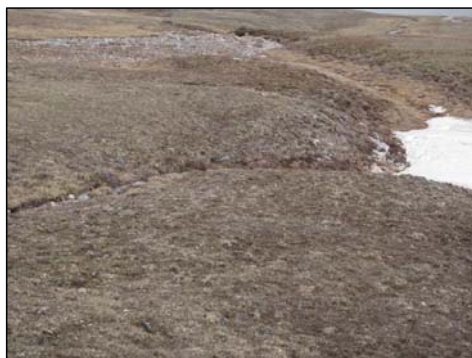
These are two branches of the same stream. Both crossings were steep with low water levels. In addition, there were multiple subsurface flow barriers downstream including at the confluence of these two branches. The combined effects of all soft barriers likely prevent access under any flow condition. There is no fish use of habitat at the crossing.

Figure 1. Views of CV-63-4a (A) and 63-5 (B) at the crossing during summer, and both crossings during fall (C).

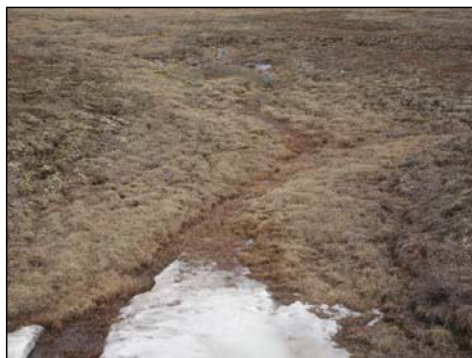
This was a moist, steep hillside valley with multiple subsurface flow barriers downstream of the crossing. There is no fish use of habitat at the crossing.

Figure 1. Views of CV-64-1 during summer (A) and fall (B).

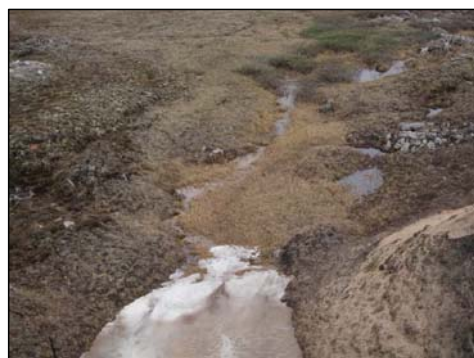
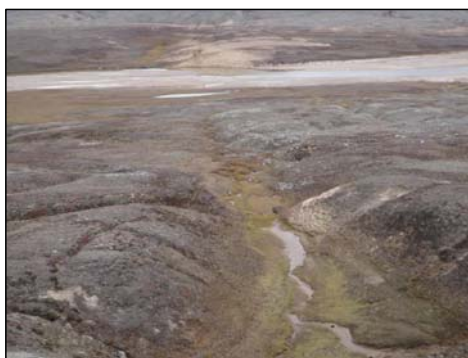
Figure 1. Views of CV-64-2 during summer (A) and fall (B).

This site was steep, had patchy surface flow and had multiple vertical barriers downstream of the crossing. There is no fish use of habitat at the crossing.

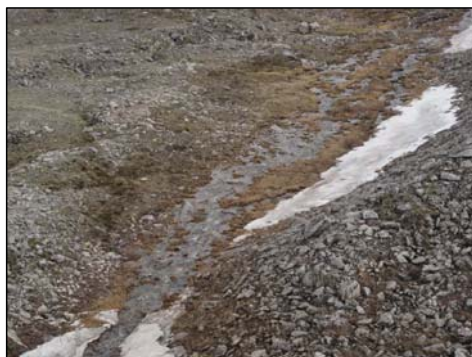
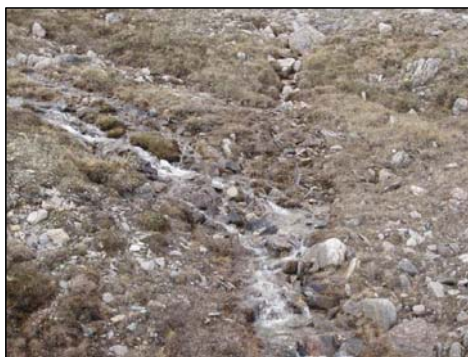
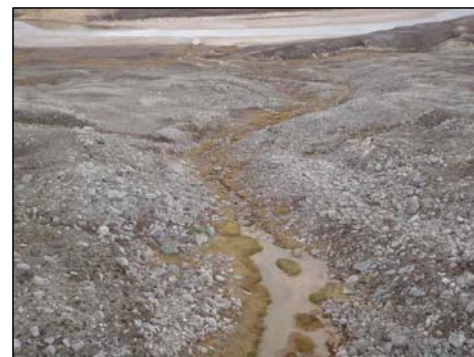
Figure 1. Views of CV-64-3 during summer at the crossing (A), at the downstream barrier (B), and during fall at the crossing (C).

This crossing was steep, but wetted in 2018. However, starting at 160 m downstream from the crossing, there were multiple vertical barriers and occasional loss of surface flow. There is no fish use of habitat at the crossing.

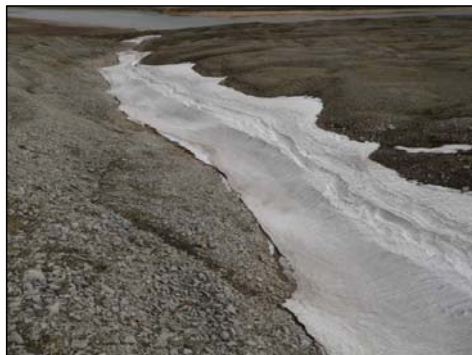
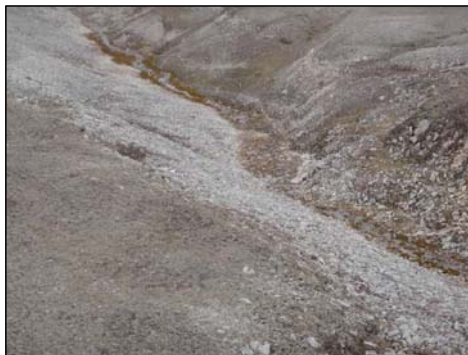
Figure 1. Views of CV-64-4 at the crossing during summer (A) and fall (B).

This crossing was very steep with no flows in summer (still snow-covered) and nearly dry in fall 2018. There were multiple vertical barriers and occasional loss of surface flow downstream. There is no fish use of habitat at the crossing.

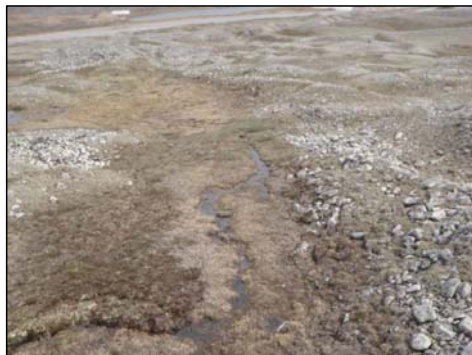
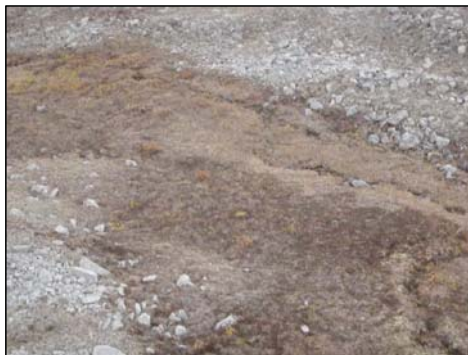
Figure 1. Views of CV-64-5 at the crossing during summer (A) and fall (B).

This crossing was very steep and surface flows were intermittent in 2018. There are additional vertical barriers and loss of surface flow downstream. There is no fish use of habitat at the crossing.

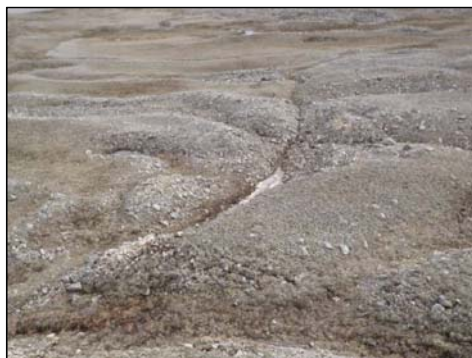
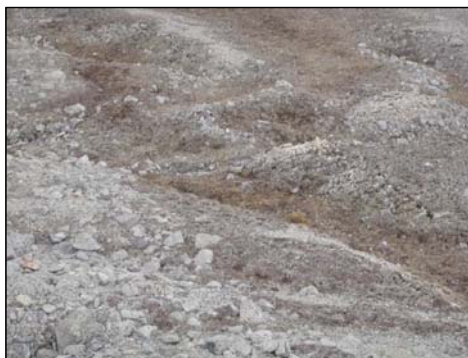
Figure 1. Views of CV-64-5a at the crossing during summer (A) and fall (B).

This crossing was a dry low point. There is no fish use of habitat at the crossing.

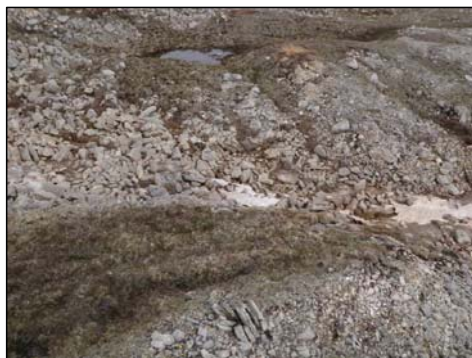
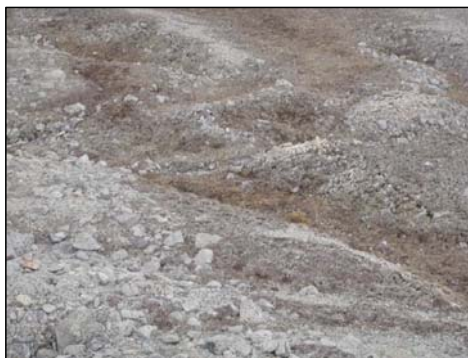
This crossing was nearly dry and steep. Additional vertical barriers and lack of surface flow were observed downstream. There is no fish use of habitat at the crossing.

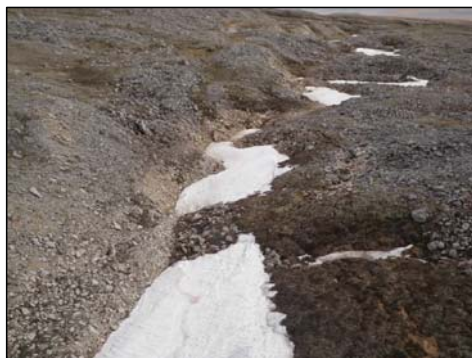
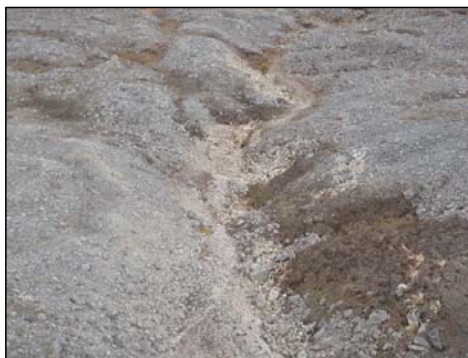
Figure 1. Views of CV-65-1 at the crossing during summer (A) and fall (B).

This crossing was a dry and steep rocky valley. There is no fish use of habitat at the crossing.

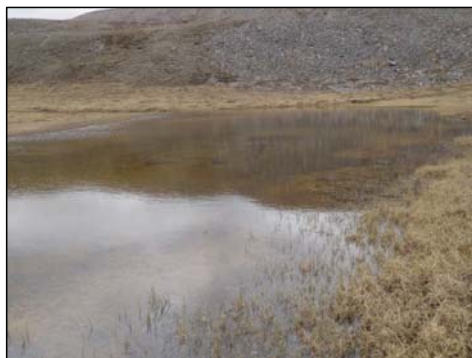
This was a shallow (0.40 m maximum depth), isolated pond. No fish were captured or observed during the survey. There is no fish use of habitat at the crossing.

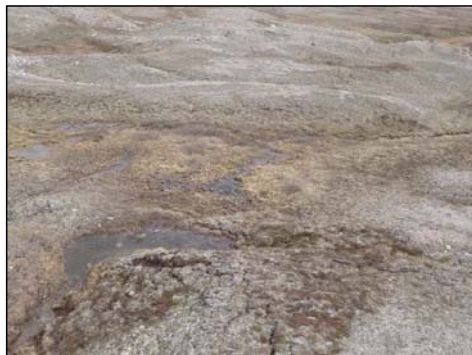
This was some moist terrain on a steep hill. Some downstream portions were channelized, but flows were low and frequently subsurface. There is no fish use of habitat at the crossing.

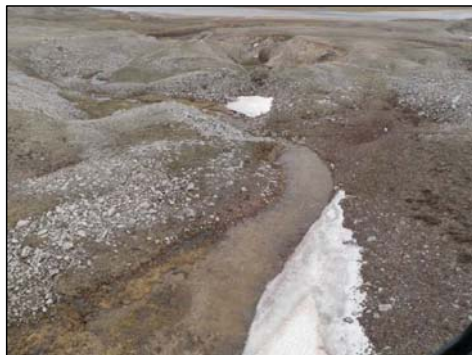
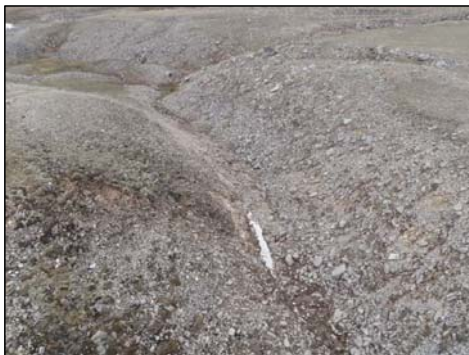
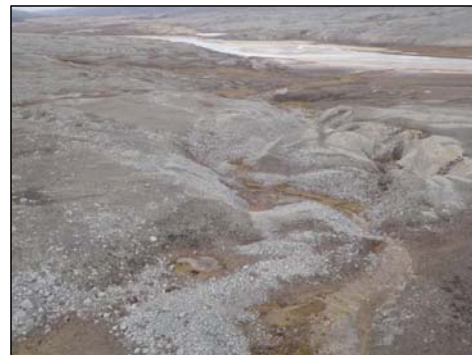
Figure 1. Views of CV-66-1 at the crossing during summer (A), at one of the downstream barriers (B), and at the crossing during fall (C).

There was shallow water present at the crossing in 2018. However, there were multiple vertical barriers downstream, preventing all access. There is no fish use of habitat at the crossing.

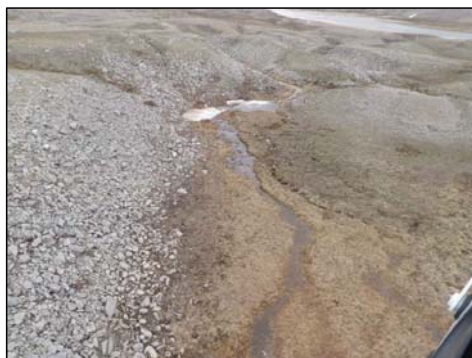
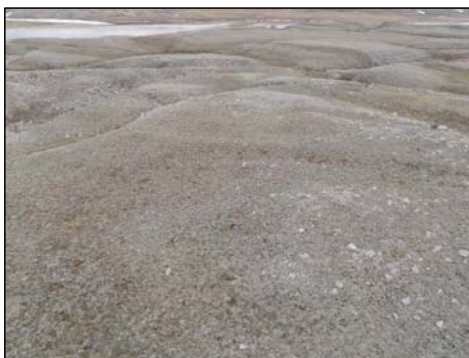
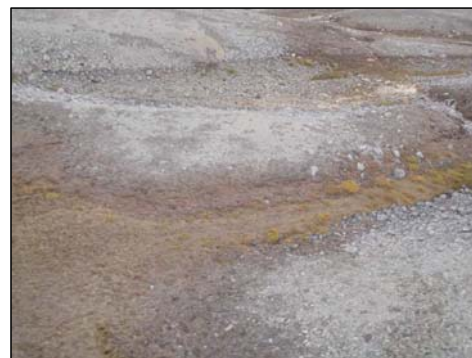
Figure 1. Views of CV-66-2 (A) and 66-2a (B) at the crossing during summer, and 66-2 at the crossing during fall (C).

This crossing and 66-2a were contained within a small depression at the top of a hill. There was no access from any downstream habitat. There is no fish use of habitat at the crossing.

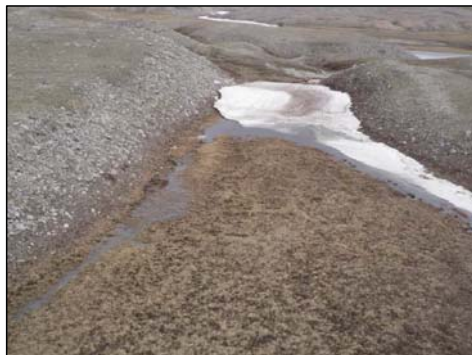
This site was nearly dry in 2018 and had a very steep gradient almost immediately downstream of the crossing. The barrier would prevent access under all flow conditions. There is no fish use of habitat at the crossing.

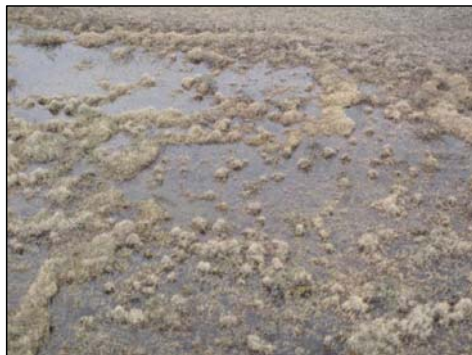
Figure 1. Views of CV-66-4 at the crossing during summer.

This site was a very shallow, marshy spot on top of a hill, lacking any noticeable downstream flow or connections to other waterbodies. There is no fish use of habitat at the crossing.

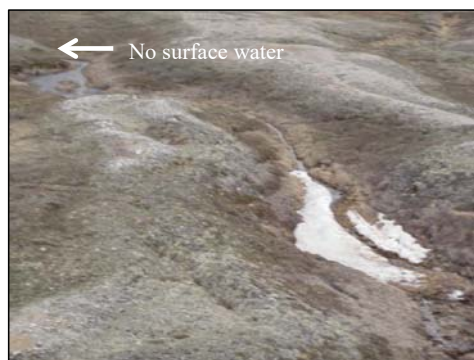
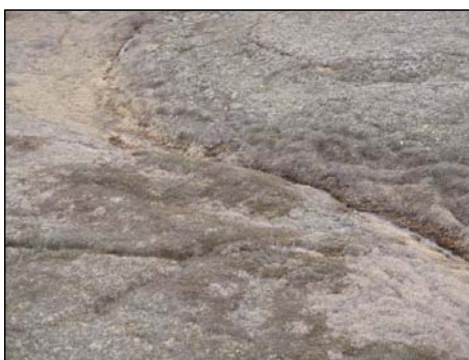
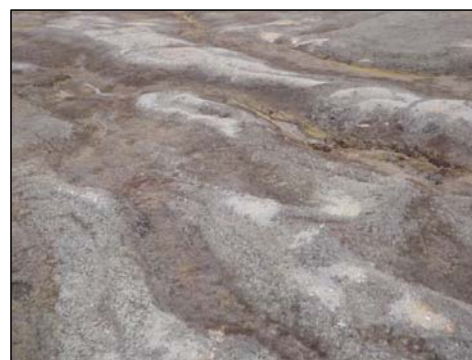
Figure 1. Views of CV-66-7 (A) and 66-8 (B) at the crossing during summer, and 66-7 at the crossing during fall (C).

These are two branches of the same stream. Water levels were low in summer and even lower during fall. In addition, there were several patches of subsurface flow in both seasons. These barriers are likely impassable in all flows. There is no fish use of habitat at the crossing.

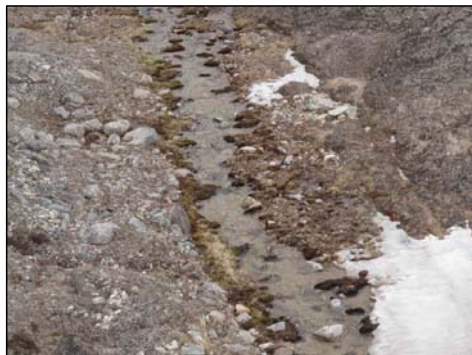
This crossing is steep, but had sufficient flows throughout the open-water period in 2018. However, there is a large boulder almost completely blocking the channel 100 m downstream of the crossing, creating a high vertical drop. There are additional vertical barriers downstream. There is likely never fish use of habitat at the crossing.

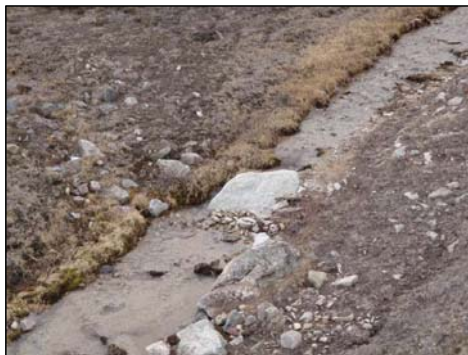
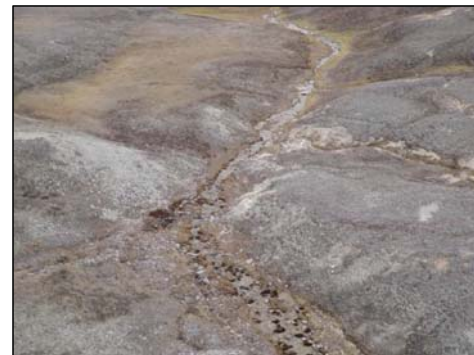
Figure 1. Views of CV-67-1 at the crossing during summer (A), one of the barriers (B), and at the crossing during fall (C).

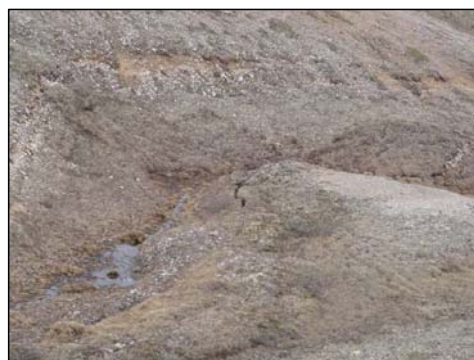
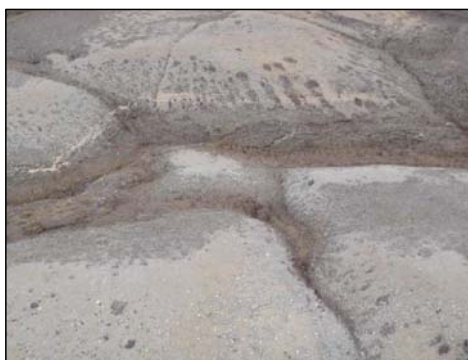
This crossing was nearly dry in summer and dry in fall, 2018. The crossing is also atop a plateau with a very steep drop downstream. There is no fish use of habitat at the crossing.

Figure 1. Views of CV-67-2 at the crossing during summer (A) and fall (B).

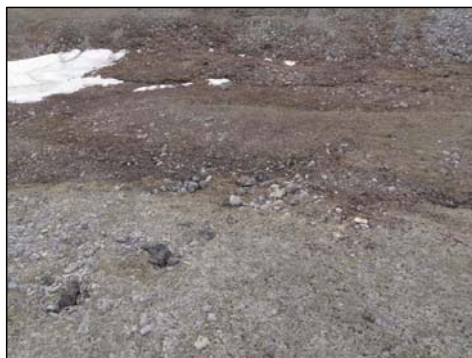
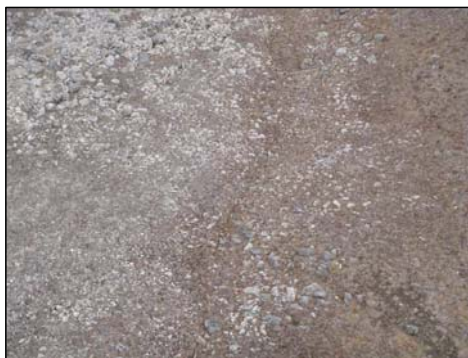
This crossing was dry throughout 2018. There is no fish use of habitat at the crossing.

Figure 1. Views of CV-68-2 at the crossing during summer (A) and fall (B).

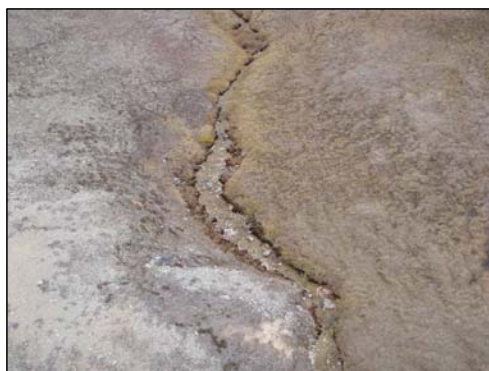
Figure 3. Rail crossing (A) and downstream (B) aerial views during fall.

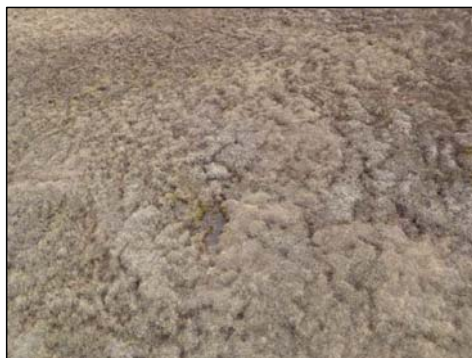
This crossing was a moist hillside in summer and dry in fall during 2018. There is no fish use of habitat at the crossing.

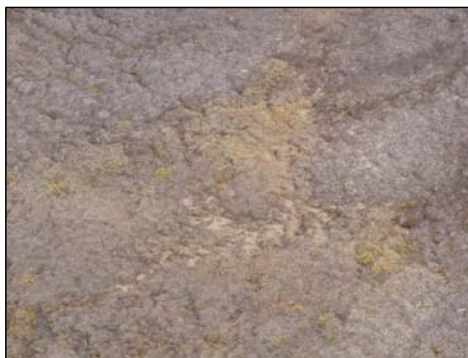
B

Figure 1. Views of CV-68-4 at the crossing during summer (A) and fall (B).

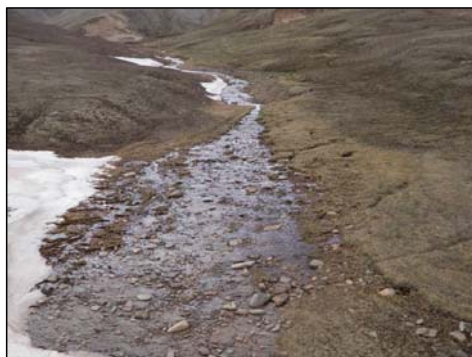
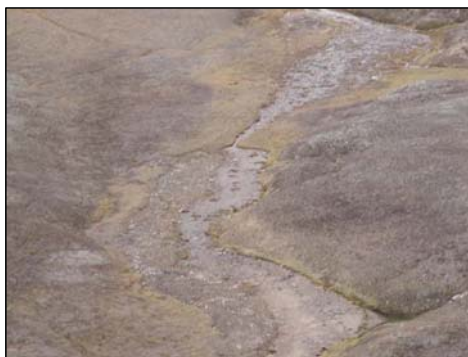
This crossing was broad and very shallow in summer with even less water in fall. The channel narrows downstream, but there is also a near vertical drop at approximately 150 m downstream of the crossing. The gradient is likely sufficiently high to prevent access under all flows. There is no fish use of habitat at the crossing.

Figure 1. Views of CV-68-5 at the crossing during summer (A) and fall (B).

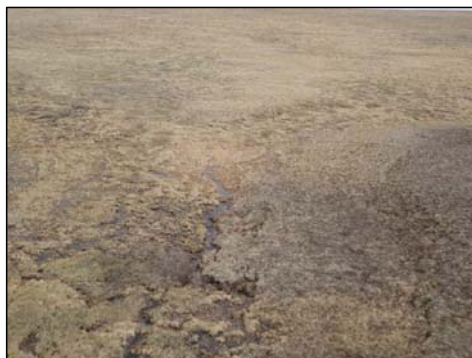
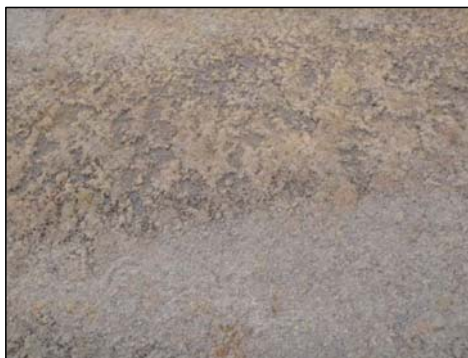
This crossing was shallow and marshy with no channel and no connections to other waterbodies. There is no fish use of habitat at the crossing.

Figure 1. Views of CV-69-1 at the crossing during summer (A) and fall (B).

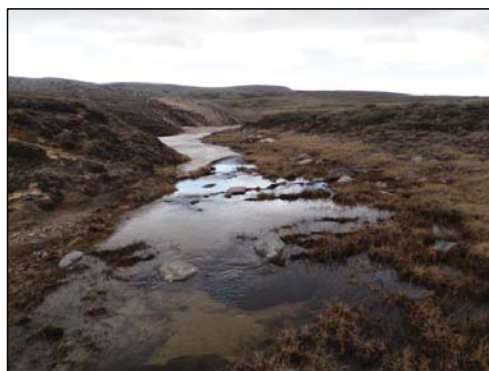
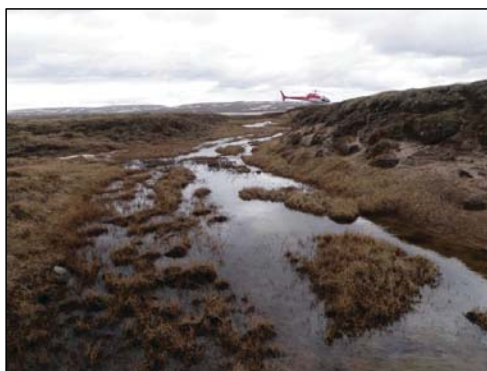
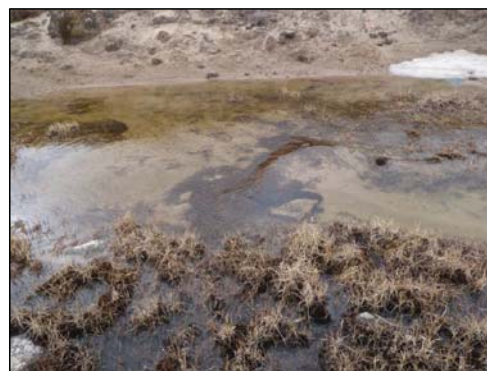
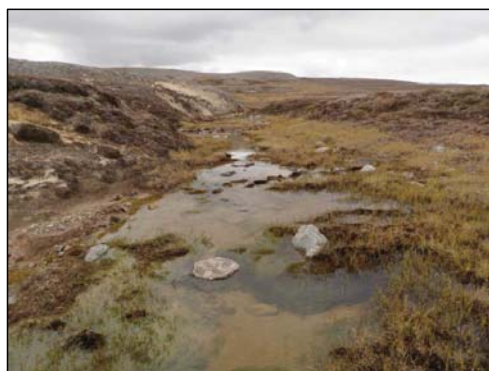
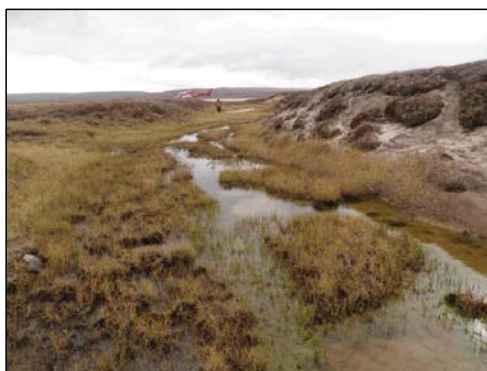
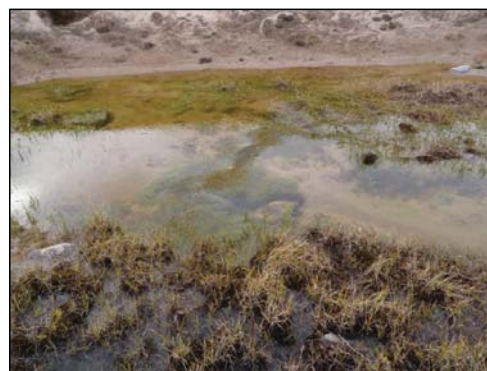
Figure 3. Summer (top) and fall (bottom) views of CV-69-2 at the rail crossing; (A) looking upstream; (B) looking downstream; and (C) looking across.

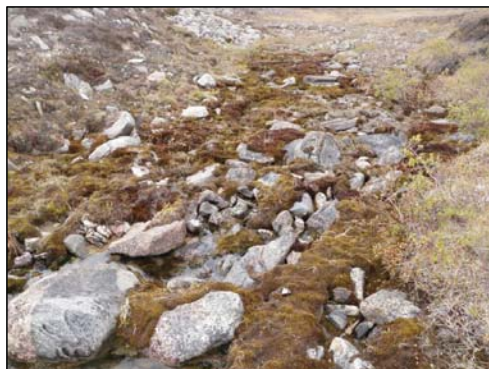
A

Figure 5. Subsurface flow barrier at 70 m upstream from the CV-69-2 rail crossing.

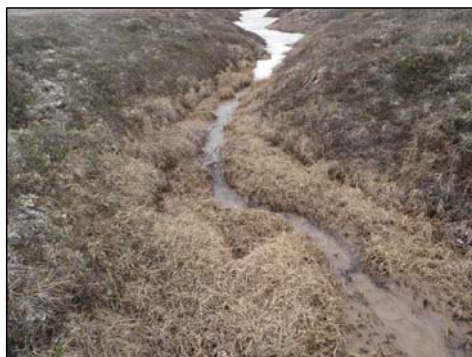
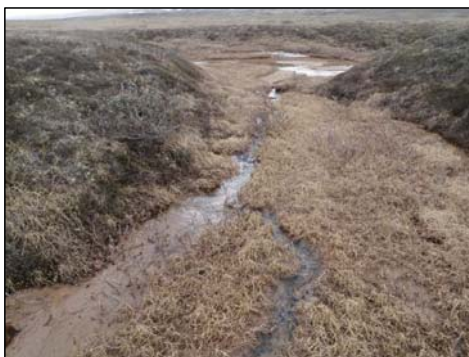
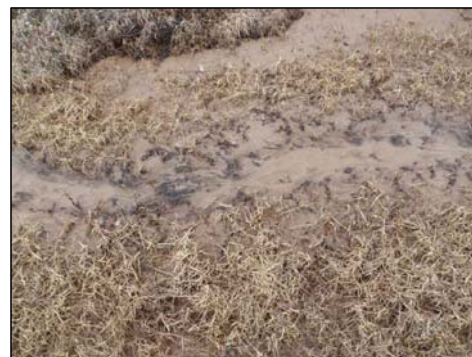
This crossing was shallow in 2018, but had a relatively low gradient. However, there was a vertical drop near the downstream confluence with CV-69-2 that is likely impassable by the small juveniles that could be using 69-2 (though none were captured in 2018). There is likely no fish use of habitat at the crossing.

Figure 1. Views of CV-69-3 at the crossing during summer, looking upstream (A), looking downstream (B), and looking across (C).

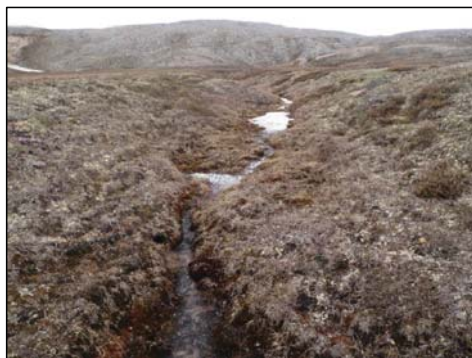
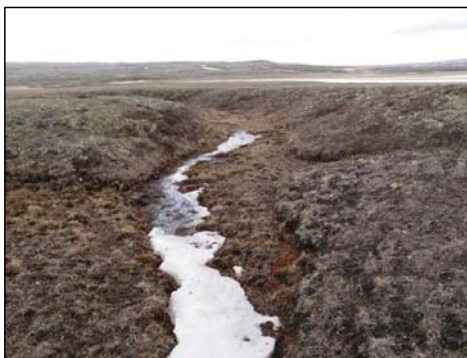
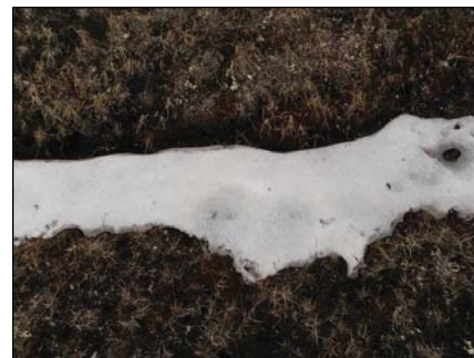
Figure 1. Views of CV-69-4 at the crossing during summer, looking upstream (A), looking downstream (B), and looking across (C).

This crossing was nearly dry in summer and dry in fall 2018. There is no connection or access from CV-69-2. There is no fish use of habitat at the crossing.

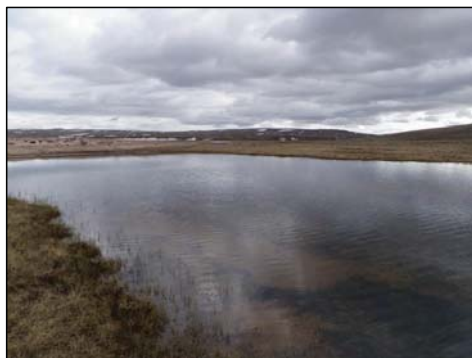
This was a shallow (maximum 1.0-1.5 m), isolated pond atop a hill. Fish were not captured or observed during the survey. There is no fish use of habitat at the crossing.

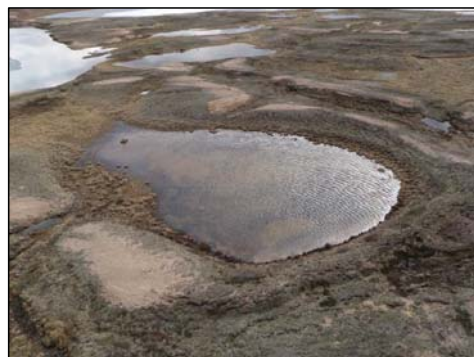
This was a shallow (maximum 0.3 m), isolated pond. The pond is too shallow for overwintering and it likely remains disconnected from other waterbodies in the area during all flow conditions. There is no fish use of habitat at the crossing.

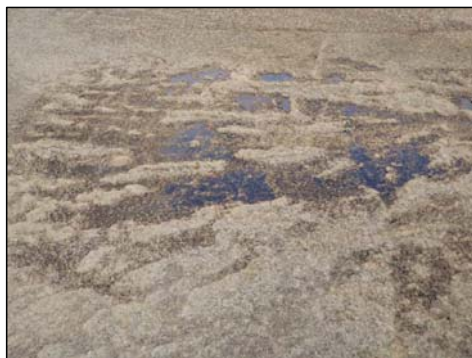
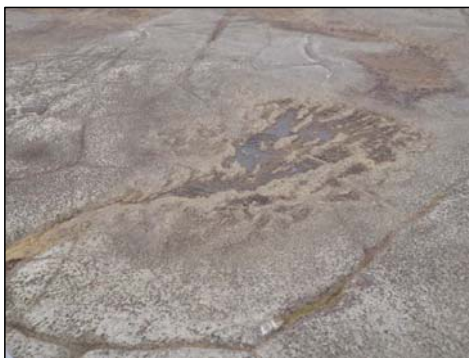
This is shallow, marshy, unconnected terrain. There is no fish use of habitat at the crossing.

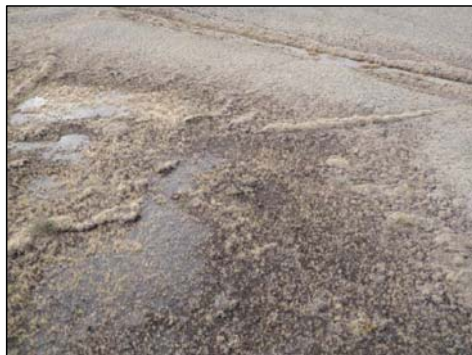
This is shallow, marshy, terrain adjacent to a fishless pond. It may occasionally become connected to the pond in high water conditions, but not to any fish-bearing waterbodies. There is no fish use of habitat at the crossing.

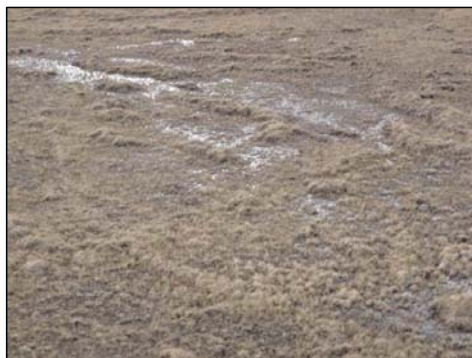
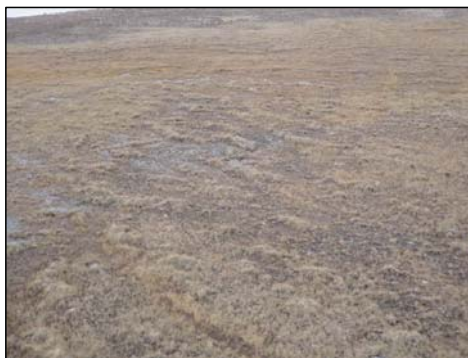
Figure 1. Views of CV-72-1a at the crossing during summer (A) and fall (B).

This is shallow, marshy, isolated terrain. There is no fish use of habitat at the crossing.

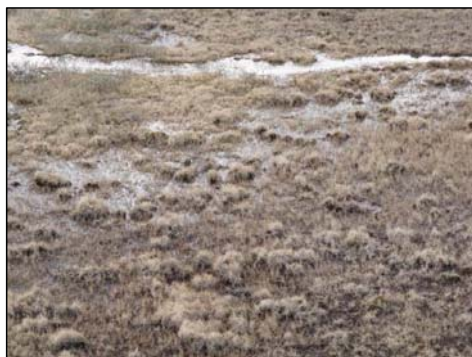
This is shallow, marshy, isolated terrain. There is some minor flow at the crossing, but no sustained channel and no connection to fish habitat due to a general lack of surface flow over large areas. There is no fish use of habitat at the crossing.

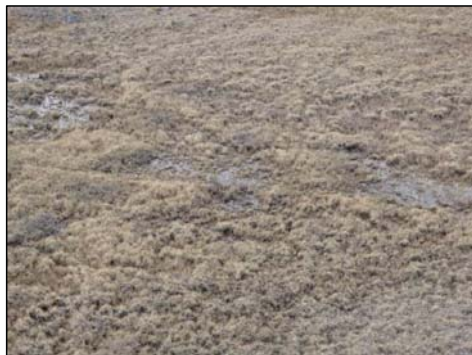
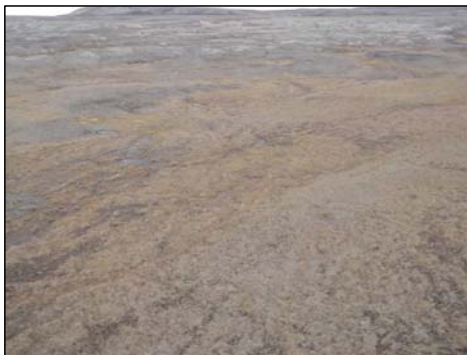
Figure 1. Views of CV-72-3 at the crossing during summer (A) and fall (B).

This is shallow, marshy, isolated terrain. There is no sustained channel and no connection to fish habitat due to a general lack of surface flow over large areas. There is no fish use of habitat at the crossing.

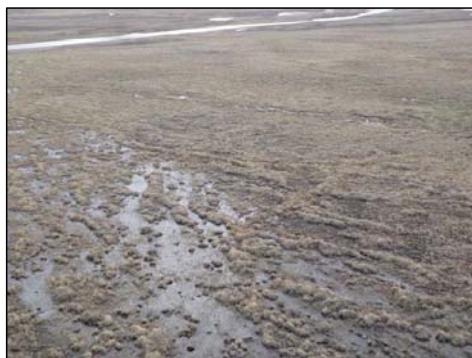
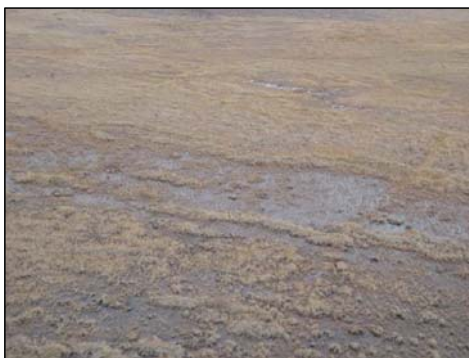
Figure 1. Views of CV-72-3a and 72-4 at the crossing during summer (A) and fall (B). Note that accurately pinpointing the specific crossings is difficult at this location.

These crossings are part of a broad, shallow, marshy, area. There is no sustained channel and no connection to fish habitat due to a general lack of surface flow at several intervals. There is also no access from the downstream river. There is no fish use of habitat at the crossing.

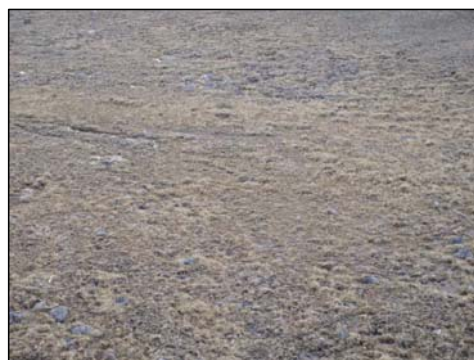
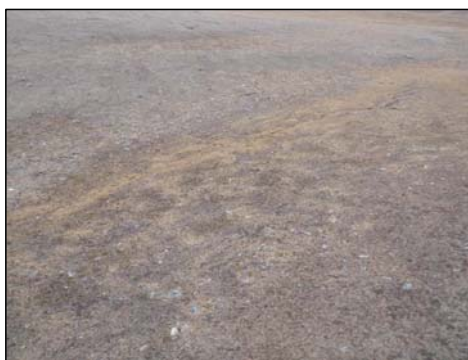
This crossing was nearly dry in 2018. There is no fish use of habitat at the crossing.

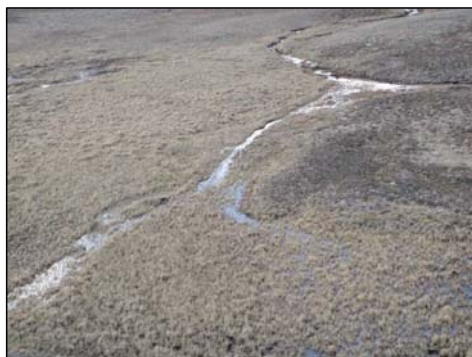
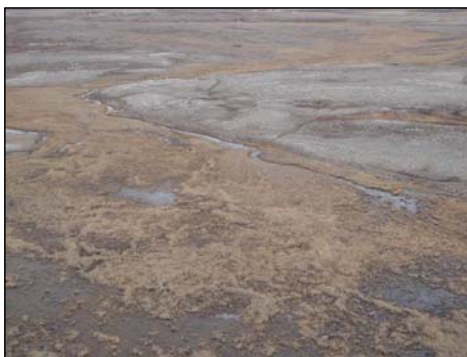
Figure 1. Views of CV-73-2 at the crossing during summer (A) and fall (B).

There was a wetted channel at the crossing in 2018; however the channel disappears downstream and the water disperses over the tundra. Subsurface flows are common. There is no fish use of habitat at the crossing.

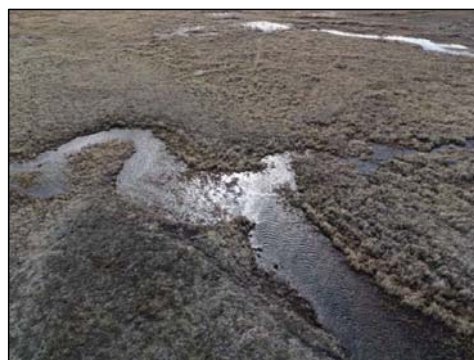
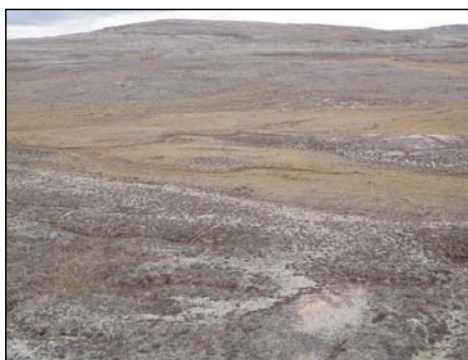
This crossing is part of the same system as CV-73-2 with the same downstream barriers preventing fish access to the site. There is no fish use of habitat at the crossing.

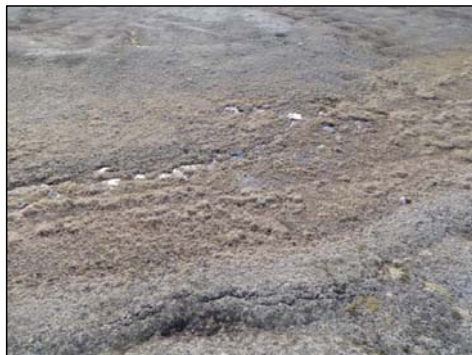
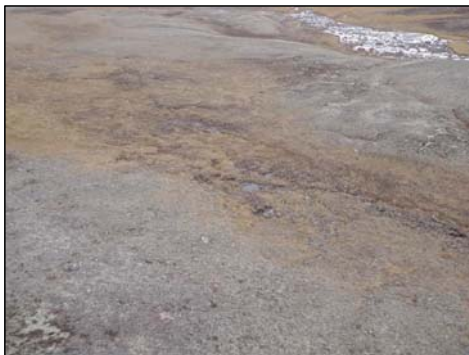
This crossing is part of the same system as CV-73-2 and CV-73-3 with the same downstream barriers preventing fish access to the site. There is no fish use of habitat at the crossing.

Figure 1. Views of CV-73-4 at the crossing during summer (A) and fall (B).
