Phase 2 Milne Rail Corridor Aquatic Habitat Assessment

Crossing ID: CV-62-1

**Baffinland Iron Mines
Mary River Project**

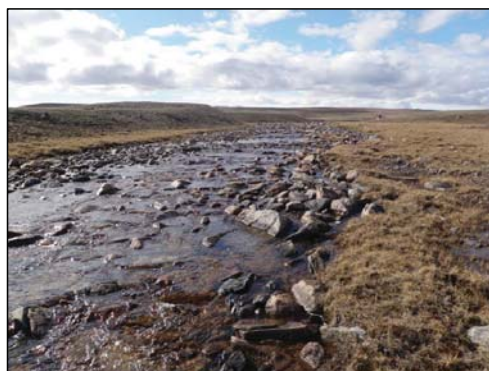
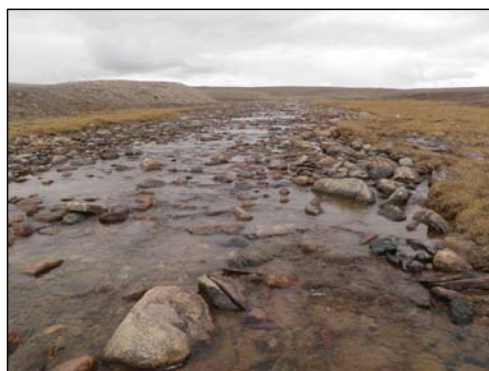
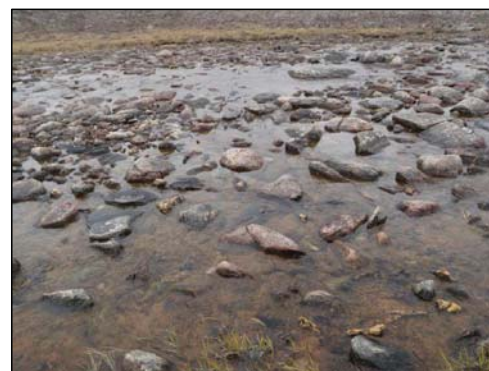
Figure 3. Summer (top) and fall (bottom) views of CV-74-1 at the 60 m downstream cross-section; (A) looking upstream; (B) looking downstream; and (C) looking across.

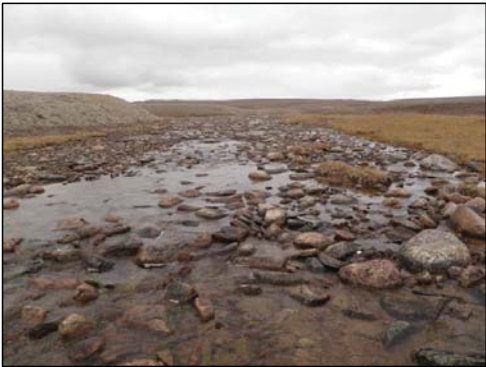
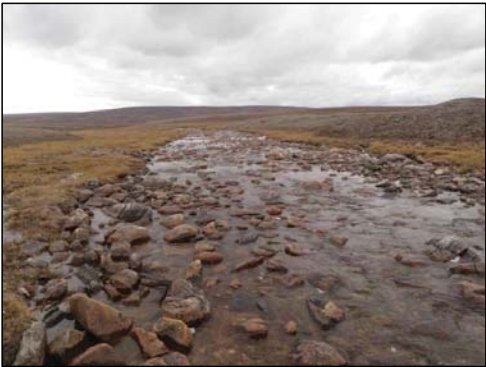
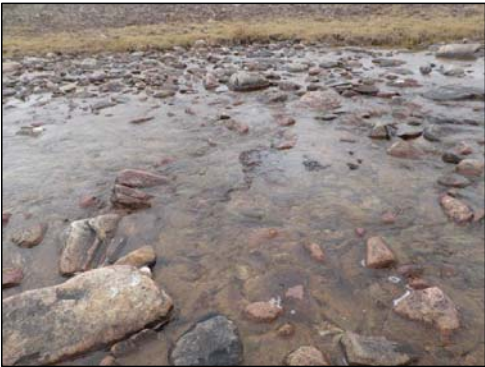
Figure 2. Summer (top) and fall (bottom) views of CV-74-1 at the 80 m downstream cross-section; (A) looking upstream; (B) looking downstream; and (C) looking across.

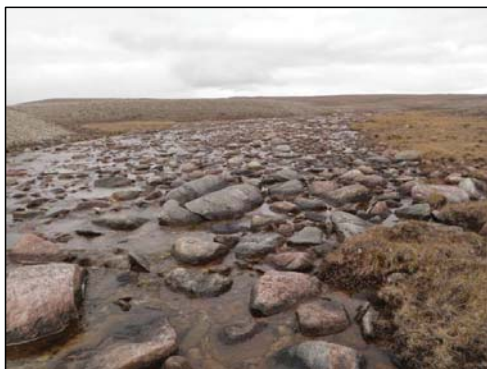
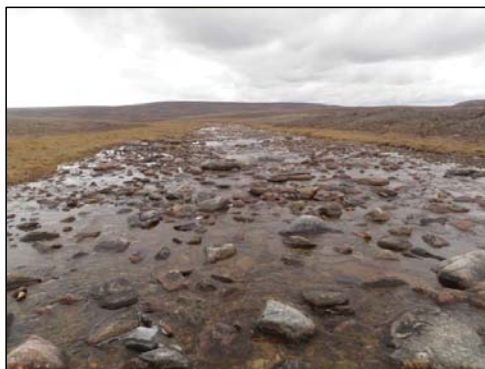
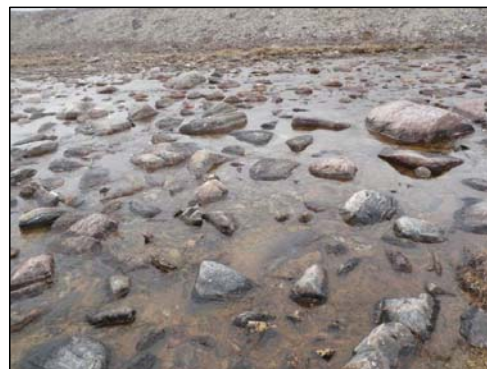
Figure 5. Summer (top) and fall (bottom) views of CV-74-1 at the 40 m downstream cross-section; (A) looking upstream; (B) looking downstream; and (C) looking across.

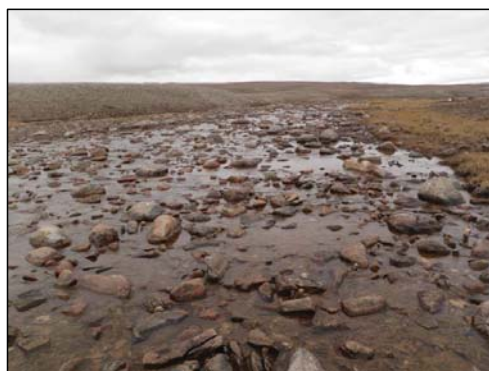
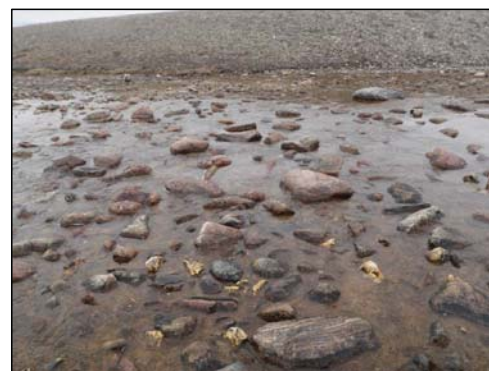
Figure 8. Summer (top) and fall (bottom) views of CV-74-1 at the 20 m upstream cross-section; (A) looking upstream; (B) looking downstream; and (C) looking across.

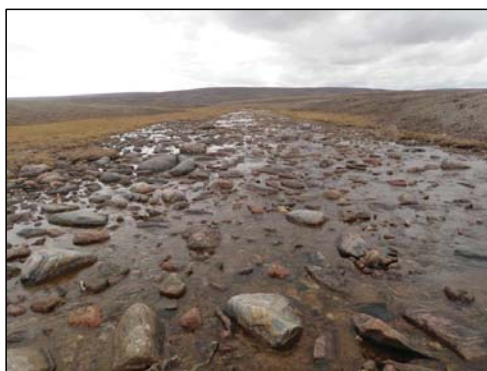
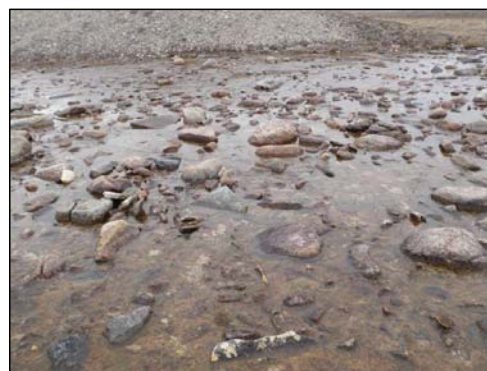
Figure 6. Summer (top) and fall (bottom) views of CV-74-1 at the 20 m downstream cross-section; (A) looking upstream; (B) looking downstream; and (C) looking across.

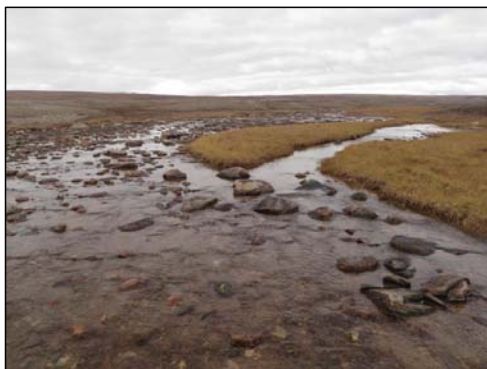
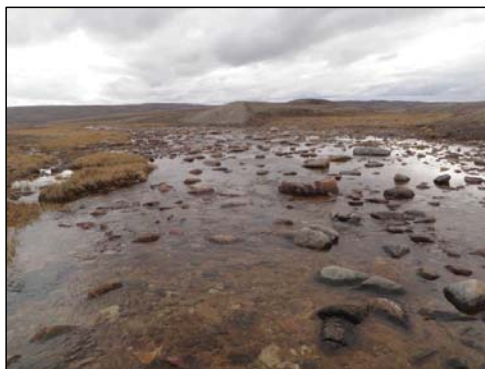
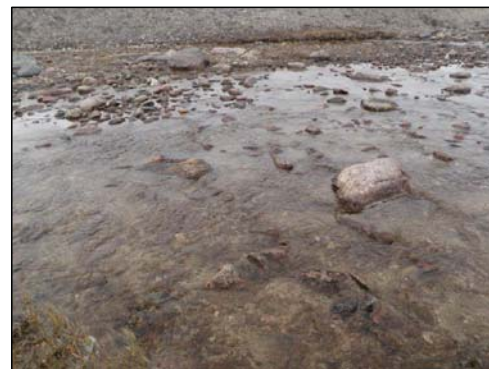
Figure 9. Summer (top) and fall (bottom) views of CV-74-1 at the 40 m upstream cross-section; (A) looking upstream; (B) looking downstream; and (C) looking across.

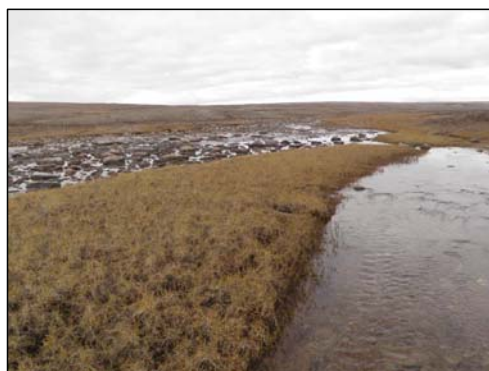
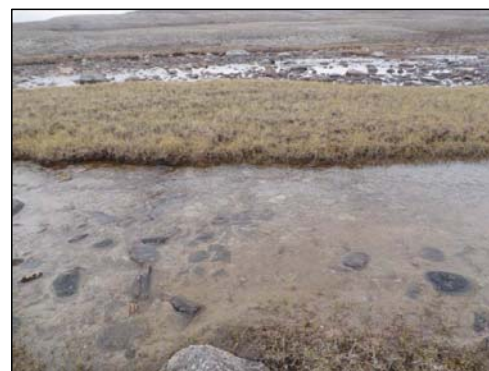
Figure 11. Summer (top) and fall (bottom) views of CV-74-1 at the 60 m upstream cross-section; (A) looking upstream; (B) looking downstream; and (C) looking across.

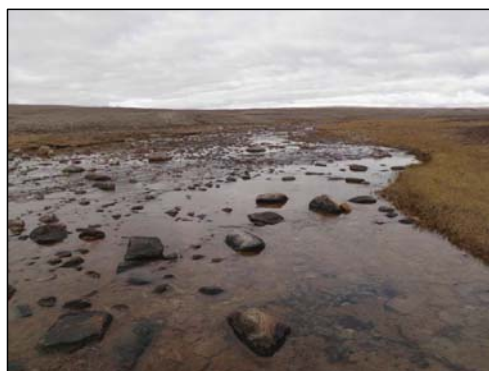
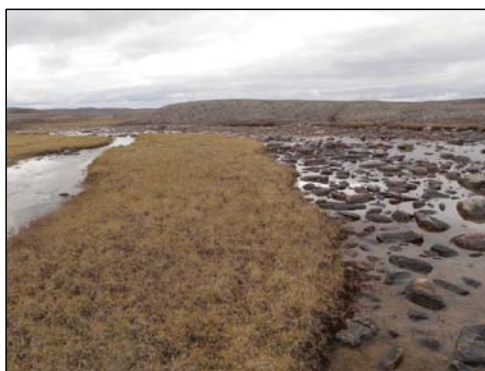
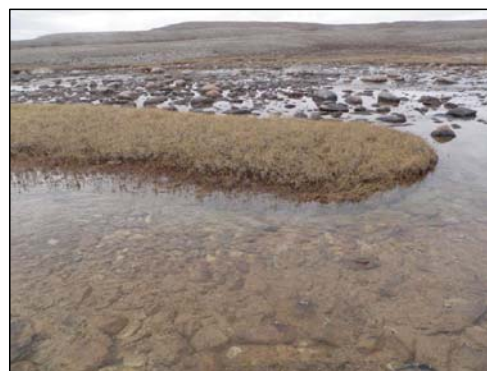
Figure 12. Summer (top) and fall (bottom) views of CV-74-1at the 80 m upstream cross-section; (A) looking upstream; (B) looking downstream; and (C) looking across.

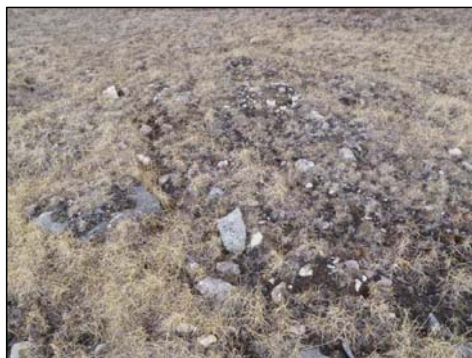
This was a dry low point in 2018. There is no fish use of habitat at the crossing.

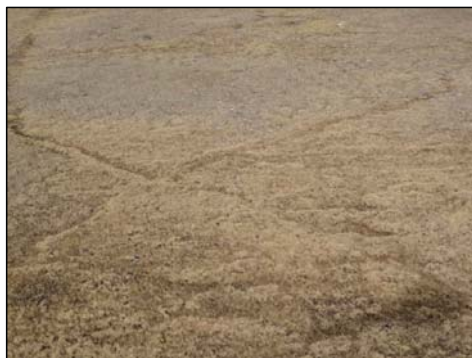
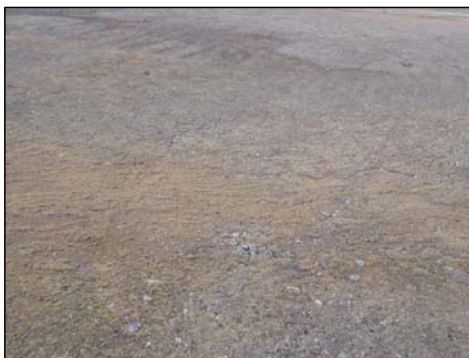
This was nearly dry tundra in 2018. There is no fish use of habitat at the crossing.

Figure 1. Views of CV-74-3 at the crossing during summer (A) and fall (B).

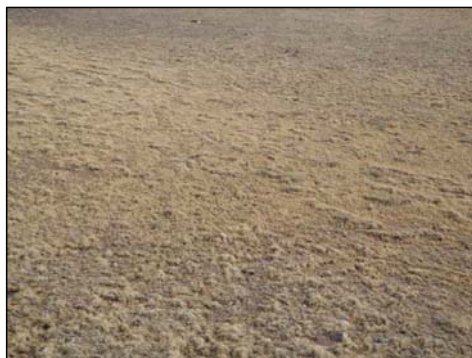
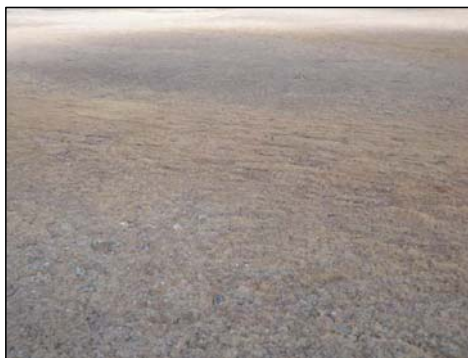
This was a nearly dry hillside in summer and dry in fall, 2018. There is no fish use of habitat at the crossing.

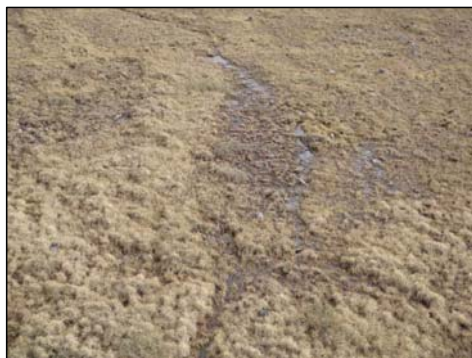
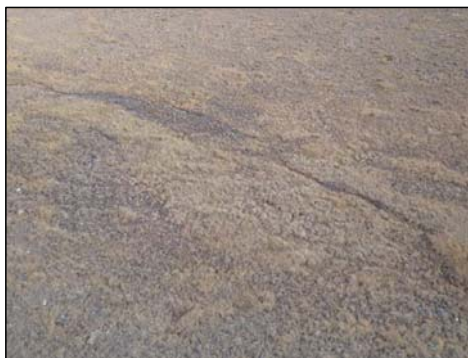
This crossing was nearly dry in 2018 with no access for fish due to the lack of channel and surface flow downstream. There is no fish use of habitat at the crossing.

Figure 1. Views of CV-74-6 at the crossing during summer (A) and fall (B).

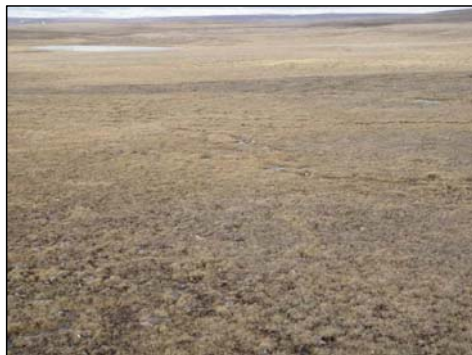
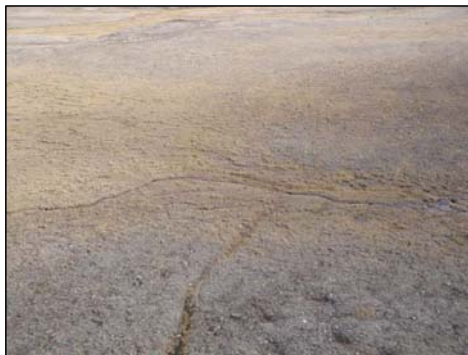
This crossing had some shallow flows in 2018, but the channel disappeared downstream and flows dispersed. There was no access for fish due to the lack of channel and surface flow downstream to the confluence with a large river. There is no fish use of habitat at the crossing.

Figure 1. Views of CV-74-7 at the crossing during summer (A) and fall (B).

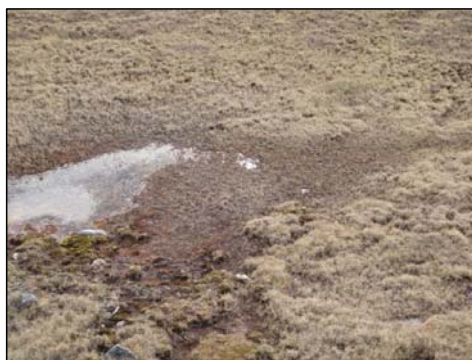
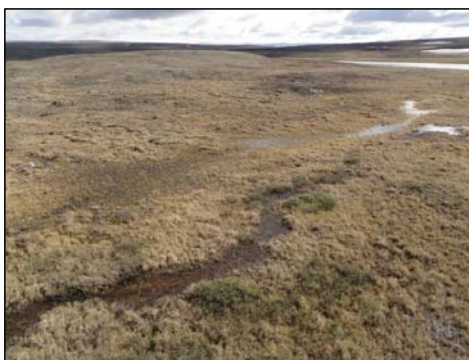
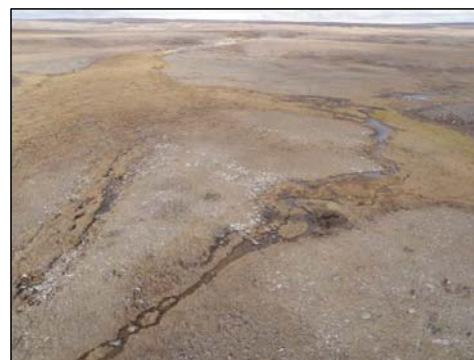
These are two branches of the same waterbody. They are mostly wet puddles with a few longer reaches of surface water with flow. However, no fish were captured in these areas and there was a lack of surface flow/connectivity at the downstream confluence with a large river. There is no fish use of habitat at the crossing.

Figure 1. Views of CV-75-1 at the crossing during summer (A), the loss of surface flow downstream (B), and both crossings during fall (C)

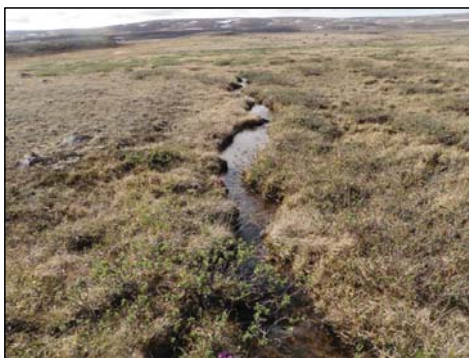
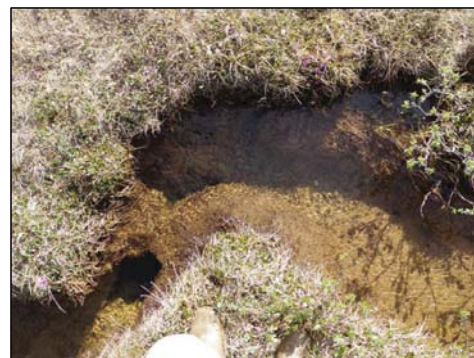
Figure 2. Views of CV-75-1a at the crossing during summer, looking upstream (A), downstream (B), and across (C).

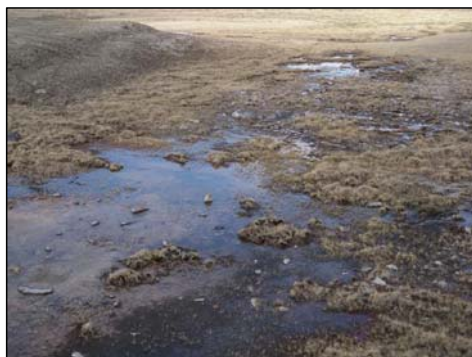
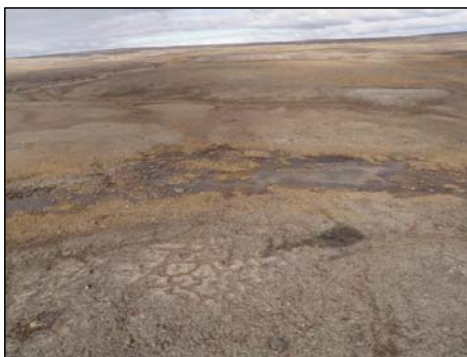
The crossing was broad and shallow with minor flows during 2018. However, there is no connection to either upstream or downstream habitat due to lengthy patches of subsurface flow. There is no fish use of habitat at the crossing.

Figure 1. Views of CV-75-2 at the crossing during summer (A) and fall (B).

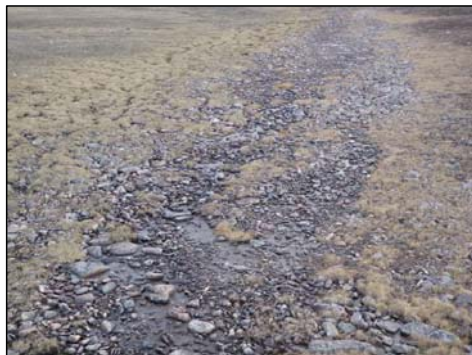
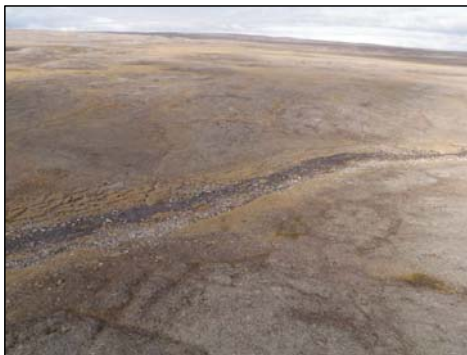
The crossing was shallow with water trickling among the rocks in 2018. However, there were multiple soft subsurface flow barriers between the crossing and the nearest overwintering site. There is no fish use of habitat at the crossing.

Figure 1. Views of CV-76-1 at the crossing during summer (A) and fall (B).

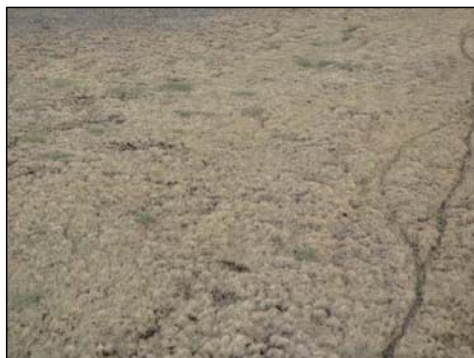
The crossing was nearly dry in 2018 with no connection to other waterbodies. There is no fish use of habitat at the crossing.

Figure 1. Views of CV-76-1a at the crossing during summer (A).

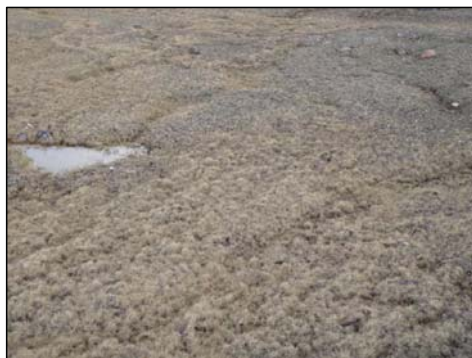
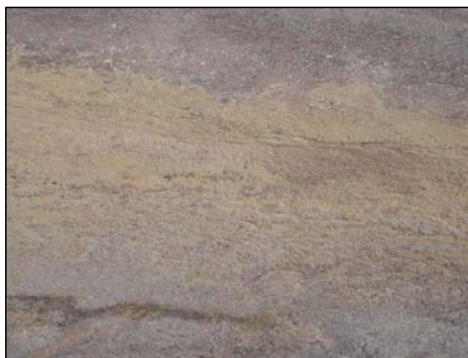
The crossing was nearly dry in 2018 with no connection to other waterbodies. There is no fish use of habitat at the crossing.

Figure 1. Views of CV-76-2 at the crossing during summer (A) and fall (B).

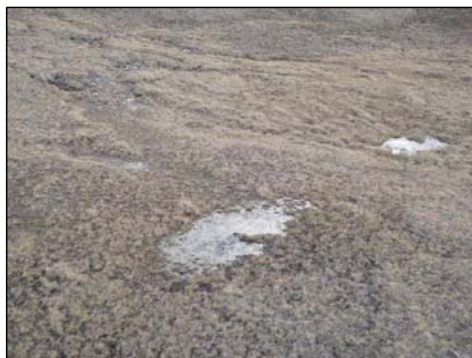
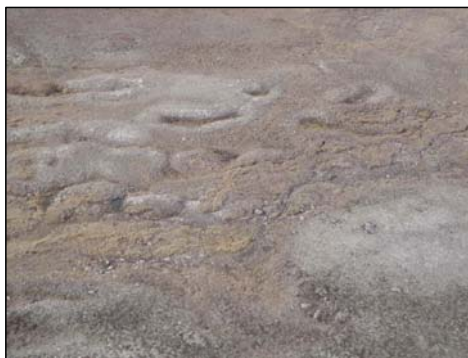
The crossing was nearly dry in 2018 with no connection to other waterbodies. There is no fish use of habitat at the crossing.

Figure 1. Views of CV-76-3 at the crossing during summer (A) and fall (B).

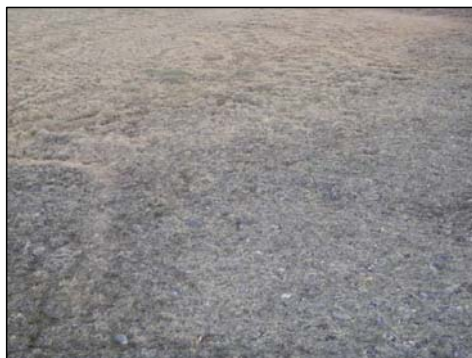
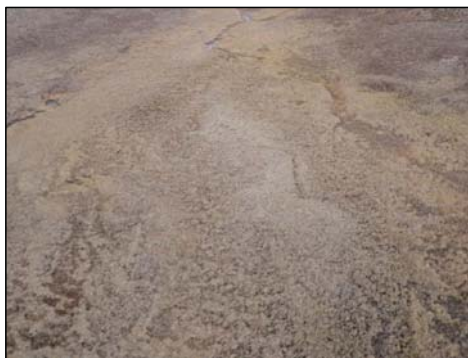
The crossing was nearly dry in 2018 with no connection to other waterbodies. There is no fish use of habitat at the crossing.

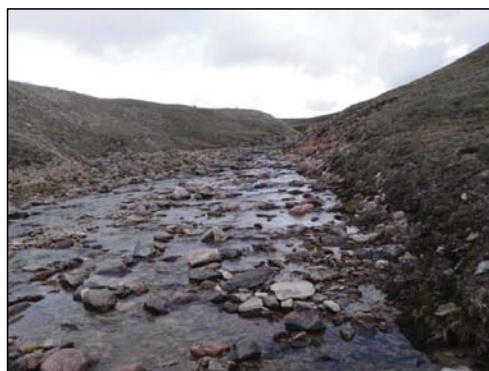
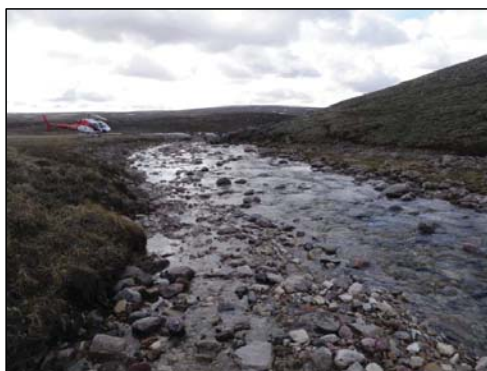
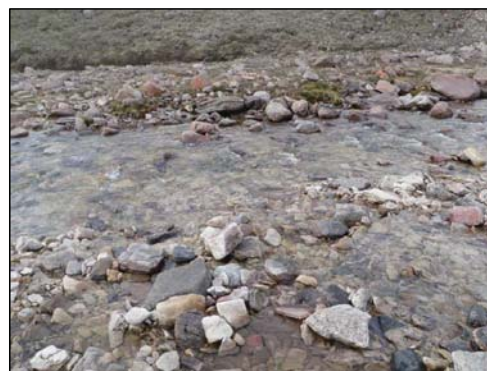
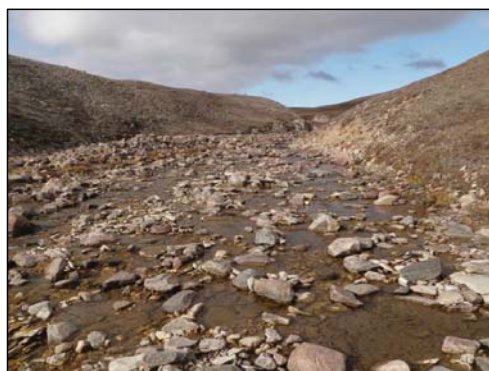
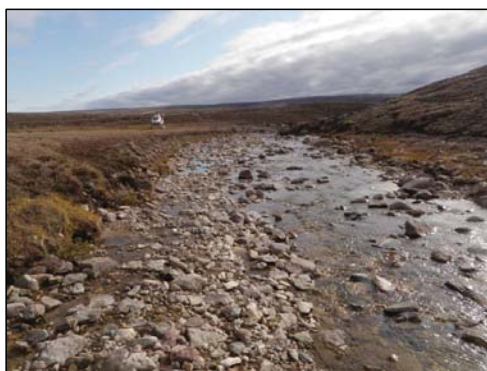
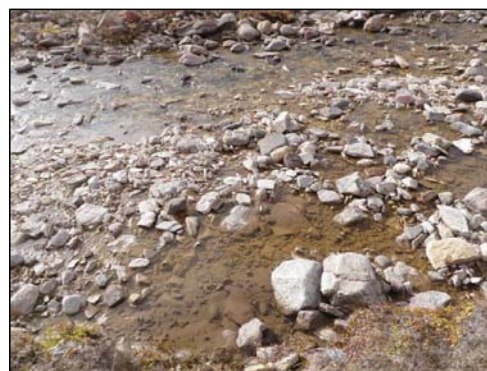
Figure 2. Summer (top) and fall (bottom) views of CV-77-2 at the 80 m downstream cross-section; (A) looking upstream; (B) looking downstream; and (C) looking across.
