Phase 2 Milne Rail Corridor Aquatic Habitat Assessment

Crossing ID: CV-101-1

**Baffinland Iron Mines
Mary River Project**

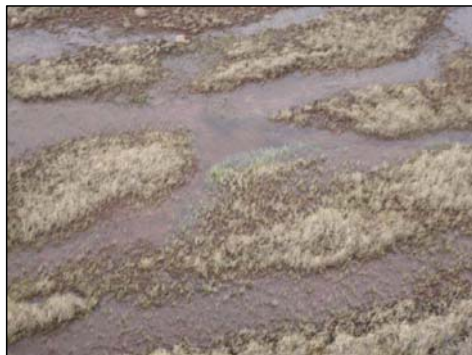
A

The crossing was shallow, broad, and often lacking a defined channel, particularly upstream and downstream of the rail alignment. In addition, surface flow periodically disappeared. There was no access from overwintering waterbodies. This site was also surveyed in 2017 with the same results. There is no fish use of habitat at this crossing.

Figure 1. Views of CV-101-1 at the crossing during summer (A) and fall (B).

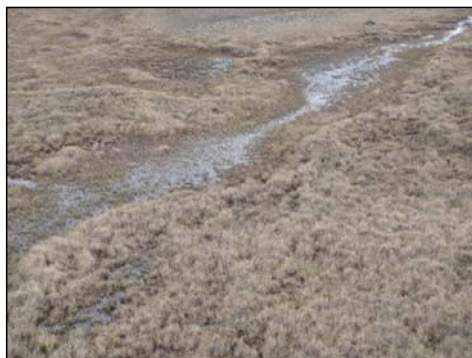
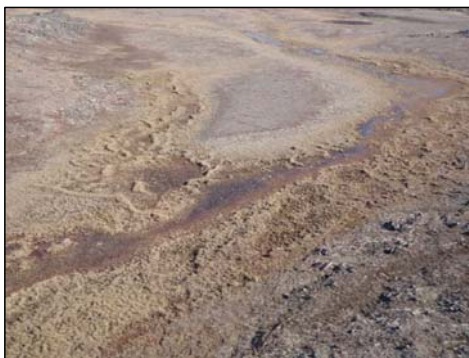
The crossing was very shallow, marshy habitat with periodic surface flow and no connections to overwintering habitat. There is no fish use of habitat at this crossing.

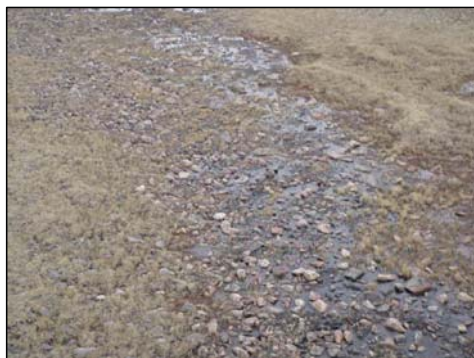
A

The crossing was very shallow, broad and rocky with periodic surface flow loss and no connections to overwintering habitat. There is no fish use of habitat at this crossing.

Figure 1. Views of CV-101-1b at the crossing during summer (A).

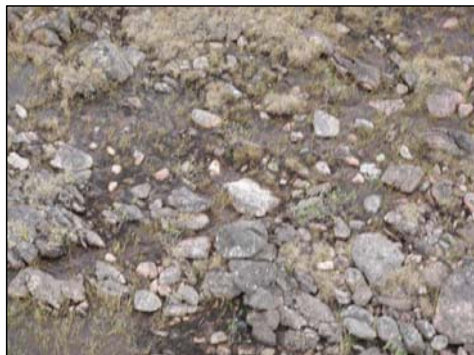
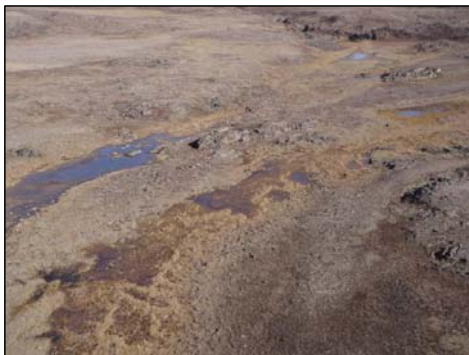
The crossing was very shallow, broad, lacked a defined channel, and had periodic surface flow loss and no connections to overwintering habitat. There is no fish use of habitat at this crossing.

Figure 1. Views of CV-101-2 at the crossing during summer (A) and fall (B).

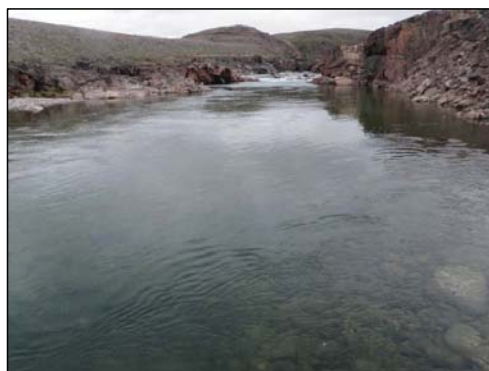
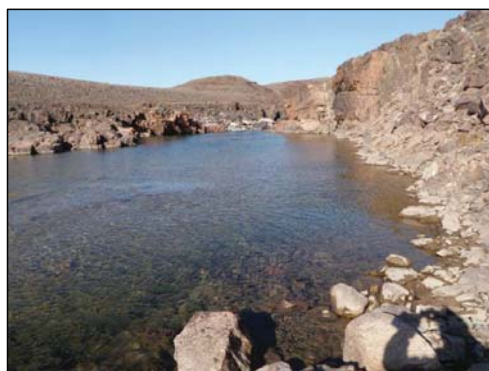
Figure 1. Summer (top) and fall (bottom) views of CV-102-1 at the 60 m downstream cross-section; (A) looking upstream; (B) looking downstream; and (C) looking across.

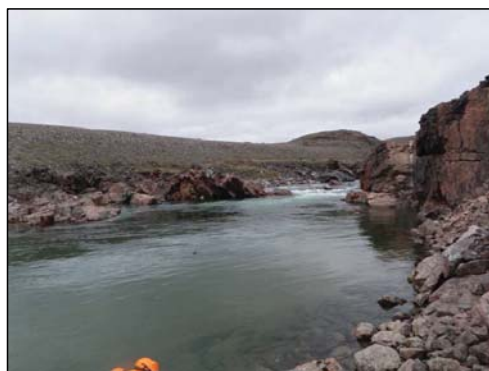
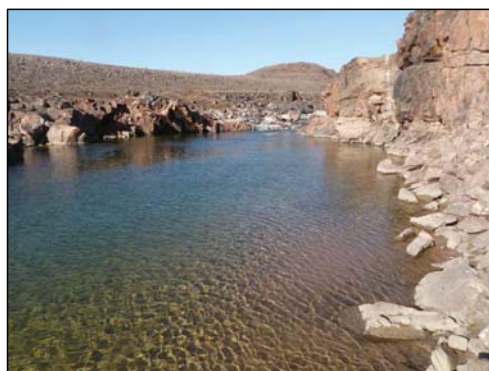
Figure 2. Summer (top) and fall (bottom) views of CV-102-1 at the 40 m downstream cross-section; (A) looking upstream; (B) looking downstream; and (C) looking across.

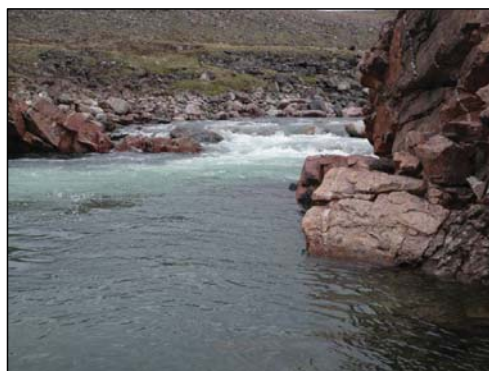
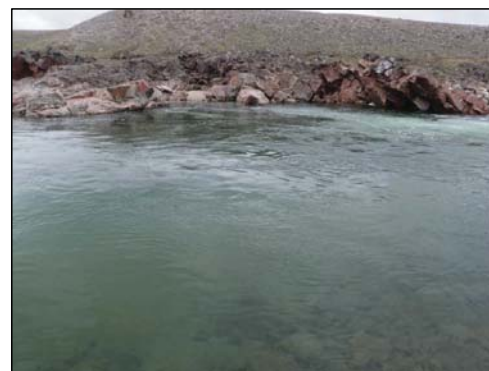
Figure 3. Summer (top) and fall (bottom) views of CV-102-1 at the 20 m downstream cross-section; (A) looking upstream; (B) looking downstream; and (C) looking across.

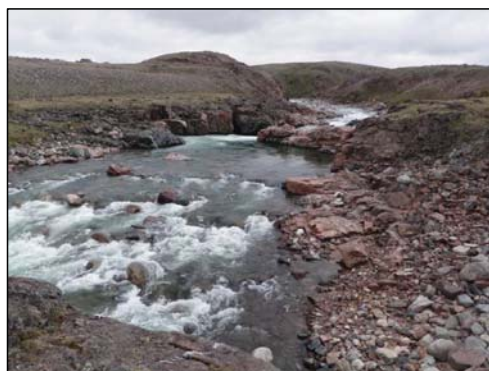
Figure 4. Summer (top) and fall (bottom) views of CV-102-1 at the rail crossing; (A) looking upstream; (B) looking downstream; and (C) looking across.

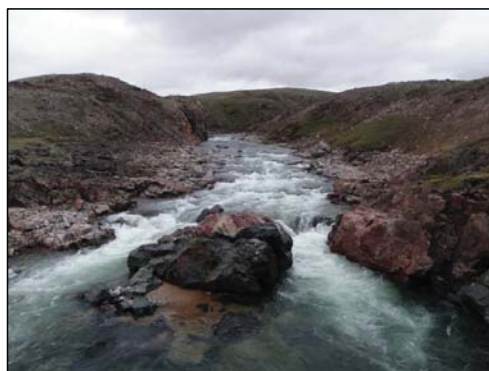
Figure 7. Summer (top) and fall (bottom) views of CV-102-1 at the 60 m upstream cross-section; (A) looking upstream; (B) looking downstream; and (C) looking across.

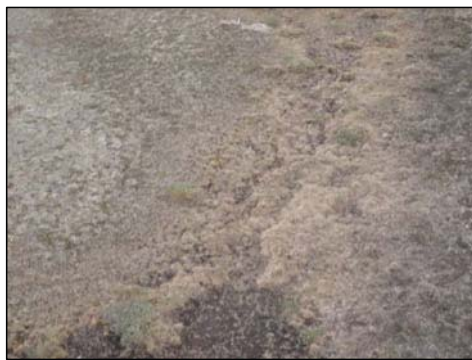
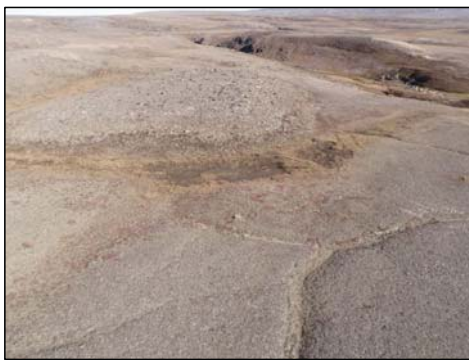
The crossing was a nearly dry spot that is never connected to fish habitat. There is no fish use of habitat at this crossing.

Figure 1. Views of CV-102-1a at the crossing during summer (A) and fall (B).

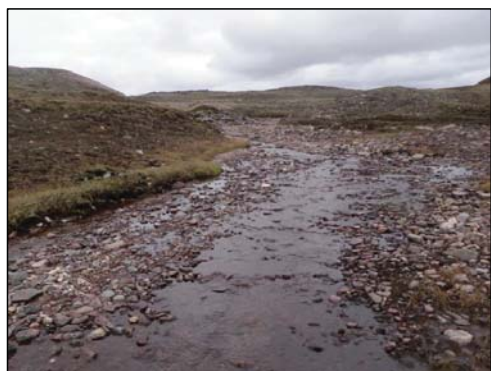
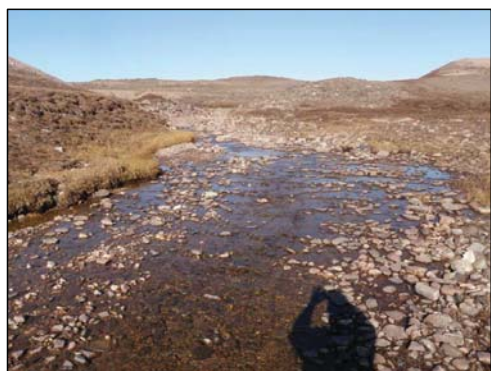
Figure 1. Summer (top) and fall (bottom) views of CV-102-2 at the 100 m downstream cross-section; (A) looking upstream; (B) looking downstream; and (C) looking across.

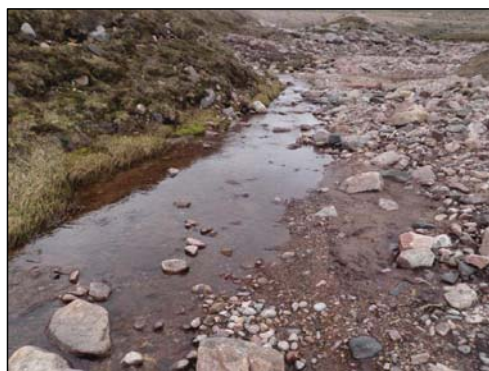
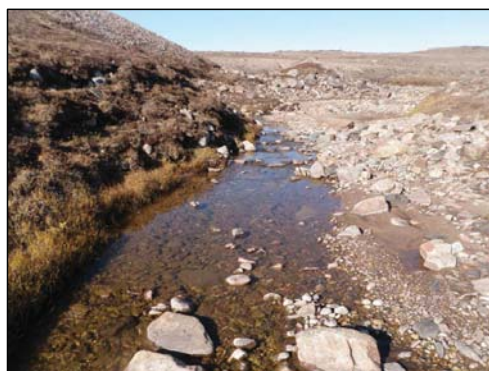
Figure 2. Summer (top) and fall (bottom) views of CV-102-2 at the 80 m downstream cross-section; (A) looking upstream; (B) looking downstream; and (C) looking across.

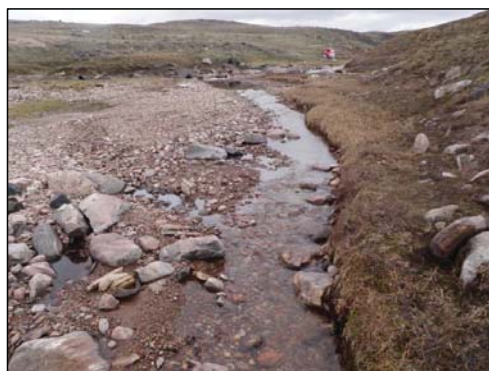
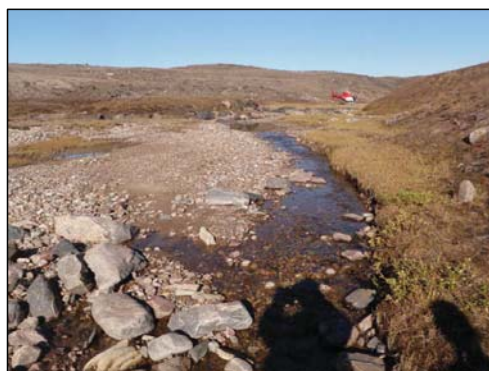
Figure 4. Summer (top) and fall (bottom) views of CV-102-2 at the 40 m downstream cross-section; (A) looking upstream; (B) looking downstream; and (C) looking across.

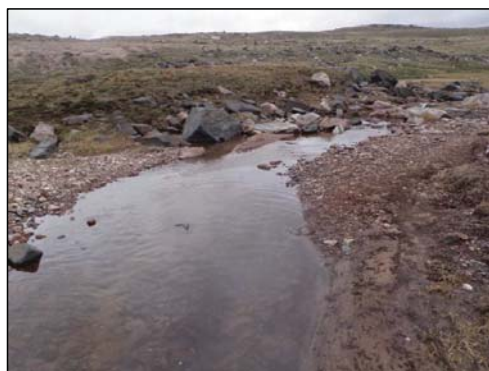
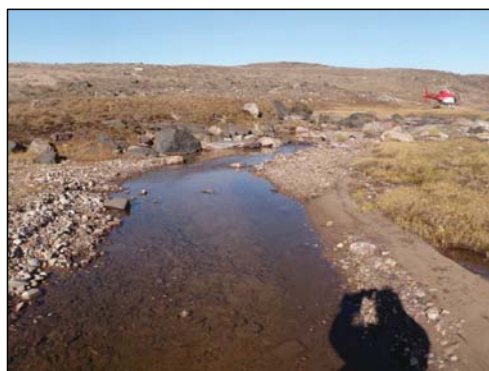
Figure 5. Summer (top) and fall (bottom) views of CV-102-2 at the 20 m downstream cross-section; (A) looking upstream; (B) looking downstream; and (C) looking across.

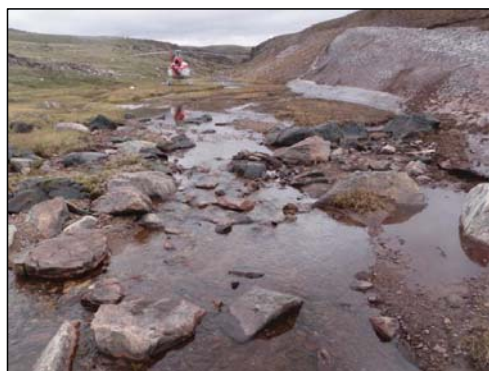
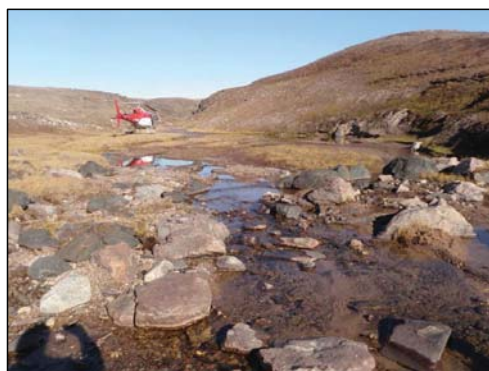
Figure 6. Summer (top) and fall (bottom) views of CV-102-2 at the rail crossing; (A) looking upstream; (B) looking downstream; and (C) looking across.

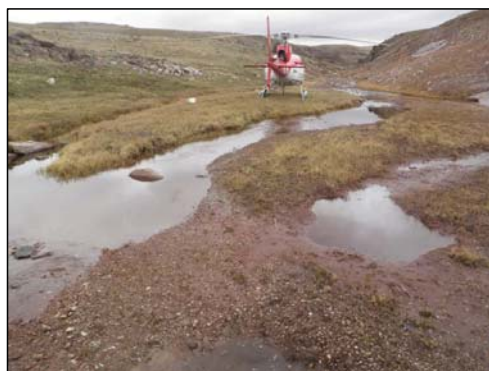
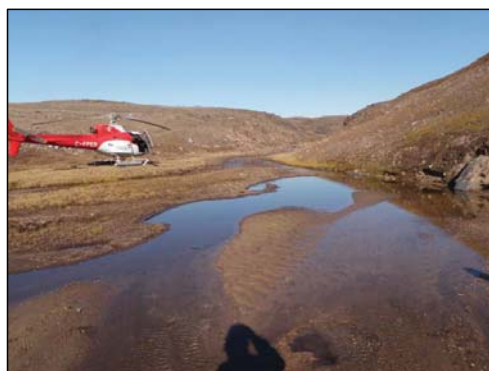
Figure 7. Summer (top) and fall (bottom) views of CV-102-2 at the 20 m upstream cross-section; (A) looking upstream; (B) looking downstream; and (C) looking across.

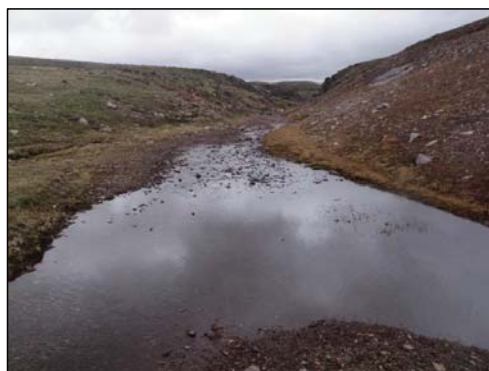
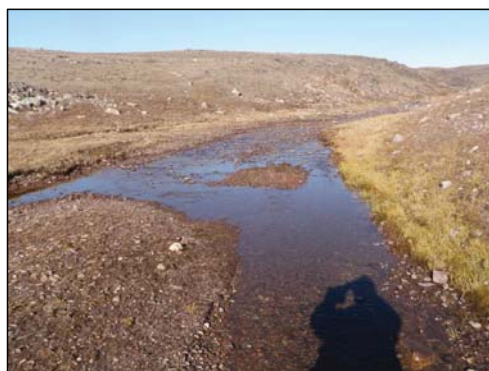
Figure 8. Summer (top) and fall (bottom) views of CV-102-2 at the 40 m upstream cross-section; (A) looking upstream; (B) looking downstream; and (C) looking across.

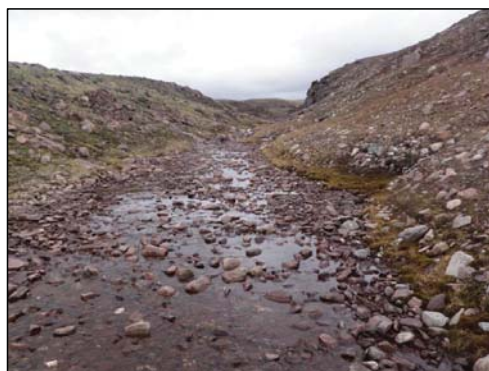
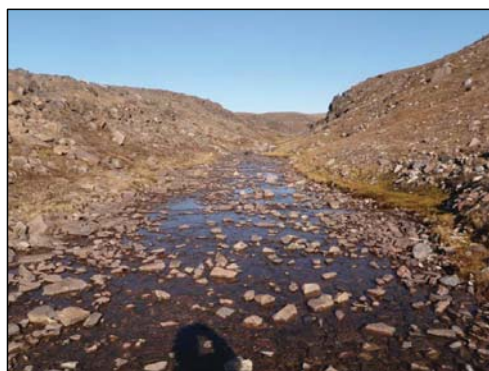
Figure 10. Summer (top) and fall (bottom) views of CV-102-2 at the 80 m upstream cross-section; (A) looking upstream; (B) looking downstream; and (C) looking across.

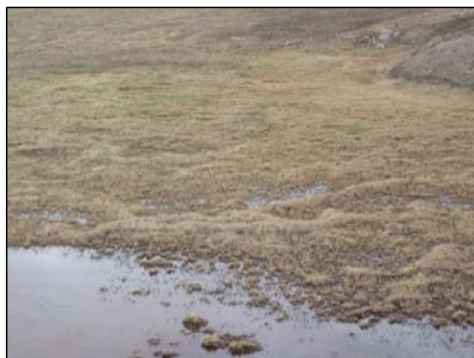
A

The crossing was a marshy area that has periodic surface flow loss and is never connected to fish habitat. There is no fish use of habitat at this crossing.

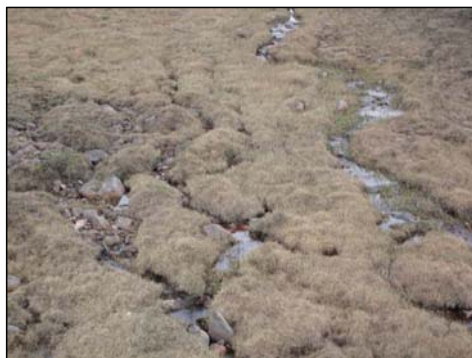
A

The crossing was shallow, steep and shared all the same downstream barriers (loss of surface flow) as CV-102-3. There is no fish use of habitat at this crossing.

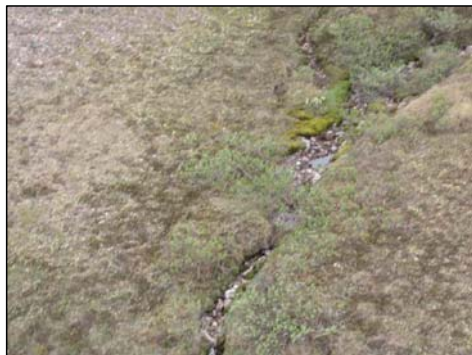
A

The crossing was nearly dry, steep, and lacked surface flow downstream. In addition, there is a permanent vertical barrier between the crossing and the nearest overwintering habitat. There is no fish use of habitat at this crossing.

Figure 1. Views of CV-102-5 at the crossing during summer (A) and during fall (B).

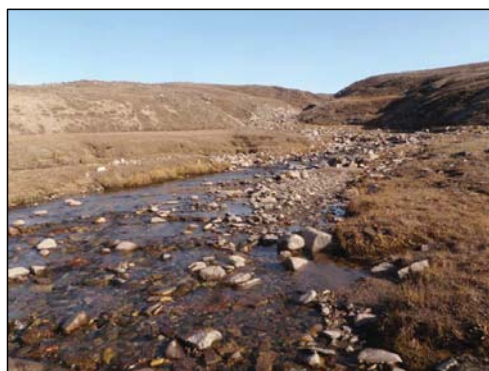
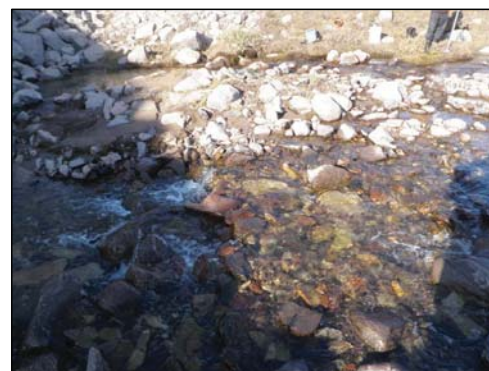
Figure 1. Summer (top) and fall (bottom) views of CV-103-1 at the 40 m downstream cross-section; (A) looking upstream; (B) looking downstream; and (C) looking across.

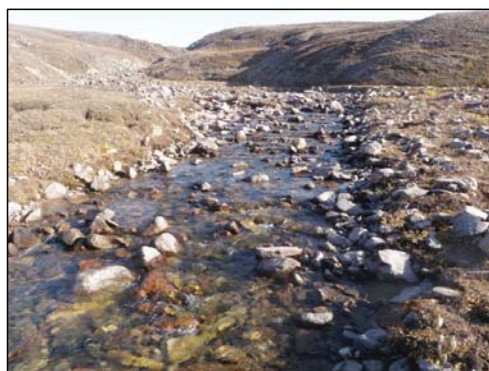
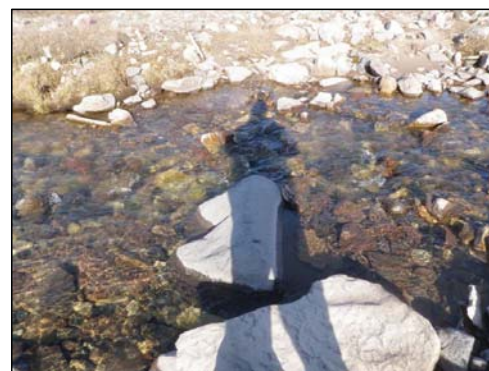
Figure 2. Summer (top) and fall (bottom) views of CV-103-1 at the 20 m downstream cross-section; (A) looking upstream; (B) looking downstream; and (C) looking across.

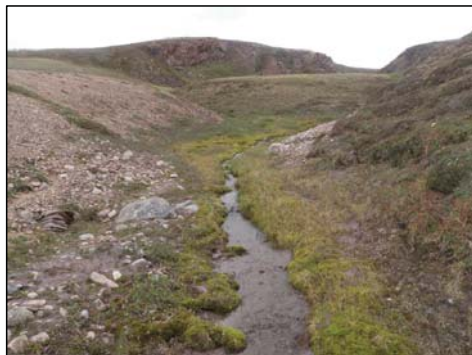
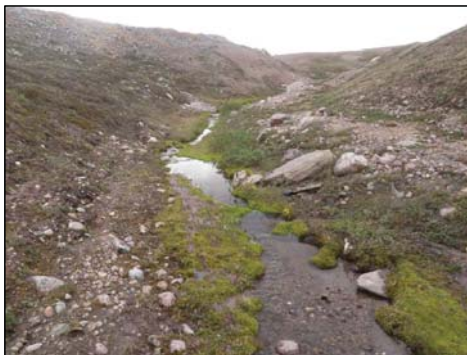
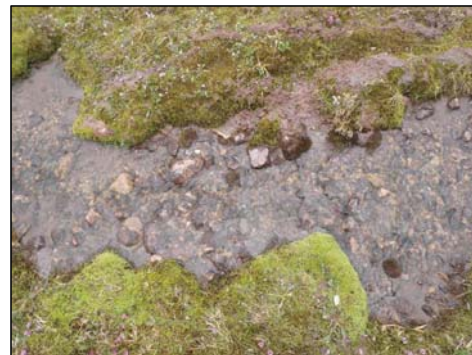
The crossing was shallow and narrow with a permanent vertical barrier downstream near the confluence with CV-103-1. There is no access to this site from overwintering habitat. There is no fish use of habitat at this crossing.

Figure 1. Views of CV-104-1 at the crossing during summer, looking upstream (A) downstream (B) and across (C).

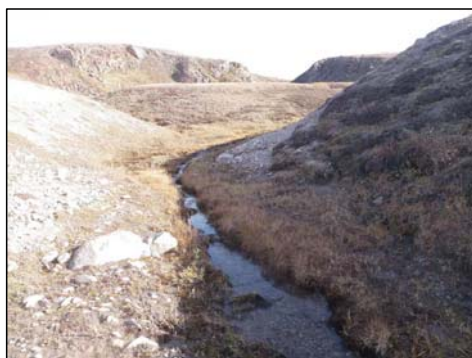
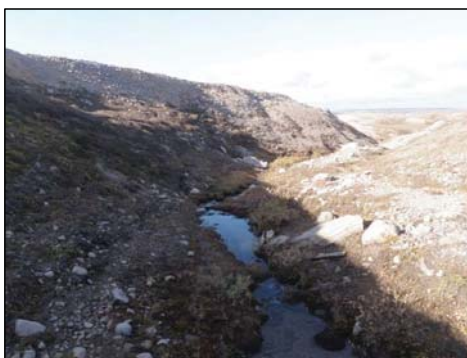
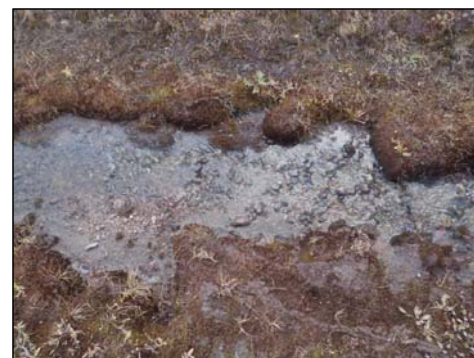
Figure 2. Views of CV-104-1 at the crossing during fall, looking upstream (A) downstream (B) and across (C).

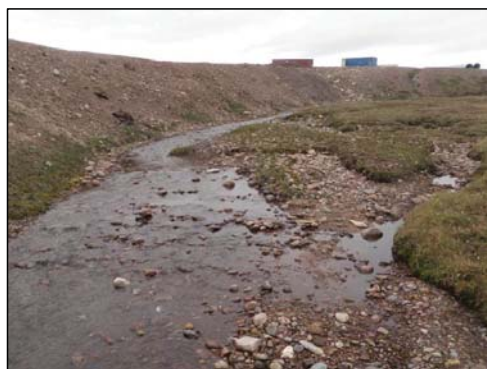
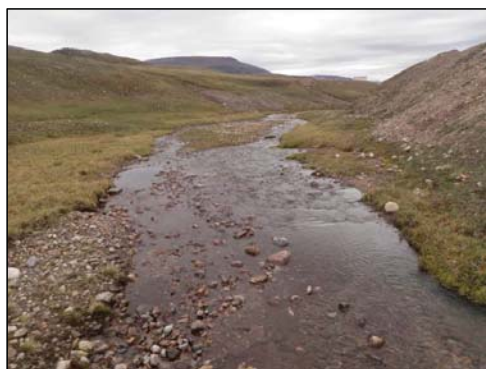
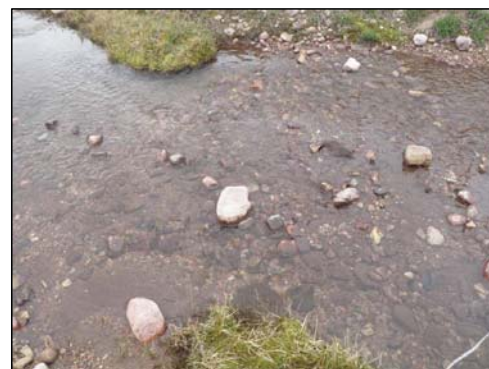
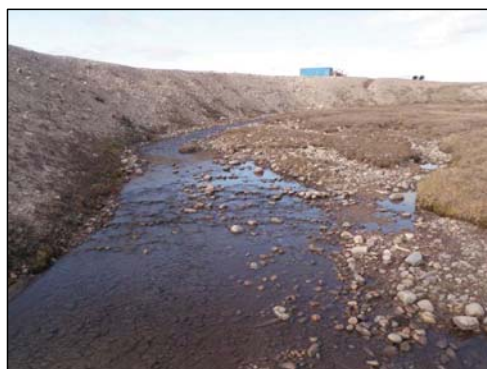
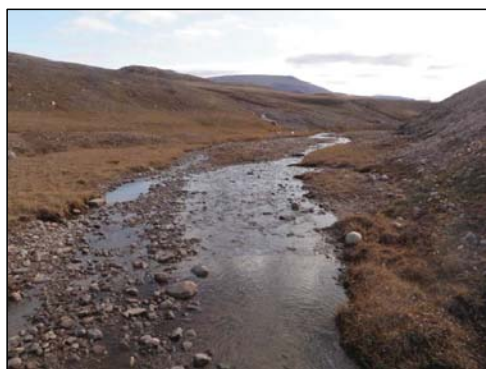
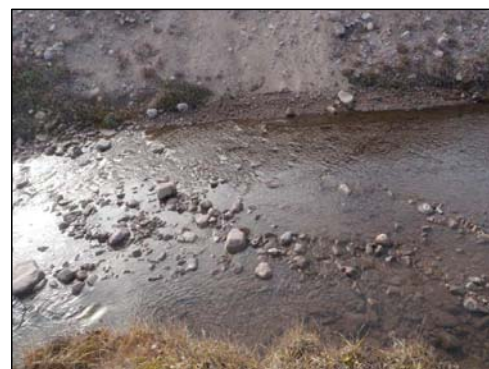
Figure 2. Summer (top) and fall (bottom) views of CV-104-2 at the 50 m downstream cross-section; (A) looking upstream; (B) looking downstream; and (C) looking across.

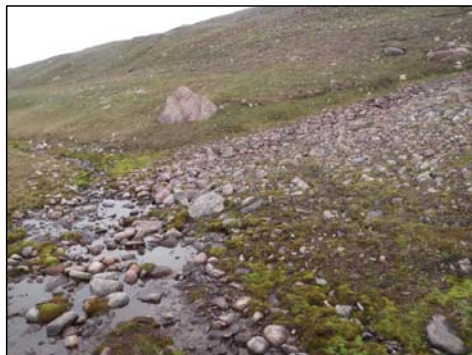
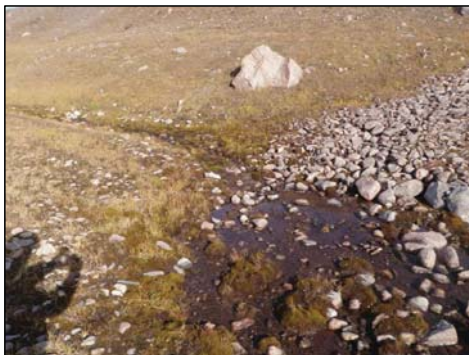
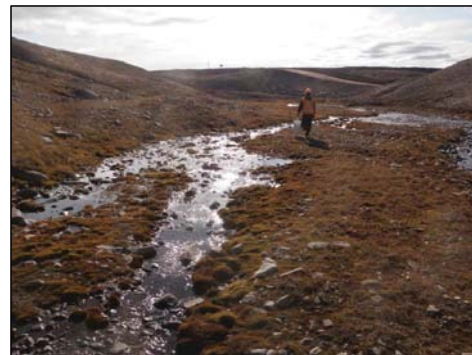
This is a very small side channel of CV-104-2 that likely only occasionally has sufficient water levels to support fish use. Fish were not observed during either survey in 2018. Fish use of habitat at this crossing is intermittent.

Figure 1. Views of CV-104-3 at the crossing during summer (A), fall (B) and looking downstream towards CV-104-2 (C).

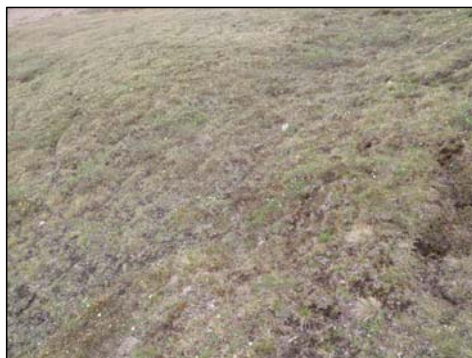
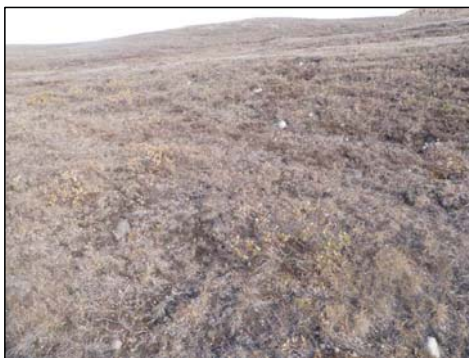
The crossing was a dry low point. There is no fish use of habitat at this crossing.

Figure 1. Views of CV-104-4 at the crossing during summer (A) and during fall (B).

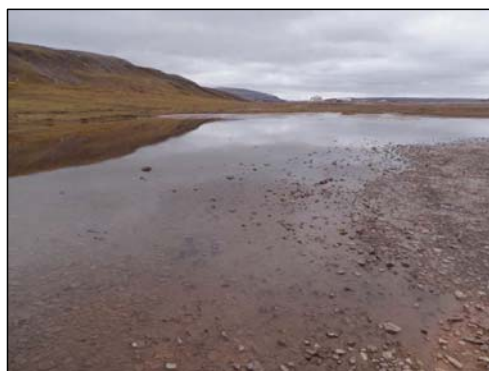
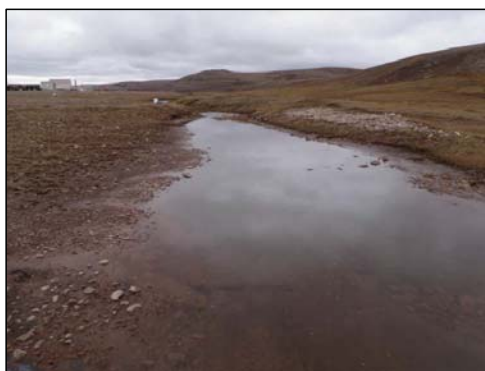
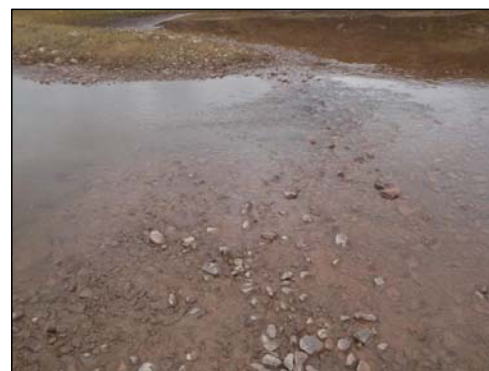
Figure 4. Summer (top) and fall (bottom) views of CV-105-2 at the 80 m upstream cross-section; (A) looking upstream; (B) looking downstream; and (C) looking across.

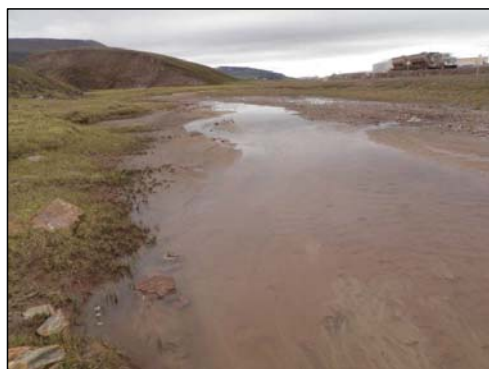
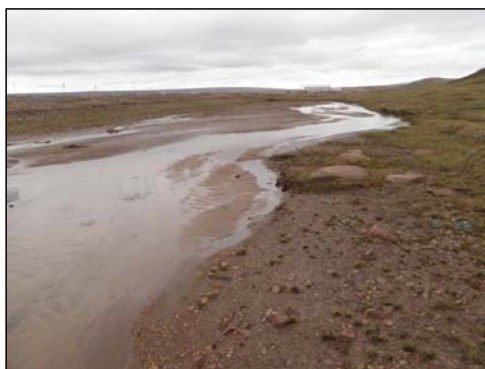
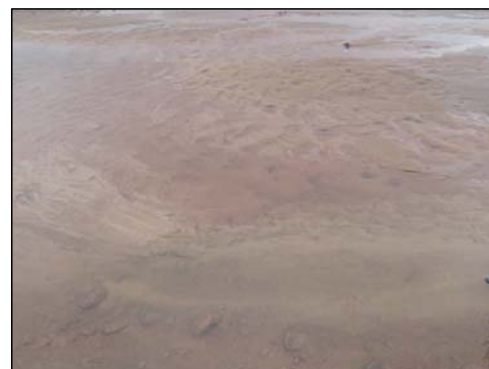
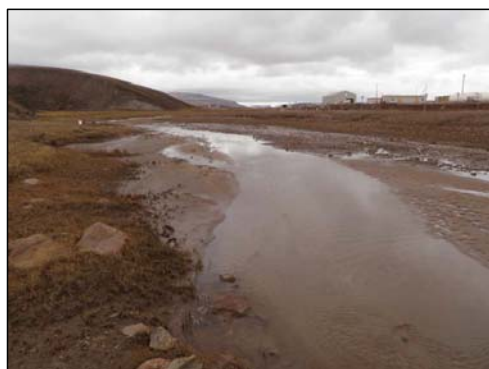
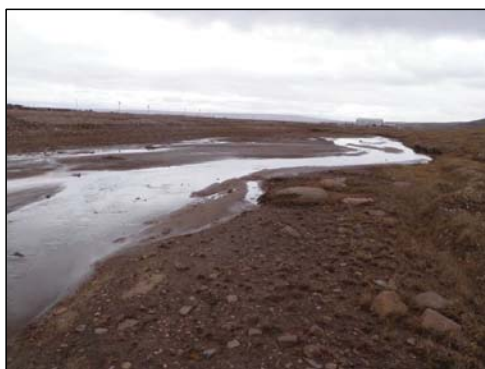
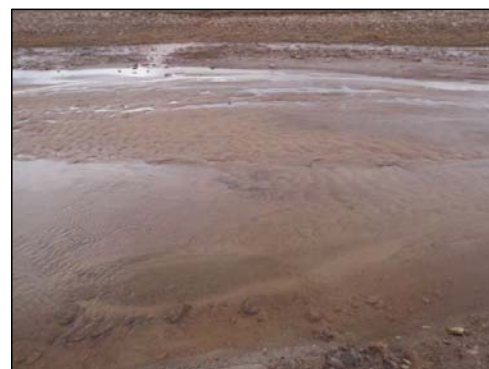
Figure 3. Summer (top) and fall (bottom) views of CV-105-4 at the rail crossing; (A) looking upstream; (B) looking downstream; and (C) looking across.

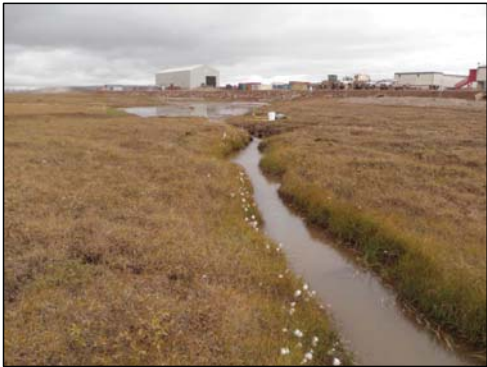
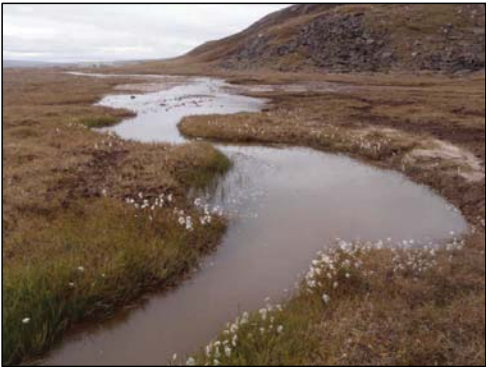
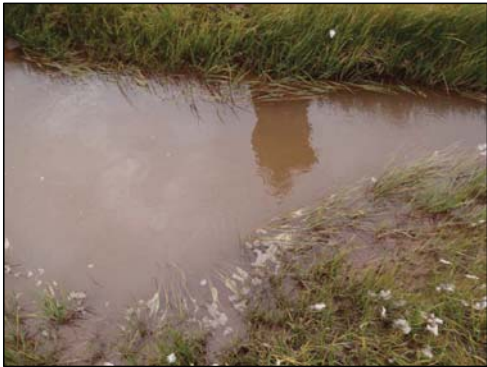
Figure 1. Summer (top) and fall (bottom) views of CV-106-1 at the 50 m downstream cross-section; (A) looking upstream; (B) looking downstream; and (C) looking across.

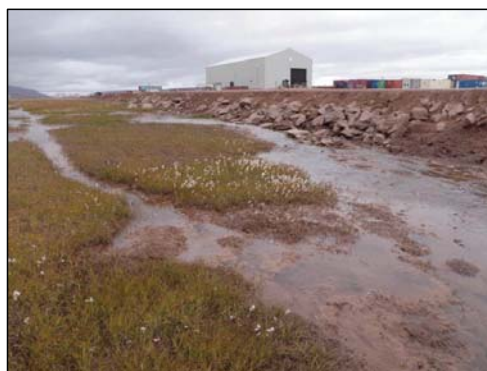
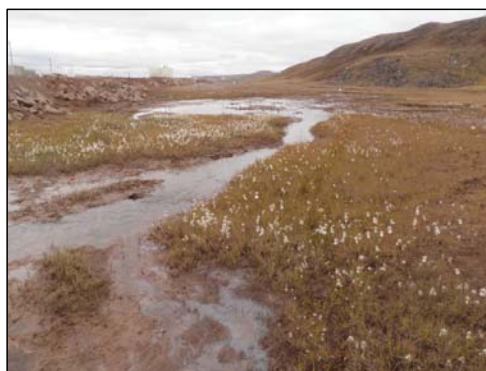
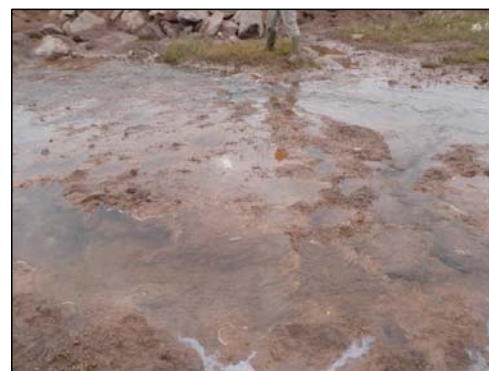
Figure 3. Summer (top) and fall (bottom) views of CV-106-1 at the 50 m upstream cross-section; (A) looking upstream; (B) looking downstream; and (C) looking across.

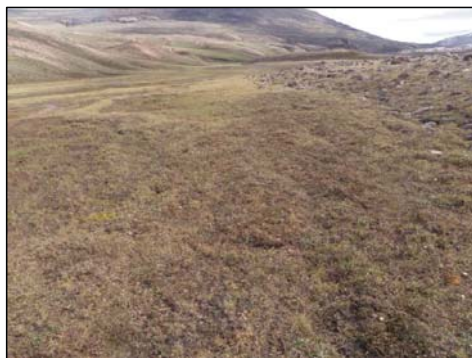
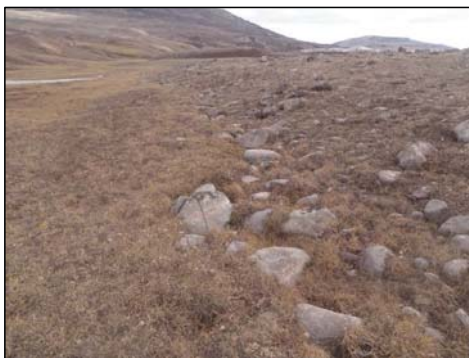
The crossing was a dry low point. There is no fish use of habitat at this crossing.

Figure 1. Views of CV-107-2 at the crossing during summer (A) and during fall (B).

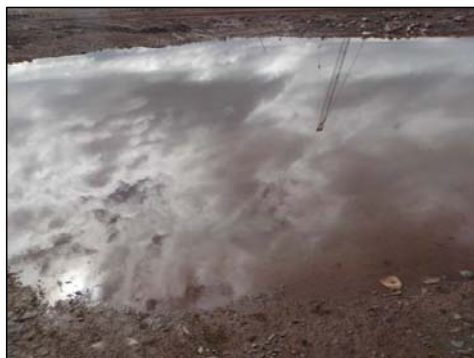
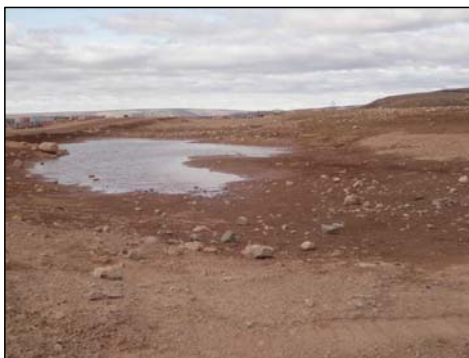
The crossing was shallow, isolated roadside ditch/pond. There is no fish use of habitat at this crossing.

Figure 1. Views of CV-107-3 at the crossing during summer (A) and during fall (B).

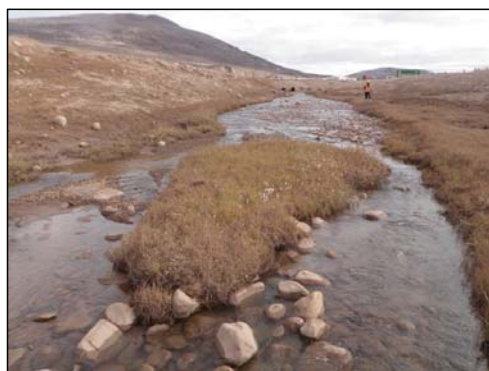
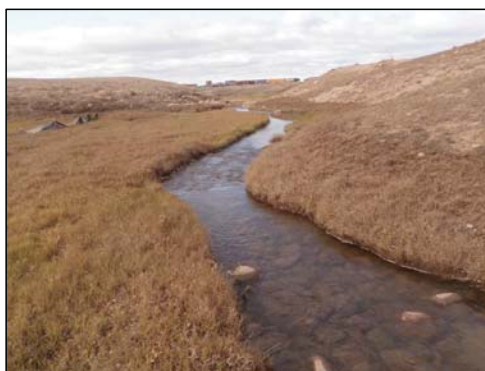
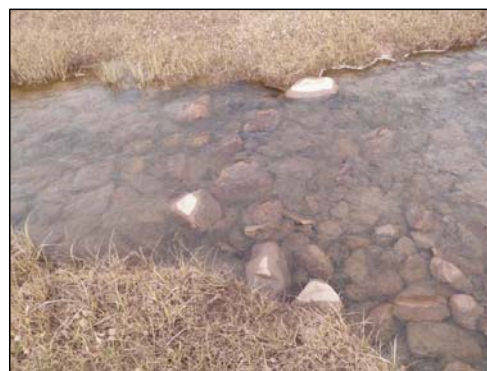
Figure 1. Summer (top) and fall (bottom) views of CV-107-4 at the 100 m downstream cross-section; (A) looking upstream; (B) looking downstream; and (C) looking across.

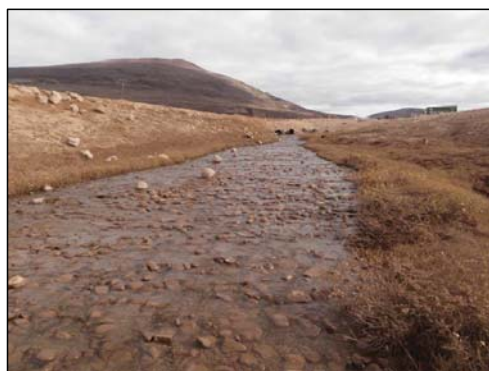
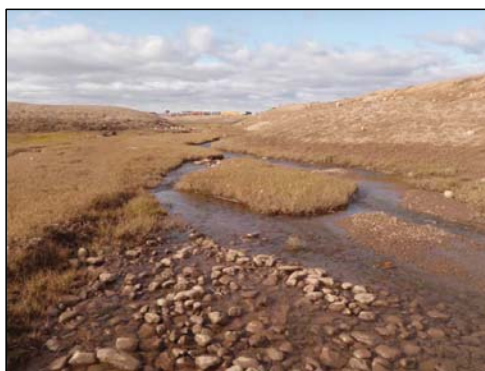
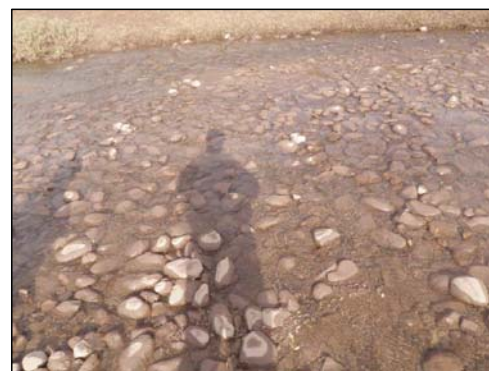
Figure 2. Summer (top) and fall (bottom) views of CV-107-4 at the 80 m downstream cross-section; (A) looking upstream; (B) looking downstream; and (C) looking across.

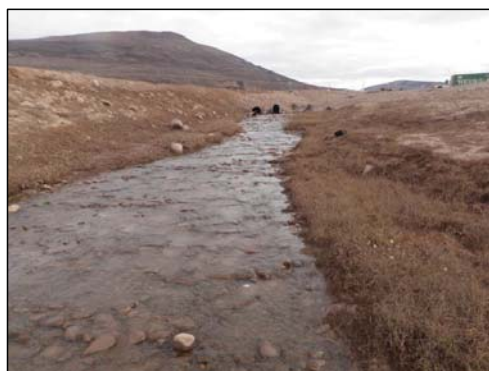
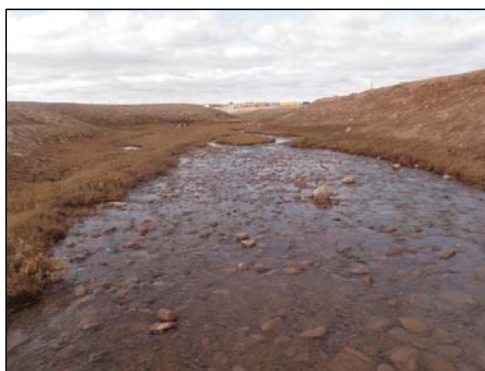
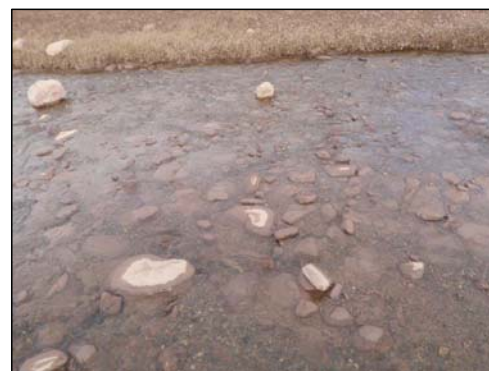
Figure 3. Summer (top) and fall (bottom) views of CV-107-4 at the 60 m downstream cross-section; (A) looking upstream; (B) looking downstream; and (C) looking across.

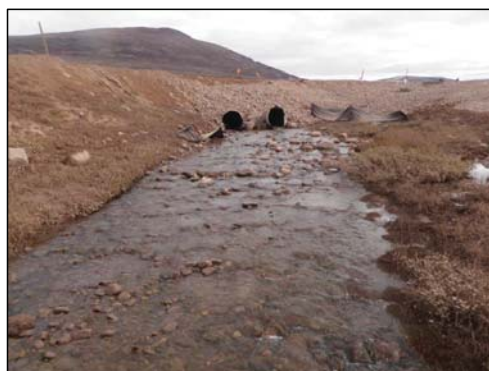
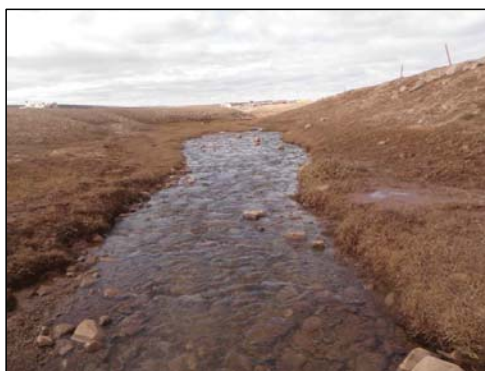
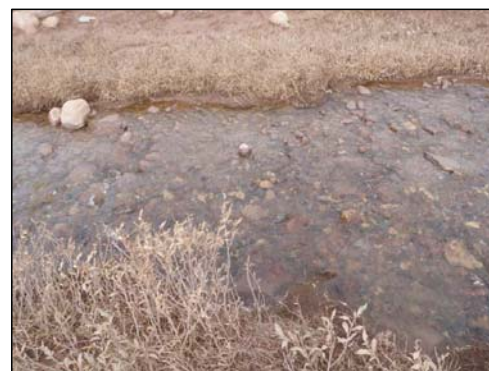
Figure 4. Summer (top) and fall (bottom) views of CV-107-4 at the 40 m downstream cross-section; (A) looking upstream; (B) looking downstream; and (C) looking across.

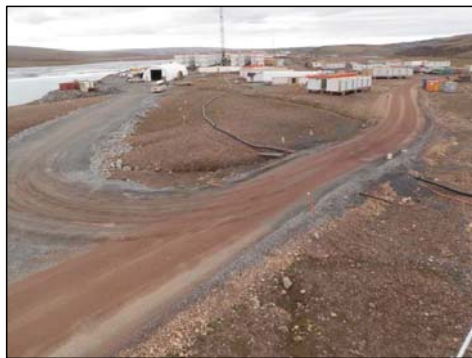
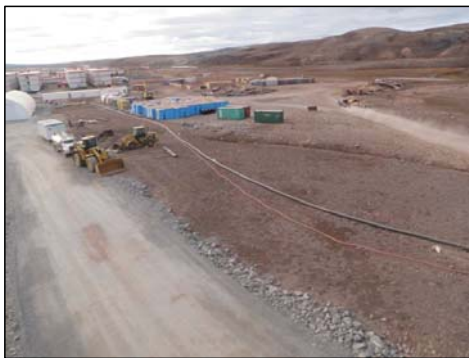
These two crossings were assessed as not fish-bearing during mine site baseline studies and current infrastructure has already altered them. There is no fish use of habitat at this crossing.

Figure 1. Views of CV-108-1 & 108-2 at the crossing during summer (A) and during fall (B).

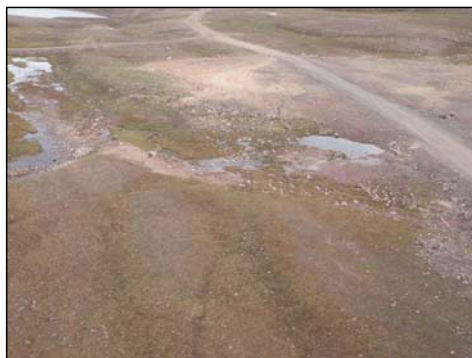
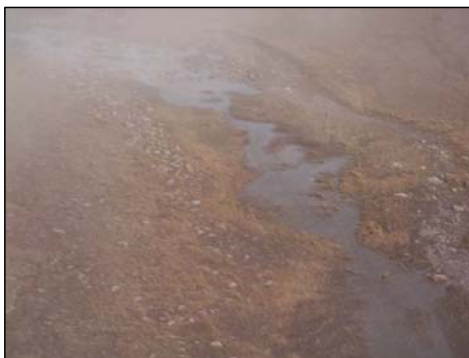
This crossing is upstream of a known permanent fish barrier identified during baseline studies. There is no fish use of habitat at this crossing.

Figure 1. Views of CV-108-3 at the crossing during summer (A) and during fall (B).

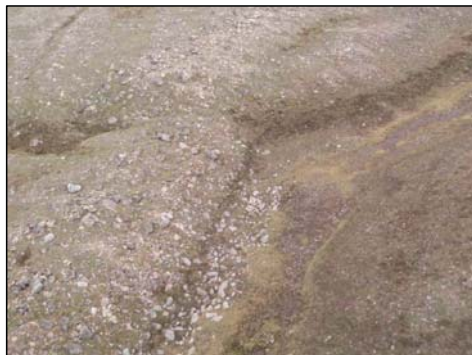
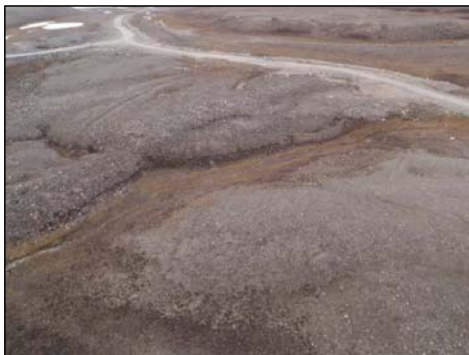
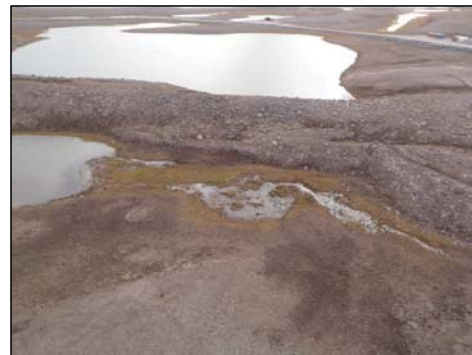
This crossing is upstream of a known permanent fish barrier identified during baseline studies. There is intermittent use of the low-gradient marshy/pond area at the downstream confluence with a fish-bearing lake, but the barrier prevents any further upstream access. There is no fish use of habitat at this crossing.

Figure 1. Views of CV-109-1 at the crossing during summer (A), during fall (B), and looking towards the downstream confluence (C).

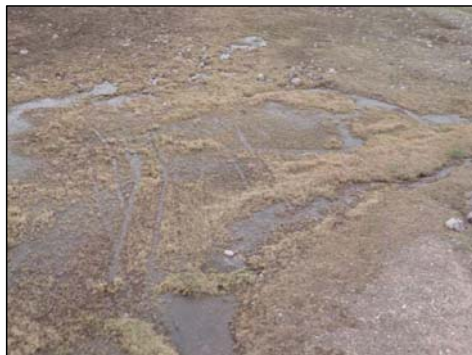
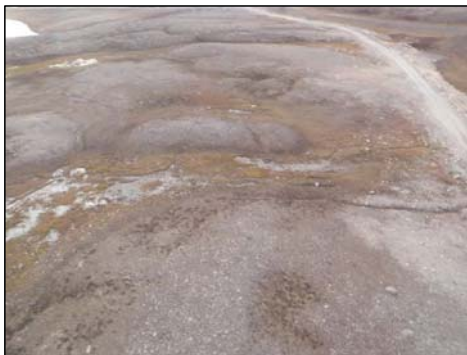
This crossing is upstream of a known permanent fish barrier identified during baseline studies. The site is steep, marshy and lacks a defined channel. There is no fish use of habitat at this crossing.

Figure 1. Views of CV-109-2 at the crossing during summer (A) and during fall (B).

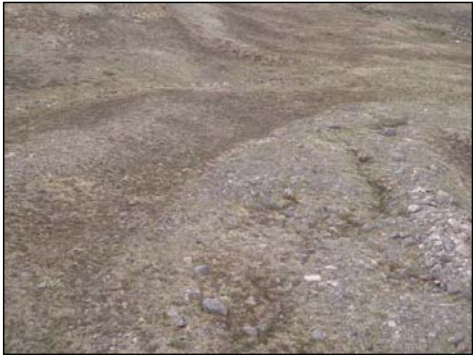
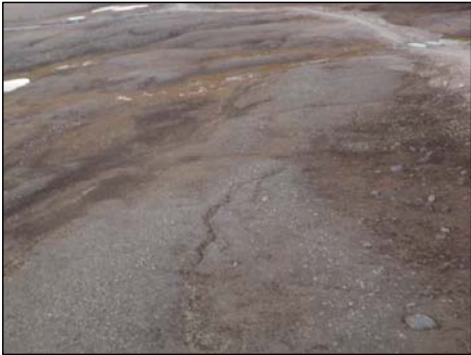
Phase 2 Milne Rail Corridor Aquatic Habitat Assessment				
Location				
Crossing ID: CV-109-3		Dates Surveyed: 4 July & 30 August, 2018		UTM Coordinates: 17 W 562024 7912215
General Physical Characteristics				
Channel Confinement: UC		Channel Gradient (range): N/A		Flow Regime: N/A
Fisheries Data				
Gear Used: Not Fished		Effort (min): N/A		Transect Length (m): N/A
Fish Habitat Potential				
Species	Spawning	Overwintering	Rearing	Migration Corridor
ARCH	N	N	N	N
NNST	N	N	N	N
Comments & Summary				
This crossing is a dry low point. There is no fish use of habitat at this crossing.				
Photographs				
<div><div>

</div></div> <p>A</p> <p>B</p> <p>Figure 1. Views of CV-109-3 at the crossing during summer (A) and during fall (B).</p>				
Baffinland Iron Mines Mary River Project
