## Phase 2 Milne Rail Corridor Aquatic Habitat Assessment

**Baffinland Iron Mines  
Mary River Project**

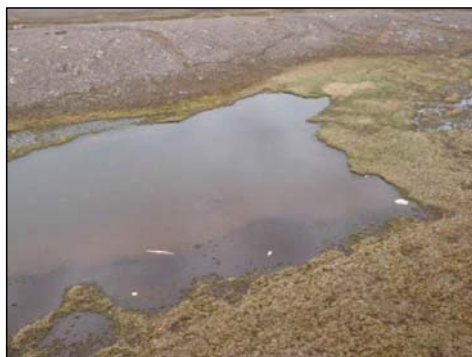
**Figure 1.** Views of CV-110-2 at the crossing during summer (A) and during fall (B).

This crossing was a small, shallow (max depth of 2.0 m) fishless pond that was unconnected to any fish-bearing waterbodies in the area. It was also examined during baseline studies more than a decade ago with the same results. There is no fish use of habitat at this crossing.

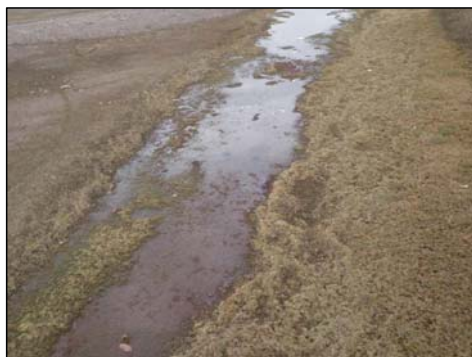
**Figure 1.** Views of CV-110-3 at the crossing during summer (A) and during fall (B).

This crossing was a small, shallow (max depth of 0.8 m) fishless pond that was unconnected to any fish-bearing waterbodies in the area. It was also examined during baseline studies more than a decade ago with the same results. There is no fish use of habitat at this crossing.

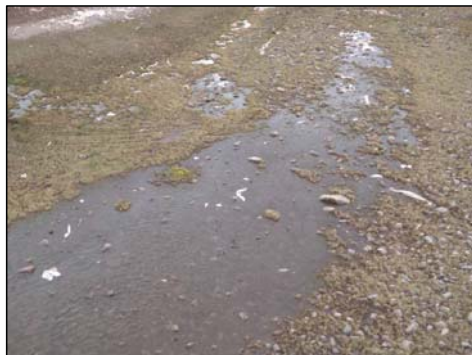
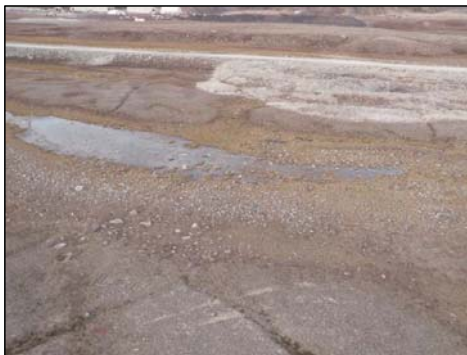
This crossing was a small, shallow (max depth of 0.5 m) fishless pond that was unconnected to any fish-bearing waterbodies in the area. It was also examined during baseline studies more than a decade ago with the same results. There is no fish use of habitat at this crossing.

**Figure 1.** Views of CV-110-4 at the crossing during summer (A) and during fall (B).

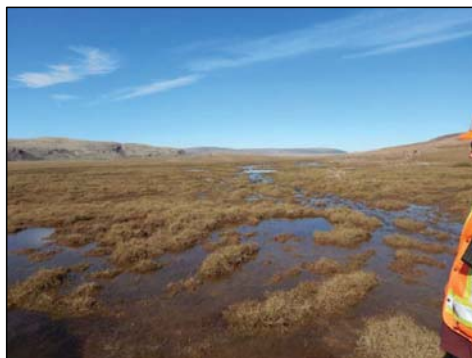
**Figure 1.** Views of CV-169-1 downstream from the laydown access road crossing; (A) and (B).

Although not captured in 2018, juvenile char have been occasionally observed in this stream during annual Tote Road surveys. It is thought that these char are from an anadromous population that uses Milne Inlet as the stream is not connected to any other overwintering habitat.

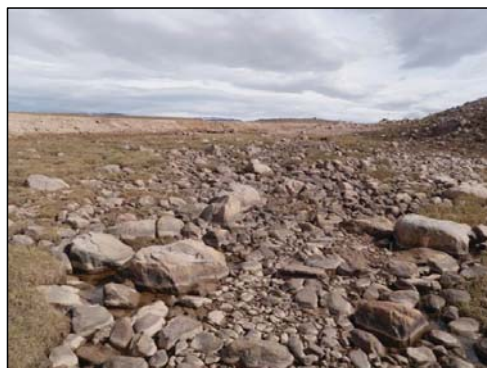
**Figure 1.** Views of CV-146-1 & CV-146-2 upstream of the rail crossing during summer (A), CV-146-3 during summer (B), and all three aerially during fall (C).

This stream had low flows during both surveys. Downstream of the Tote Road it is connected to a fishless pond that flows into Phillips Creek. In addition to several soft barriers (subsurface flow), a permanent vertical barrier between the downstream pond and Phillips Creek prevents fish access to the rail site. There is never aquatic habitat at this crossing.

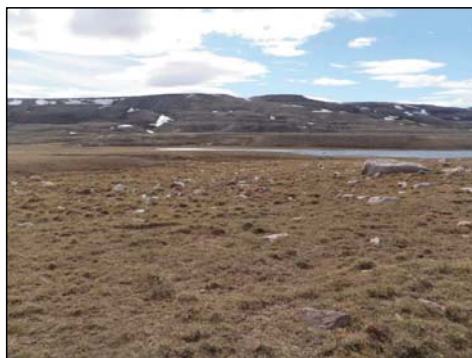
**Figure 1.** Views of CV-131-1 at the road diversion crossing during summer (A) and fall (B).

Same location as rail crossing CV-12-4. This entire area is a dry, low point on both sides of the existing Tote Road. There is never aquatic habitat at this crossing.

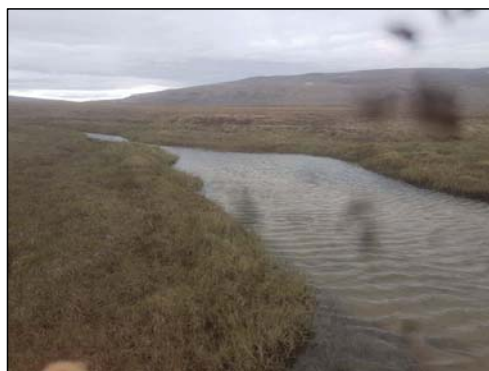
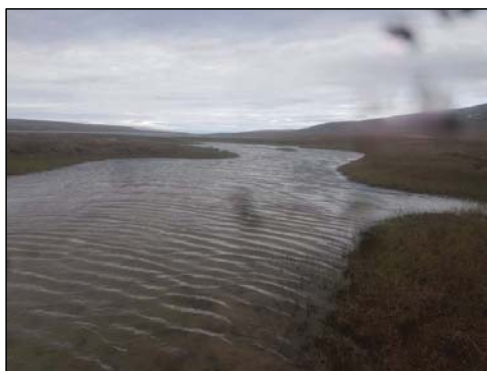
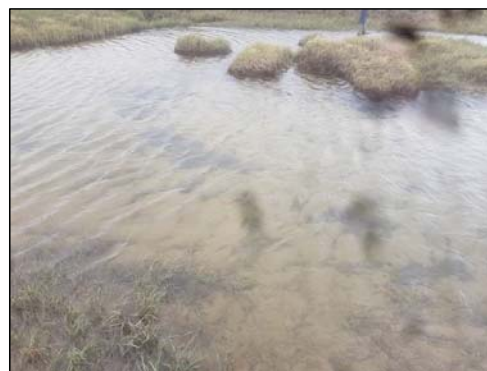
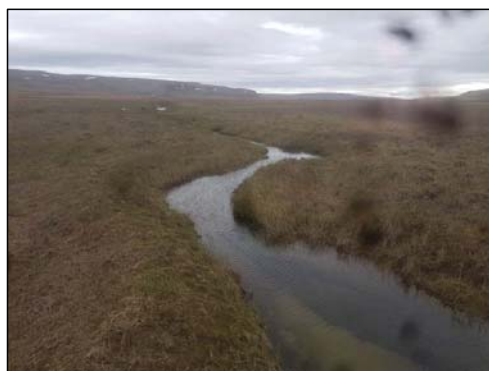
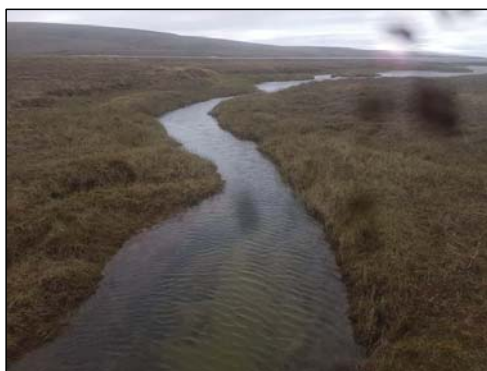
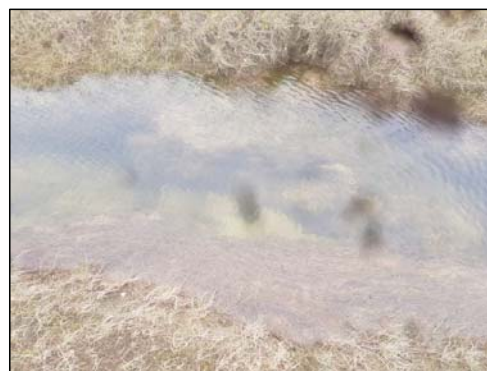
**Figure 1.** 100 m (top) and 50 m (bottom) downstream cross-section views of temp haul road crossing CV-060-1; (A) looking upstream; (B) looking downstream; and (C) looking across.

This temporary haul road crossing is downstream of Tote Road crossing CV-060 and proposed rail crossing CV-55-3. The 100 m upstream transect for CV-060-1 is the equivalent of the existing Tote Road crossing. This stream is important rearing habitat for juvenile char throughout the open-water season, but particularly during summer.

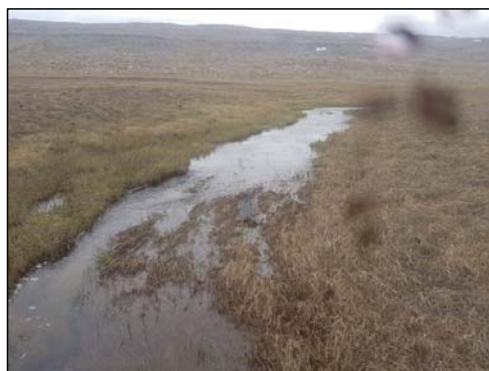
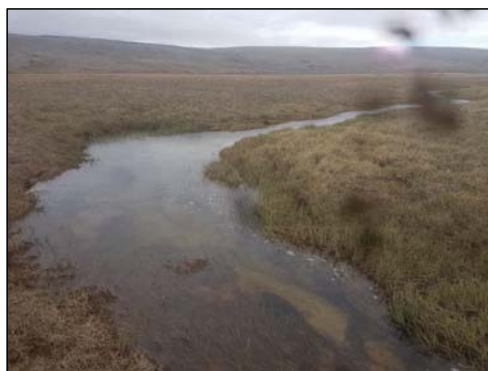
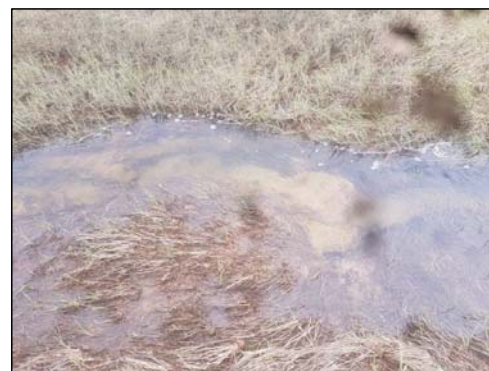
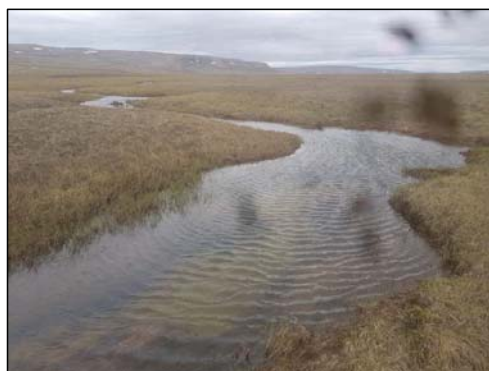
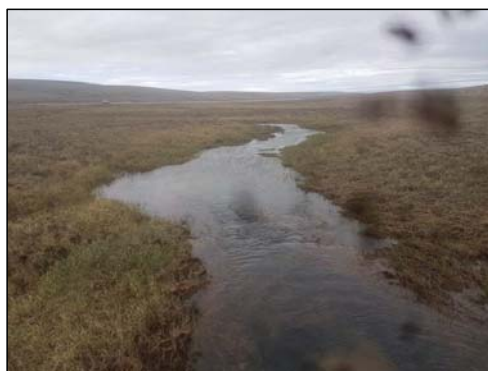
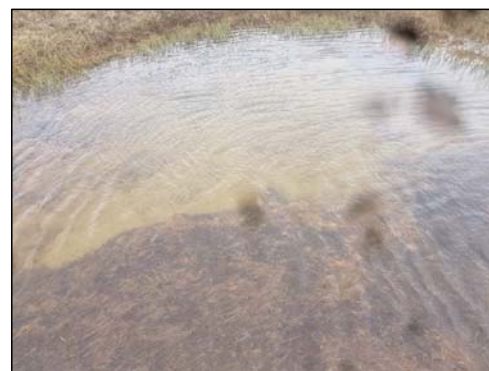
**Figure 1.** Road crossing (top) and 50 m (bottom) upstream cross-section views of road diversion CV-060-2; (A) looking upstream; (B) looking downstream; and (C) looking across.

This diversion of the Tote Road is upstream of the existing CV-060 crossing and proposed rail CV-55-3 crossing. The 20 m downstream transect of CV-060-2 is approximately 100 m upstream of the rail crossing CV-55-3. This stream is important rearing habitat for juvenile char throughout the open water season, but particularly during summer.

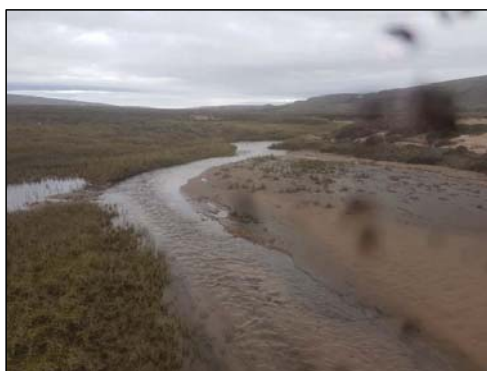
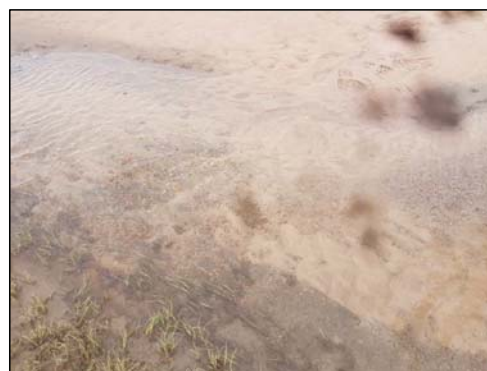
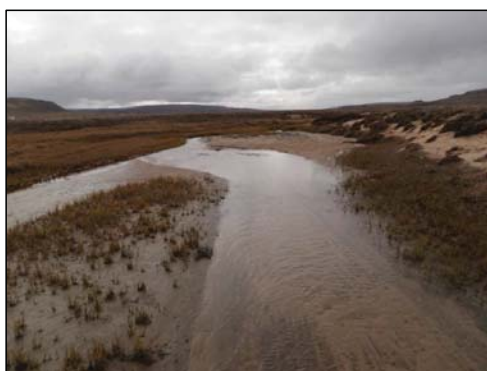
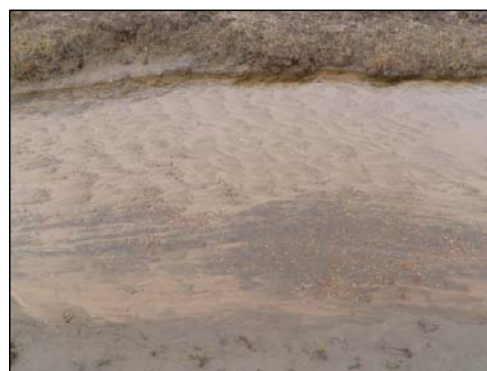
**Figure 1.** Summer (top) and fall (bottom) views at temporary haul road crossing CV-059-1; (A) looking upstream; (B) looking downstream; and (C) looking across.

This temporary haul road crossing is approximately 120 m downstream of the rail crossing at CV-56-1. Additional habitat information for this area can be obtained from the CV-56-1 assessment sheet. The site provides marginal rearing habitat for smaller juvenile char throughout the open-water season, but particularly during summer. Stickleback have never been captured in this watershed in any sampling year.

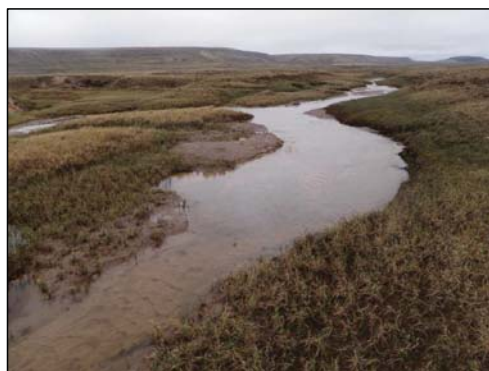
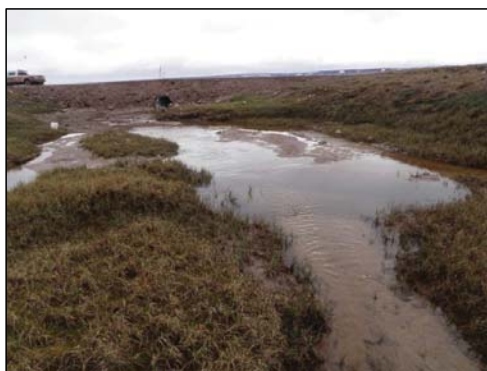
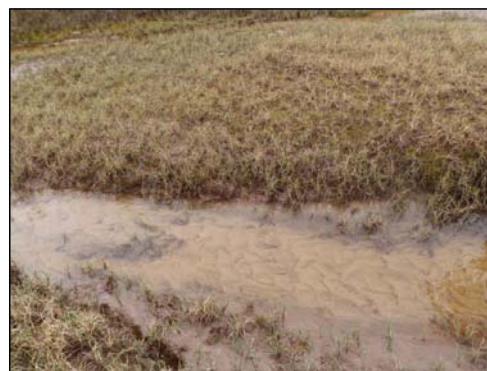
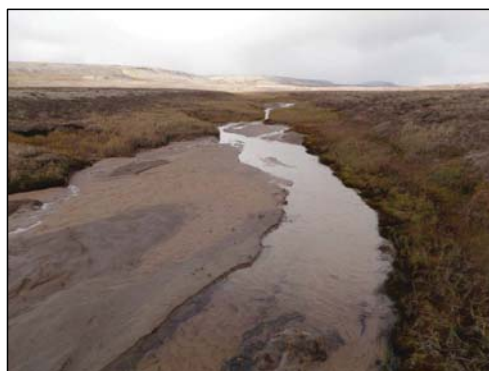
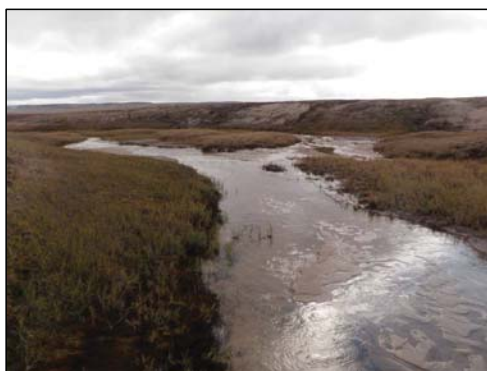
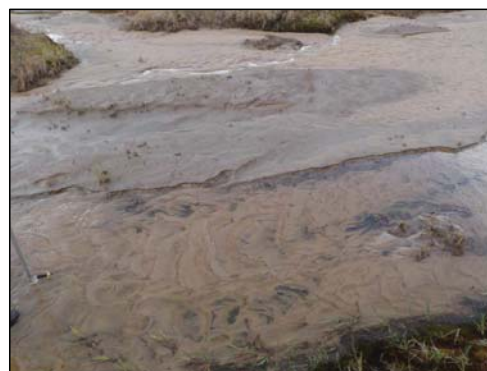
**Figure 1.** Summer (top) and fall (bottom) views of CV-214-1 at the 50 m downstream cross-section; (A) looking upstream; (B) looking downstream; and (C) looking across.

The same stream as rail crossing CV-84-3. There was no evidence of fish use of stream habitat in 2018. This broad, flat, very shallow stream does not provide ideal habitat for either species and access from the large downstream river is intermittent with water level fluctuations.

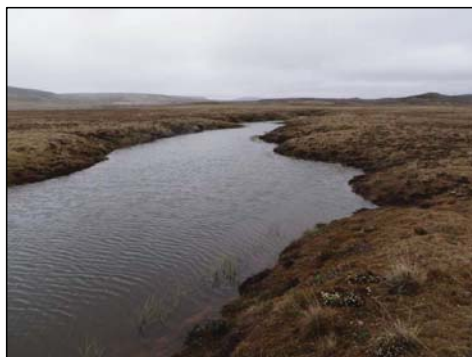
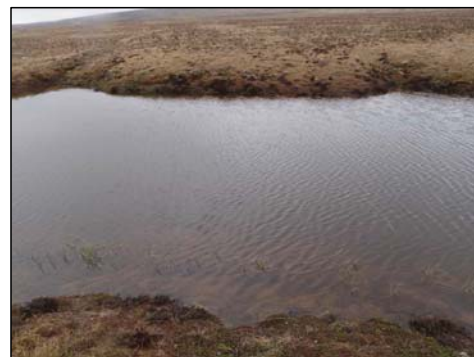
**Figure 1.** Views of CV-214-2 at the road diversion crossing during summer, looking upstream (A) downstream (B) and across (C). Fall photos were not taken.

This stream is known to be not fish-bearing from Tote Road surveys. Despite the fact that it is a tributary to a major river, the culvert at Tote Road crossing CV-85-1 was installed at a natural drop, so it is elevated above the water's surface on the downstream side. As a result, there is no fish use of habitat upstream of CV-85-1, which is where the road diversion is located.

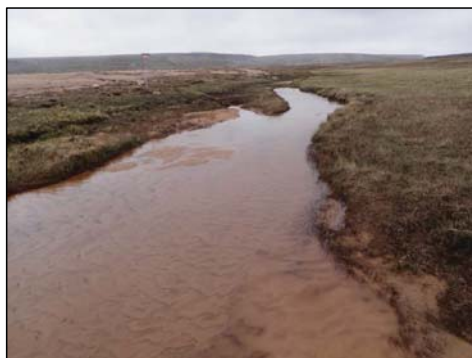
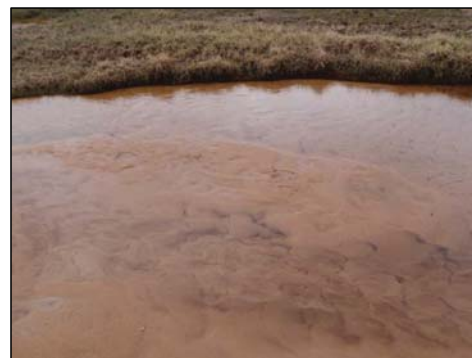
**Figure 1.** Views of CV-215-1 at the road diversion crossing during summer, looking upstream (A) downstream (B) and across (C). Fall photos were not taken, see rail sheet.

This stream is the same as rail crossing CV-85-2. See that assessment for general habitat information, as the road diversion is adjacent to the rail. There was no evidence of fish use of crossing habitat in 2018. Access to the crossing area is likely intermittent and habitat is very shallow with fine substrates. Fish have not previously been noted in this stream, but it is very close to a large, overwintering lake (Muriel Lake) and high water may allow access.

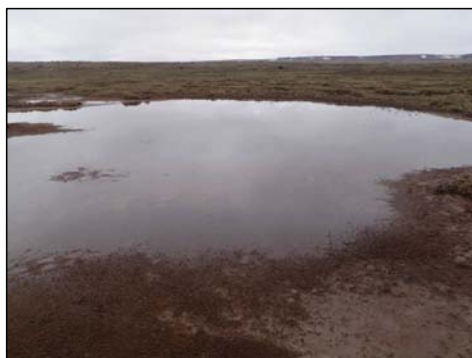
**A**  
**Figure 1.** View of CV-216-1 at the road diversion crossing during summer.

The crossing is a very shallow (< 5 cm), fishless puddle with no connections to overwintering habitat. There is no fish use of habitat at this crossing.

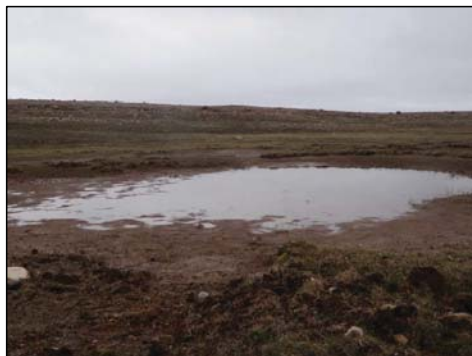
**A**  
**Figure 1.** Views of CV-216-2 at the road diversion crossing during summer.

The crossing is an isolated, shallow, fishless puddle with no connection to overwintering waterbodies. There is no fish use of habitat at this crossing.

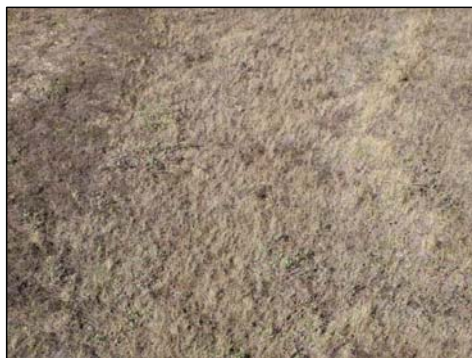
This crossing was moist land (terrestrial habitat) in 2018. This road diversion is in the same area as rail crossing CV-91-2 and shares the same downstream barriers and lack of connection to overwintering habitat. There is no fish use of habitat at this crossing.

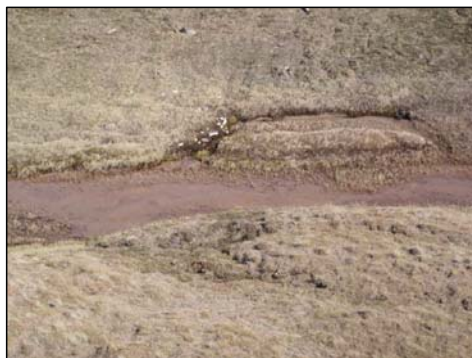
This crossing is on the same stream as rail crossing CV-91-0. The stream is shallow and steep, and had intermittent surface water downstream of the crossing in 2018 with no connections to overwintering waterbodies. There is no fish use of habitat at this crossing.

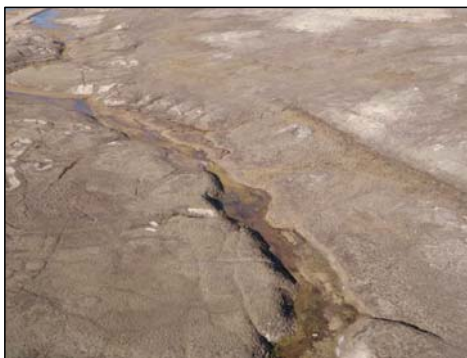
B

**Figure 1.** Views of CV-020-2 at the road diversion crossing during summer (A) and fall (B).
