Phase 2 Milne Rail Corridor Aquatic Habitat Assessment

**Baffinland Iron Mines
Mary River Project**

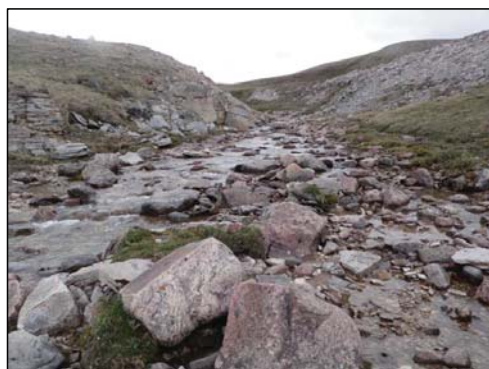
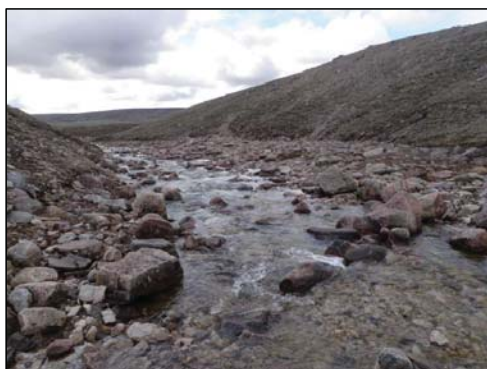
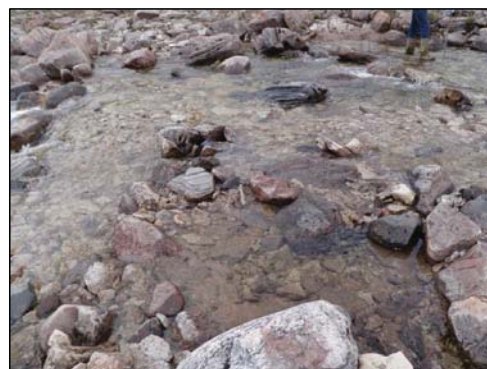
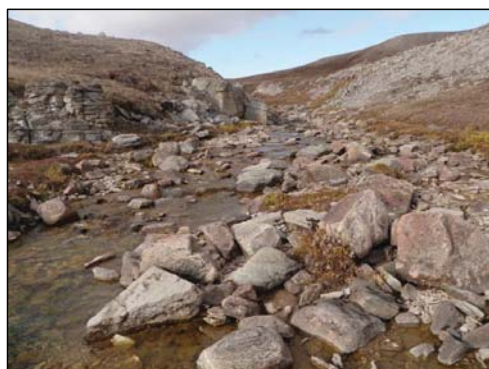
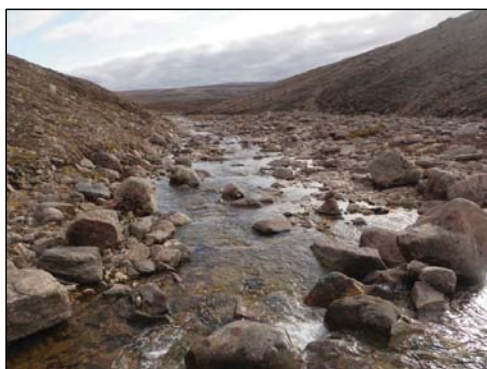
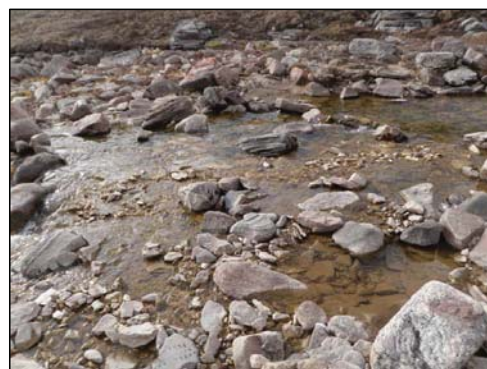
Figure 5. Summer (top) and fall (bottom) views of CV-77-2 at the 20 m downstream cross-section; (A) looking upstream; (B) looking downstream; and (C) looking across.

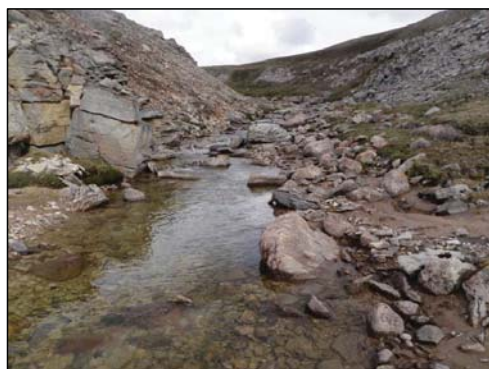
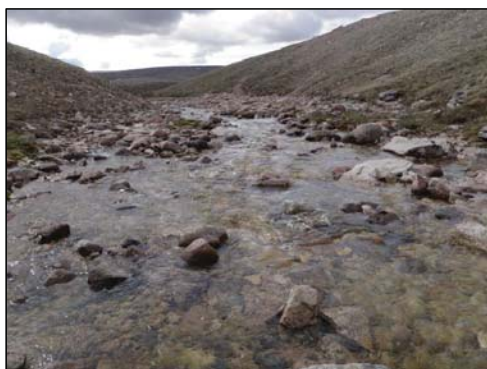
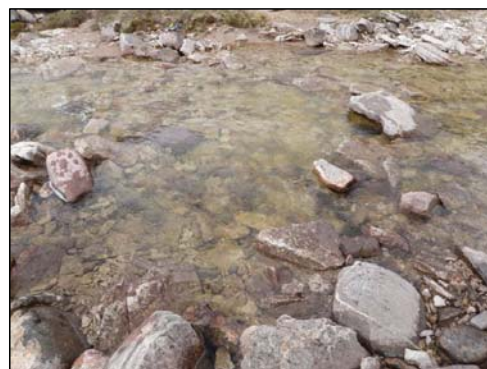
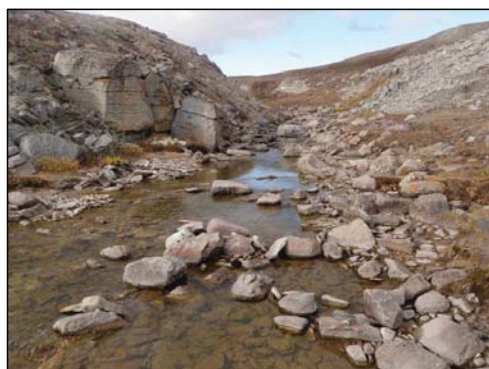
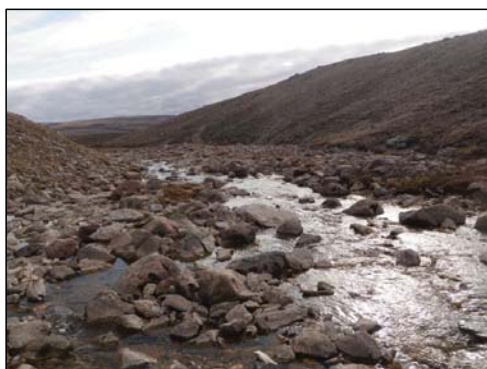
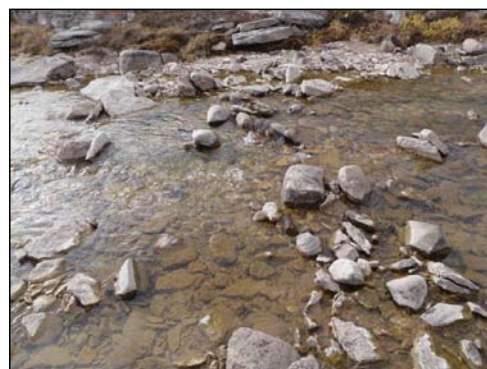
Figure 6. Summer (top) and fall (bottom) views of CV-77-2 at the rail crossing; (A) looking upstream; (B) looking downstream; and (C) looking across.

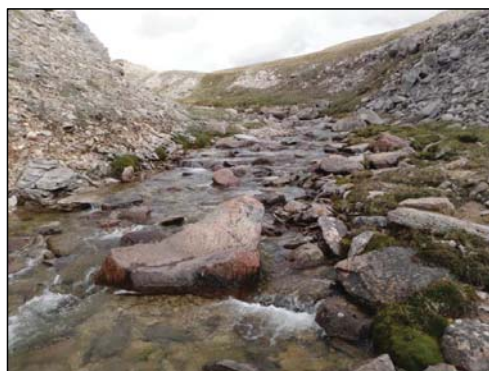
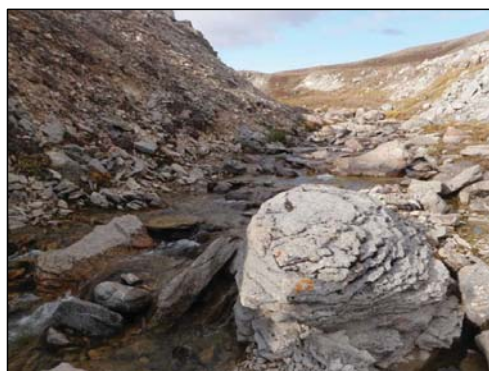
Figure 7. Summer (top) and fall (bottom) views of CV-77-2 at the 20 m upstream cross-section; (A) looking upstream; (B) looking downstream; and (C) looking across.

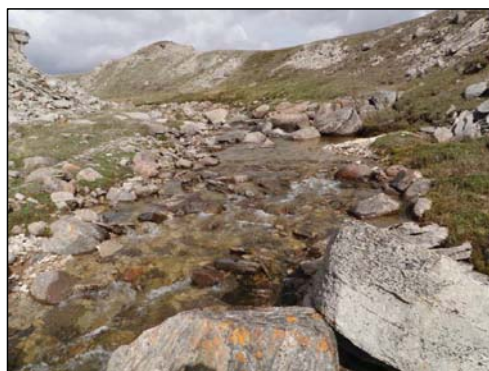
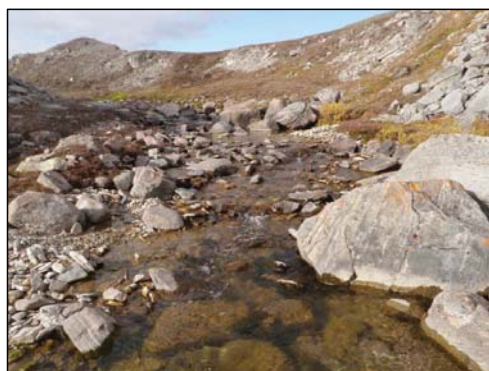
Figure 8. Summer (top) and fall (bottom) views of CV-77-2 at the 40 m upstream cross-section; (A) looking upstream; (B) looking downstream; and (C) looking across.

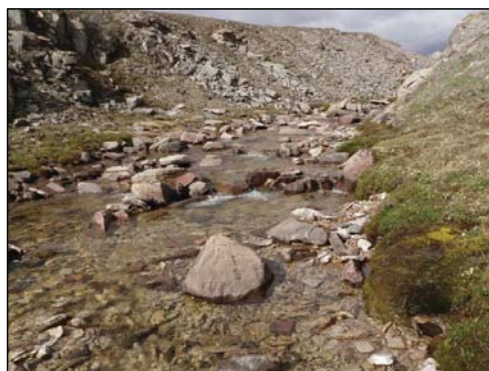
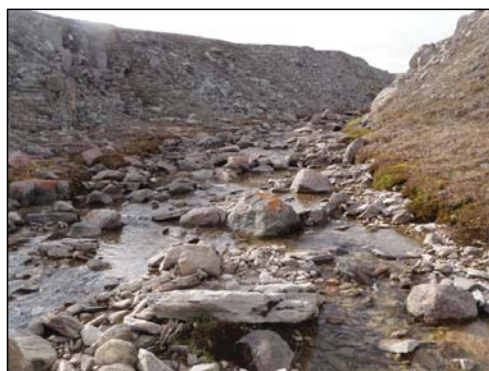
Figure 10. Summer (top) and fall (bottom) views of CV-77-2 at the 80 m upstream cross-section; (A) looking upstream; (B) looking downstream; and (C) looking across.

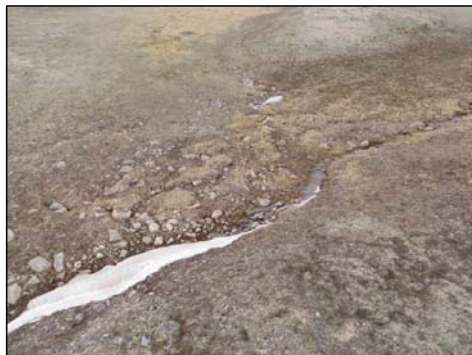
The crossing was small, but wetted in 2018. However a steep downstream gradient and lack of connectivity to overwintering habitat prevents access. There is no fish use of habitat at the crossing.

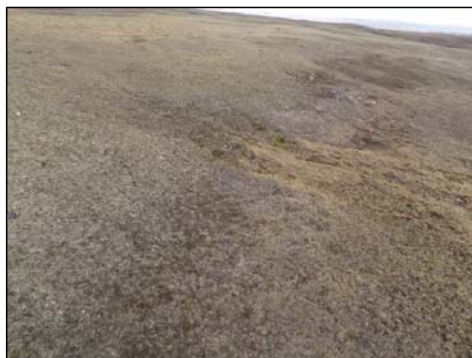
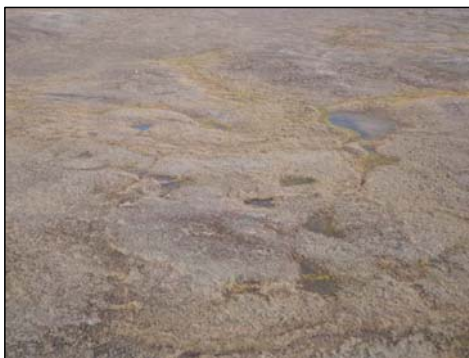
The crossing was a nearly dry, isolated low point on a hillside. There is no fish use of habitat at the crossing.

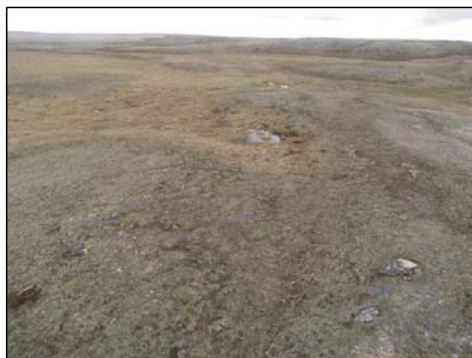
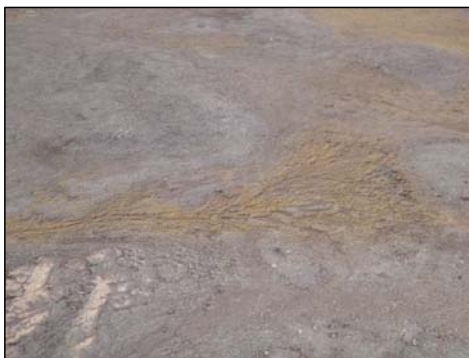
The crossing was a nearly dry, isolated low point on a hillside. There is no fish use of habitat at the crossing.

Figure 1. Views of CV-78-2 at the crossing during summer (A) and fall (B).

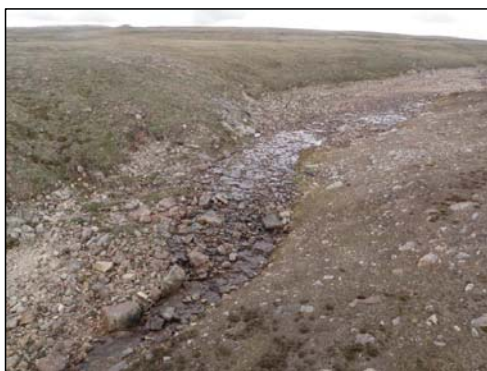
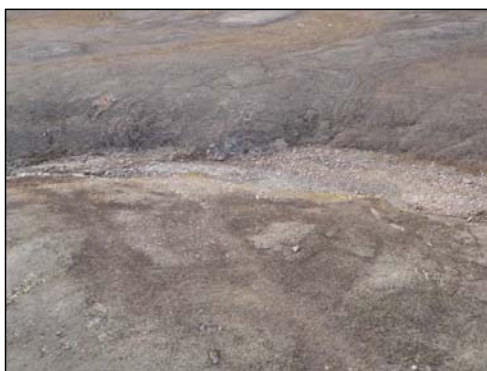
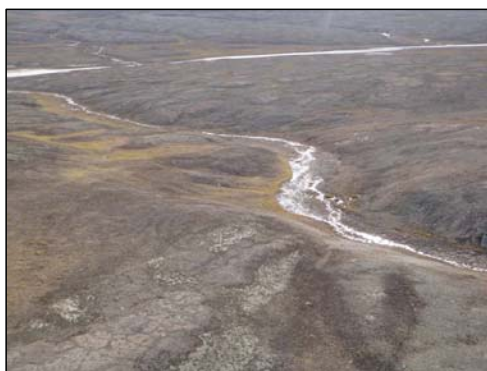
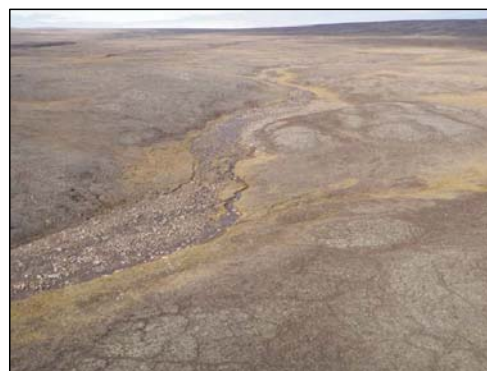
Figure 1. Summer (top) and fall (bottom) views of CV-78-3 at the rail crossing. Fall (B) image shows the suitable downstream habitat while all others show a lack of habitat at and upstream of the crossing.

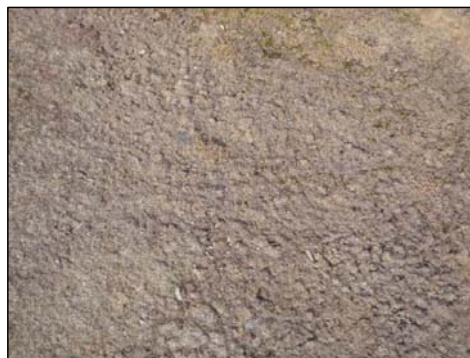
The crossing was a dry low point on a hillside. There is no fish use of habitat at the crossing.

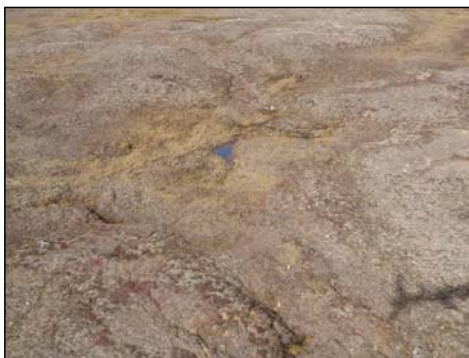
The crossing was a nearly dry low point on a hillside. There is no fish use of habitat at the crossing.

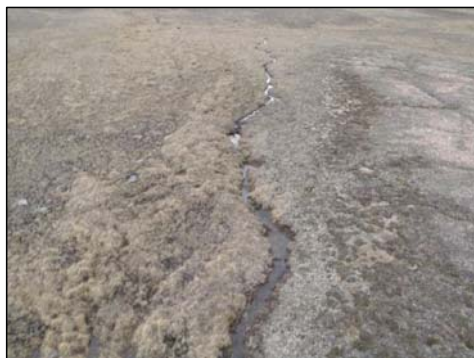
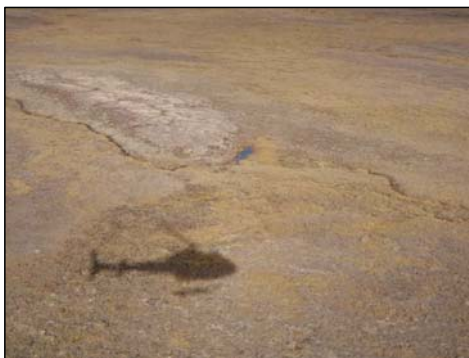
Figure 1. Views of CV-78-6 at the crossing during summer (A) and fall (B).

There was a wetted channel at the crossing, but the channel disappeared downstream and water was subsurface. There is no fish use of habitat at the crossing.

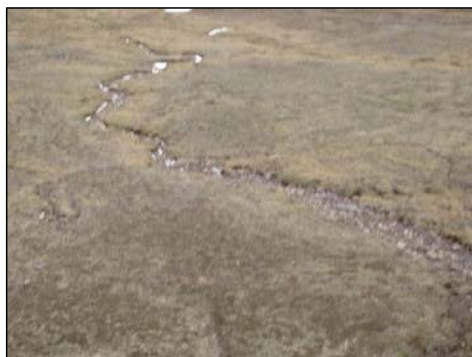
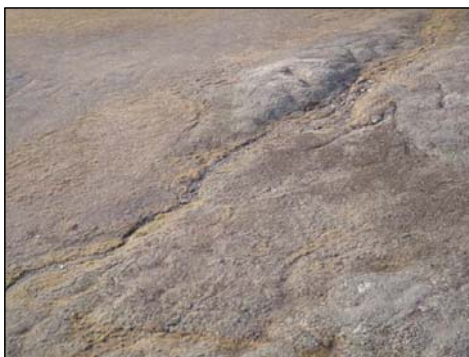
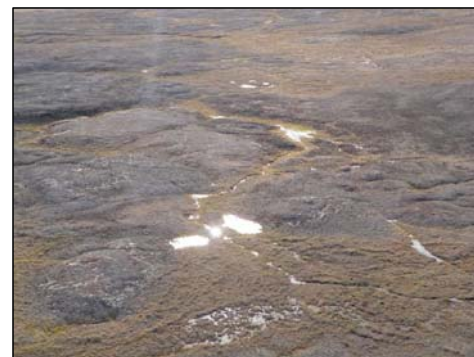
Figure 1. Views of CV-79-0 at the crossing during summer (A) and fall (B), and a downstream view of the stream with subsurface flows (C).

The crossing was steep, though flows were maintained during the open-water period in 2018. However, downstream closer to the confluence with a large river, the channel disappeared and flows spread across and under the tundra. There is no fish use of habitat at the crossing.

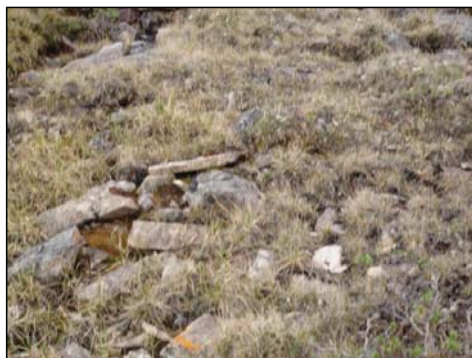
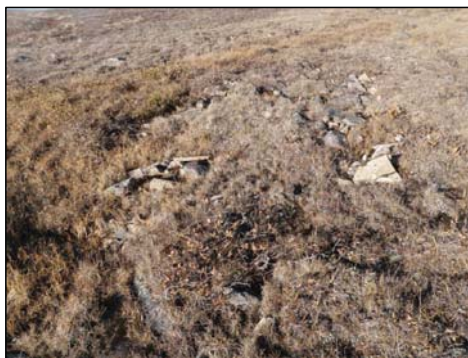
Figure 1. View of CV-79-1 at the crossing during summer (A) and fall (B).

This was a dry spot adjacent to the CV-80-1 fish-bearing stream. There is no fish use of habitat at the crossing.

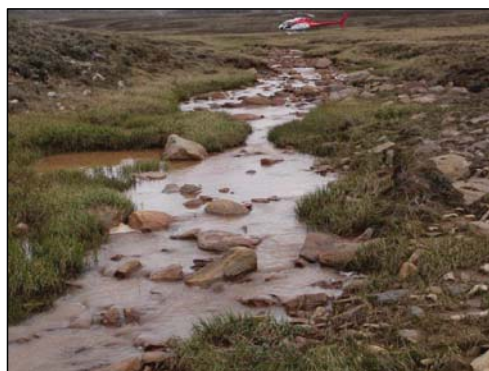
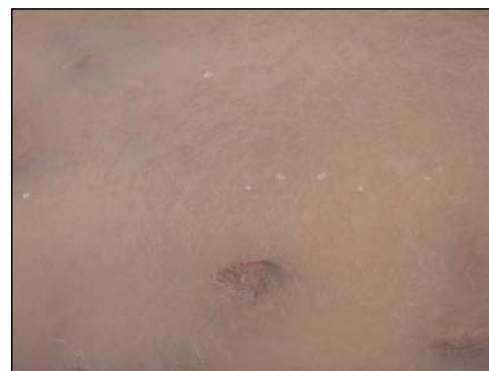
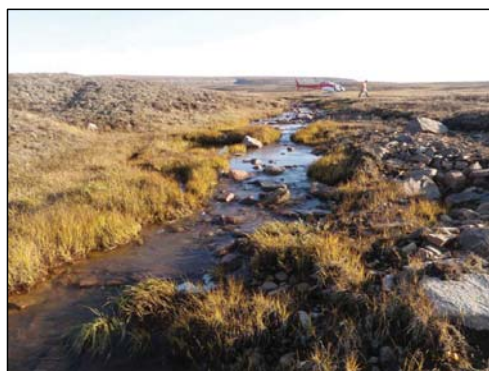
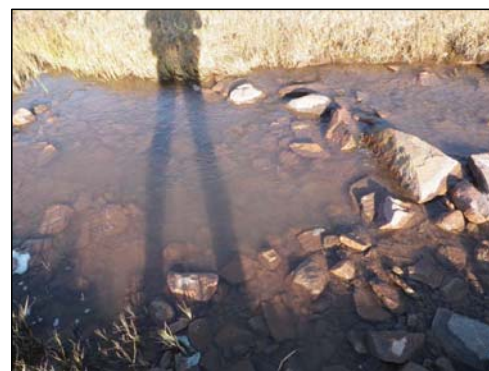
Turbidity was very high during summer sampling due to erosion from the upstream Tote Road, which may have affected fish use of the stream and catch rates. This stream provides suitable rearing habitat for juvenile char throughout the open-water season, particularly during summer, but turbidity and a layer of loose sediment covering existing substrate may reduce usage.

Figure 2. Summer (top) and fall (bottom) views of CV-80-1 at the 80 m downstream cross-section; (A) looking upstream; (B) looking downstream; and (C) looking across.

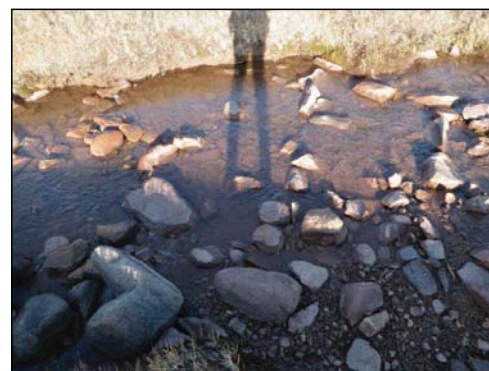
Figure 3. Summer (top) and fall (bottom) views of CV-80-1 at the 60 m downstream cross-section; (A) looking upstream; (B) looking downstream; and (C) looking across.

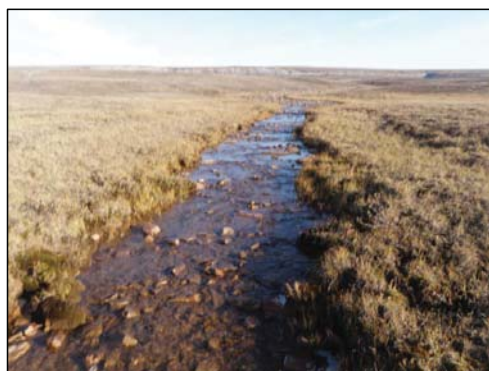
Figure 8. Summer (top) and fall (bottom) views of CV-80-1 at the 20 m upstream cross-section; (A) looking upstream; (B) looking downstream; and (C) looking across.

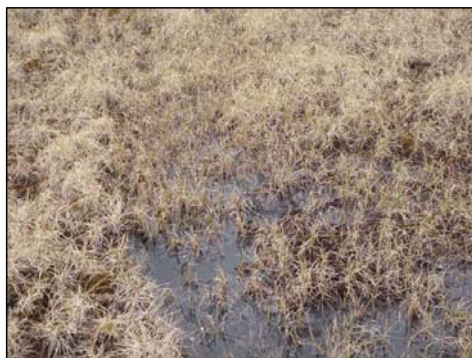
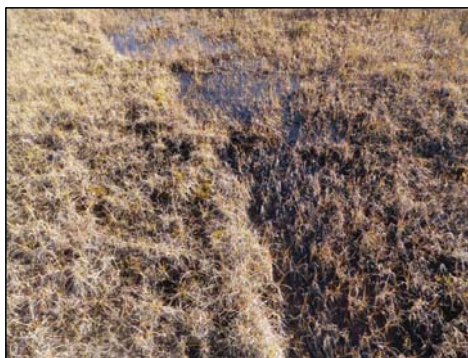
This was a moist, grassy spot adjacent to CV-80-1. There is no fish use of habitat at the crossing.

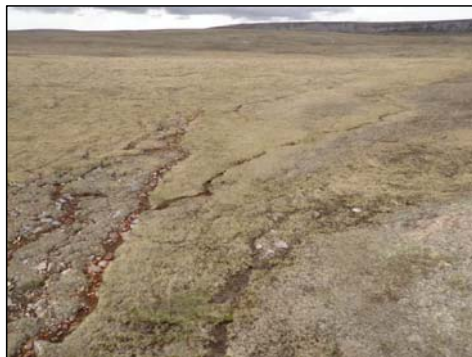
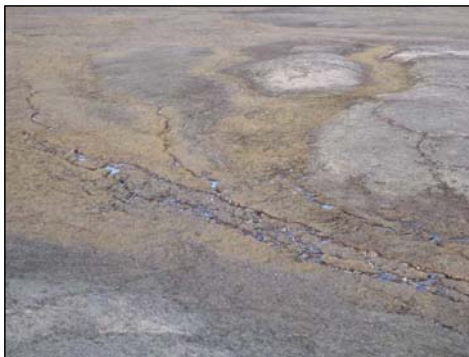
Figure 1. Views of CV-80-2, 80-2a, and 80-2b (from left to right in each photo) at the crossings during summer (A) and fall (B).

These are three branches of the same stream. The stream was shallow and steep, and surface flows disappeared downstream preventing all access. There is no fish use of habitat at the crossing.

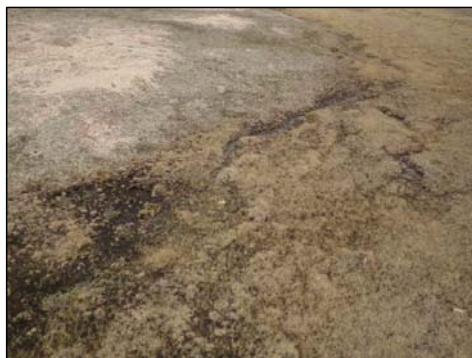
This was a moist spot with no connections to other waterbodies. There is no fish use of habitat at the crossing.

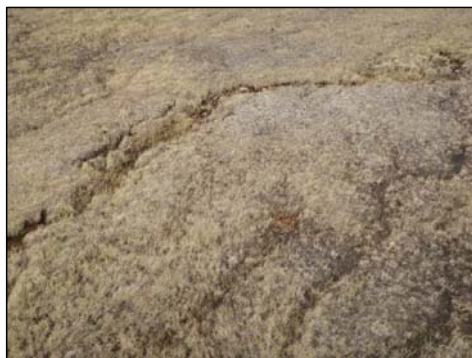
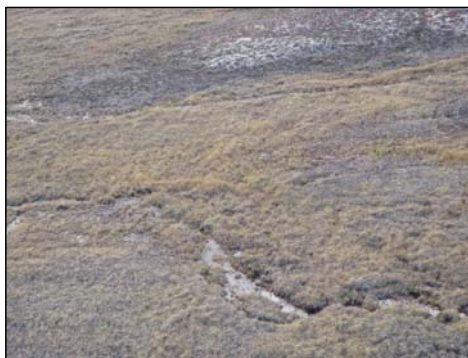
Figure 1. Views of CV-80-4 at the crossing during summer (A) and fall (B).

This was barely wetted with many stretches of subsurface flows and no connections to other waterbodies. There is no fish use of habitat at the crossing.

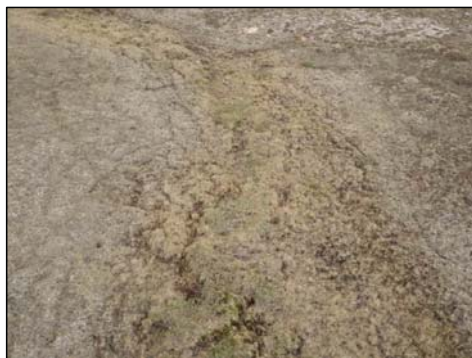
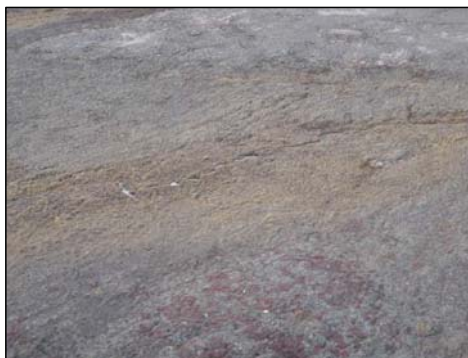
Figure 1. Views of CV-81-1 at the crossing during summer (A) and fall (B).

This was a nearly dry marshy area. Most of the stream lacks a defined channel and there are multiple reaches with no surface flow. There is no fish use of habitat at the crossing.

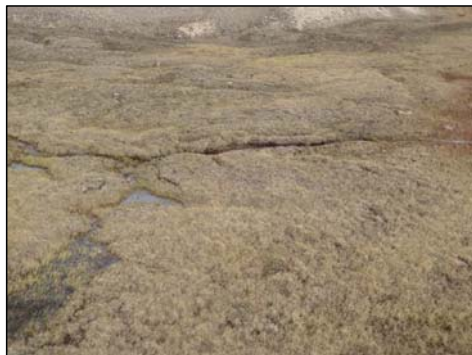
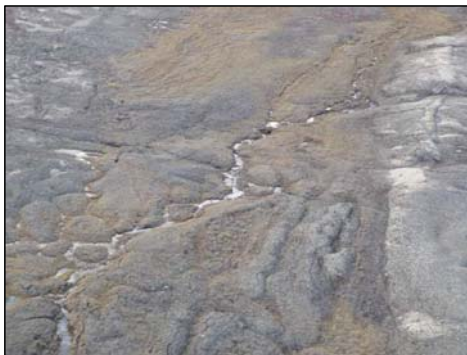
Figure 1. Views of CV-81-2 at the crossing during summer (A) and looking downstream during fall to show the loss of surface flow (B).

There was a channel and sufficient flows at the crossing in 2018, but surface flows disappeared downstream and there was no connection to a pond or other waterbodies in the area. There is no fish use of habitat at the crossing.

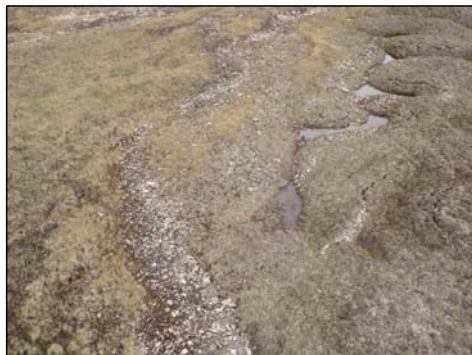
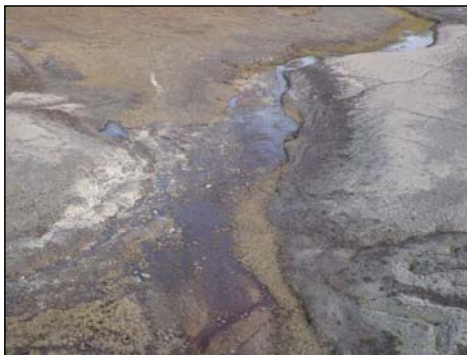
Figure 1. Views of CV-81-3 near the crossing during summer, showing the lack of surface flow (A) and looking at the crossing during fall (B).

There was a very shallow, wide channel at the crossing in 2018, but surface flows disappeared downstream and there was no connection to other waterbodies in the area. There is no fish use of habitat at the crossing.

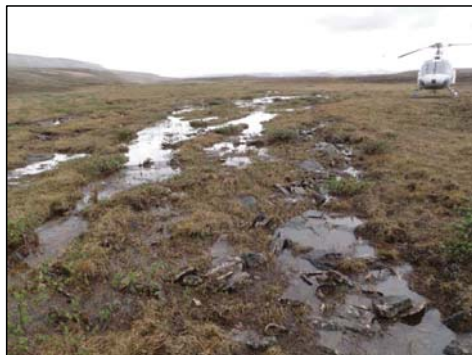
The crossing was broad and shallow (max depth – 0.10 m) in 2018. No fish were captured or observed near the crossing. Fish were observed in deep pools near the confluence with a large downstream river. It is likely that the shallow, steep conditions at and near the crossing prevent all fish access to the area.

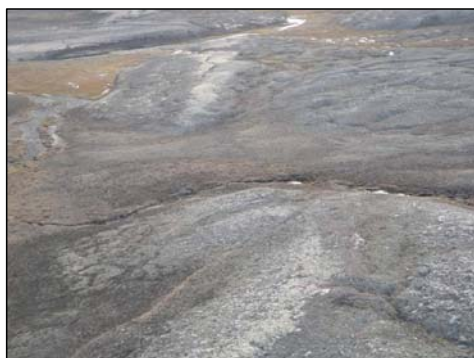
A
Figure 2. View of CV-81-4 during fall.

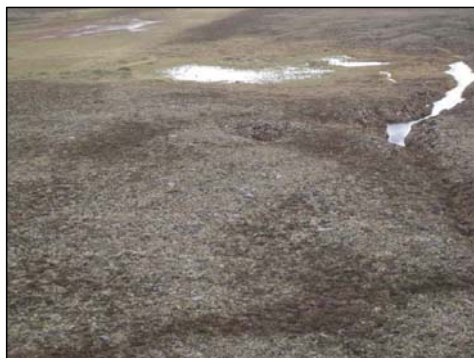
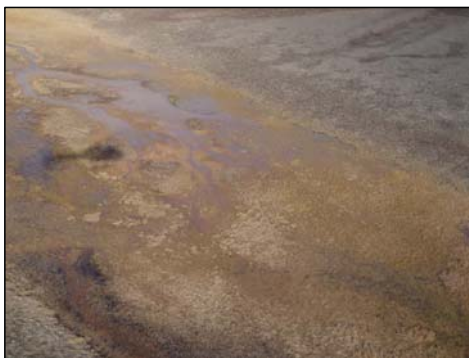
Figure 1. Views of CV-82-1 near the crossing during summer (A) and fall (B).

The crossing was marshy habitat with intermittent surface flows and no connections to other waterbodies in 2018. There is no fish use of habitat at this crossing.

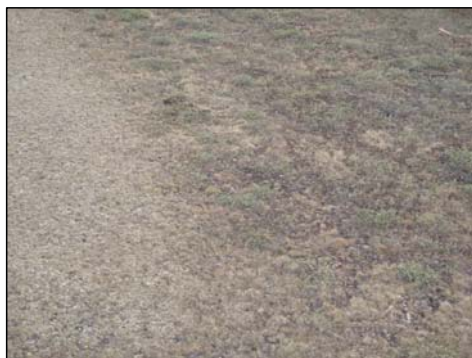
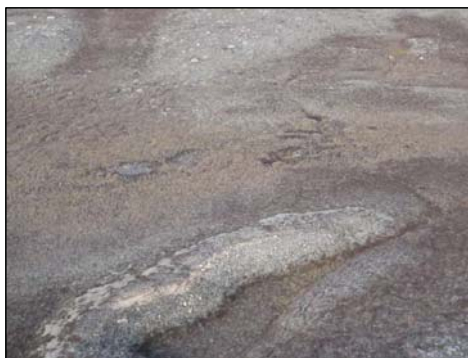
Figure 1. Views of CV-82-1a near the crossing during summer (A) and fall (B).

The crossing was a dry low point. There is no fish use of habitat at this crossing.

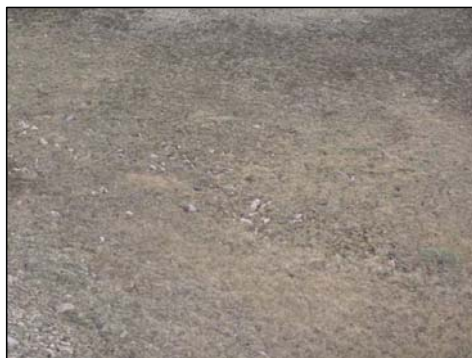
The crossing and entire stream was dry during 2018. There is likely no access to the crossing under any flow conditions. There is no fish use of habitat at this crossing.

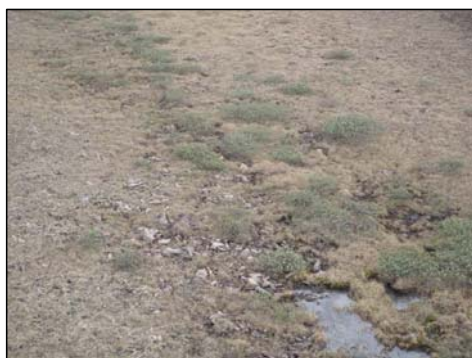
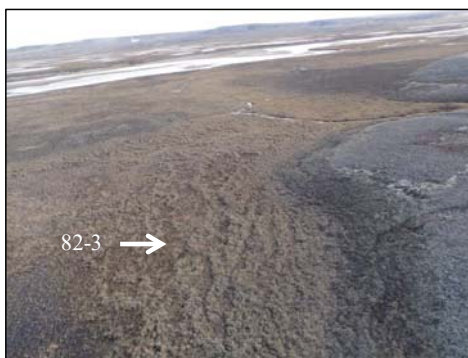
Figure 1. Views of CV-82-3 near the crossing during summer (A) and fall facing downstream (B).

The crossing was an intermittently wet spot, with no surface water upstream and very little downstream. There is no fish use of habitat at this crossing.

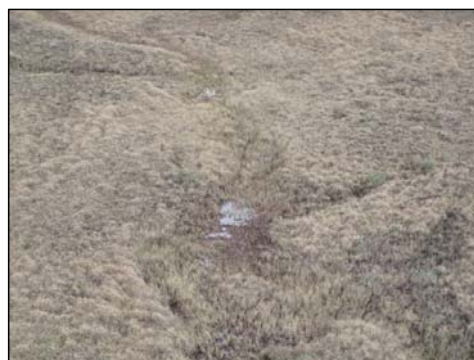
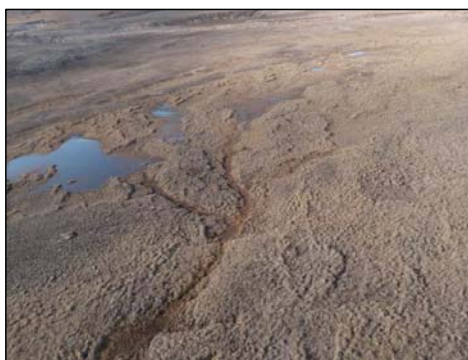
Figure 1. Views of CV-82-4 near the crossing during summer (A) and fall facing downstream (B).

The crossing was patches of shallow surface water with no flows or connections to other waterbodies. There is no fish use of habitat at this crossing.

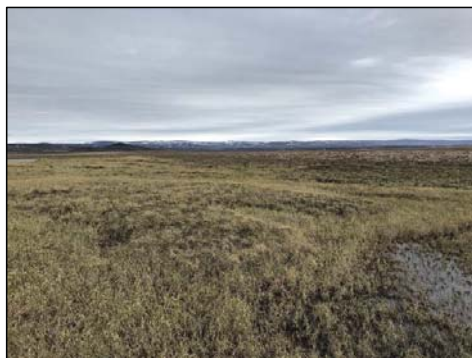
The crossing was nearly dry, particularly during fall, with no connections to other waterbodies, probably under all flow conditions. There is no fish use of habitat at this crossing.

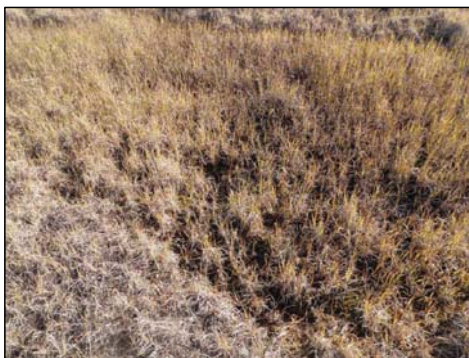
Figure 1. Views of CV-83-1a near the crossing during summer (A) and fall (B).

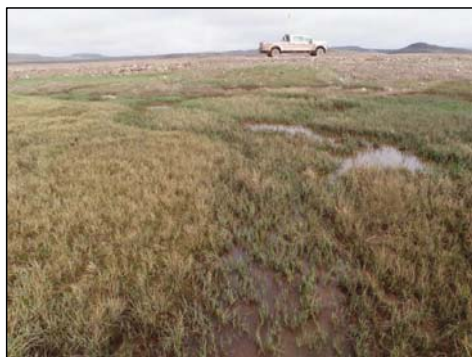
The crossing was a series of isolated pools with some nearly dry marshy, grassy areas in between. No fish were captured or observed in the isolated pools, indicating no upstream movements and subsequent stranding at peak freshet. There is likely no fish use of habitat at this crossing except under extreme high flows.

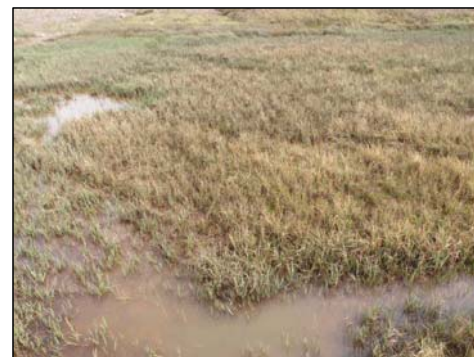
Figure 1. Views of CV-84-2 at the crossing during summer, looking upstream (A) downstream (B) and across (C).

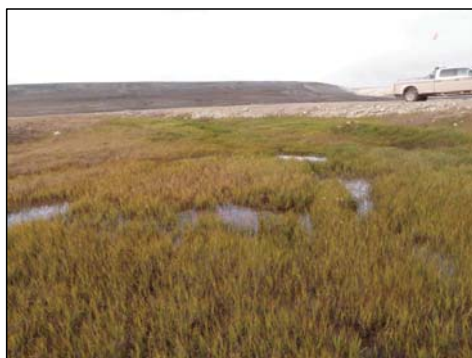
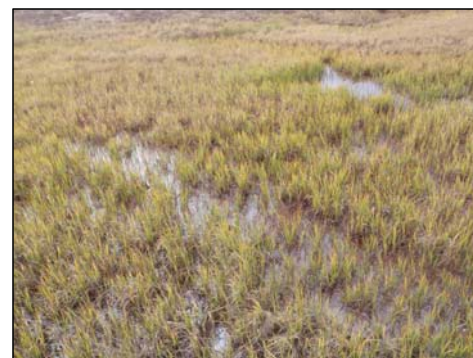
Figure 2. Views of CV-84-2 at the crossing during fall, looking upstream (A) downstream (B) and across (C).

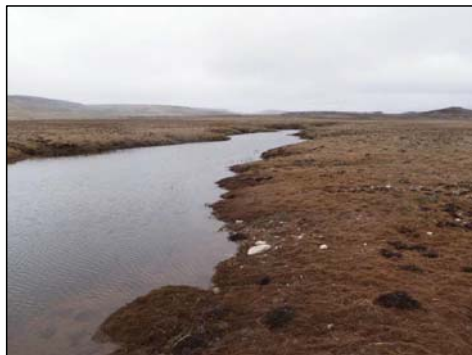
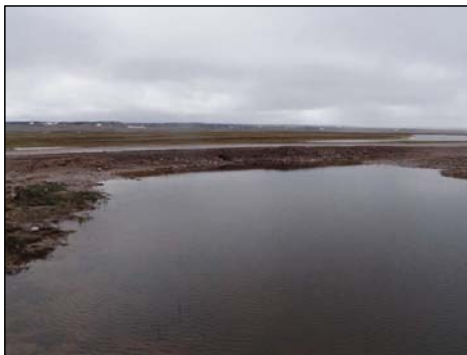
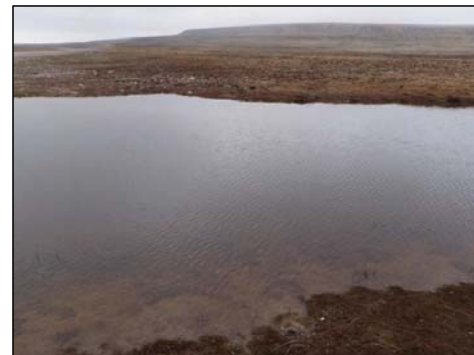
Figure 1. Views of CV-85-1 at the crossing during summer, looking upstream (A) downstream (B) and across (C).

The crossing is known to be not fish-bearing from Tote Road surveys. There is some ponding upstream of the road due to the small diameter, elevated culvert installed at a natural drop upstream from a major river. There is no fish use of habitat at this crossing.

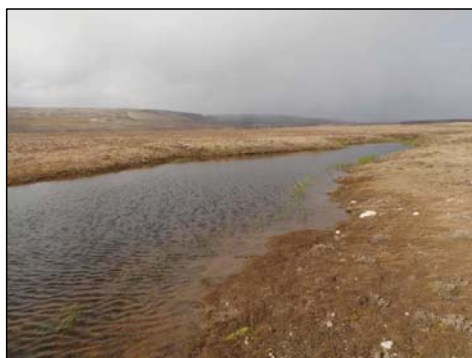
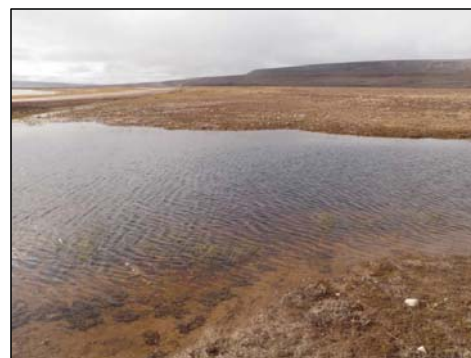
Figure 2. Views of CV-85-1 at the crossing during fall, looking upstream (A) downstream (B) and across (C).

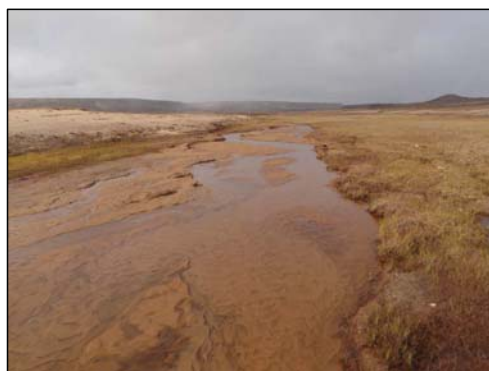
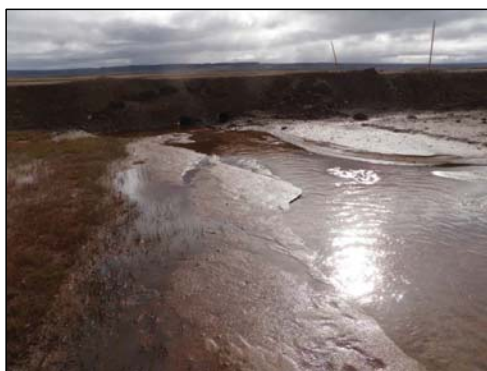
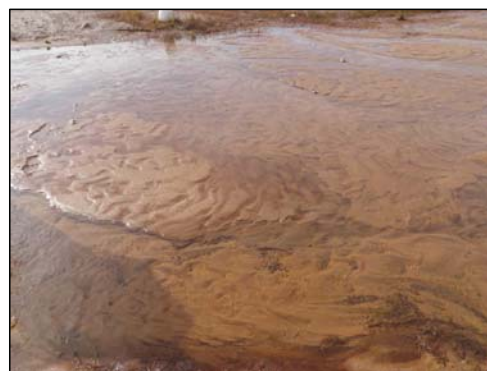
Figure 1. Summer (top) and fall (bottom) views of CV-85-2 at the 50 m downstream cross-section; (A) looking upstream; (B) looking downstream; and (C) looking across.

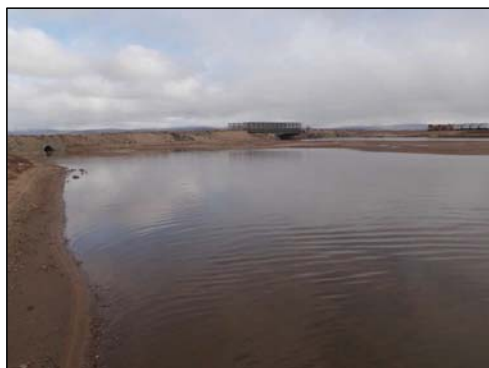
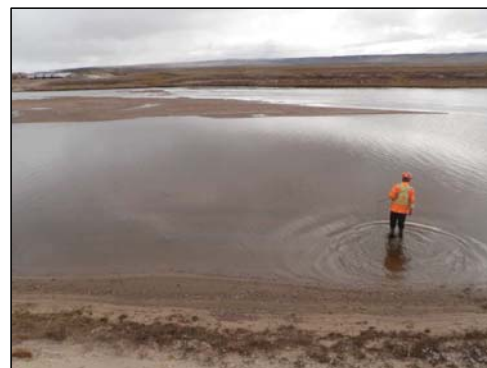
Figure 1. Summer (top) and fall (bottom) views of CV-85-3 & CV-85-4 at the 60 m downstream cross-section; (A) looking upstream; (B) looking downstream; and (C) looking across.

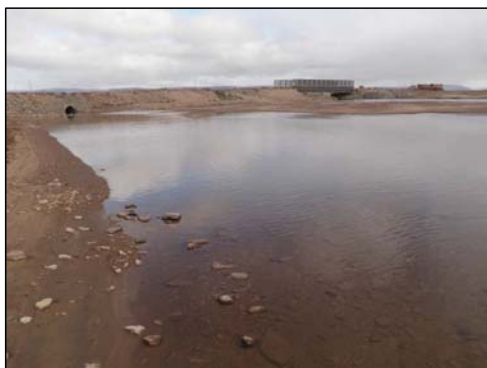
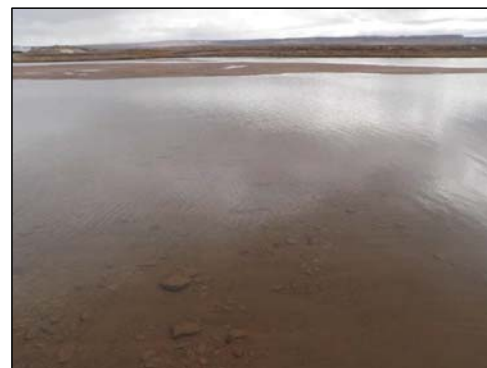
Figure 2. Summer (top) and fall (bottom) views of CV-85-3 & CV-85-4 at the 40 m downstream cross-section; (A) looking upstream; (B) looking downstream; and (C) looking across.

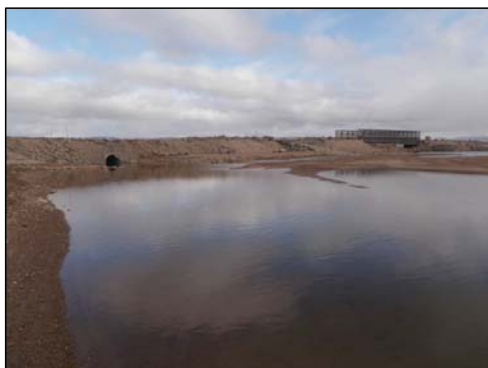
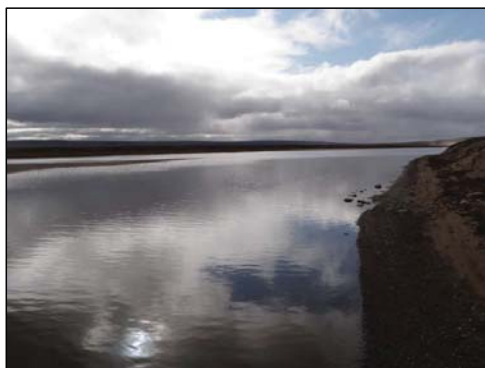
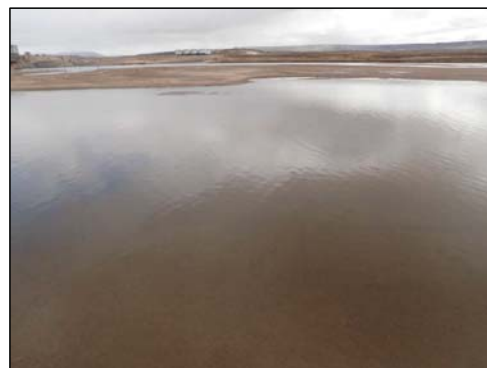
Figure 3. Summer (top) and fall (bottom) views of CV-85-3 & CV-85-4 at the 20 m downstream cross-section; (A) looking upstream; (B) looking downstream; and (C) looking across.

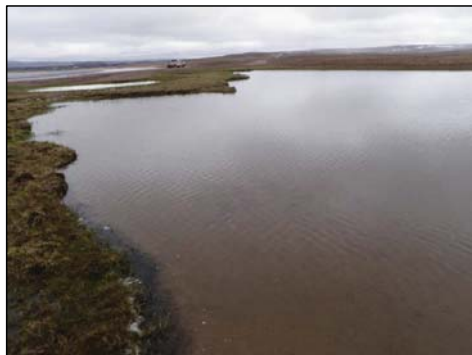
The crossing is an isolated pond with a maximum depth of approximately 1.0 m. Fish were not captured or observed in 2018 despite fishing most of its shoreline. There is no fish use of habitat at this crossing.

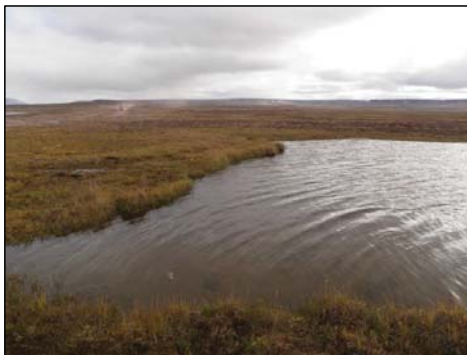
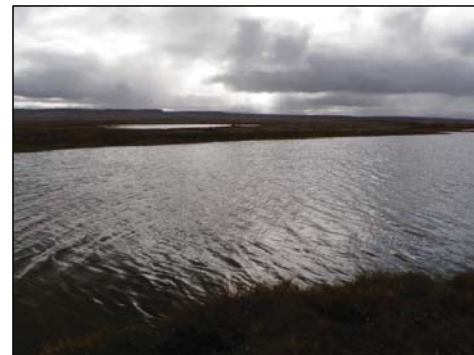
Figure 1. Views of CV-86-1 at the crossing during summer (A) and fall (B) and (C).

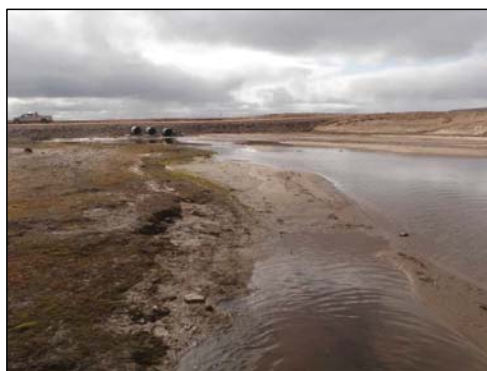
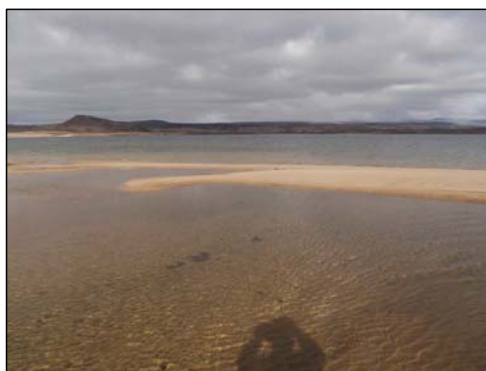
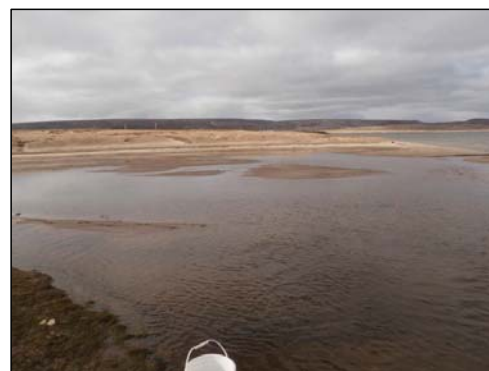
Figure 1. Summer (top) and fall (bottom) views of CV-86-2 at the 100 m downstream cross-section; (A) looking upstream; (B) looking downstream; and (C) looking across.

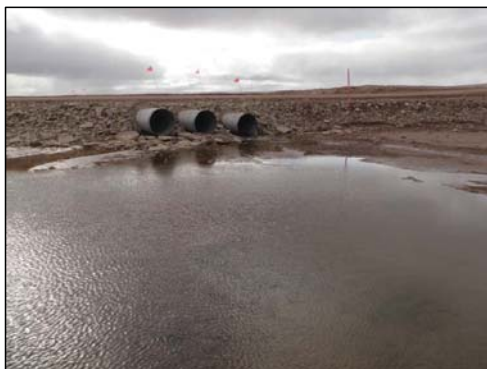
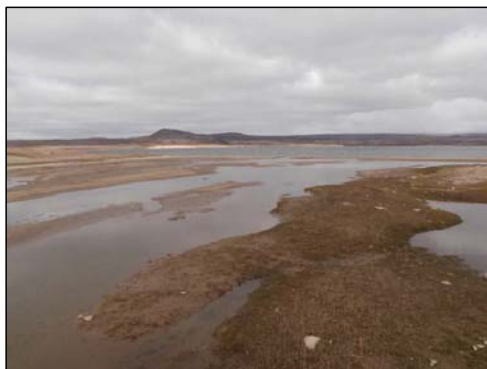
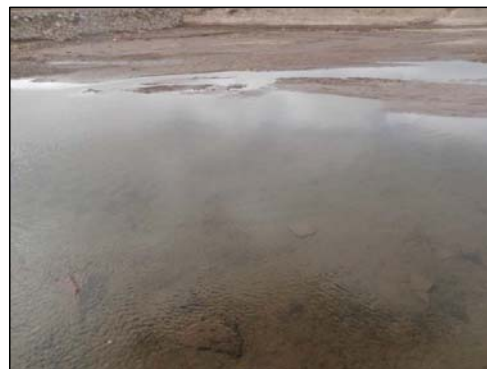
Figure 2. Summer (top) and fall (bottom) views of CV-86-2 at the 50 m downstream cross-section; (A) looking upstream; (B) looking downstream; and (C) looking across.

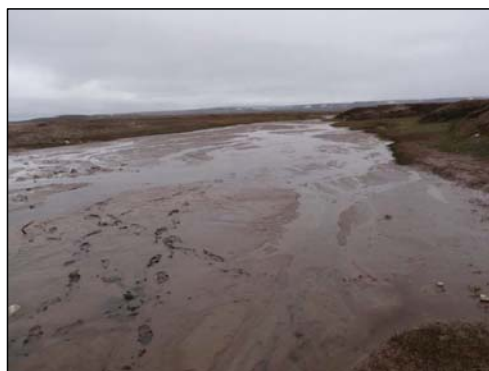
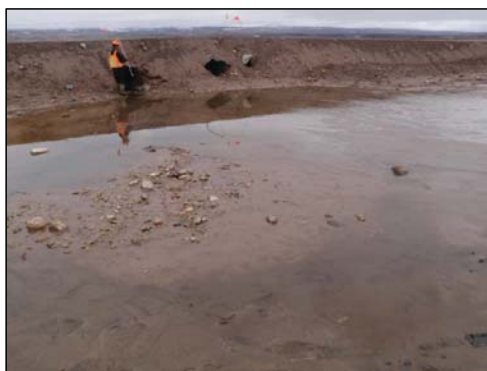
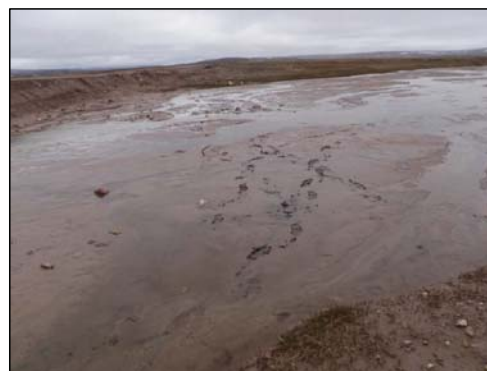
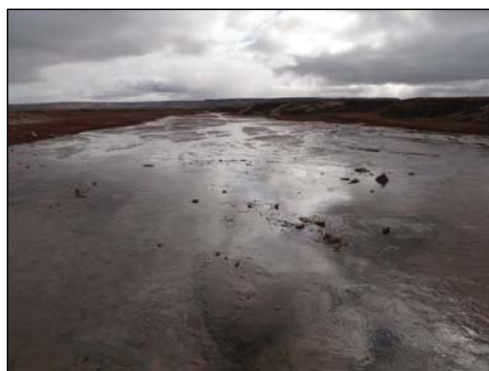
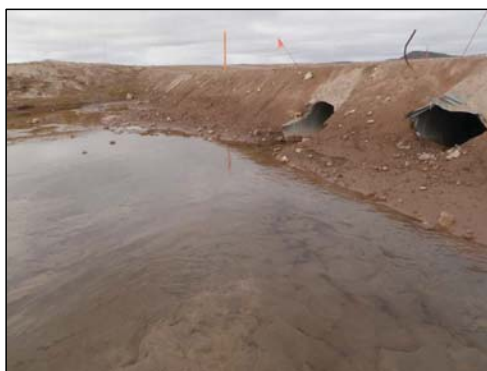
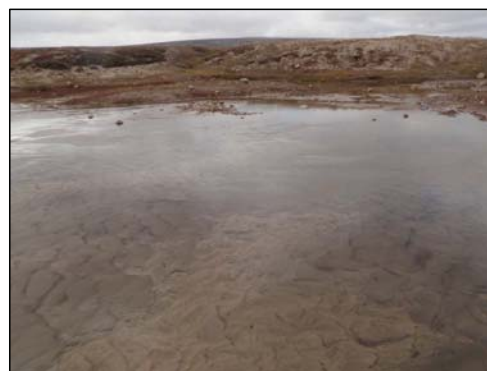
Figure 3. Summer (top) and fall (bottom) views of CV-86-2 at the rail crossing; (A) looking upstream; (B) looking downstream; and (C) looking across.

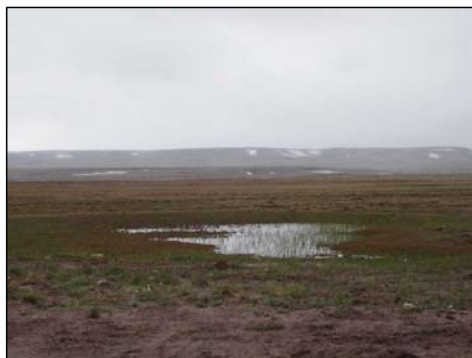
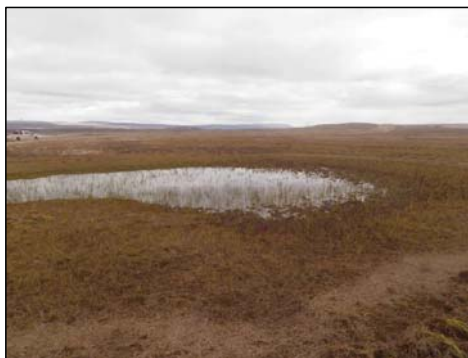
The crossing is a nearly dry puddle. There is no fish use of habitat at this crossing.

Figure 1. Views of CV-87-1 at the crossing during summer (A) and fall (B).

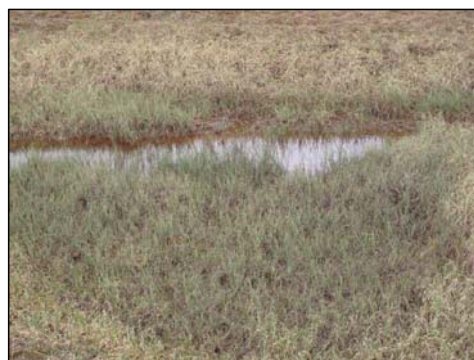
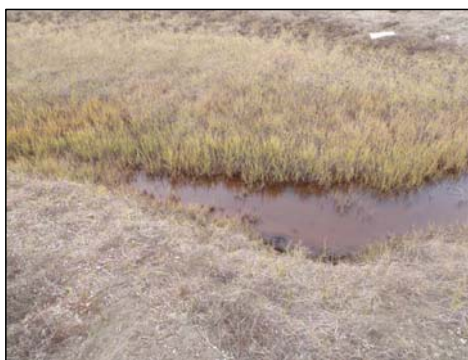
The crossing is a nearly dry puddle. There is no fish use of habitat at this crossing.

Figure 1. Views of CV-87-2 at the crossing during summer (A) and fall (B).

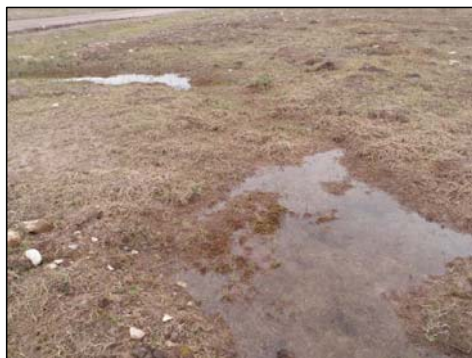
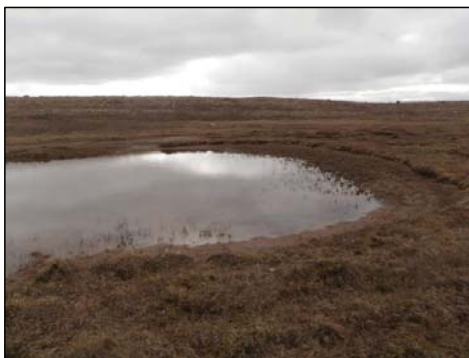
The crossing is an isolated puddle/pond with no connection to other waterbodies. There is no fish use of habitat at this crossing.

Figure 1. Views of CV-87-3 at the crossing during summer (A) and fall (B).

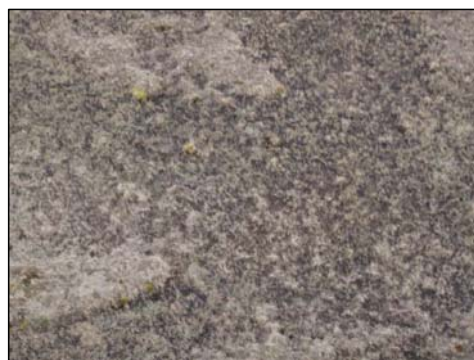
The crossing is moist terrestrial with no surface water. There is no fish use of habitat at this crossing.

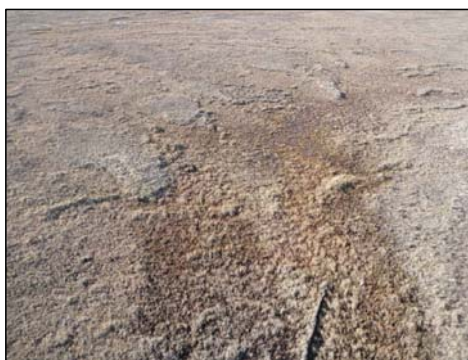
B

Figure 1. Views of CV-88-1 at the crossing during summer (A) and fall (B).
