4.3.2 ENTRAINMENT IN PUMPS / IMPINGEMENT ON SCREENS

4.4 SITE-SPECIFIC ASSESSMENTS

4.4.1 MP-MRY-2 (PHILLIPS CREEK AT MILNE PORT)

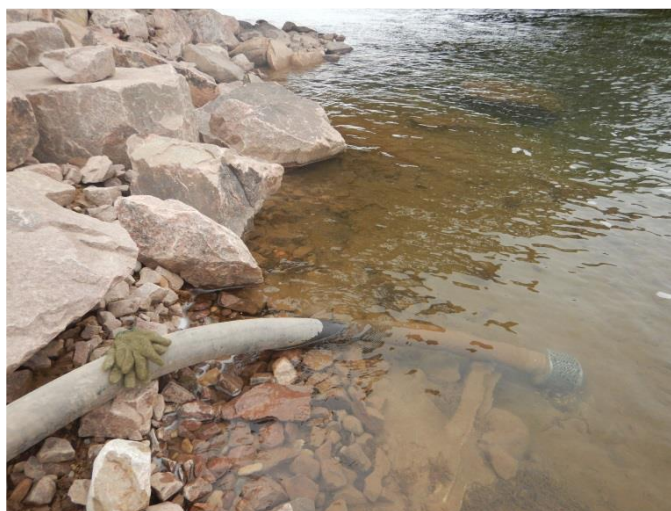
Figure 4.2 Water intake at site CV128

No residual effects are anticipated on fish and fish habitat from the footprint of the pumps at the top of bank or the hose and screened intake in the wetted channel.

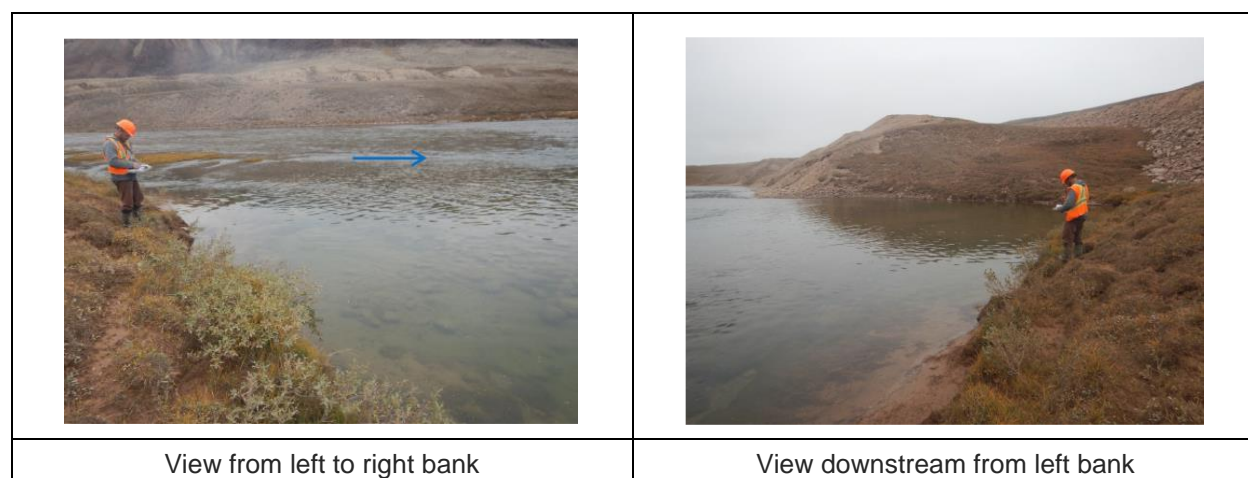
Plate 4.2 **WS9.2 (CWP1-AIt)**

Photos of the intake site are shown in Plate 4.2. The risk to fish and fish habitat is low with implementation of the mitigation measures noted in Section 4.3.

Channel morphology at the intake site is primarily run with some deeper (>1 m) pools. Substrate is primarily gravel, with some cobble and boulder. Depths throughout most of the reach downstream of the falls are shallow (<2.0 m), and the creek likely freezes to the bottom during winter. The shoreline is a steep and riparian vegetation is abundant, comprised of mosses and willows.

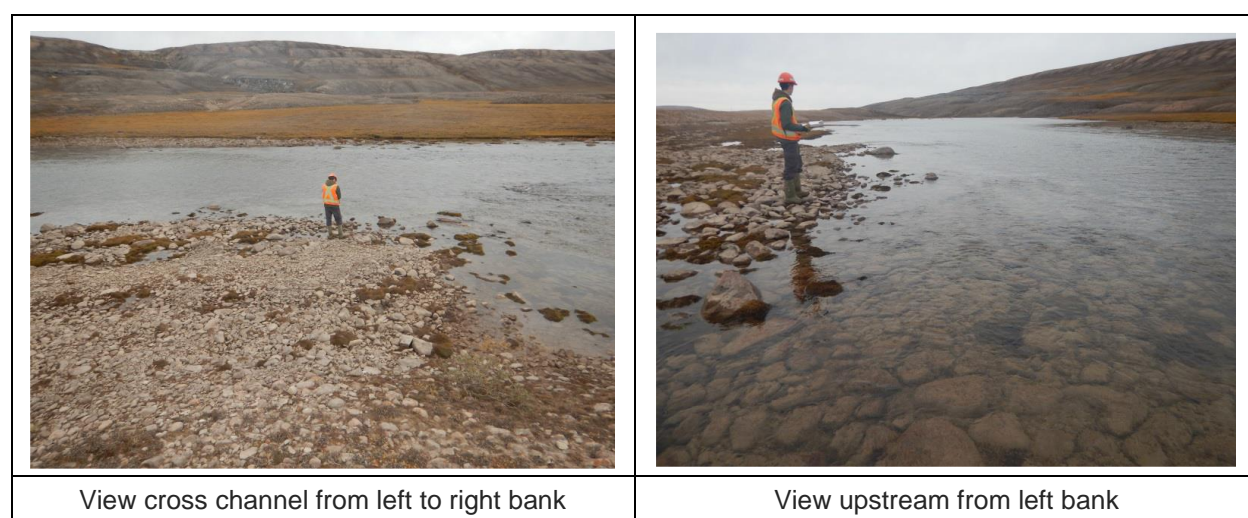
Plate 4.5 WS20.5 (CWP3-Alternate)

Photos of intake site WS20.5 are provided in Plate 4.5, showing the cobble and gravel substrate and low velocity near-shore habitat. The risk to fish and fish habitat from water withdrawal is low with implementation of the mitigation measures noted in Section 4.3.

Channel morphology is primarily riffle and run, and substrate is predominantly cobble and gravel with some boulder. Aquatic vegetation is restricted to periphyton. Riparian vegetation is comprised of grasses and moss, with the occasional willow.

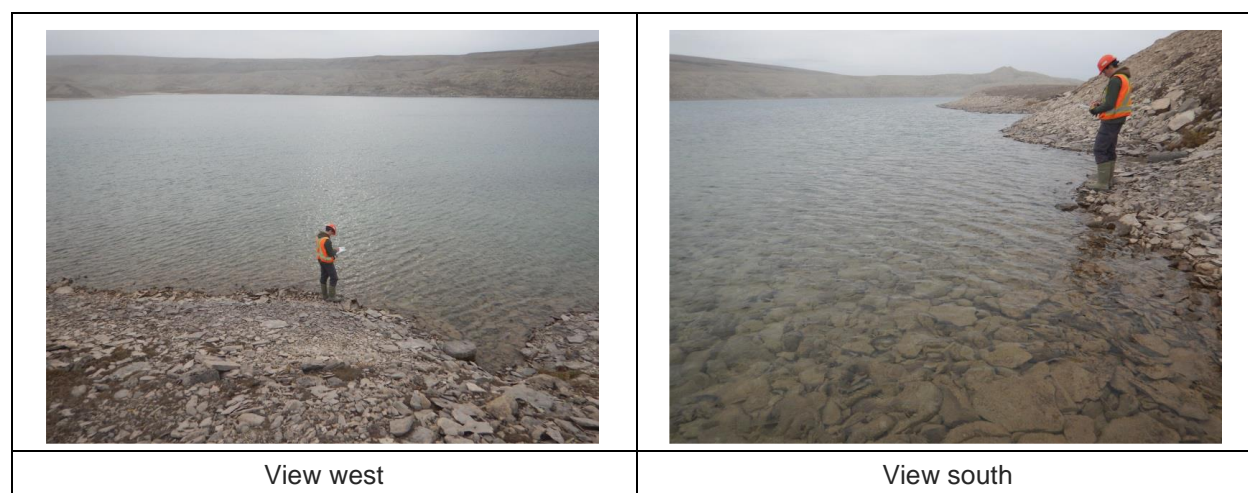
Plate 4.11 WS45.0 (CWP7)

Photos of intake site WS47.0 are shown in Plate 4.11. The risk to fish and fish habitat from water withdrawal is low with implementation of the mitigation measures noted in Section 4.3.

The proposed water intake site is located on the eastern shore of the lake. The immediate nearshore area at the proposed intake site is relatively shallow (less than 1 m within 8 m of the shoreline) and the substrate is angular boulder and cobble with some gravel. No aquatic vegetation is present.

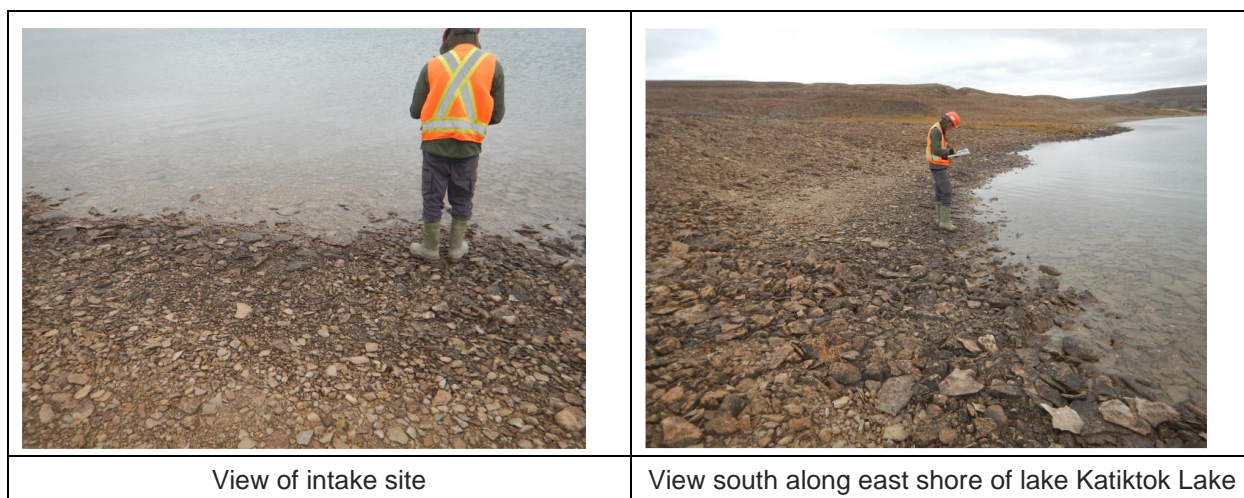
Plate 4.13 WS52.9 (Katiktok Lake) Intake Site

Photos of water intake site WS52.9 are provided in Plate 4.13, showing the predominantly gravel substrate and lack of riparian vegetation. The risk to fish and fish habitat as a result of water withdrawal is low, due to the shallow water in the littoral zone and lack of cover.

Substrate at the intake site is largely gravel with some cobble, and the bed is moderately sloping, increasing to greater than 1 m at approximately 4 m from the shore. The bank shore texture is cobble and gravel and gradually sloping. No aquatic vegetation is present near the site, and riparian vegetation is patchy and comprised of sparse grass and moss.

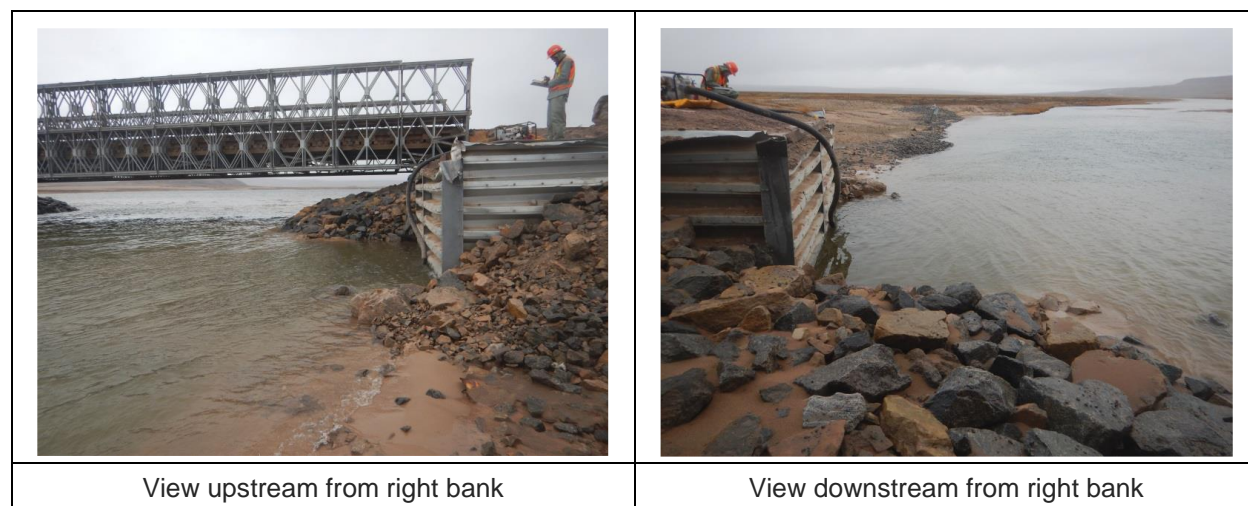
Plate 4.16 WS79.9 (CV217) Intake Site

Photos of water intake site WS79.9 are provided in Plate 4.16, showing the primarily sand substrate, shallow depth, and lack of instream and overbank cover. The risk to fish and fish habitat because of water withdrawal is low, given the lack of optimal rearing habitat.

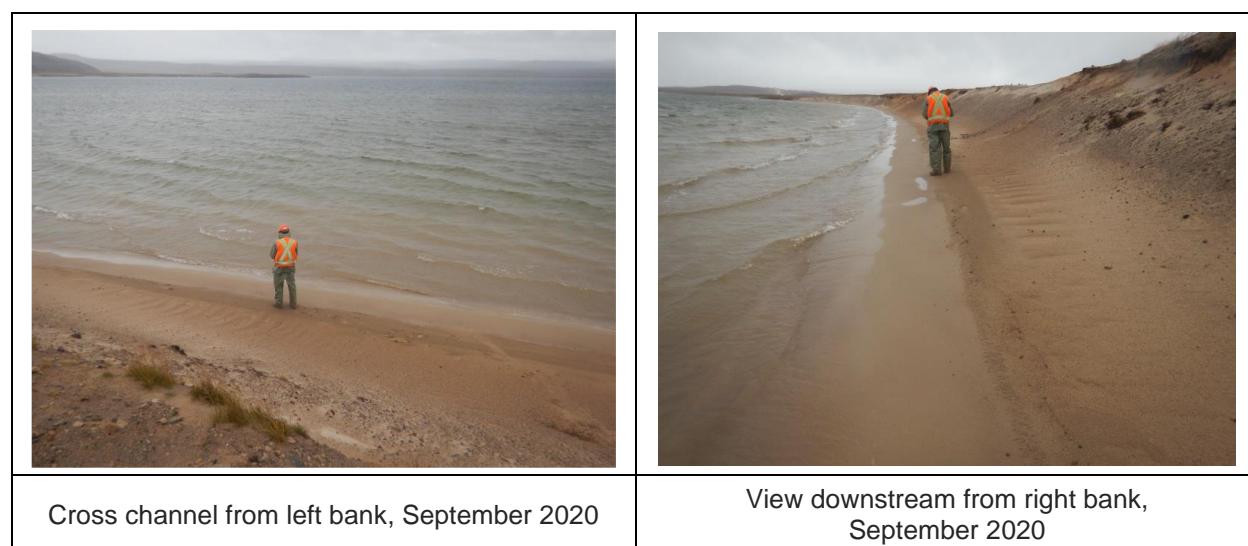
Plate 4.17 WS80.3 (Muriel Lake Intake Site)

The substrate near the shore is sand, and the shoreline is gently sloping, remaining relatively shallow (<0.5 m) until approximately 10 m from shore. No instream cover or aquatic vegetation are present. Riparian vegetation, primarily grasses, are present at the top of bank. Photos of water intake site WS79.9 are shown in Plate 4.17. The risk to fish and fish habitat from water withdrawal is low.

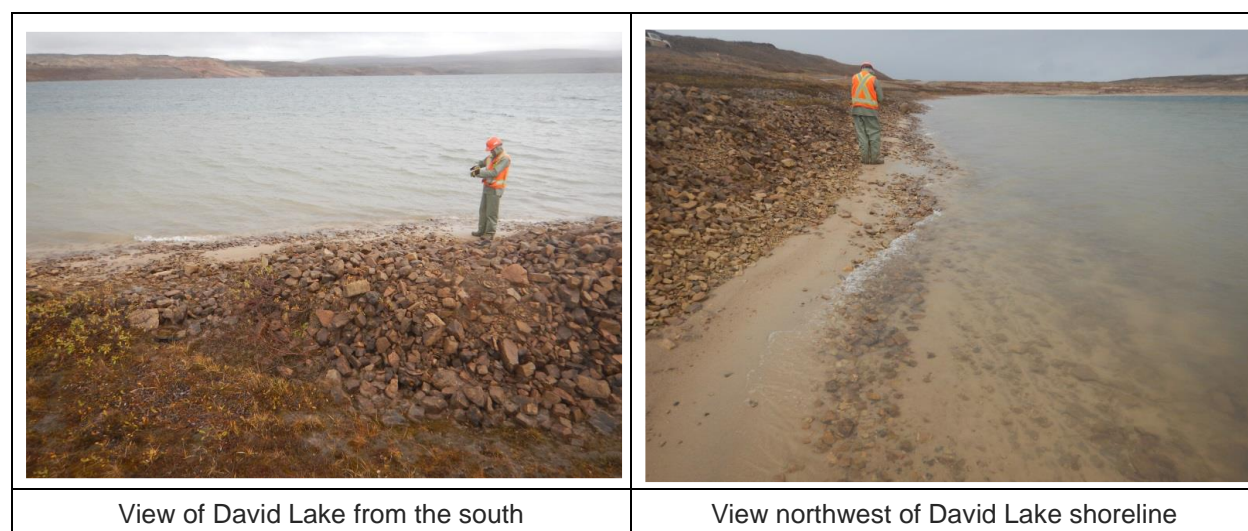
Plate 4.18 WS87.7 (David Lake) Intake Site

Photos of water intake site WS87.7 are shown in Plate 4.18. The risk to fish and fish habitat as a result of water withdrawal is low, due to the lack of fish cover.
