AR-BR-37-1

Structure Design

E337697-2000-07-124-0001

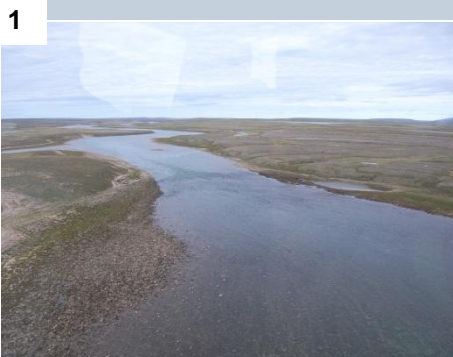
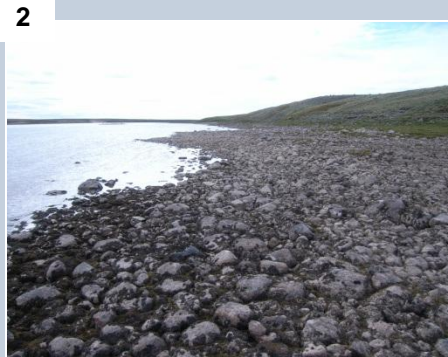
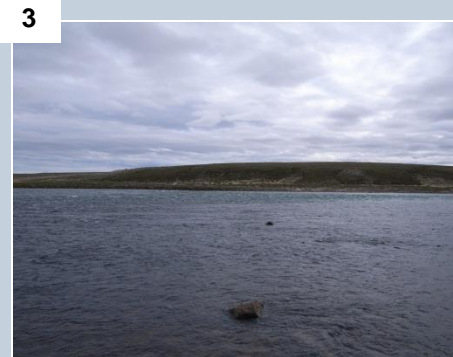
Site Photos

Photo 1 is an aerial image of the Ravn River of the crossing area. Photos 2 and 3 are taken at the approximate crossing location, looking downstream and across from the northern shore.

The lands surrounding the Ravn River Crossing are relatively flat and are characterized by numerous ponds and small lakes. Approximately 9 km downstream of the crossing, the river enters Angajurjua Lake. This site is an important fish habitat and provides abundant, suitable habitat for both Arctic Char and the Ninespine stickleback. The river at this location has high potential as rearing habitat and as a migration corridor for both species. However it does not provide overwintering habitat for either species and only provides low spawning habitat potential for ninespine stickleback.

Navigability:	Navigable	
Width and Depth:	Bankflow width = 146m Wetted width = 114m Maximum Depth = >1m	
Substrate and Vegetation:	Channel Morphology: 50% Riffle, 20% Pool, 30% Rapid Substrate Composition: 5%Fines, 15% Gravel, 50% Small Cobble, 20% Large Cobble, 10% Boulder Stream Cover: N/A	
Channel Meander Pattern:	Floodplain Width (m): not measured Channel Pattern: Meandering Channel Confinement: Partially Confined Channel Gradient: <0.5°	Bank Height (L/R; m): 0.0-3.0 Bank Shape (L/R): 20% undercut, 80% sloped Bank Stability: Not determined
Fish Habitat :	The Ravn River provides abundant suitable habitat for both Arctic char and the ninespine stickleback species.
