Assessment of Watercourses Near Railway Aggregate Sources

Crossing ID: B5

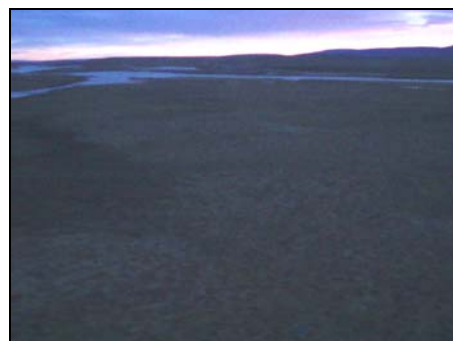
Figure 1: Aerial view of area near aggregate source B6

This aggregate source is ~50 m from the nearest small body of water and ~500 m from the nearest major waterbody.

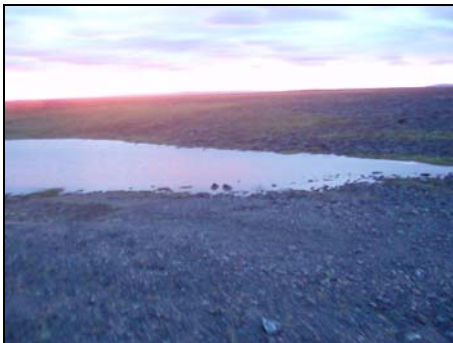
Figure 2: Another aerial view of area near aggregate source B9

This aggregate source is close to, but not encroaching on a small tributary ~100 m upstream of a large, persistent river.

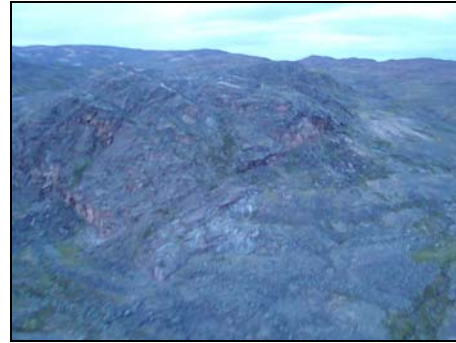
Figure 1: Aerial view of area near aggregate source B13

The small stream near this aggregate source is a 1st order tributary ~3 km upstream of a larger river.

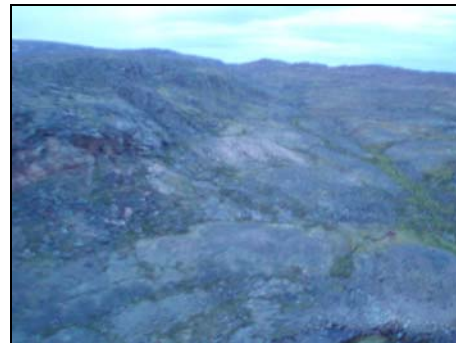
Figure 2: Another aerial view of area near aggregate source B13
