MARY RIVER PROJECT

Access Road Stream Crossing Sites (MAP K)

Rail Alignment Watercourse Crossing Assessment

APPENDIX 5.1-4.

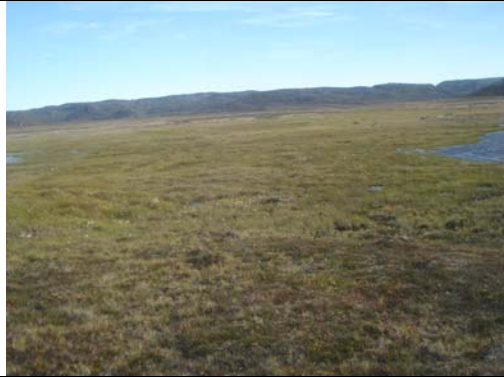
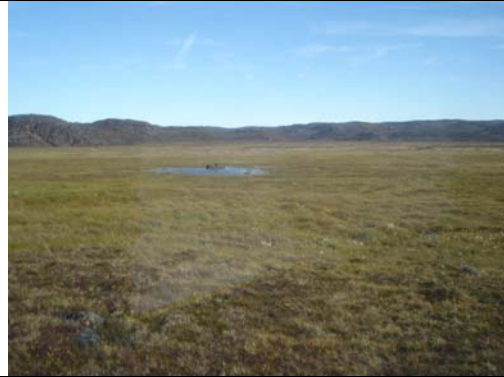
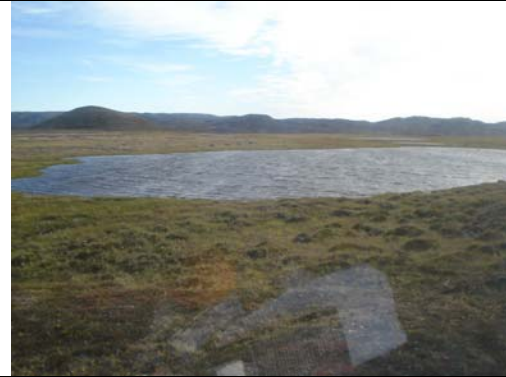
Saturated wetted connection between two shallow waterbodies (each < 3 m deep) that are unlikely to support fish.

Fish Habitat Quality – NO FISH HABITAT

Figure 1. View of crossing area (A), view upstream of crossing (B), view downstream of crossing (C).

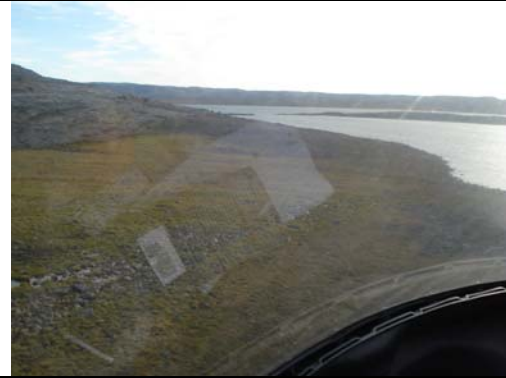
Ephemeral saturated drain with no defined channel. Drains into potential fish bearing waterbody (> 4 m deep); therefore, assumed rearing habitat for NNST.

Fish Habitat Quality – MARGINAL

Figure 1. Aerial view looking upstream from crossing location (A), aerial view of drain inlet to waterbody (B), aerial view of crossing location (C).

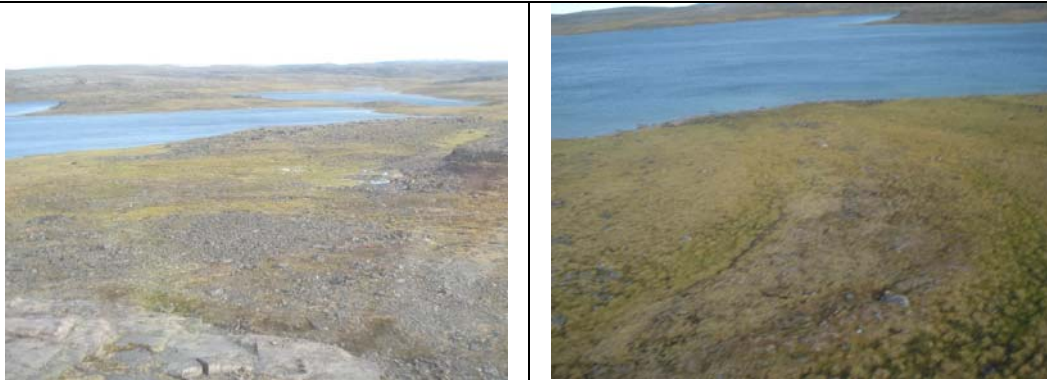
Ephemeral saturated drain with no defined channel. Drains into a shallow waterbody (< 3 m deep) that is unlikely to support fish.

Fish Habitat Quality – NO FISH HABITAT

Figure 1. Aerial view of drainage (A), aerial view of crossing location (B).

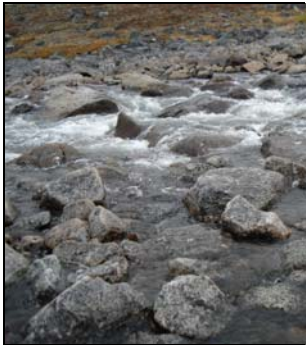
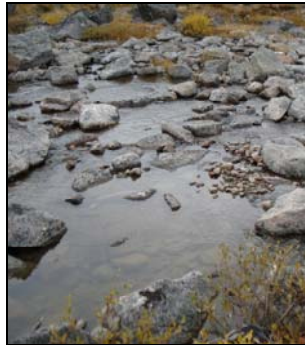
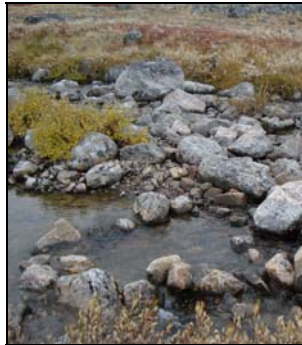
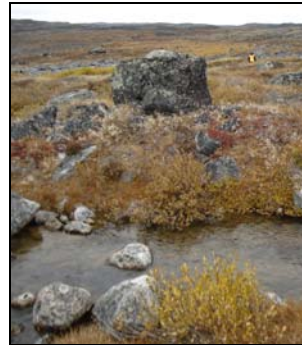
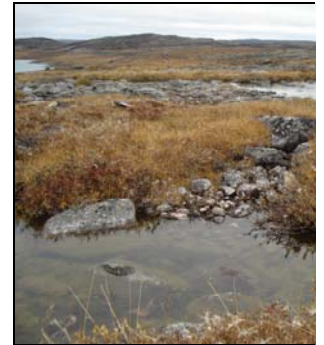
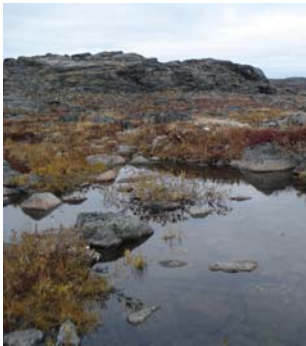
Fish Habitat Quality – IMPORTANT

Fished along the right side of the main channel.

Figure 1. View of habitat 60 (A), 40 (B), and 20 m (C) downstream of crossing, at the crossing (D), and 20 (E), 40 (F), and 60 m (G) upstream of crossing.

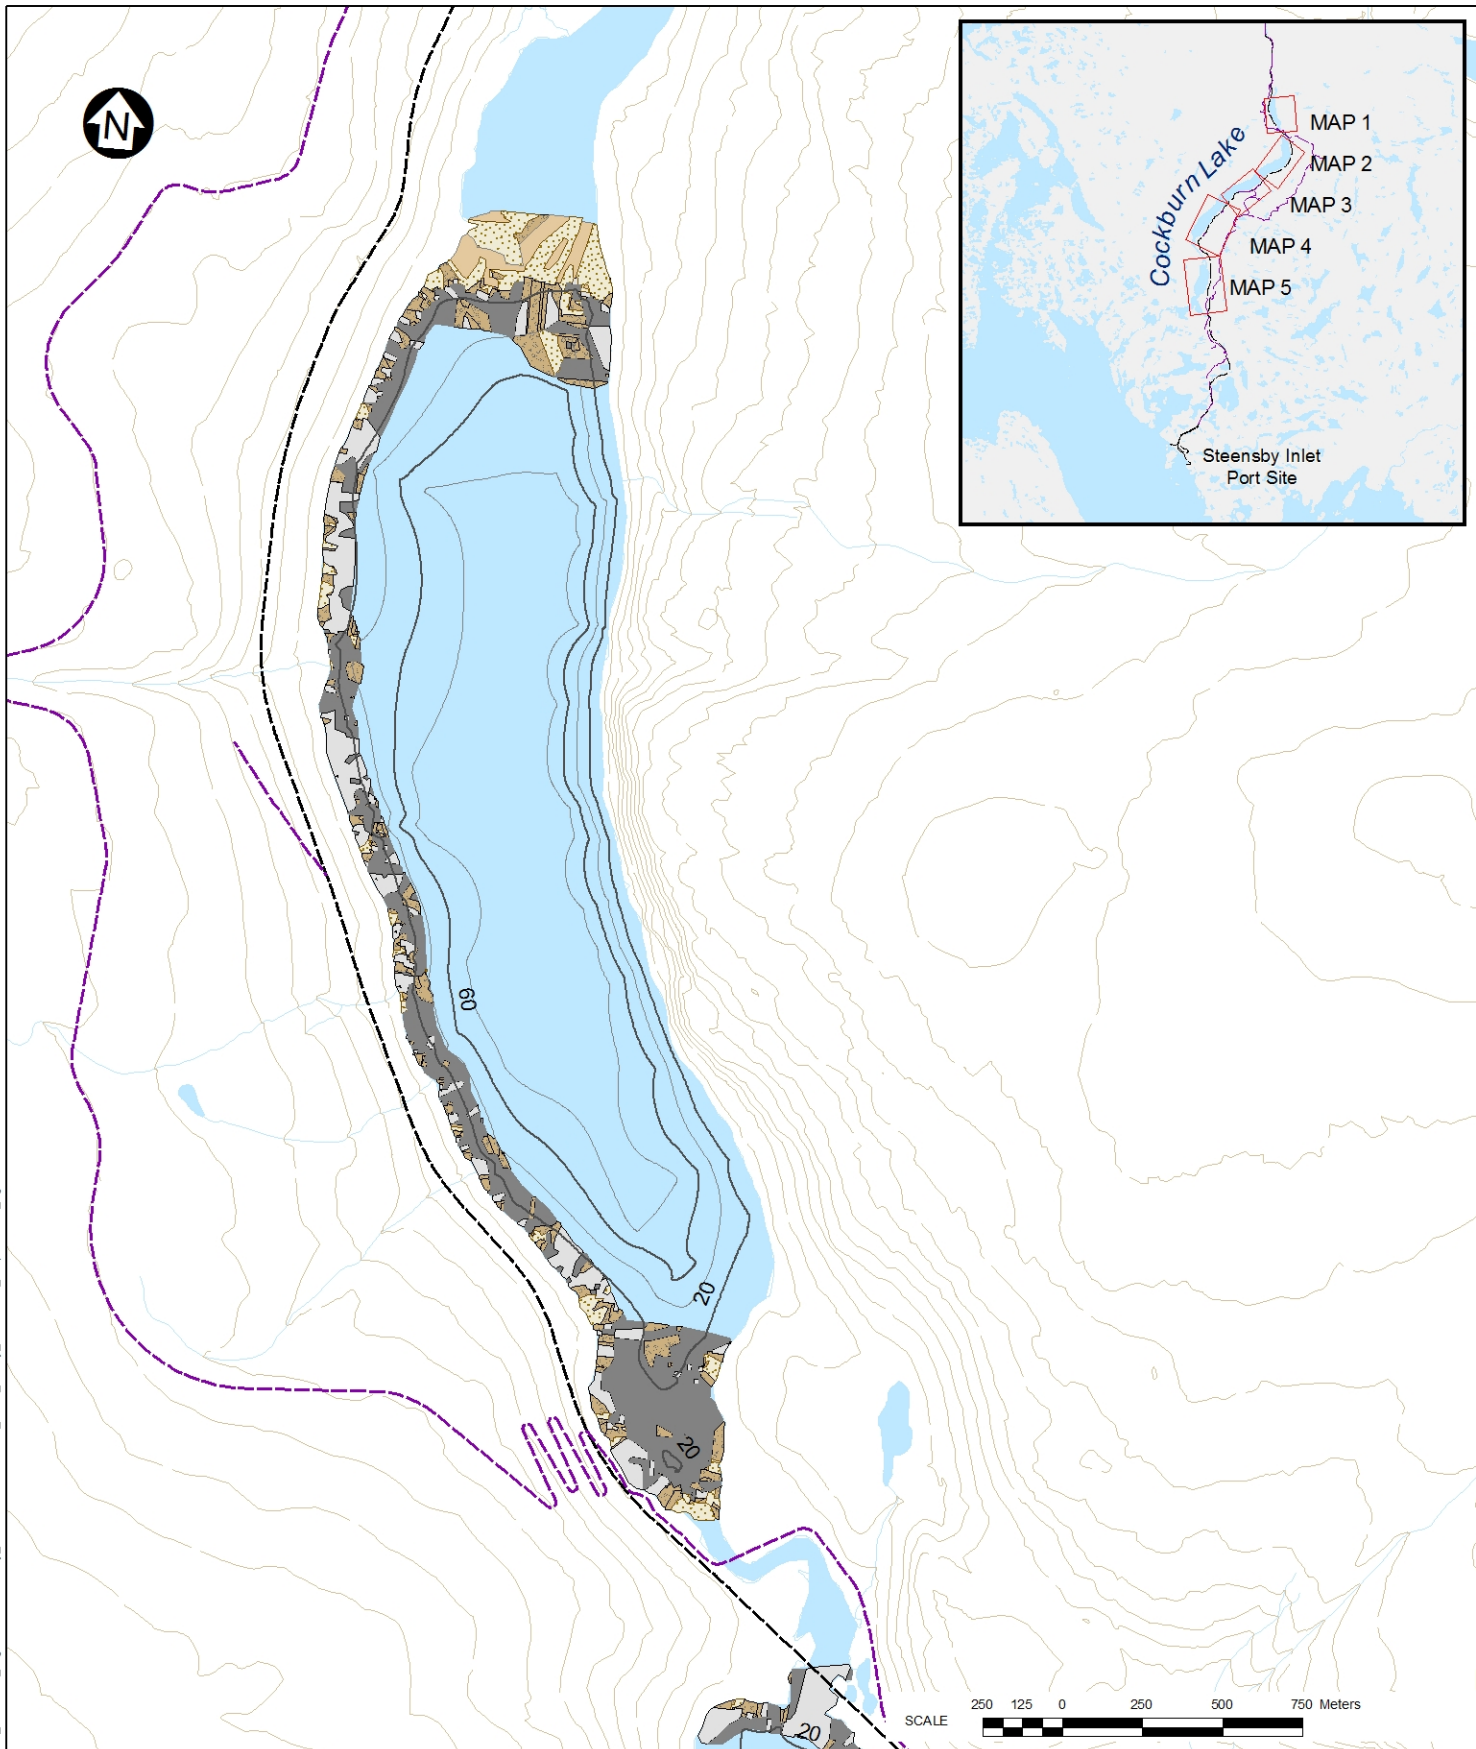
**Cockburn Lake Northwest Basin
Bathymetry and Substrate
- MAP 1 of 5 -**

1. BASE MAP: © HER MAJESTY THE QUEEN IN RIGHTS OF CANADA DEPARTMENT OF NATURAL RESOURCES (2009). ALL RIGHTS RESERVED.
2. TOPOGRAPHY PROVIDED BY EAGLE MAPPING (2005).
3. DEPTHS OF BATHYMETRIC CONTOURS ARE IN METRES AND ARE RELATIVE TO SHORELINE AT TIME OF SURVEY.
4. CONTOUR INTERVAL IS 25 M AND IS IN METRES.

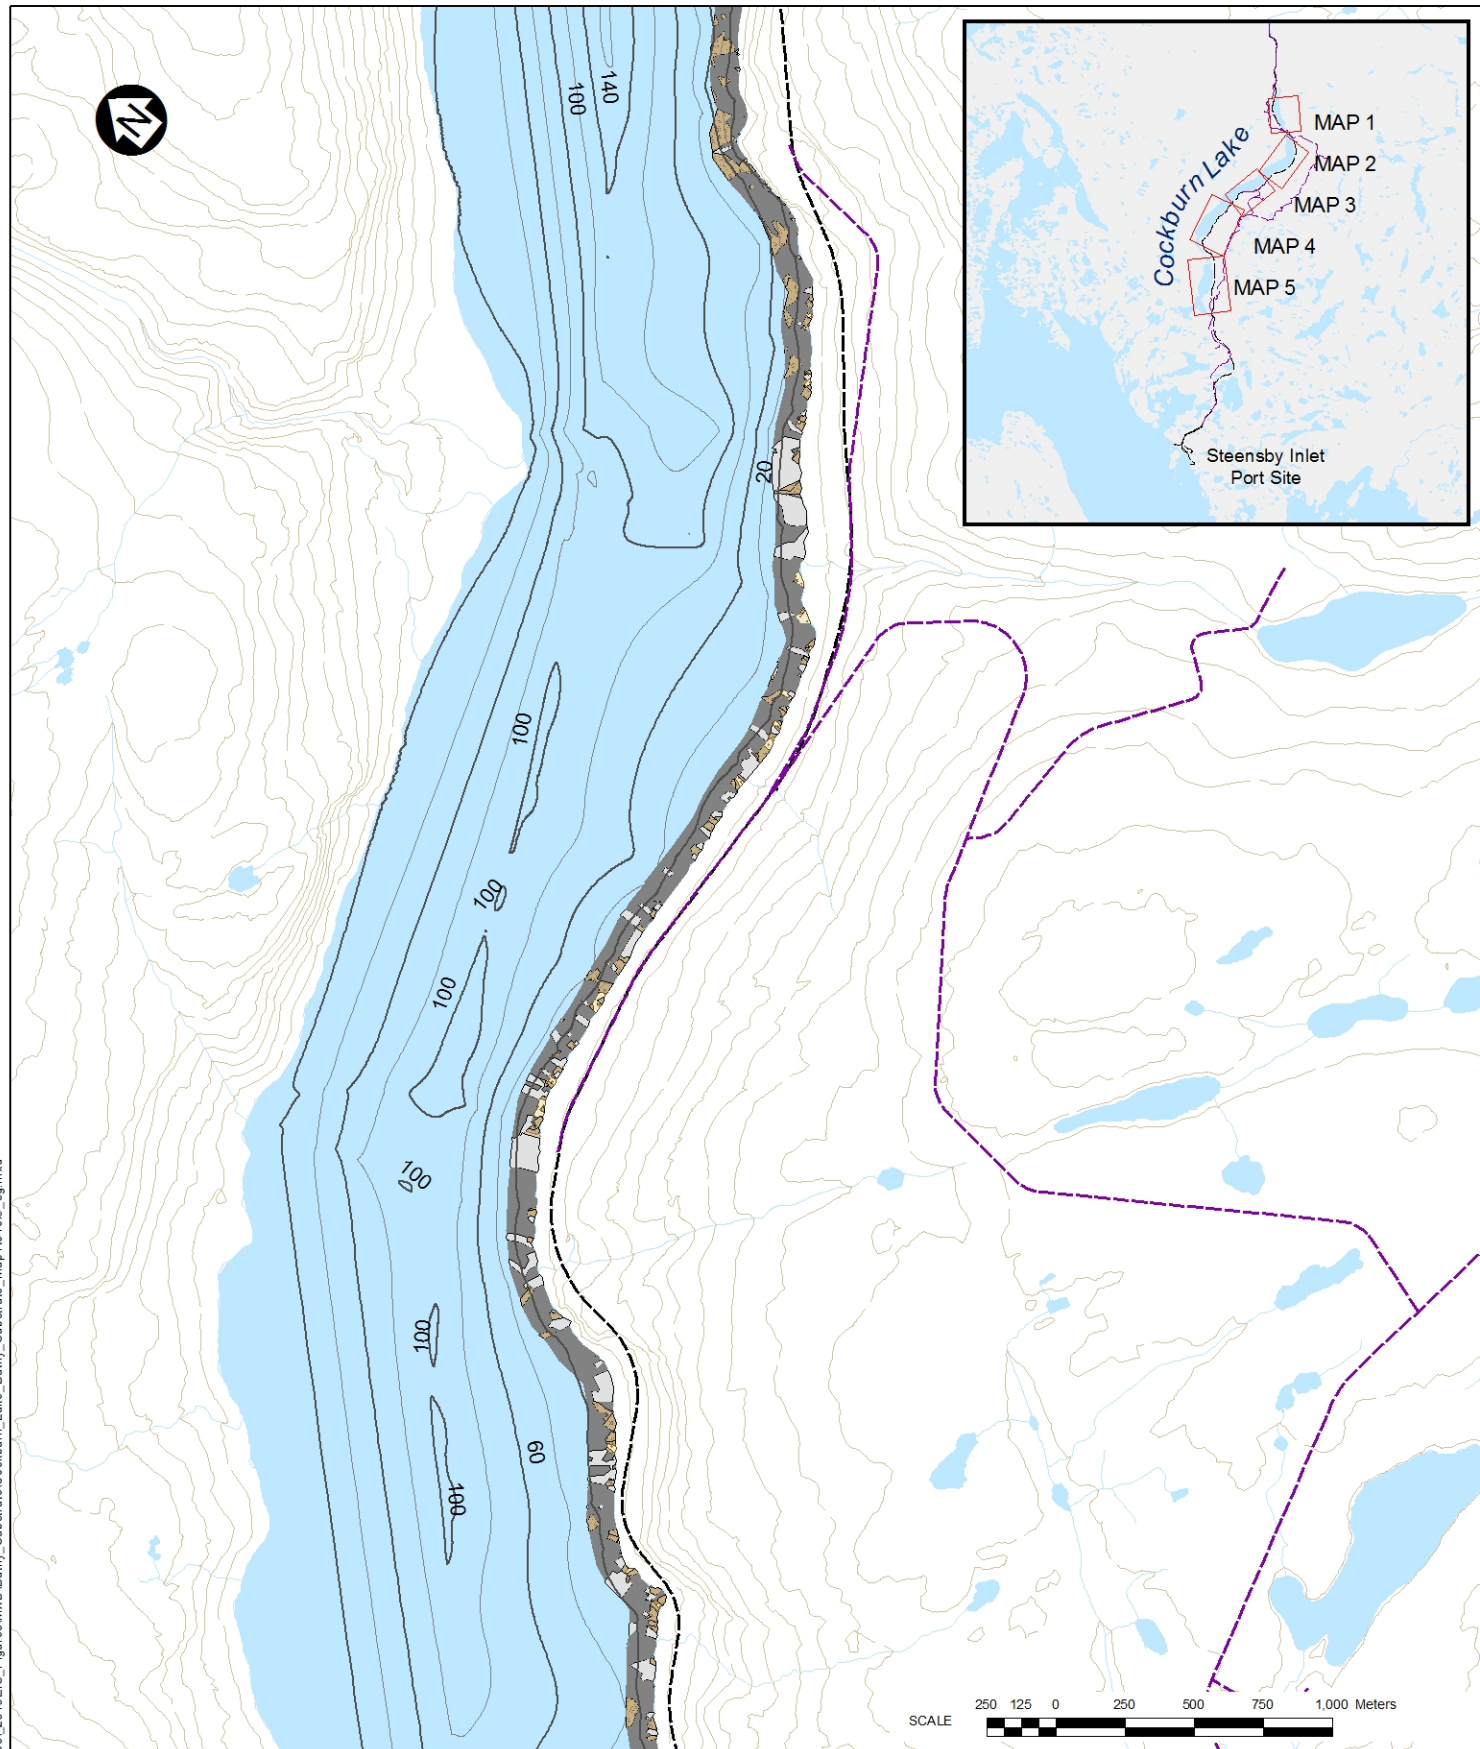
**Cockburn Lake Central Basin
Bathymetry and Substrate
- MAP 3 of 5 -**

1. BASE MAP: © HER MAJESTY THE QUEEN IN RIGHTS OF CANADA DEPARTMENT OF NATURAL RESOURCES (2009). ALL RIGHTS RESERVED.
2. TOPOGRAPHY PROVIDED BY EAGLE MAPPING (2005).
3. DEPTHS OF BATHYMETRIC CONTOURS ARE IN METRES AND ARE RELATIVE TO SHORELINE AT TIME OF SURVEY.
4. CONTOUR INTERVAL IS 25 M AND IS IN METRES.

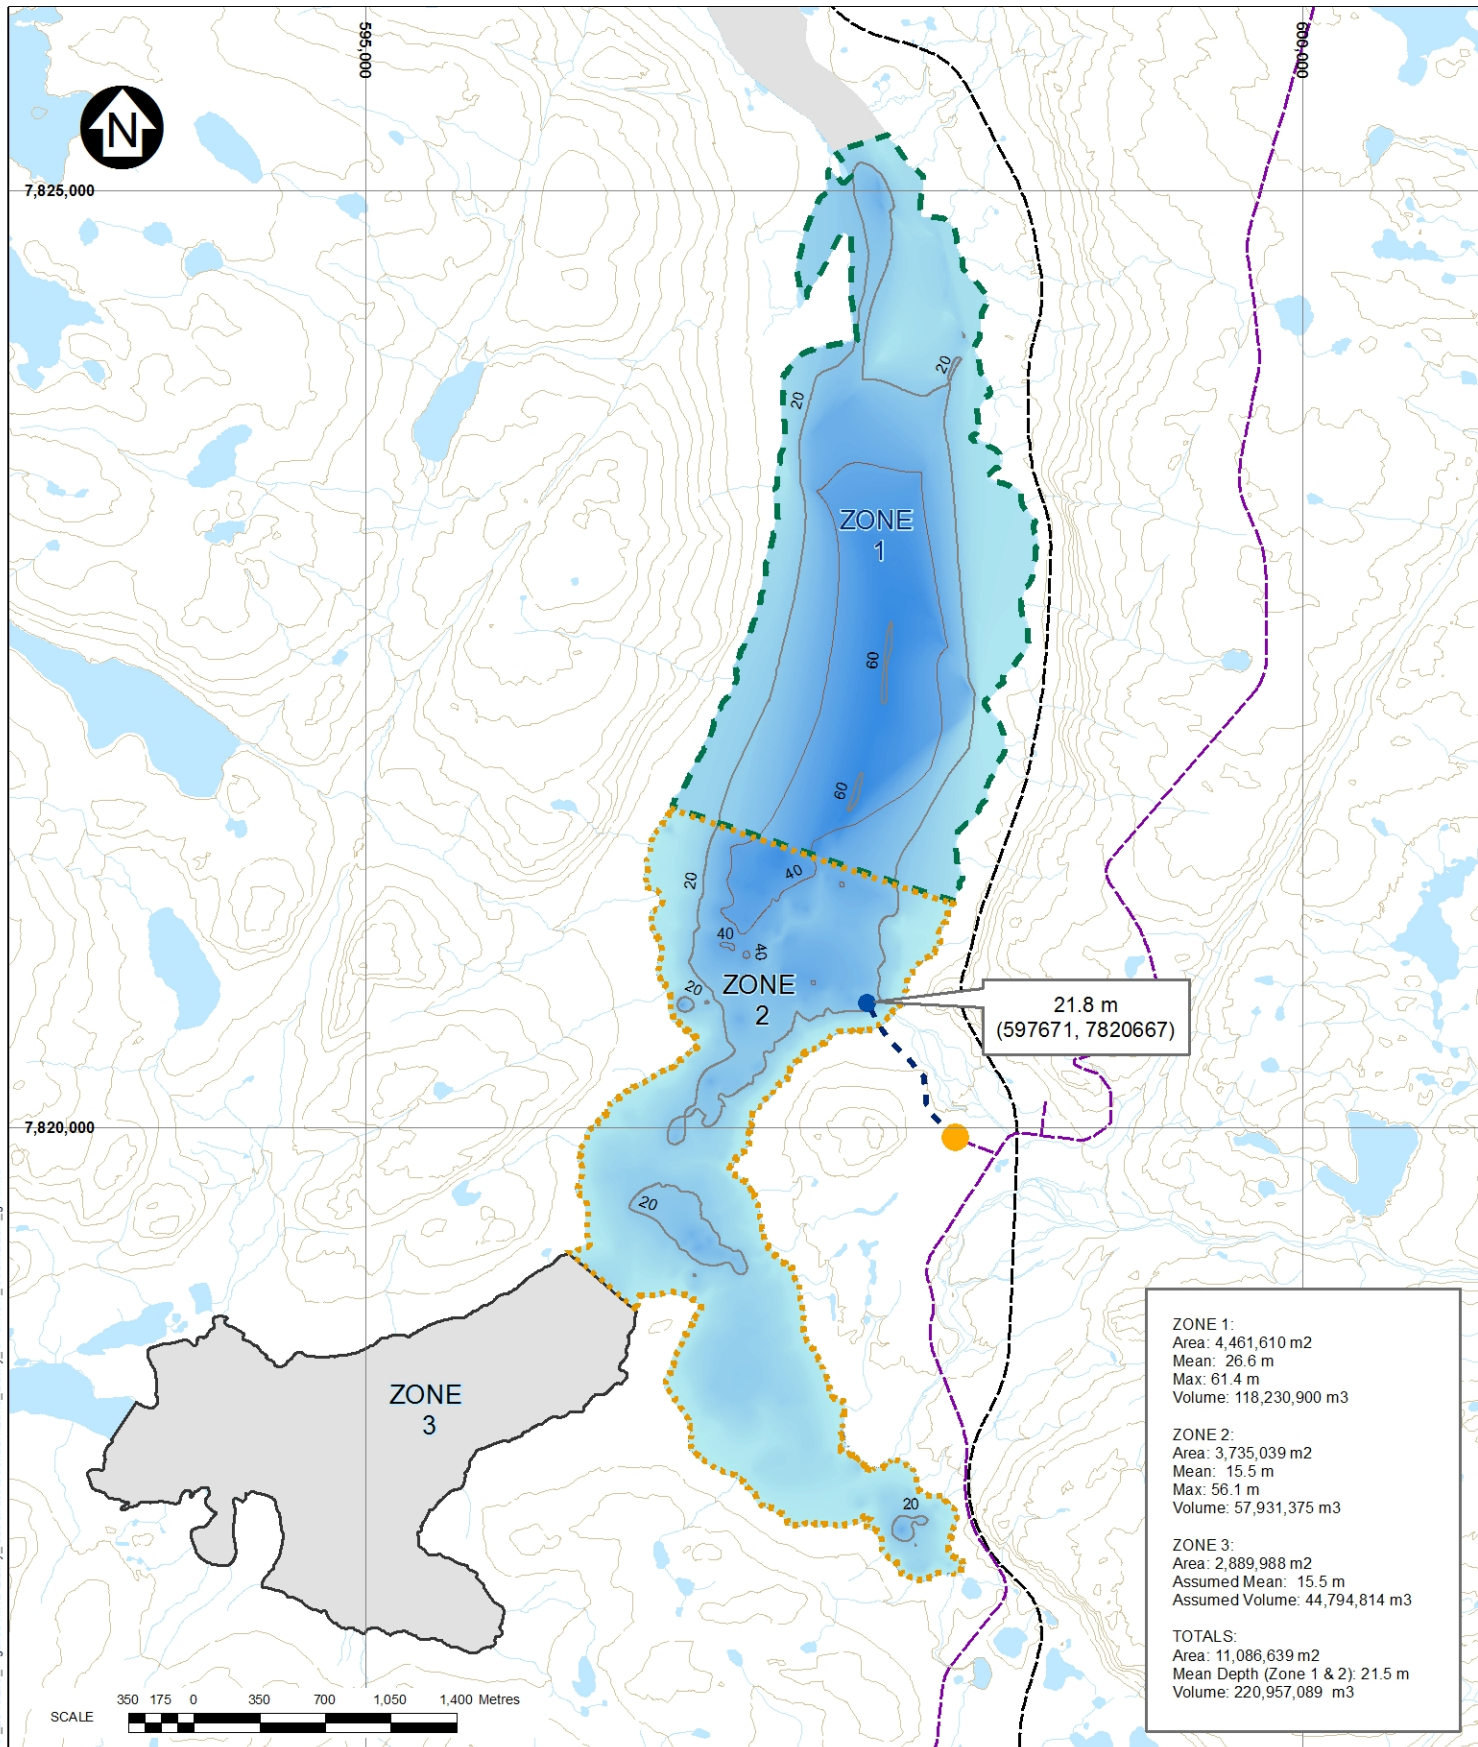
Cockburn Lake South Basin
Bathymetry Overview

- CONTOUR
 - RAILWAY CENTERLINE
 - CONSTRUCTION ACCESS ROAD
 - PROPOSED CONSTRUCTION CAMP
 - PROPOSED WATER INTAKE
- DEPTH
- HIGH : 61.4
- LOW : 0

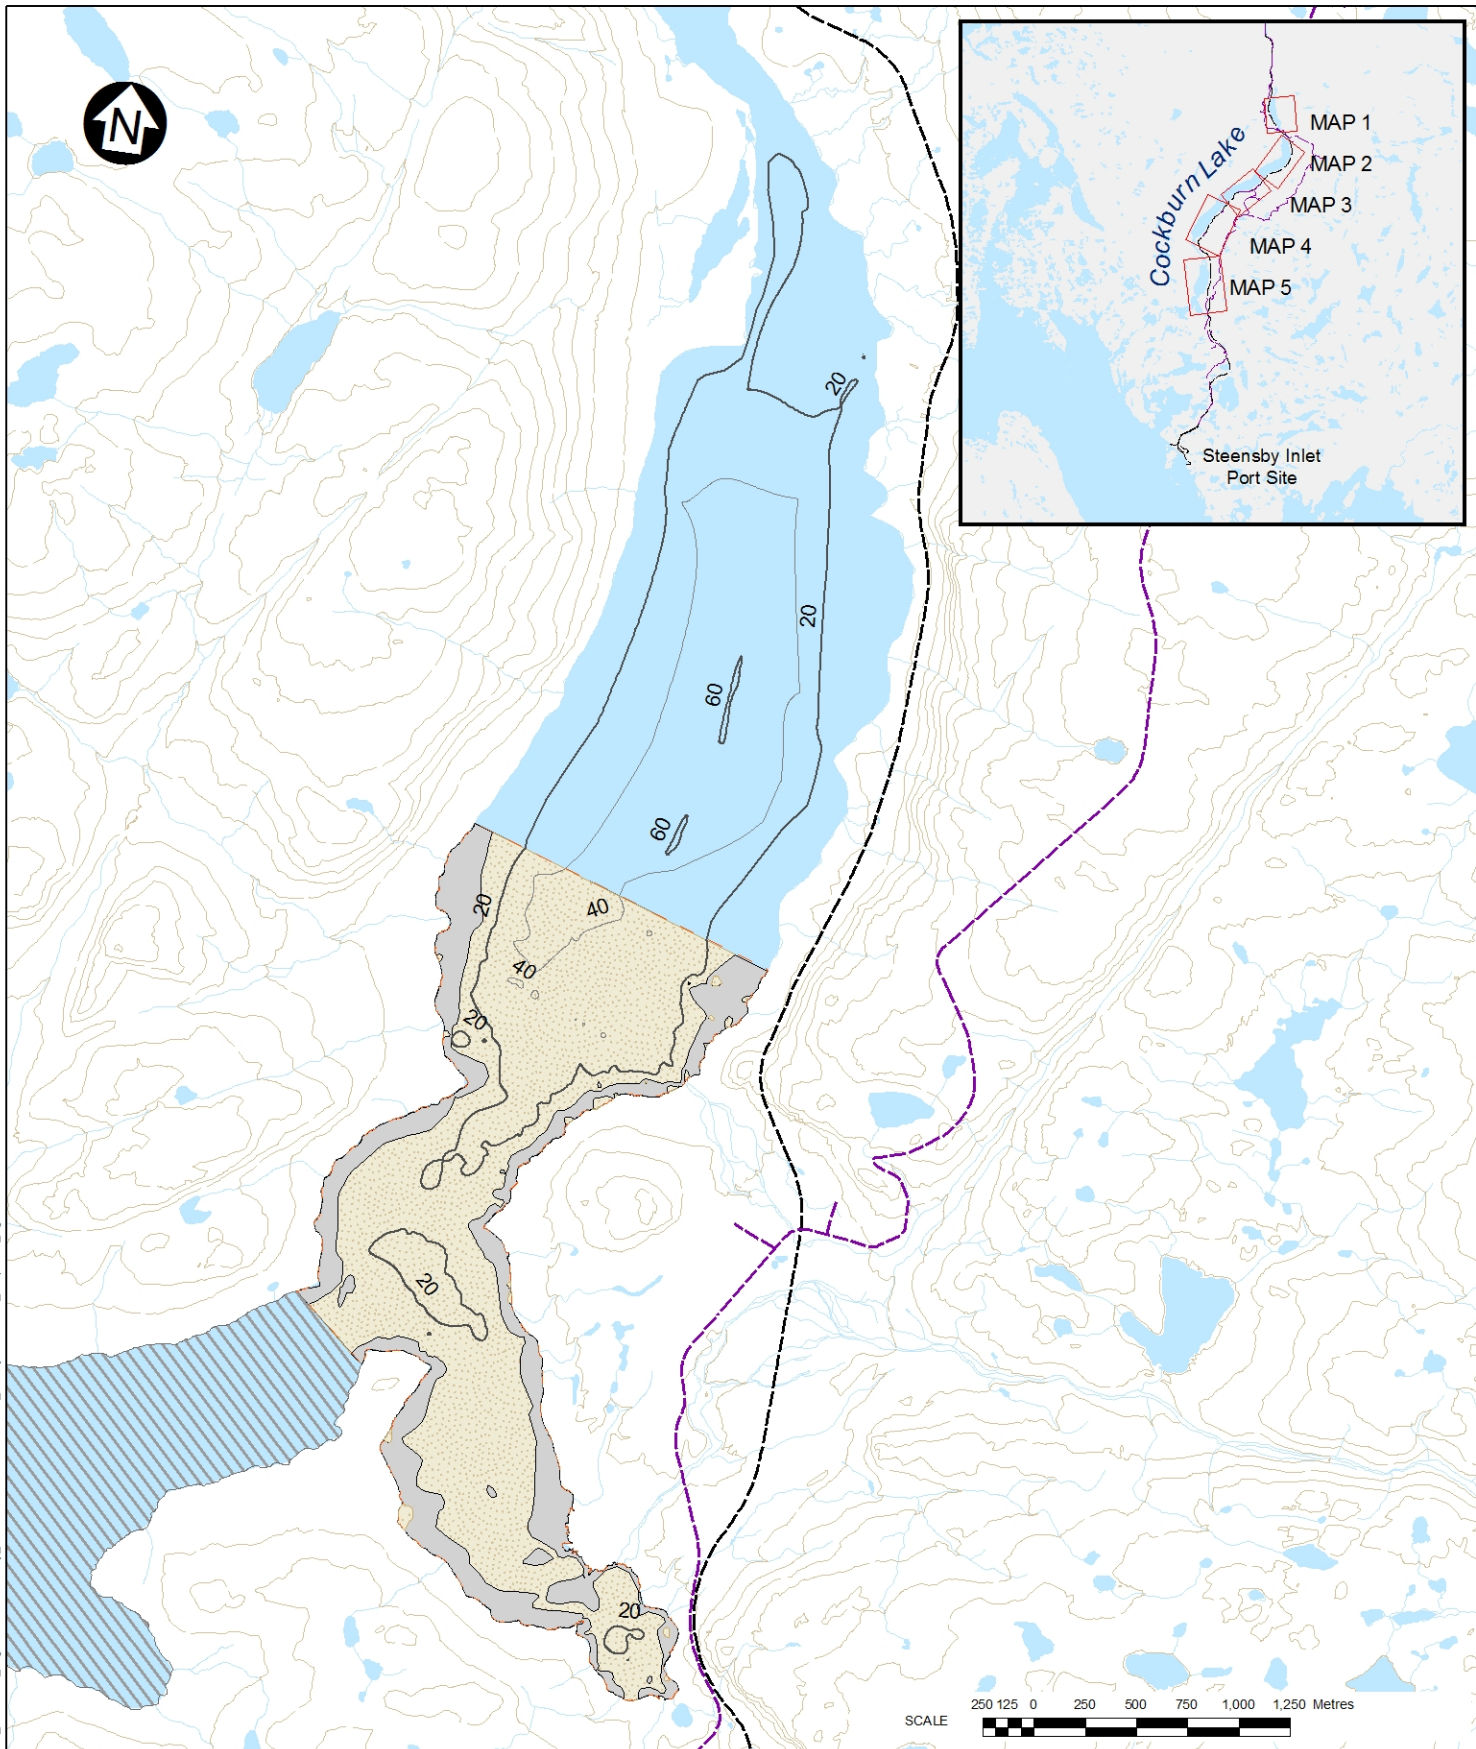
**Cockburn Lake South Basin
Bathymetry and Substrate
- MAP 5 of 5 -**

1. BASE MAP: © HER MAJESTY THE QUEEN IN RIGHTS OF CANADA DEPARTMENT OF NATURAL RESOURCES (2009). ALL RIGHTS RESERVED.
2. TOPOGRAPHY PROVIDED BY EAGLE MAPPING (2005).
3. DEPTHS OF BATHYMETRIC CONTOURS ARE IN METRES AND ARE RELATIVE TO SHORELINE AT TIME OF SURVEY.
4. CONTOUR INTERVAL IS 25 M AND IS IN METRES.
