DETAILED HABITAT ASSESSMENTS AND SUMMARY OF RESULTS FOR LAKE ENCROACHMENT SITES.

MARY RIVER PROJECT

Railway Lake Encroachment Sites

Rail Alignment Watercourse Crossing Assessment

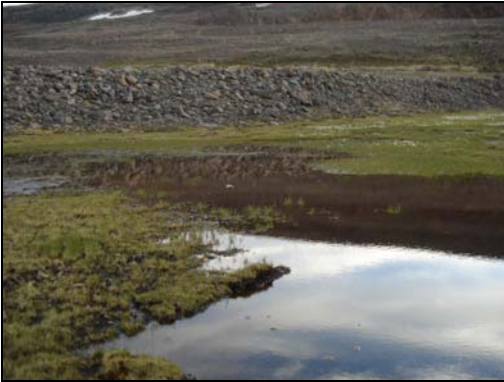
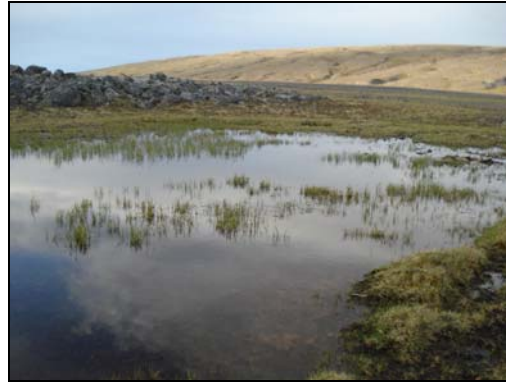
The maximum water depth was 0.05 m. The stream morphology at the crossing was a pool (< 0.2 m) and the substrate composition was 100% small cobble.

Fish Habitat Quality – NO FISH HABITAT

Figure 1. View of habitat (A-B).

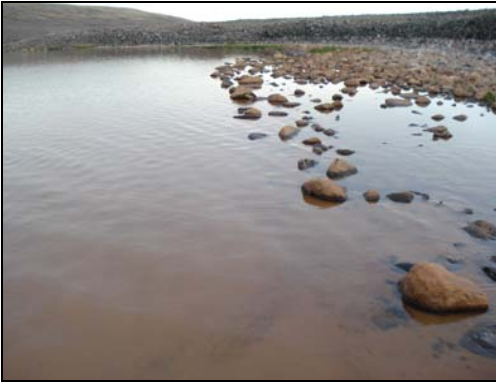
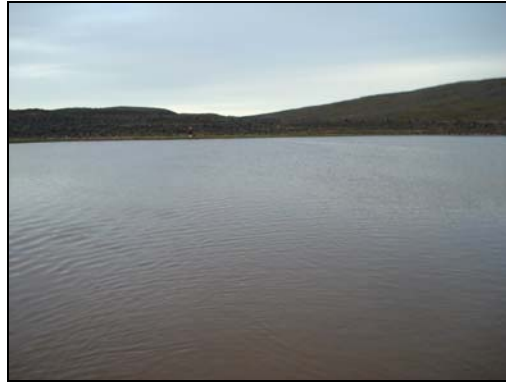
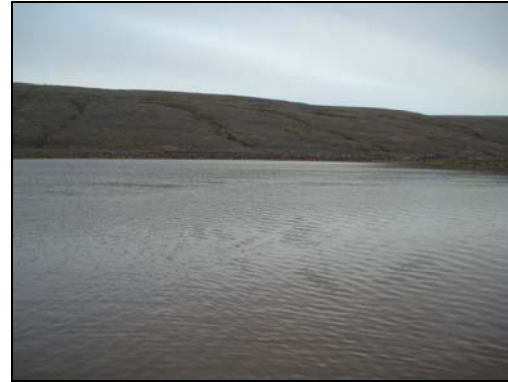
ARCH must migrate from large D/S river during high water into CV-017-1. The maximum water depth at the crossing was 0.45 m and the substrate was 100% fines. The water temperature was 4.0 °C.

Fish Habitat Quality – MARGINAL

Figure 1. View of habitat (A-C).

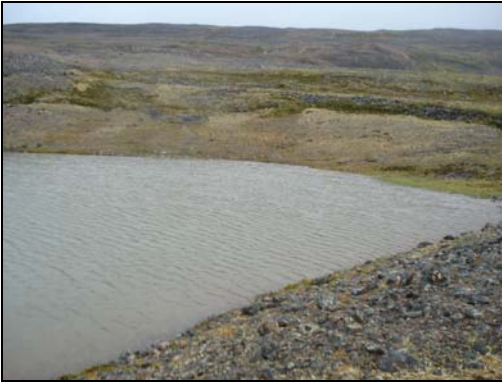
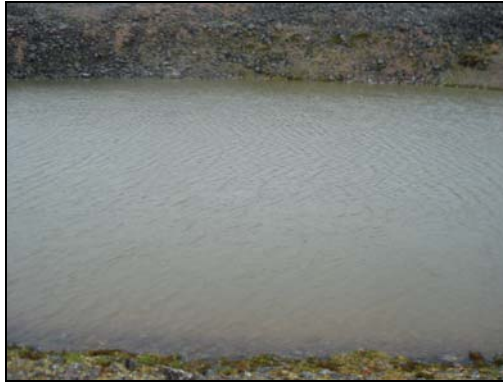
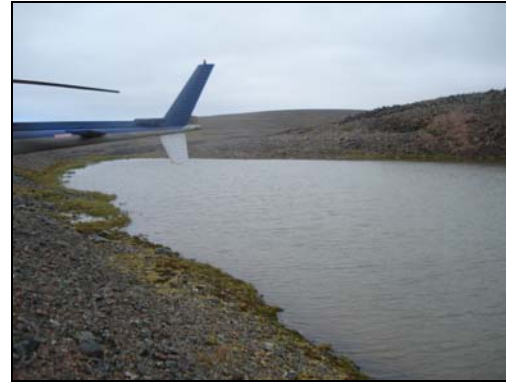
No connections with overwintering habitat. The substrate composition at the crossing was 70% small cobble and 30% large cobble.

Fish Habitat Quality – NO FISH HABITAT

Figure 1. View of habitat (A-C).

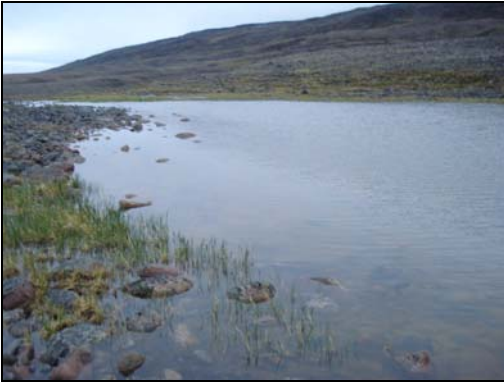
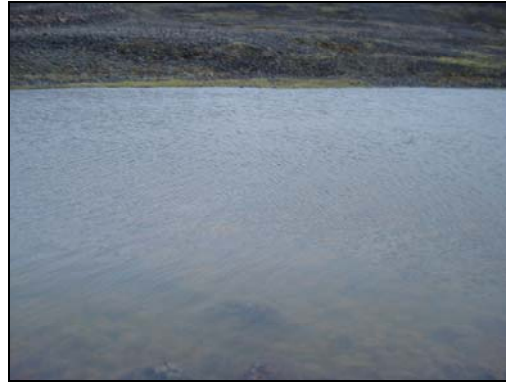
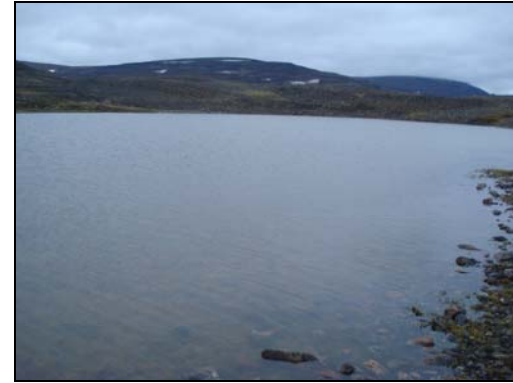
The water body was 10 X 200 m and the maximum water depth ranged from 1.0 – 1.5 m. The substrate composition at the crossing was 50% small cobble, 30% large cobble and 20% boulders. The flow regime was permanent and the water temperature was 1°C.

Fish Habitat Quality – IMPORTANT

Figure 1. View of habitat (A-C).

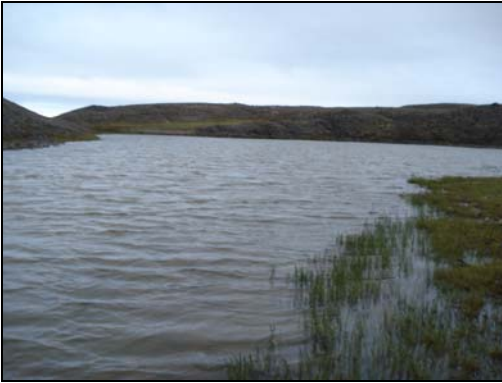
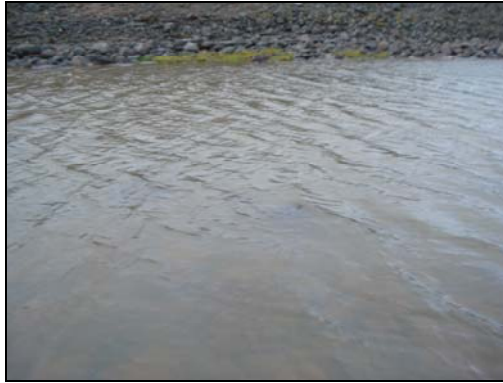
No fish habitat. Not connected to any river or deep lake. The substrate composition at the crossing was 45% small cobble, 45% large cobble and 10% boulders.

Fish Habitat Quality – NO FISH HABITAT

Figure 1. View of habitat (A-B).

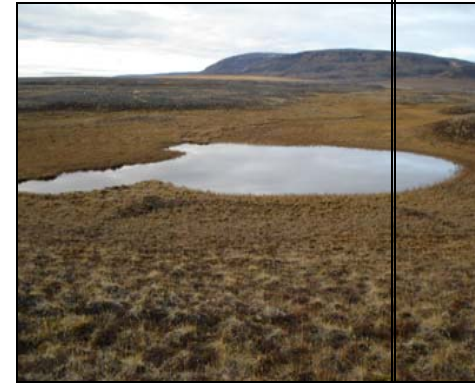
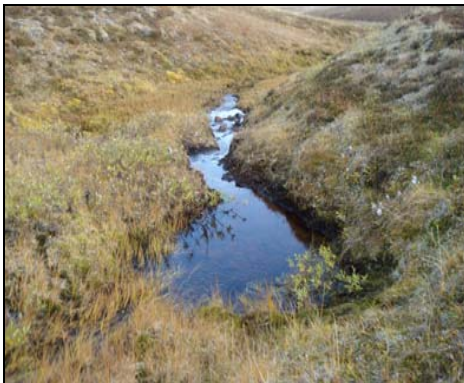
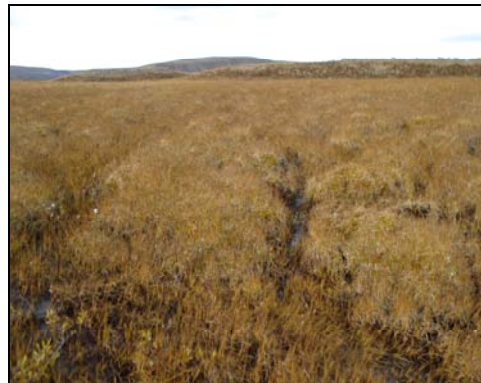
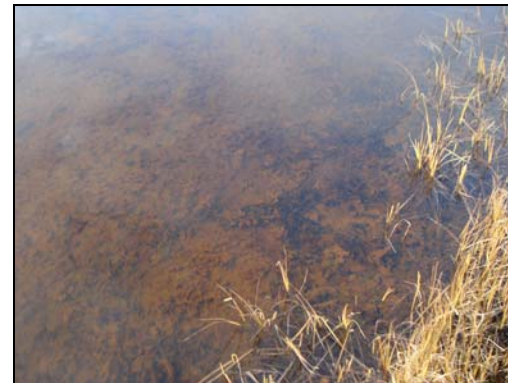
The channel gradient was 1.25° and the water temperature was 6.0 °C. The maximum water depth at the crossing was 0.75 m and the substrate was 95% algae, 2% large cobble and 3% boulders.

This is the shallow pond downstream of CV-R19 and R20. It is separated by a stretch of dry land that has a small amount of water running down over the grass in one spot. Approximately 50m downstream there is nice fish habitat, but even at high water it is very unlikely fish could reach the pond.

Fish Habitat Quality – NO FISH HABITAT

Figure 1. Aerial view of downstream stream (A), barrier between lake and downstream (B), lake (C), lake (D), disconnected stream downstream of lake (E), barrier downstream of lake (F), and lake substrate (G).

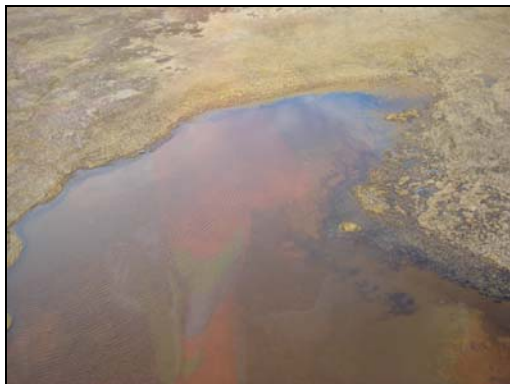
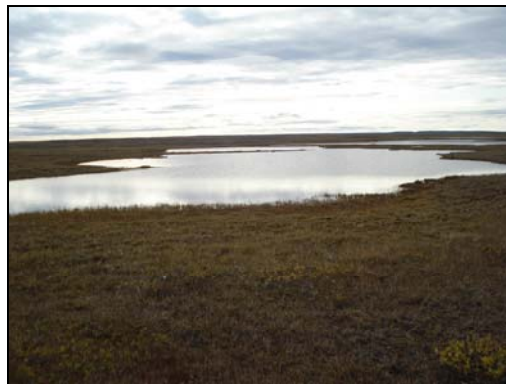
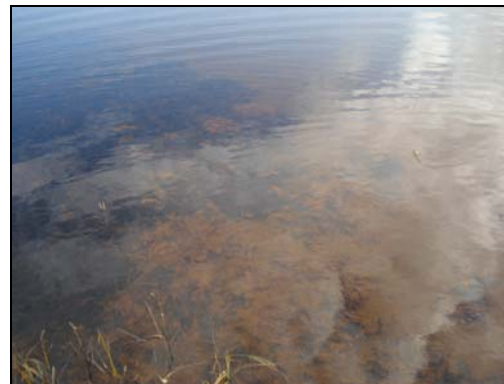
The maximum water depth at the crossing ranged from 1.0-1.5 m and the substrate was 90% fines, 8% gravel and 2% boulders.

Isolated pool on top of a rise, with no significant connectivity to other waterbodies. Fish cannot likely reach this pond.

Fish Habitat Quality – NO FISH HABITAT

Figure 1. Aerial view of lake (A), lake (B), and substrate of lake (C).

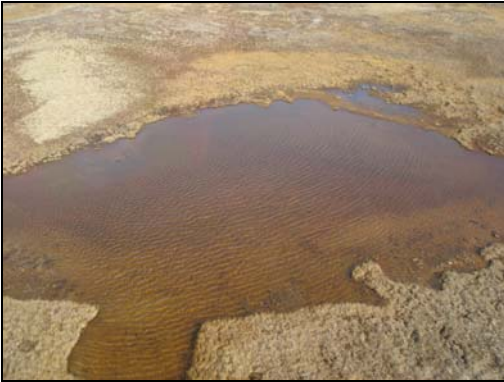
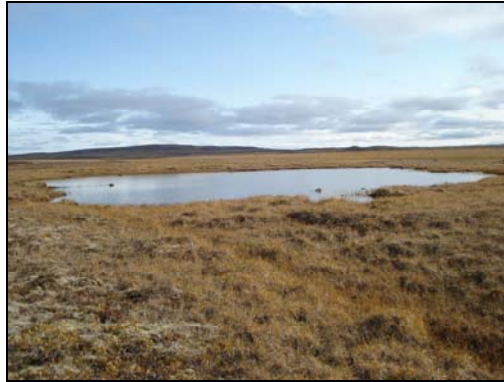
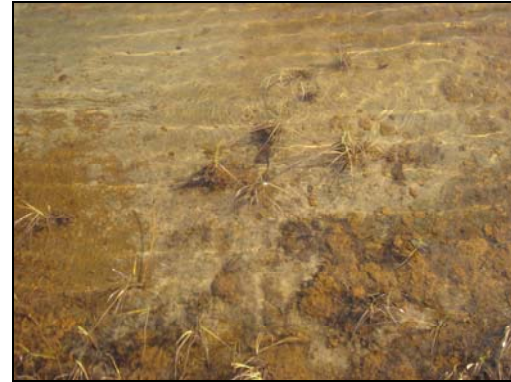
The maximum water depth at the crossing was 0.5 m and the substrate was 98% fines, 1% gravel and 1% boulders.

Isolated pool on a rise. Not connected to any other water body.

Fish Habitat Quality – NO FISH HABITAT

Figure 1. Aerial view of lake (A), lake (B), and substrate (C).

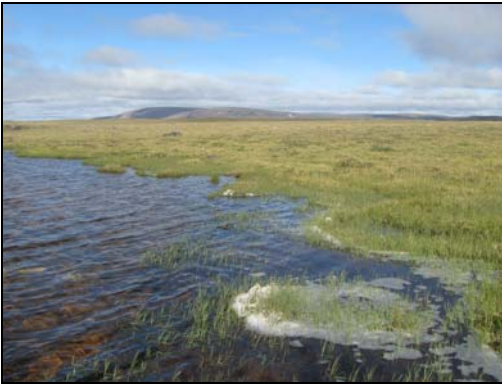
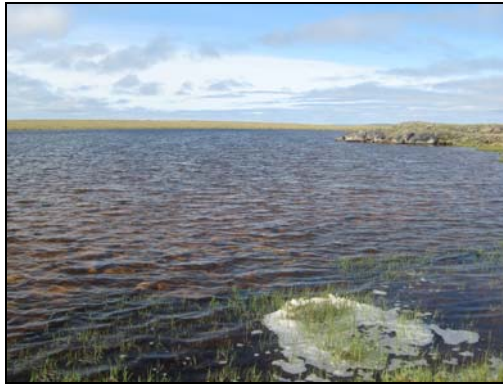
Same water body as CV-R24 previously assessed.

Fish Habitat Quality – MARGINAL

Figure 1. View of habitat at encroachment (A-B).

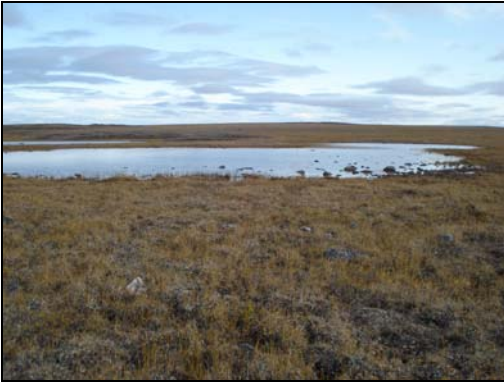
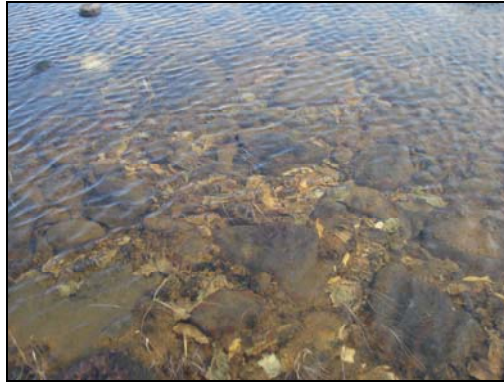
The maximum water depth at the crossing ranged was 0.75 m and the substrate was 30% fines, 20% algae, 20% gravel, 20% large cobble and 10% boulders.

Not currently connected to any other water body except via flooded terrestrial. The lake is not deep enough to overwinter fish, but in the spring this lake may be connected indirectly (through 3 or 4 ponds) to CV-029, which has fish.

Fish Habitat Quality – MARGINAL

Figure 1. View of nearby lake (A), nearby lake substrate (B), and substrate at the crossing (C).

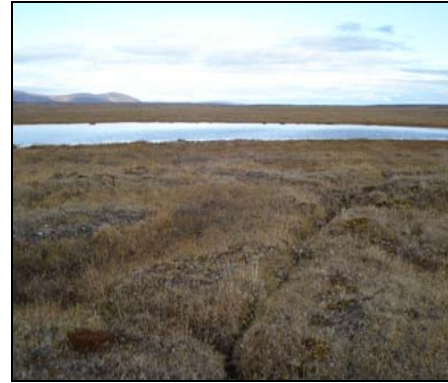
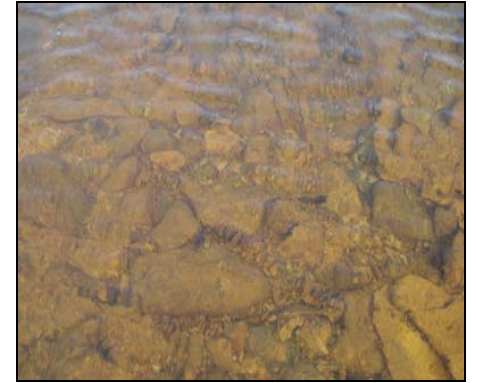
The maximum water depth at the crossing was 0.5 m and the substrate was 30% fines, 20% gravel, 40% large cobble and 10% boulders.

Not deep enough for fish to overwinter. Not connected to any other water body that is capable of providing overwinter habitat.

Fish Habitat Quality – NO FISH HABITAT

Figure 1. Views of lake (A-C), and lake substrate (D).

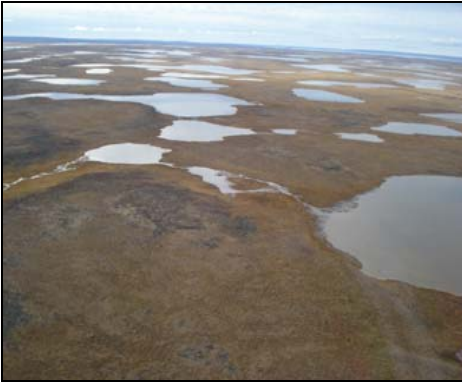
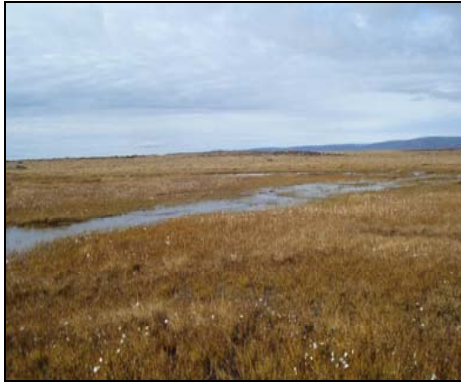
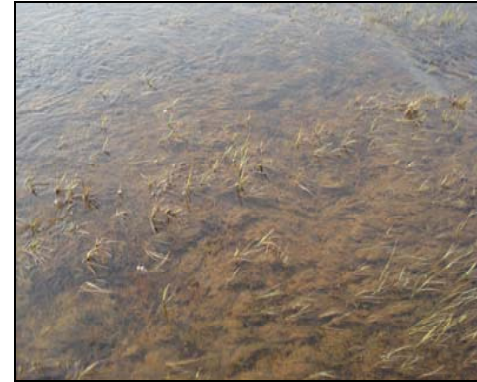
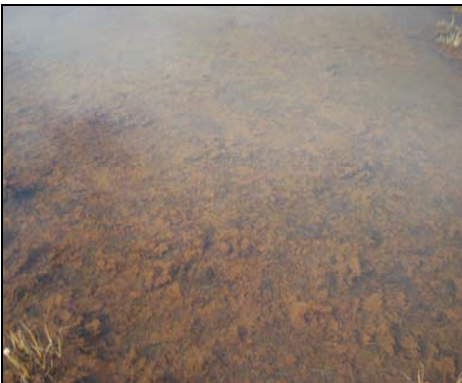
Figure 1. Aerial view of crossing between two ponds (A), crossing downstream (B), substrate and flow in downstream channel (C), crossing substrate (D), crossing upstream (E), and upstream pond (F).

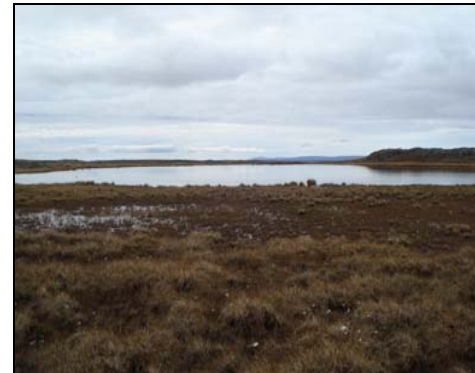
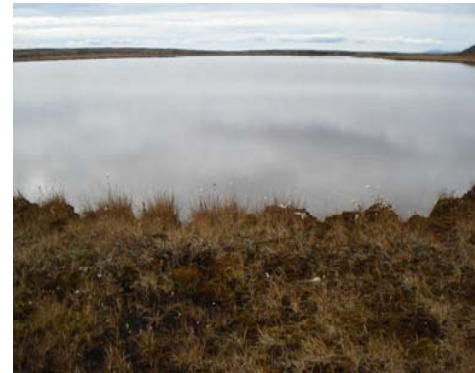
Figure 1. Aerial view of lake 1 (A), lake 2 (B), lake from ground (C), lake substrate (D), substrate of waypoint (E), and view of lake from waypoint (F).

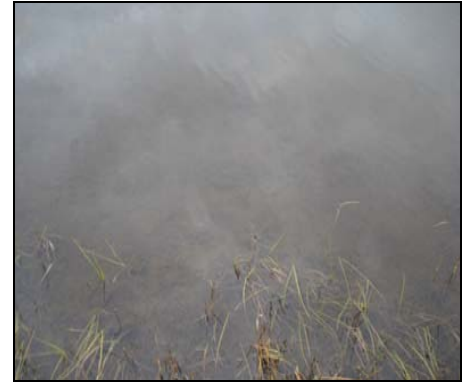
Figure 1. Aerial view of dry connection to overwintering lake (A-B), lake (C), and lake substrate (D).

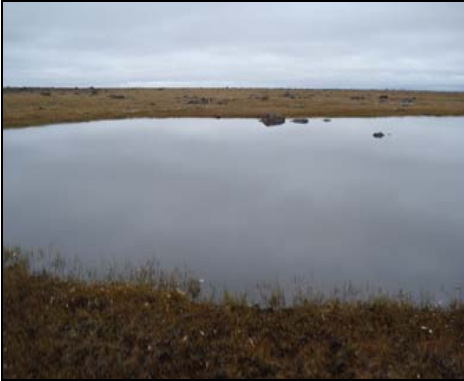
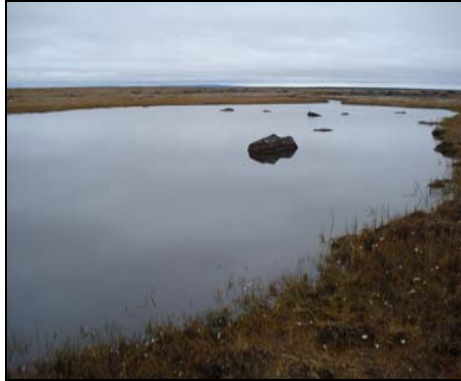
Figure 1. View of crossing across (A-B), and crossing substrate (C).

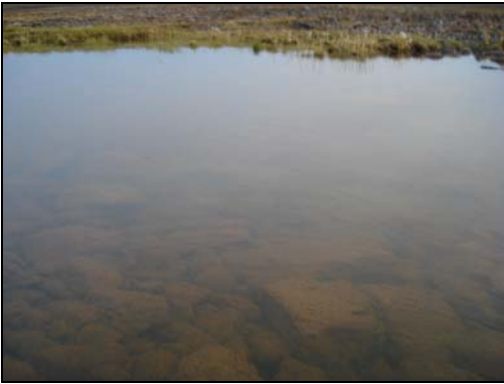
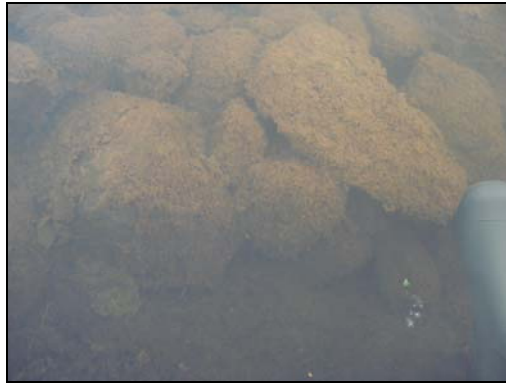
Figure 1. View of habitat (A) and substrate (B).

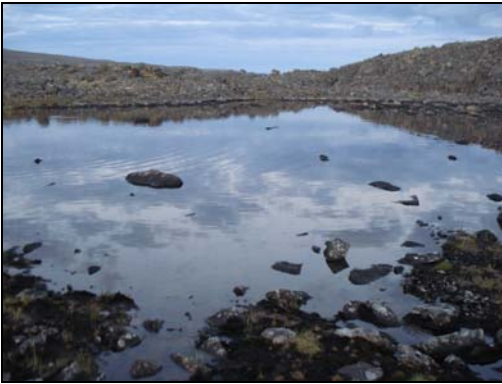
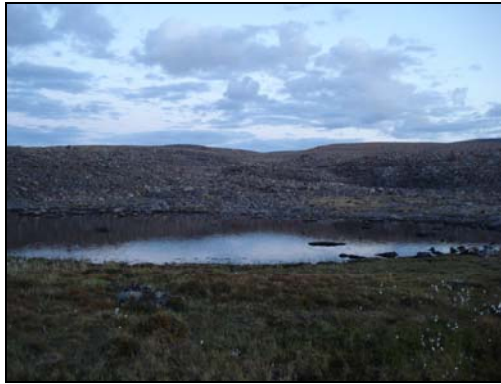
Figure 1. View of habitat (A-B).
