MARY RIVER PROJECT

Railway Lake Encroachment Sites (MAP D)

North/South Consultants Inc.
Aquatic Environment Specialists

Rail Alignment Watercourse Crossing Assessment

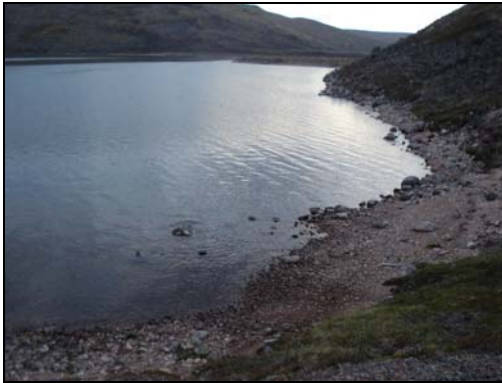
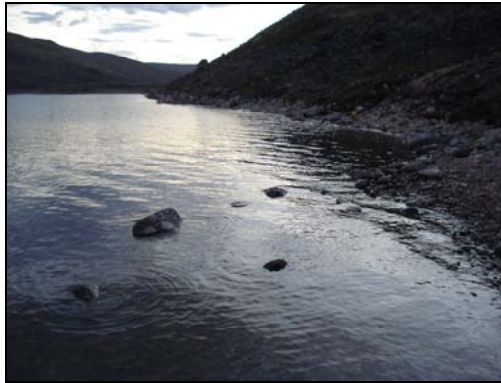
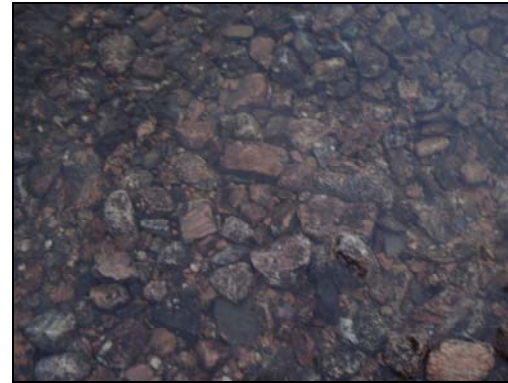
Figure 1. View of habitat at crossing (A-B), and of substrate (C).

Although depth barely sufficient for overwintering, this lake is accessible from other areas and provides abundant suitable habitat. Fish use is likely.

Fish Habitat Quality – IMPORTANT

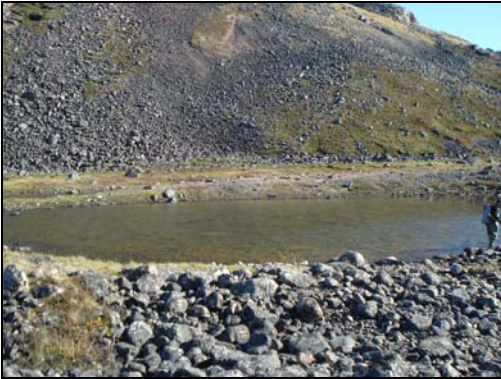
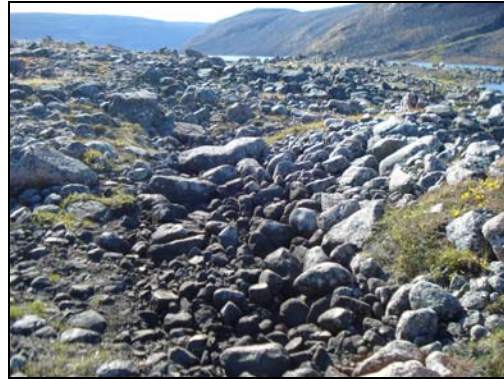
Figure 1. Waterbody AR-050a (A), dry channel connecting AR-050a with Cockburn Lake (B).

Small waterbody with boulder/cobble substrate. Connected to Cockburn Lake via short channel that was dry during survey. Approximate dimensions: 40 x 55 m; < 2 meters deep. Fish stranded after higher spring water levels and would then winter kill.

Fish Habitat Quality – MARGINAL

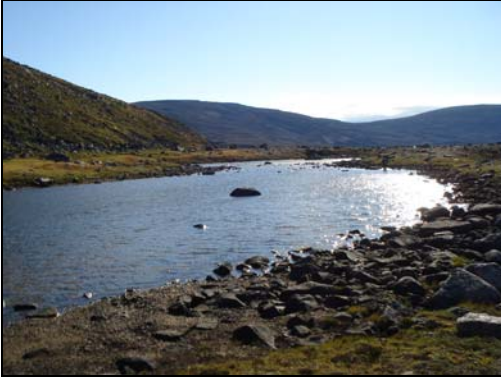
Figure 1. Waterbody AR-050b (A).

Small waterbody with boulder/cobble substrate. Connected to AR-050a, which is connected to Cockburn Lake via short channel that was dry during survey. Approximate dimensions: 40 x 200 m; < 2 meters deep. Fish stranded after higher spring water levels and would then winter kill.

Fish Habitat Quality – MARGINAL

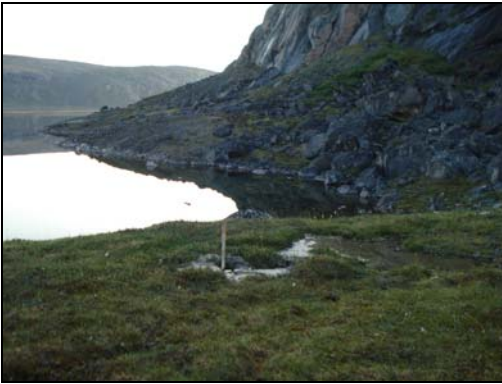
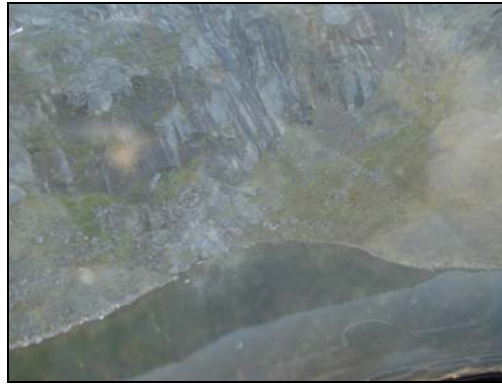
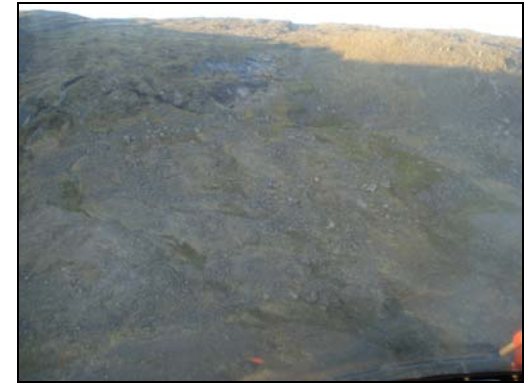
Figure 1. View of habitat at crossing (A-D).

The flow regime was permanent and the maximum water depth was > 2.0 m. The bank height was > 10.0 m. Overwintering possible and depths and substrates suitable for char spawning as well. Fish use of this lake probably extensive.

Fish Habitat Quality – IMPORTANT

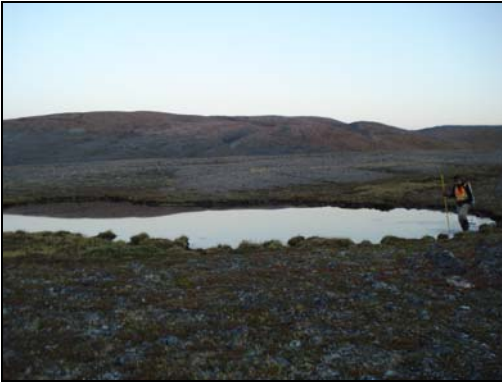
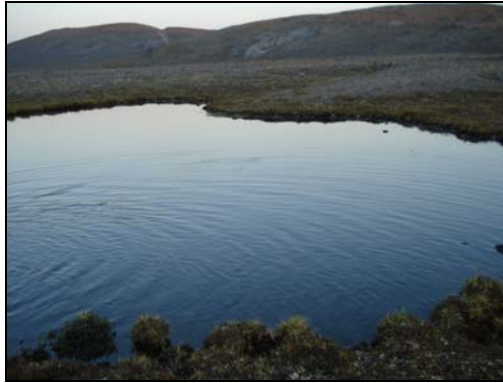
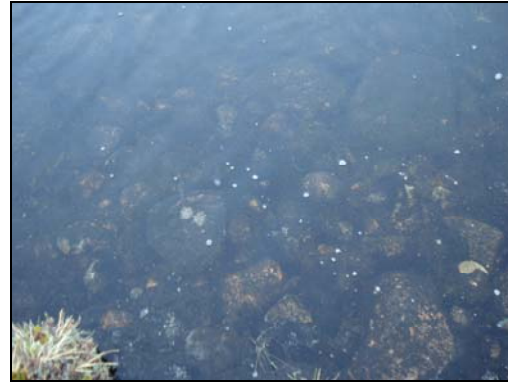
Figure 1. View of habitat (A-B), and substrate (C).

The water body was 26.52X16.46 m, with a permanent flow regime. The water temperature was 6.0 °C. The substrate was 10% fines, 25% gravel, 35% small cobble and 30% large cobble.

Fish Habitat Quality – NO FISH HABITAT

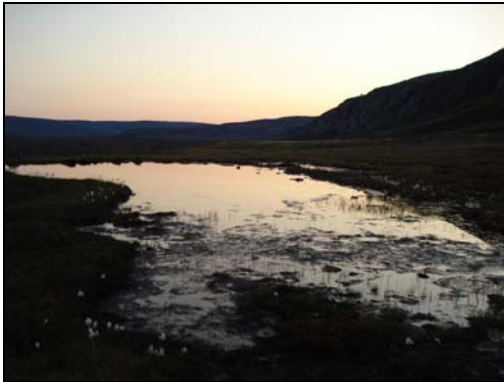
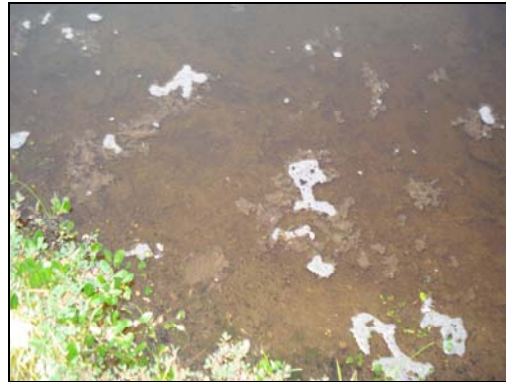
Figure 1. (A) View of habitat, and (B) substrate.

Fish Habitat Quality – NO FISH HABITAT

Under higher water conditions, would flow through CV-121-7. The flow regime of the pond is permanent and the water temperature was 12.0 °C.

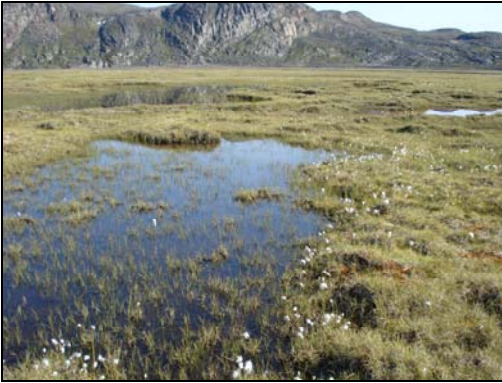
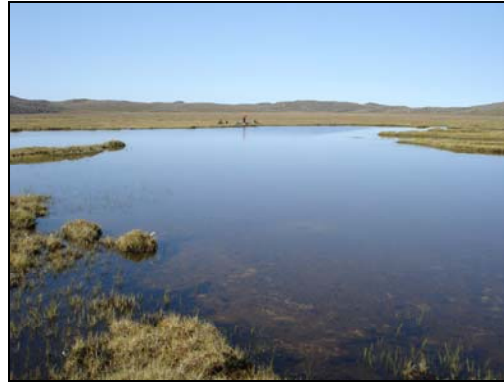
Figure 1. View of habitat, inlet/outlet (A), and pond (B).

The flow regime is permanent, the stage is normal and the water temperature was 12.0°C. The maximum water depth at the crossing was 0.25 m. The water body was 85% pool (< 0.2 m) and 15% ool (>0.2 m). The substrate composition was 20% fines, 10% gravel and 70% small cobble. Not overwintering habitat, but connected to other waterbodies. Habitat ideal for stickleback spawning and rearing during summer.

Fish Habitat Quality – IMPORTANT

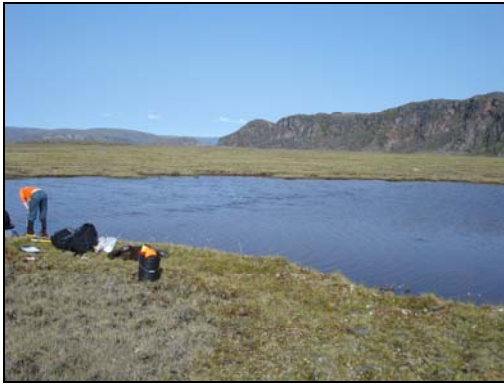
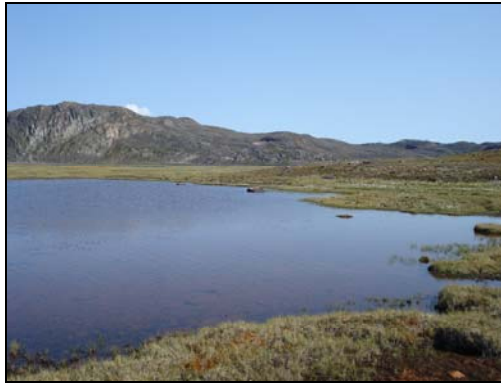
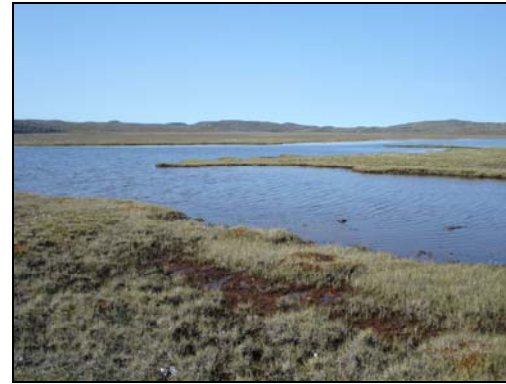
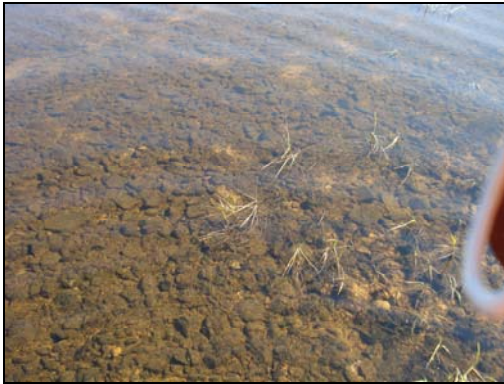
Figure 1. View of habitat, at crossing (A), towards the end of the bay (B), looking out toward main lake (C), and substrate (D).

YOY NNST seen at all points along the banks in 2008. YOY NNST were also captured at this site during an electrofishing survey in 2007. The flow regime was permanent and the stage was normal in 2008. The water temperature was 18.0 °C.

Fish Habitat Quality – IMPORTANT

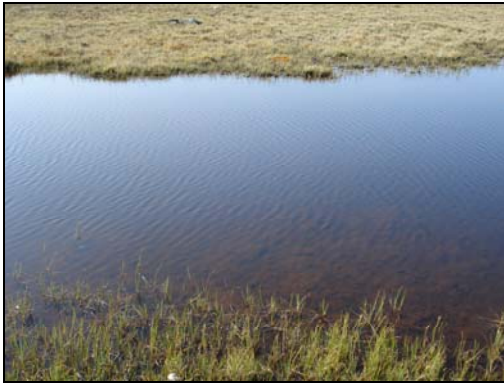
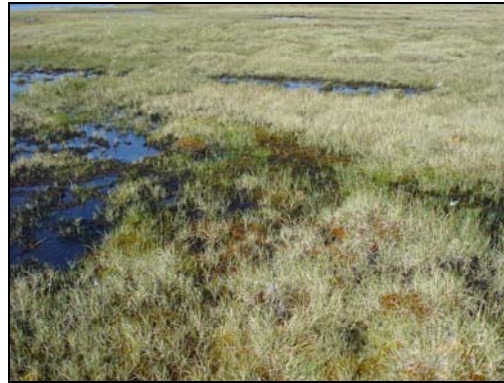
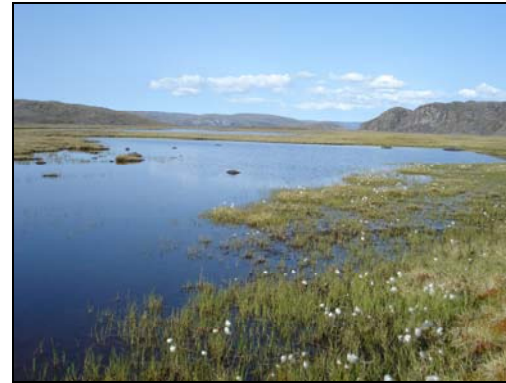
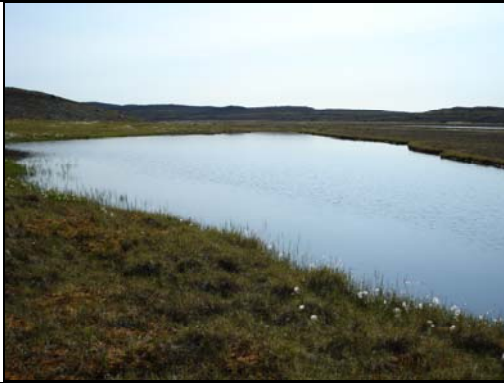
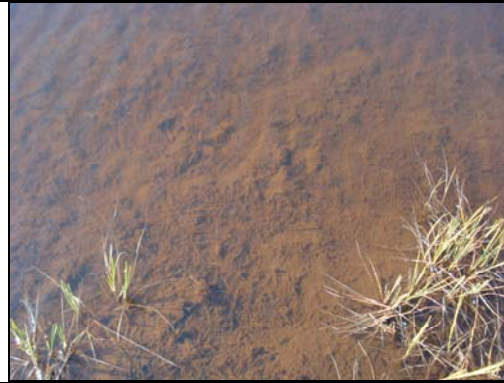
Figure 1. View of habitat, at crossing (A), at the dry creek flowing into the water body (B), facing north (C) facing south (D), and substrate (E).

Large numbers of YOY and larger NNST observed along the shoreline. The wetted channel width and the high water channel width were each 9.14 m, and the maximum water depth at the crossing was 1.0 m. The substrate composition 50% fines, 30% small cobble, 10% large cobble and 10% boulders.

Fish Habitat Quality – IMPORTANT

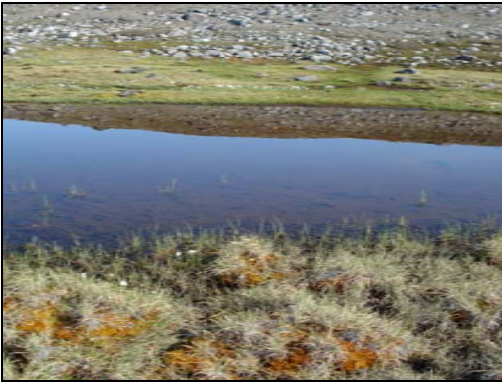
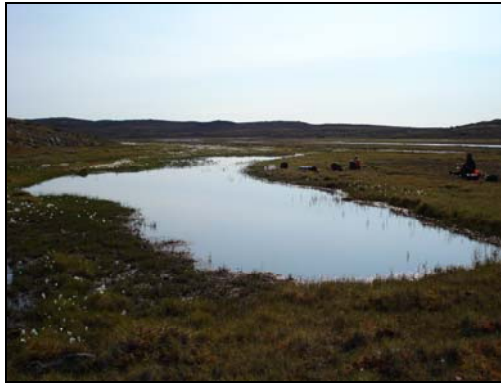
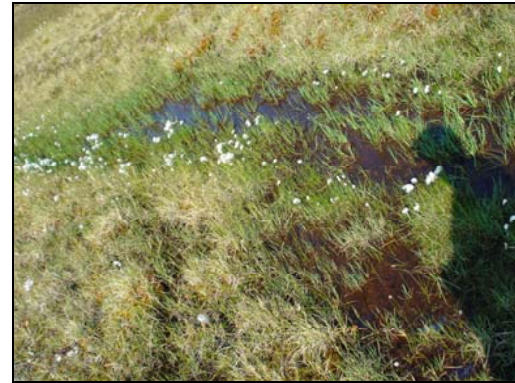
Figure 1. View of habitat, at the crossing (A), facing south (B), and at the inlet /outlet (C).

The pond is elevated and not connected to any other water bodies. The flow regime is permanent, the stage is normal and the water temperature was 21.5 °C. The wetted width was 9.0 m, the high water channel width was 15 m, and the maximum water depth was 0.2 m. The stream morphology composition was a pool (< 0.2 m), substrate made up of 90% fines, and 10% gravel.

Fish Habitat Quality – MARGINAL

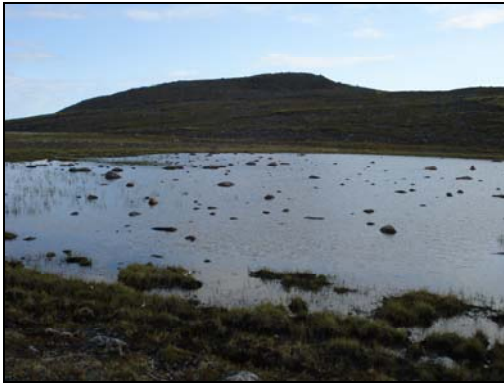
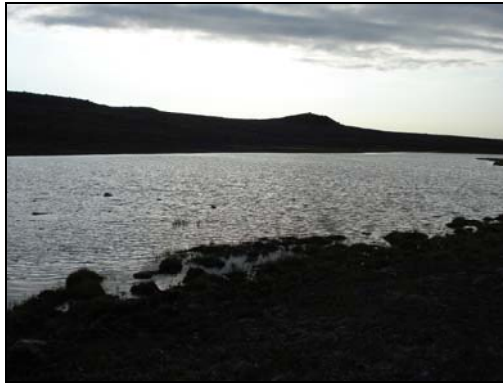
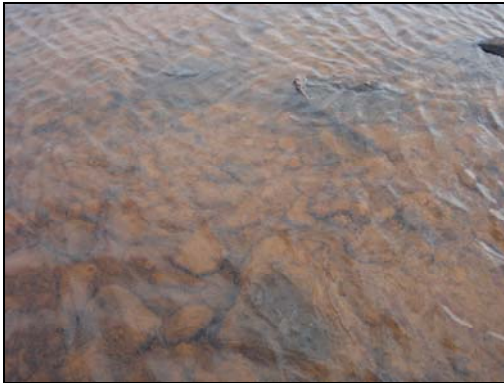
Figure 1. View of habitat, at crossing (A), facing main lake body –NW (B) facing outlet (C), and of substrate (D).

Channel Characteristics and Velocity: Wetted width that'll be encroached upon is 50 m. The wetted width was 87.78 m. The flow regime was permanent and the stage was normal.

Fish Habitat: Large cobble (60%) and boulders (30%) packed together and covered in orange algae, also with 10% fines.

Fish Habitat Quality – MARGINAL

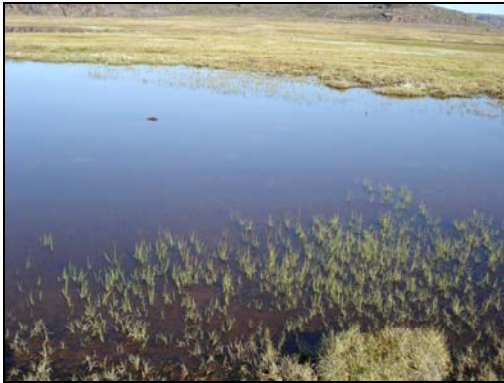
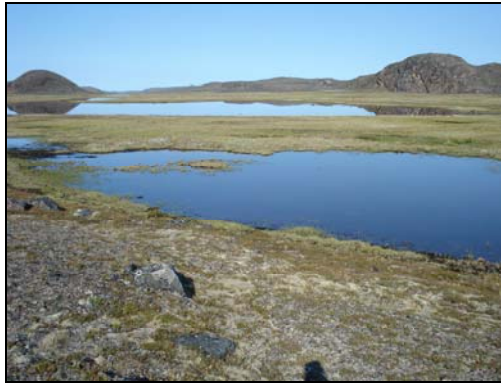
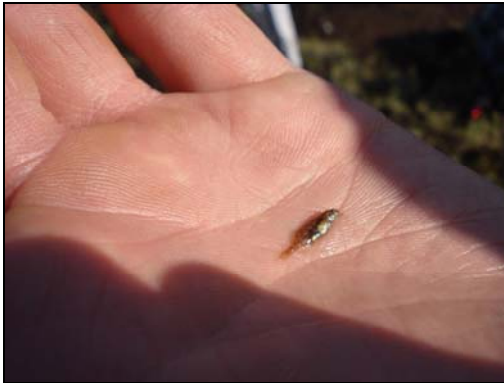
Figure 1. View of habitat, at the crossing (A) at the outflow (B), towards outflow (C), and a YOY NNST (D).

Decent spawning/rearing habitat but no way out of habitat. Many other NNST seen, but low conductivity in the pond prevented their capture. The maximum water depth was 0.2 m, the water body was a pool (< 0.2 m) and the substrate composition was 99% fines and 1% large cobble.

Fish Habitat Quality – MARGINAL

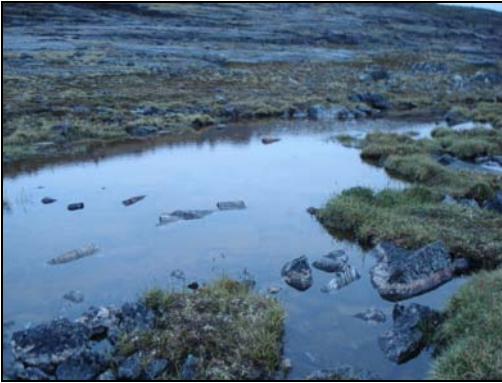
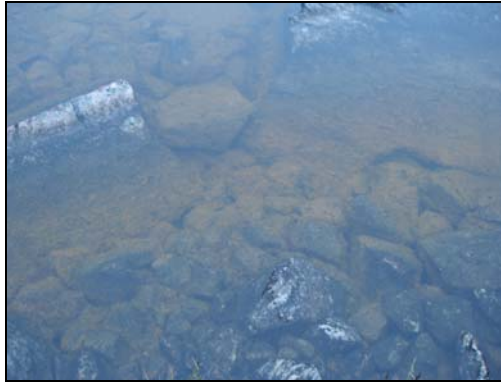
Figure 1. View of habitat (A) and substrate (B).

There is a large DS lake ~ 75m DS with ARCH that is not accessible to this pond (DS take = 40 Bo, 30 lg Co, 30 Sm Co, and > 2 m day). Suitable for overwintering and maybe spawning. Juveniles were observed.

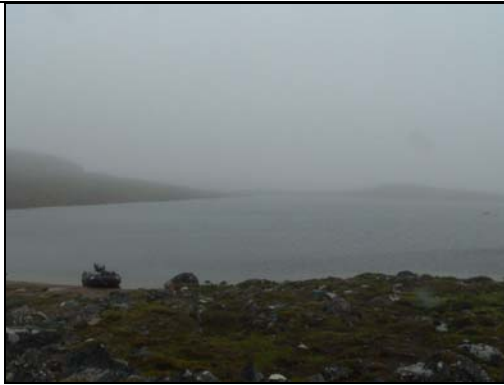
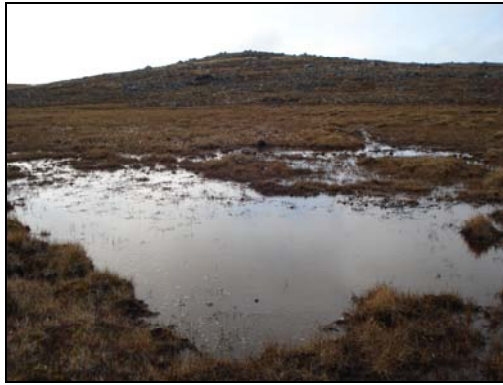
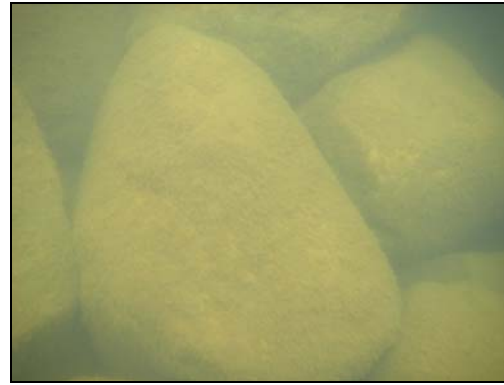
Figure 1. Pan view of ST-028 during summer (A), shoreline view (B) and substrate (C).

Gillnetting and observational studies were conducted and only one NNST was observed.

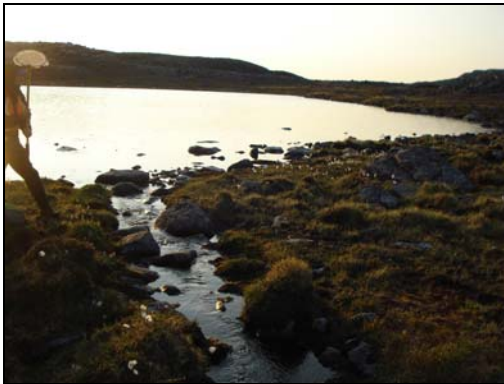
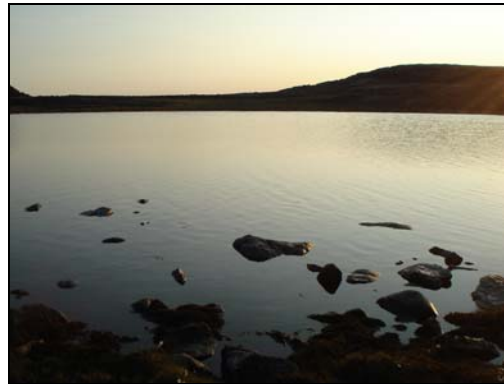
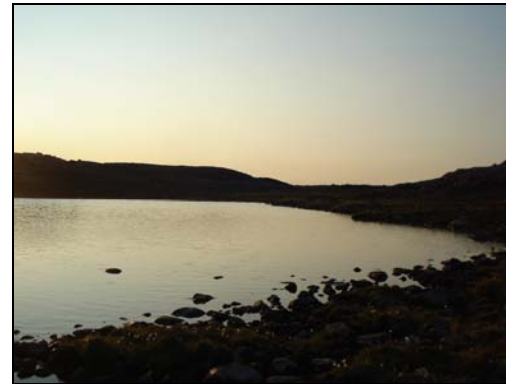
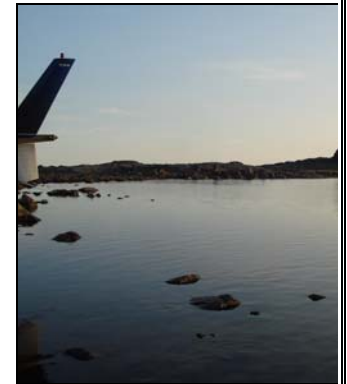
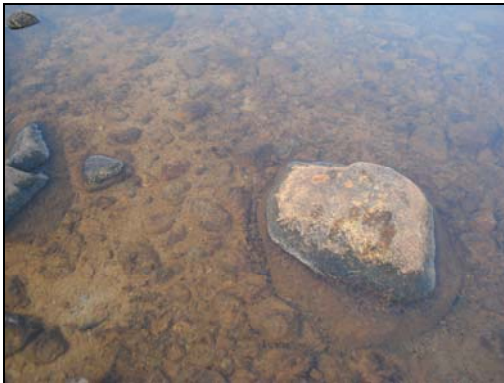
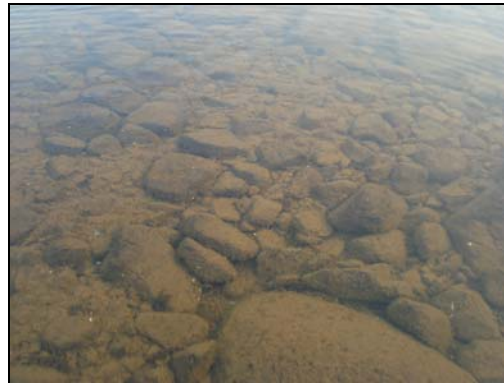
Figure 1. View of habitat (A-D), and substrate (E-G).

The flow regime was permanent and the water temperature was 11.0 °C.
Stream coming from STEP-LE-02-1.
