Full Report Title: 2013 Site Visit Report for the Nunavut Impact Review Board's
Monitoring of Baffinland Iron Mine Corp.'s Mary River Project (NIRB
File No. 08MN053)

Project: Mary River Project
Project Location: Qikiqtani Region, Nunavut

Site visit dates: August 20 and 21, 2013

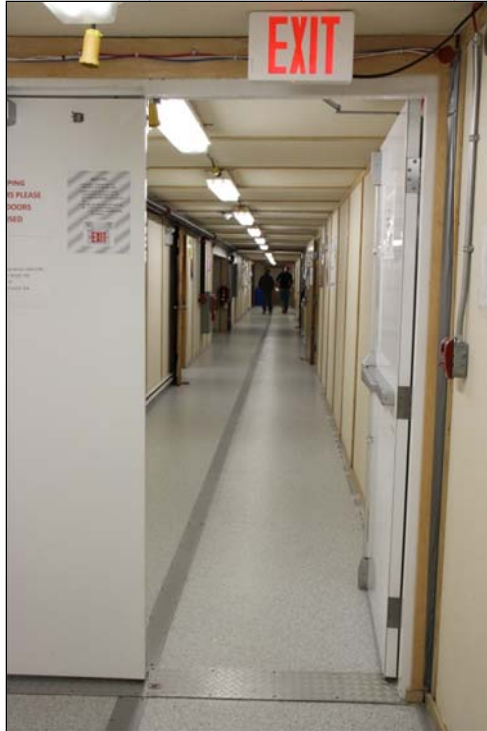
Photo 1. Hallway of main building at Mary River

- d. The main building at Mary River which houses the Environment Office, kitchen, lounge and staff training area, as well as several staff accommodation trailers was clean, and signs marking the function of specific areas were well-positioned and clearly marked (Photo 1 and Photo 2).

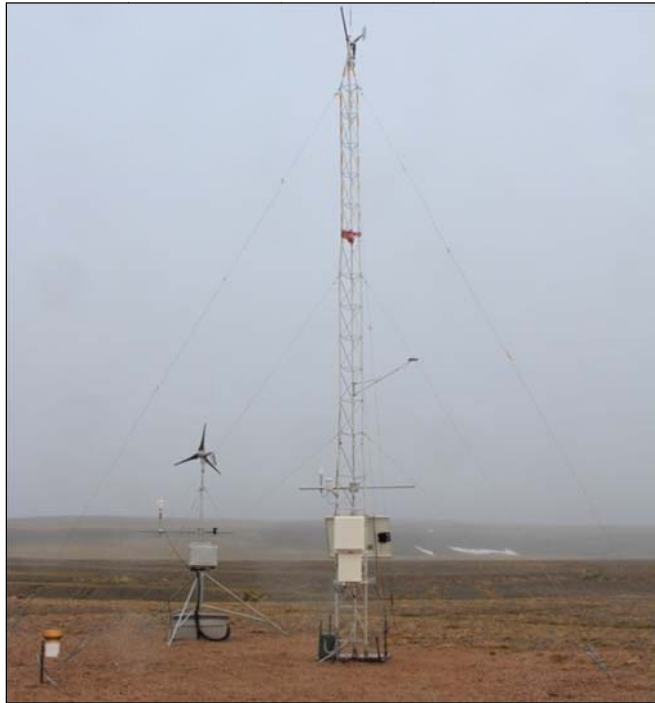
Photo 3. Telemetry station at Mary River

The Monitoring Officer noted that a telemetry station had been installed by Baffinland to obtain weather-related information for the mine site (Photo 3).

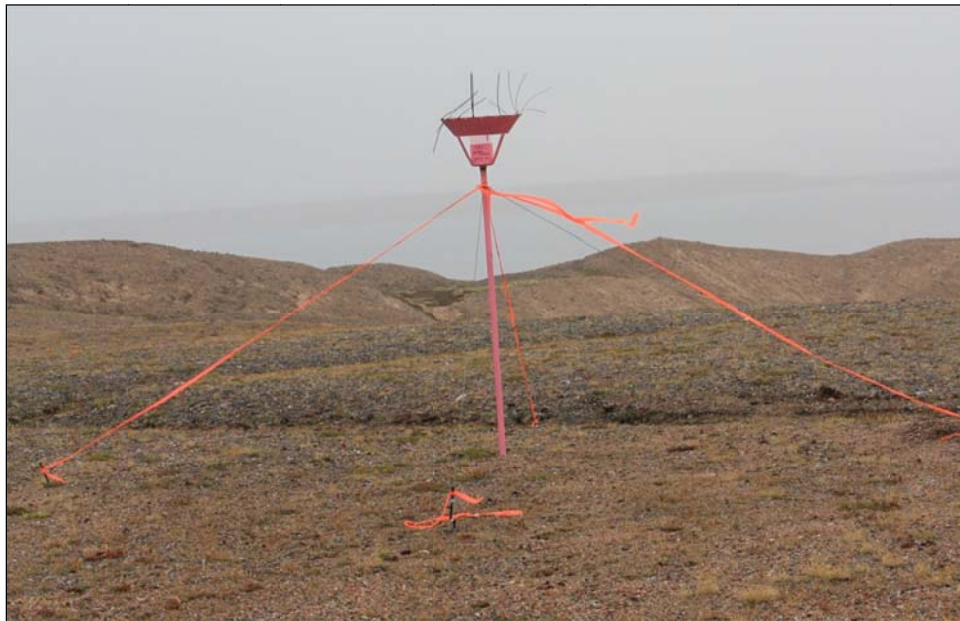
Photo 4. Dustfall monitoring station

The Monitoring Officer did not observe any air quality monitoring stations installed at Mary River, nor was it evident that any air quality monitoring work was being undertaken. Dustfall monitoring stations were observed at various locations throughout Mary River and along the Tote Road (Photo 4).

Condition 8 requires that air quality monitoring be performed at Mary River and Steensby Inlet Port site to demonstrate that pollutant emissions are within predicted levels. The Monitoring Officer noted that no air quality monitoring stations had been set up at the time of the site visit.

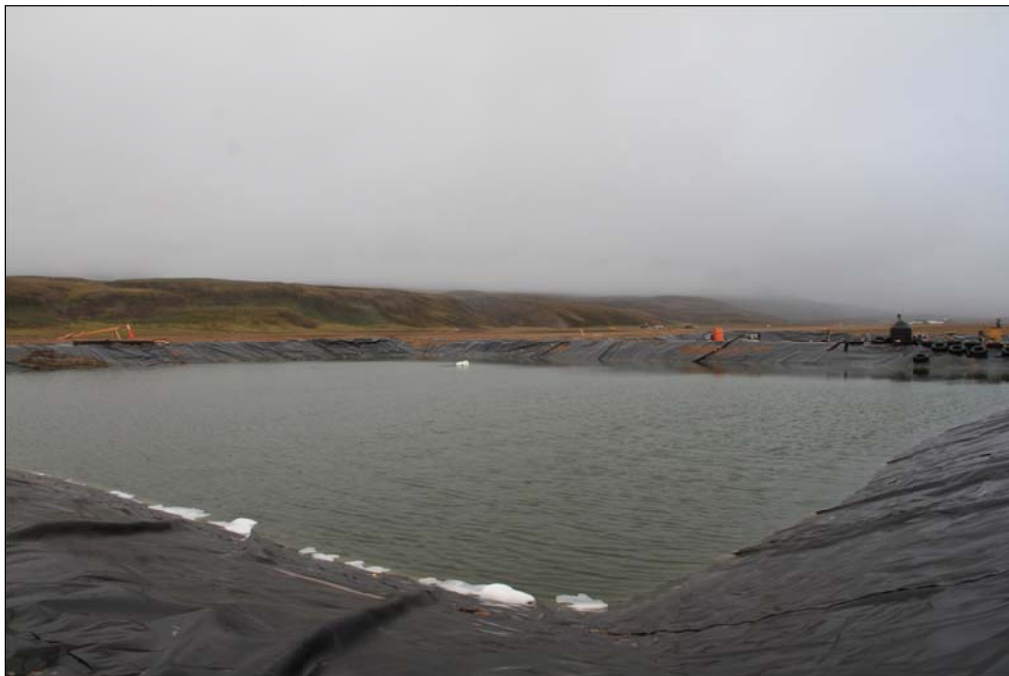
Photo 5. Polishing waste stabilisation pond (PWSP)

It was communicated by Mr. Myers that at the time of the site visit, a polishing waste stabilisation pond (PWSP) was being used to ensure that the treated sewage discharge criteria was met. The sewage treatment system in place at the time was a rotating biological contactor (RBC) which, according to Mr. Myers, does not adapt well to fluctuating loads and was not very effective in fluctuating load conditions. Baffinland indicated that it would be replacing the RBC with a membrane bioreactor (MBR), which its staff noted would be more adaptable in fluctuating load conditions. Until the new treatment system is operational, Baffinland staff noted that the PWSP would continue to be operated prior to the discharge of treated effluent to Sheardown Lake. The wastewater treatment facilities were observed to be in good general condition (Photo 5).

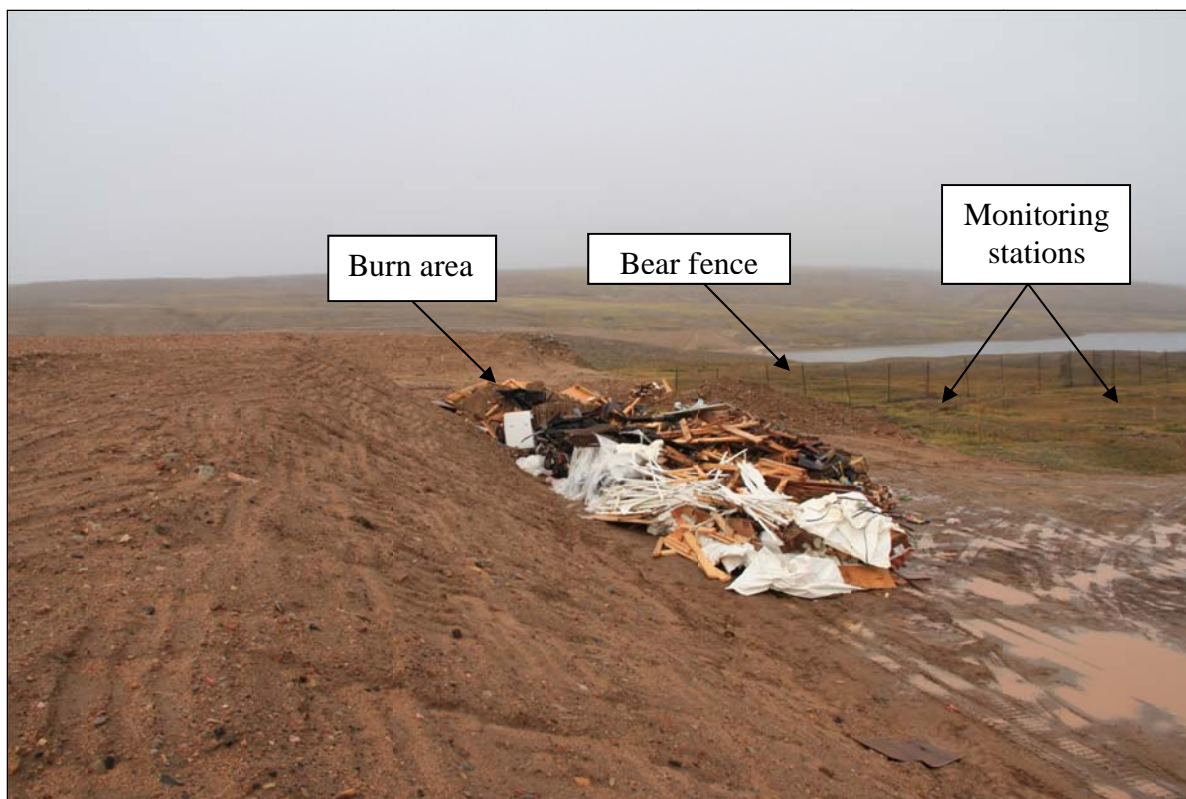
Photo 6. Landfill

Leachate monitoring points were observed to be located around the landfill (Photo 6). There were also monitoring points and well test pits observed around the ore stockpile (Photo 7 and Photo 8). Baffinland staff noted that the monitoring points and test pits were sampled once a month to ensure that the contact water meets discharge criteria. Mr. Myers further noted that if contact water does not meet criteria, it is treated prior to discharge.

During the site visit, it was observed that the landfill was equipped with a bear fence to keep wildlife (including predators) out (Photo 6). Waste is segregated adjacent to the existing incinerator, and all food waste is incinerated, untreated wood is burned at a designated burn area in the landfill and hazardous waste is stored in labelled drums on top of pallets (Photo 12). All other waste is landfilled. Mr. Curran informed the Monitoring Officer that the new incinerator was scheduled for commissioning in mid-September and that stack testing would be performed following commissioning of the new incinerator (Photo 13 depicts the existing incinerator).

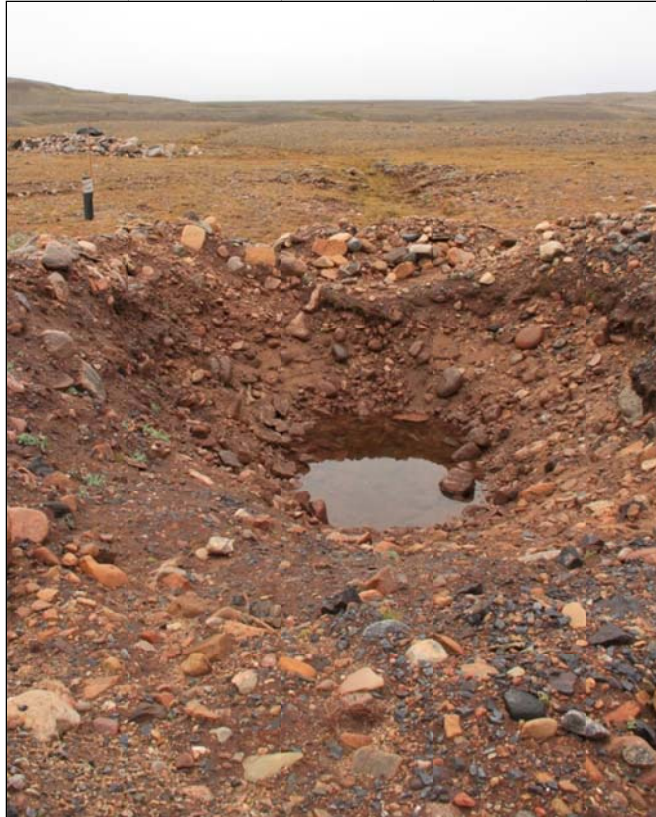
Photo 8. Monitoring Station and well test pit at iron ore stockpile

The Monitoring Officer observed that groundwater monitoring was implemented at the ore stockpile and this was confirmed by Mr. Myers (Photo 8).

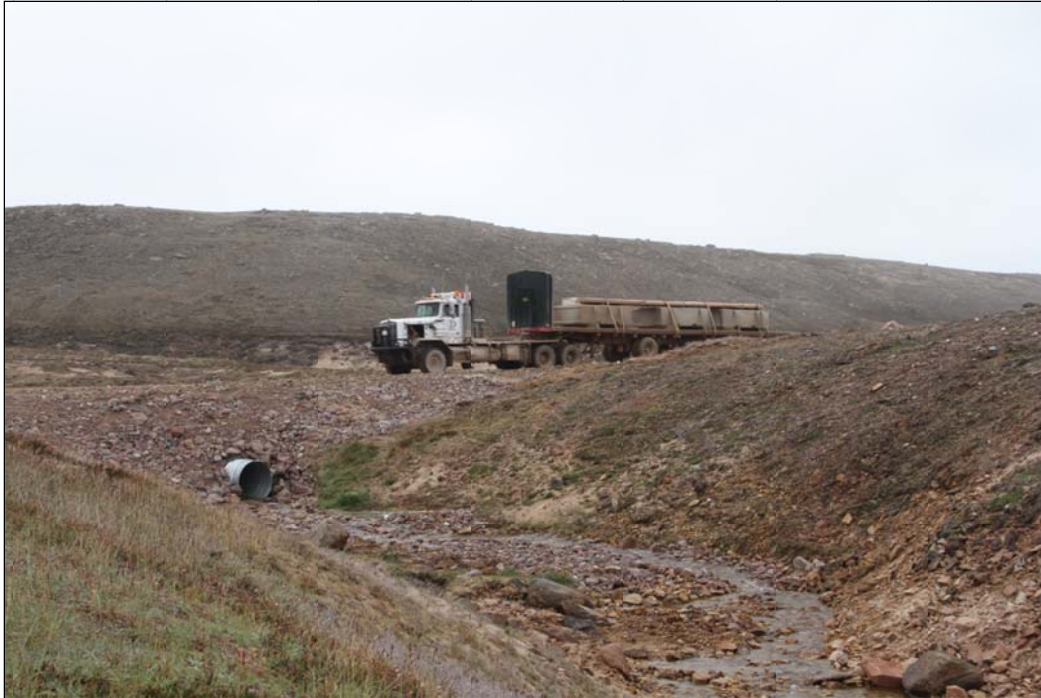
Photo 9. Culvert under the Tote Road

Mr. Myers explained that the culverts and conduits used for the Mary River project had been sized appropriately to allow water to flow naturally and that monitoring was being done on the flow of water out of culverts to determine whether the sizing is appropriate. Several drains were scheduled for replacement due to the discovery that the size of the culvert or drain was too small to allow the natural flow of water (e.g. culvert at KM 80 of the Tote Road).

Mr. Myers also noted that preventative maintenance measures were in place to prevent blockage of the culverts and conduits and that this maintenance was designed based on past experience of having had the Tote Road washed away due to blocked culverts and conduits. Baffinland’s staff indicated that it times the de-icing of the culverts and conduits slightly before break-up so that the culverts and conduits are cleared by snowmelt (Photo 9).

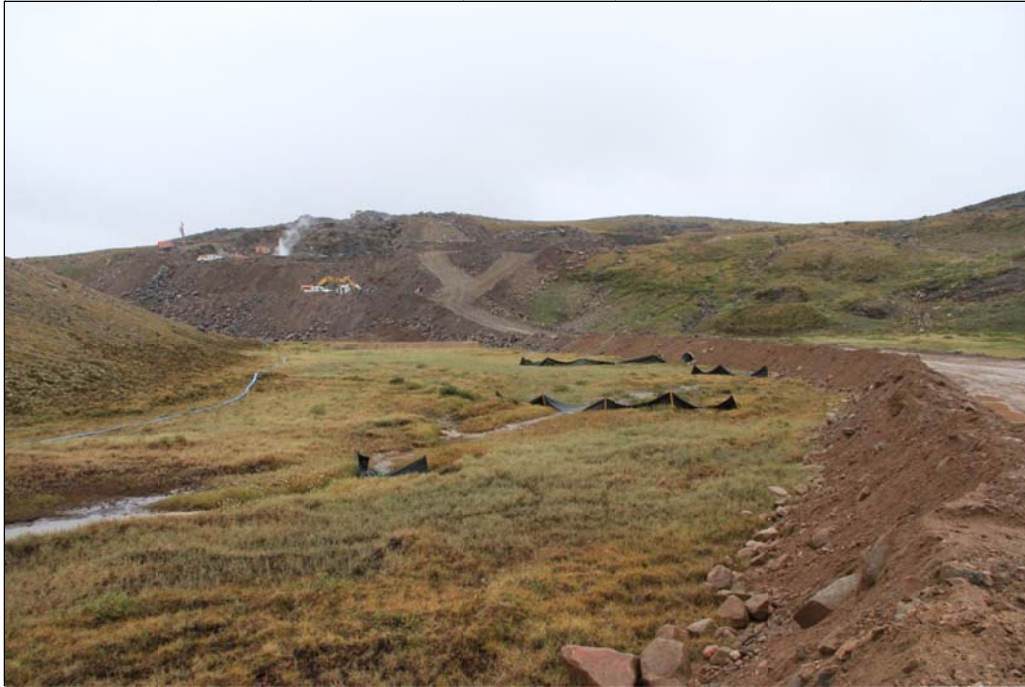
Photo 10. Quarry 2

Quarry 2 located at Mary River and Quarry 1 located at Milne Port were in operation at the time of the site visit. It was observed by the Monitoring Officer that the distance between the quarries and the nearest waterbodies was more than 100 metres (Photo 10 and Photo 11). The Monitoring Officer observed no evidence of a waterbody close to Deposit 1, although Deposit 1 was not in operation at the time of the site visit.

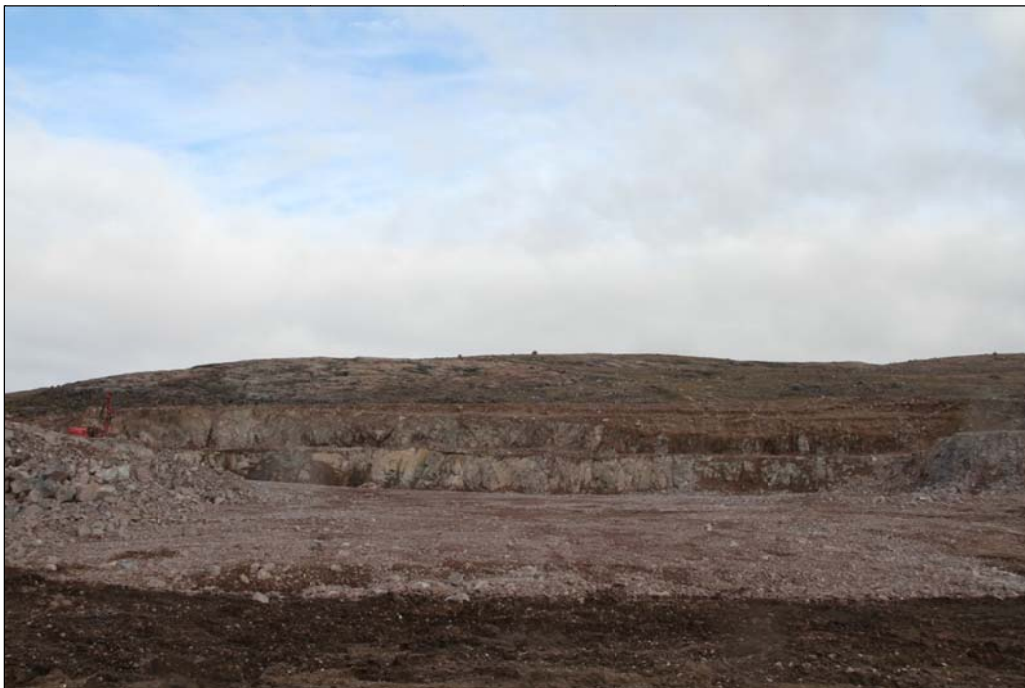
Photo 11. Quarry 1

- c. Construction was underway at Milne Port, with Quarry 1 in full operation mode (refer to Photo 11). The Milne Port fuel tank farm was under construction, where two 12 million-litre (ML) fuel tanks were being constructed (refer to Photo 17) and a 750,000 L tank was scheduled for construction. The permanent hard-wall camps were currently being erected at Milne Port. The generator sets were ready for assembly and were being stored at the Milne Port laydown area.

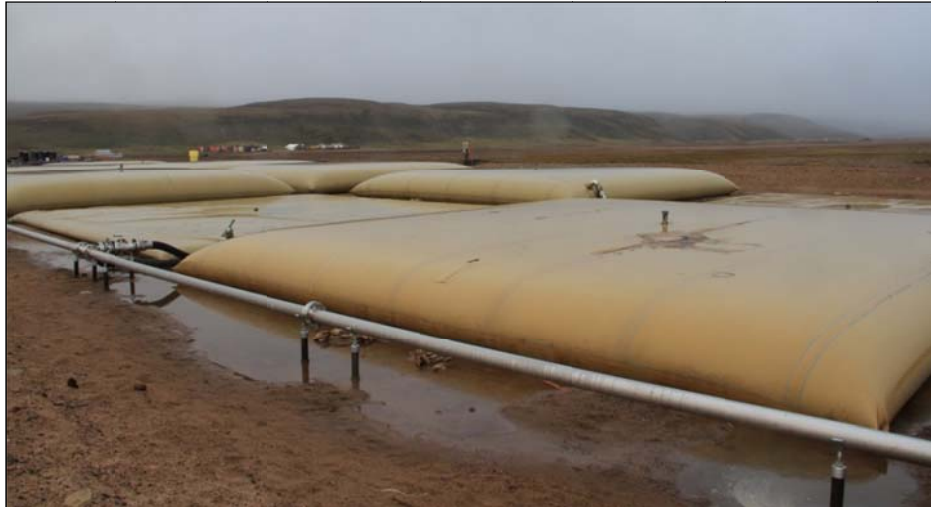
Photo 14. Fuel bladders

During the site visit, the Monitoring Officer observed that fuel storage bladders were used to store fuel at Mary River (Photo 14). Some fuel leakage was observed around the fuel bladders (Photo 15). There also appeared to be a significant amount of contact water pooled around the fuel bladders (Photo 16). Mr. Myers explained that all contact water is pumped and treated prior to discharge.

Although there are no specific term and conditions pertaining to the operation of fuel storage facilities, the Monitoring Officer noted significant contact water and in some areas, evidence of fuel leakage at the fuel storage facilities.

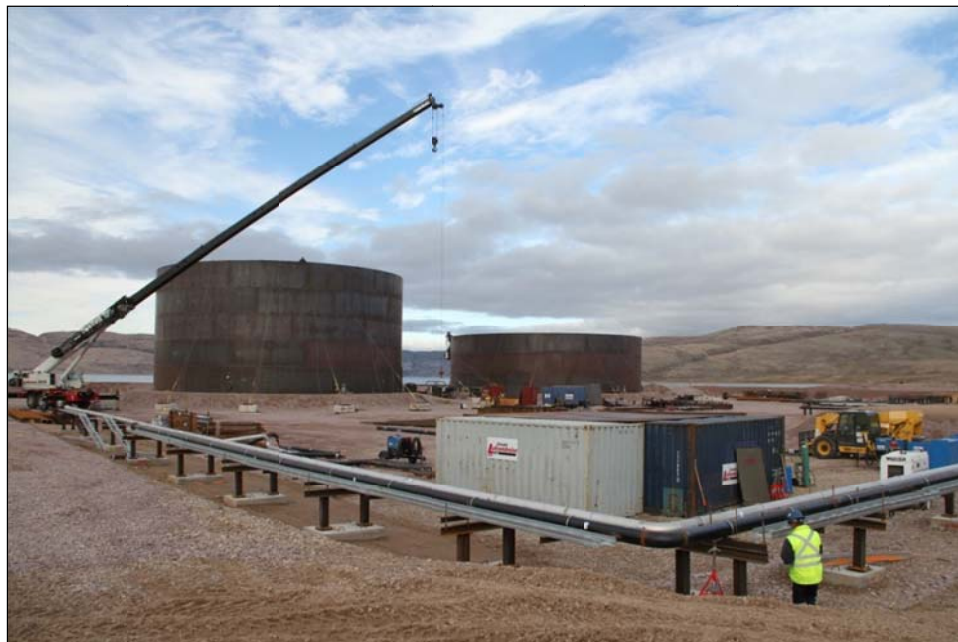
Photo 17. Milne Port fuel storage facility

During the site visit, the fuel storage facility at Milne Port was undergoing construction (Photo 17). Two 12 million-litre (ML) tanks were under construction and a 750,000 L tank was scheduled for construction shortly. An observation of the fuel storage facility revealed that there was some standing water inside the bermed area (Photo 18).
