WATER MANAGEMENT P-CULV-13

BAFFINLAND IRON MINES
MARY RIVER PROJECT

**North/South Consultants Inc.**
Aquatic Environment Specialists

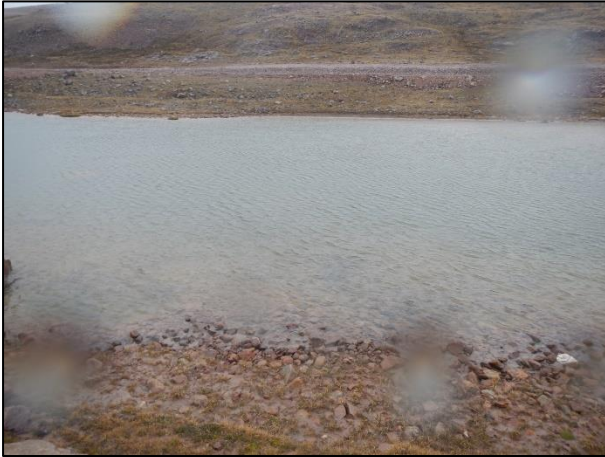
A

Fish were not observed in this small, shallow pond. The pond lacks a defined inflow or outflow, is isolated from other waterbodies, and lacks sufficient depth for overwintering of either fish species.

Photos 1. Photos of the pond in spring: (A) facing east; (B) facing south; and (C) facing north.
