# PORT SITE P-CULV-20

<b>Site ID:</b>	P-Culv-20	<b>Dates Surveyed:</b>	18-Jun-19; 2-Sep-20	<b>Waterbody Type:</b>	Pond
<b>Project Interaction:</b>	Pond Infilling + Culvert	<b>Centreline UTM Coordinates:</b>	17W 503260 E 7974699 N	<b>Culvert Length (m):</b>	22.092
<b>Number of Barrels:</b>	1	<b>Culvert Diameter/Span (mm):</b>	900	<b>Slope (%):</b>	1.3

BAFFINLAND IRON MINES  
MARY RIVER PROJECT

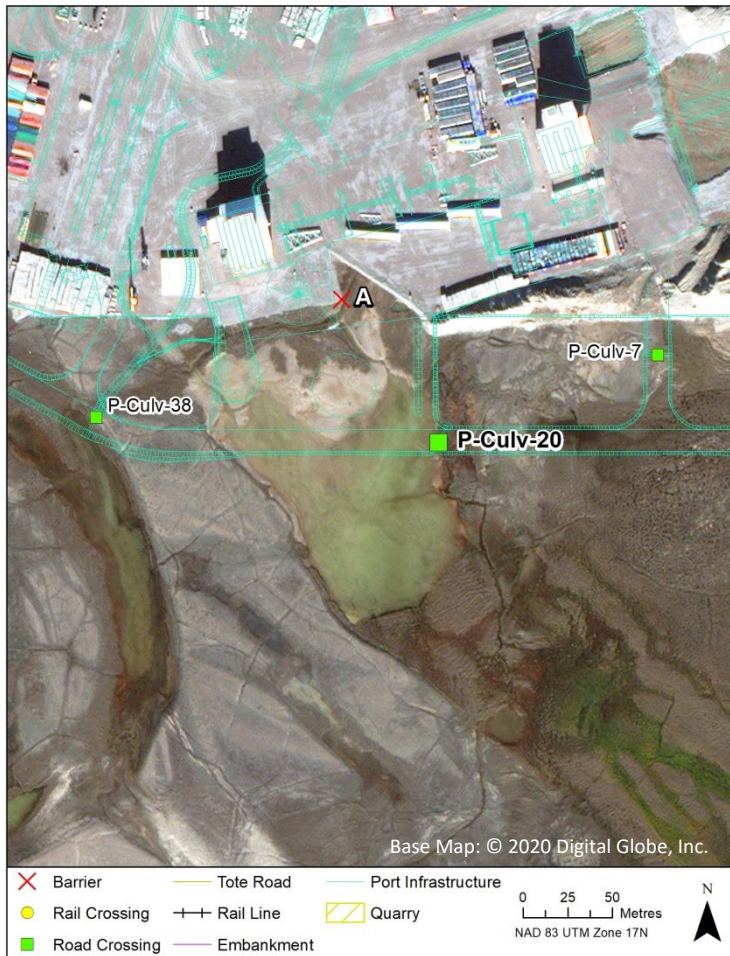
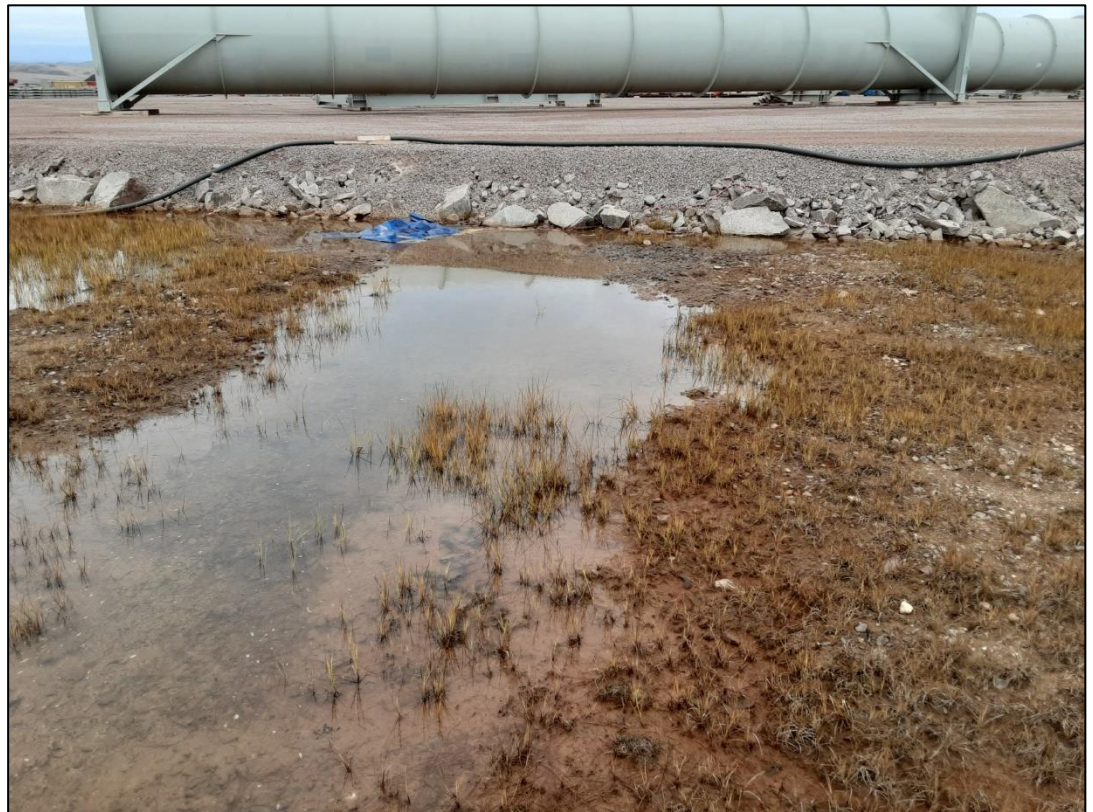
Upstream/ Downstream	UTM		Barrier Type			Height (m)	Gradient (°)	Description	Site Label
	Easting	Northing	1	2	3				
Downstream	503206	7974779	SSF					Permanent barrier: Existing laydown area	A

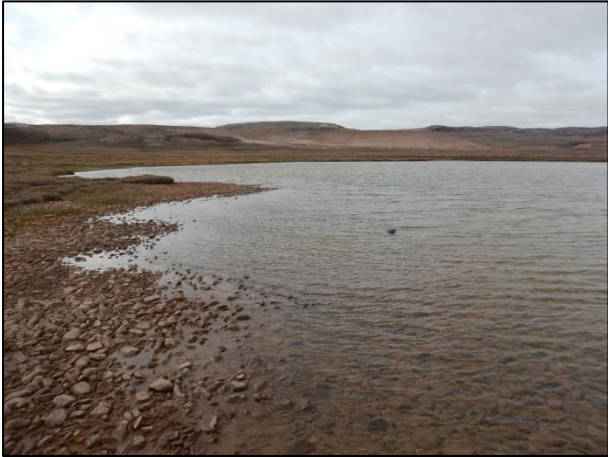
A

**Photos 1.** Photos at the site in spring 2019 (top) and fall 2020 (bottom): (A) looking south; (B) looking north; (C) looking at the drainage ditch outflow prior to laydown construction; and (D) looking upstream at the pond's inflow, (E) looking downstream (north) from the inflow; and (F) the outflow drainage post-construction.

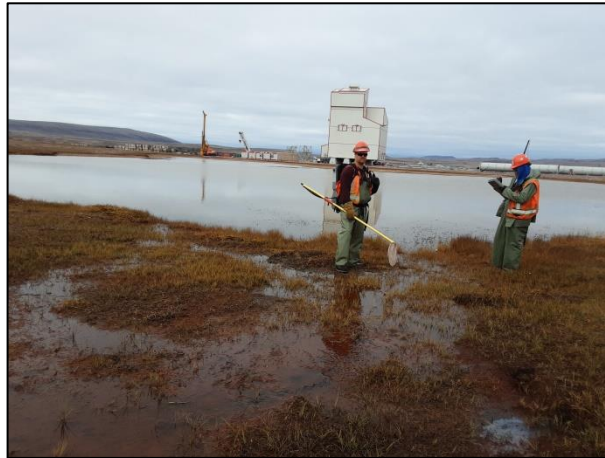
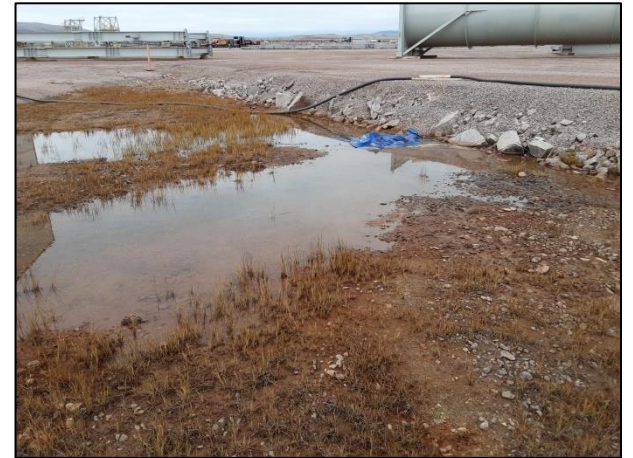
No fish were captured via electrofishing or observed in the pond in spring 2019 or fall 2020. There was no natural access from Phillips Creek prior to laydown construction and now the pond outflow is beneath the laydowns. No fish habitat in this pond.
