PORT SITE P-CULV-34

LOCATION AND CROSSING DESCRIPTION

BAFFINLAND IRON MINES
MARY RIVER PROJECT

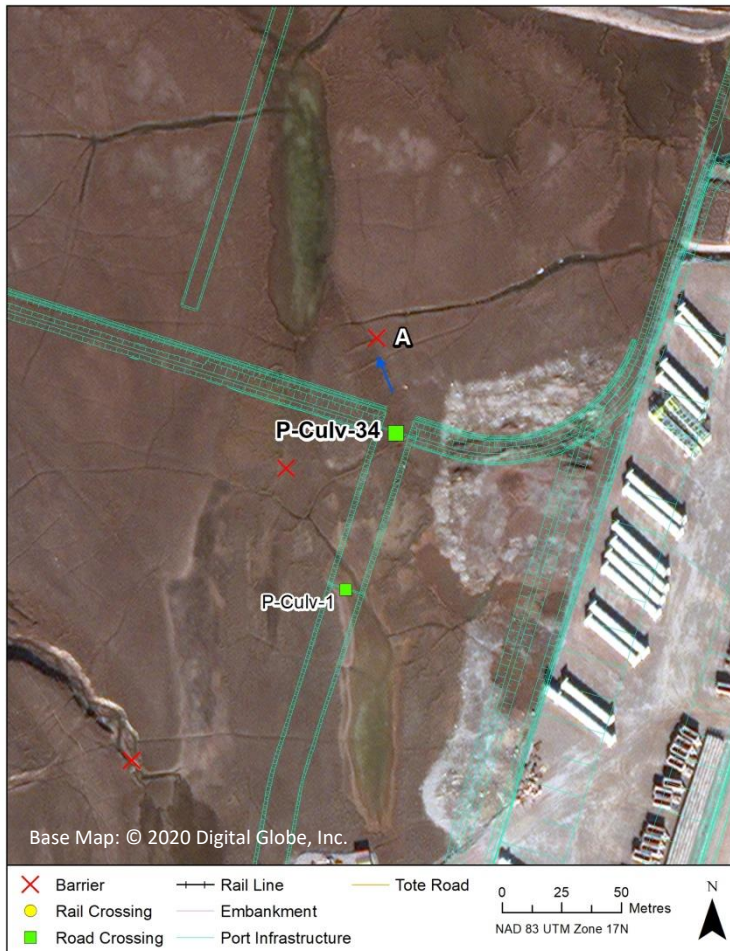
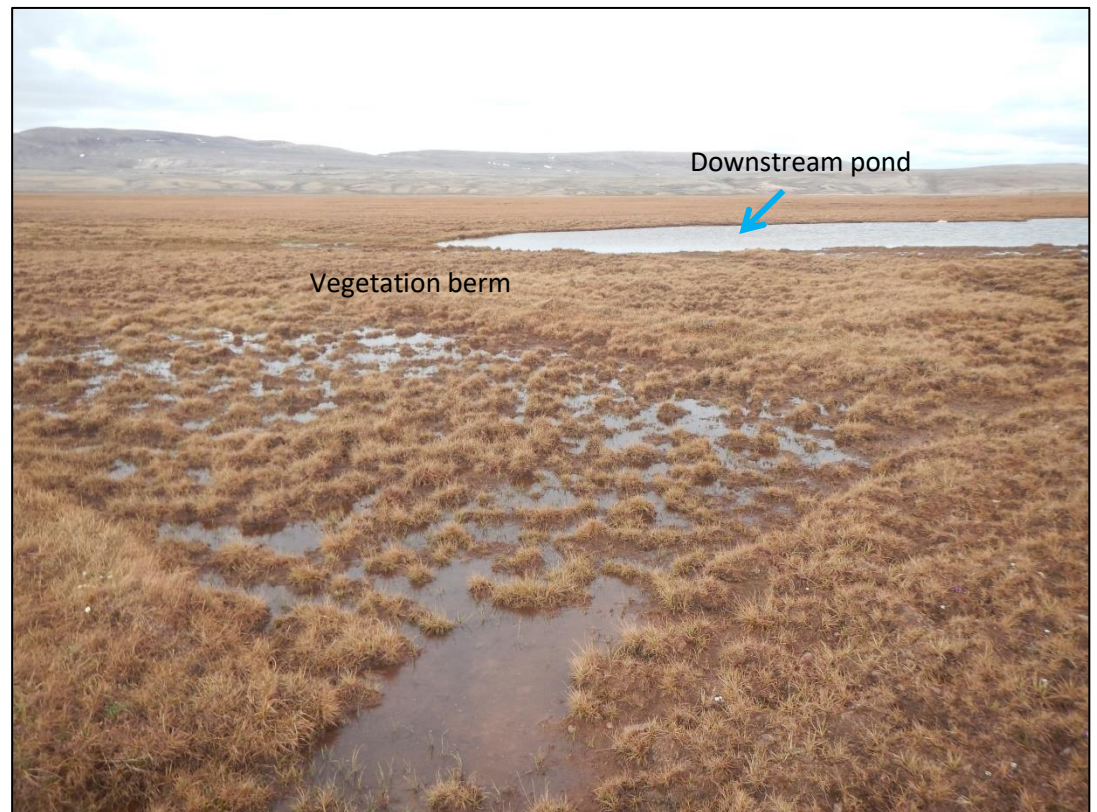
Upstream/ Downstream	UTM		Barrier Type			Height (m)	Gradient (°)	Description	Site Label
	Easting	Northing	1	2	3				
Downstream	503066	7975519	SSF					Permanent barrier: No surface water connectivity downstream from vegetation berm at this location	A
Upstream	NO INFLOW TO UPSTREAM POND

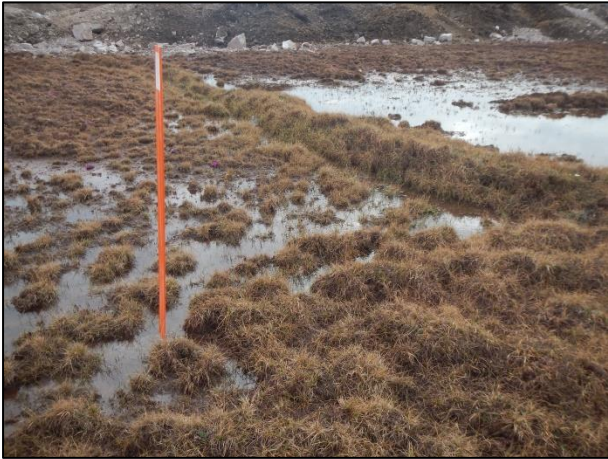
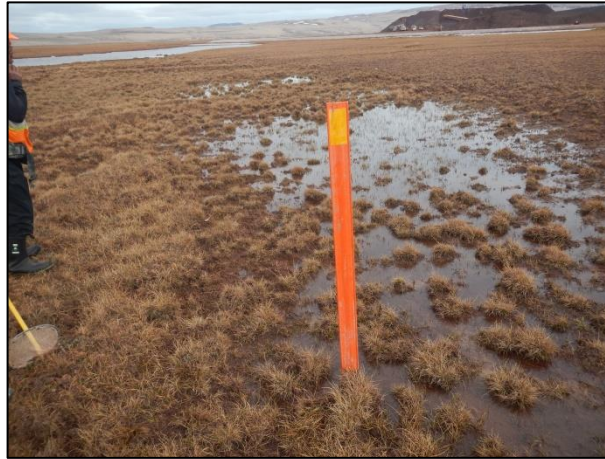
The site was an isolated, shallow marshy area in spring 2019. No fish were observed. There is no connectivity to overwintering habitat and the site is not fish-bearing.

Photos 1. Photos taken at the culvert centreline in spring: (A) facing east; and (B) facing north.
