PORT SITE P-CULV-38

BAFFINLAND IRON MINES
MARY RIVER PROJECT

**North/South Consultants Inc.**
Aquatic Environment Specialists

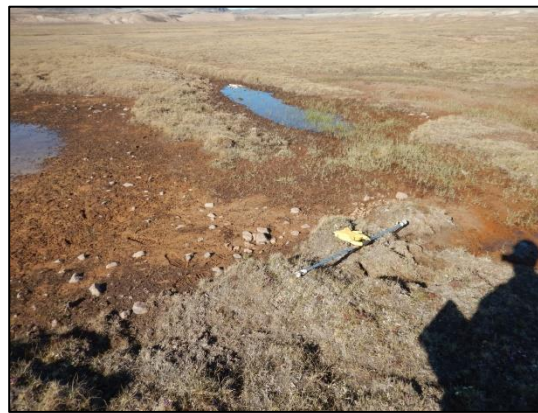
Upstream/ Downstream	UTM		Barrier Type			Height (m)	Gradient (°)	Description	Site Label
	Easting	Northing	1	2	3				
Downstream	503013	7974723	SSF					Permanent barrier: No surface water and no channel at the outflow	A
Downstream	502951	7974755	SSF					Seasonal barrier: No surface water	B
Downstream	502829	7975028	SSF					Permanent barrier: No surface water and no channel connecting to Phillips Creek	C

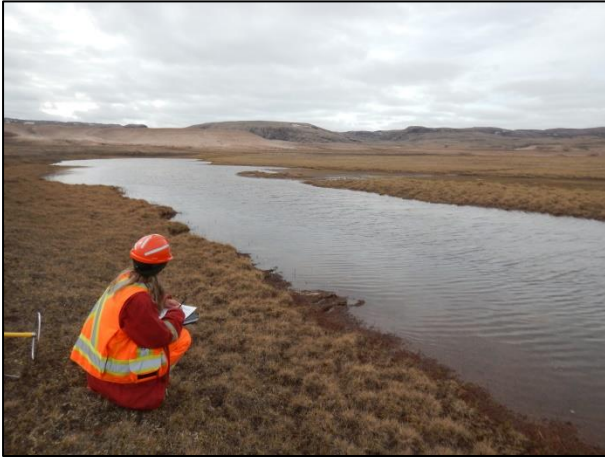
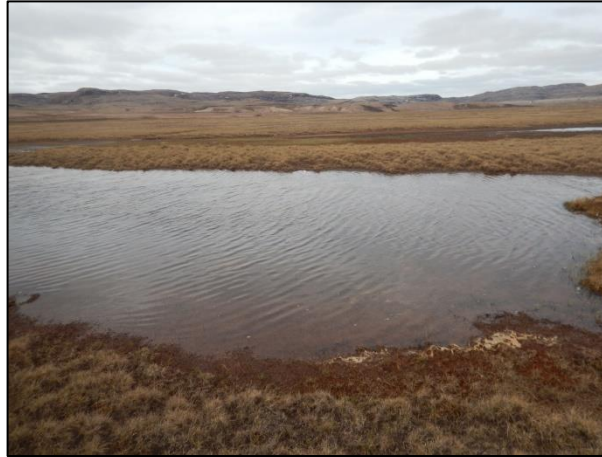
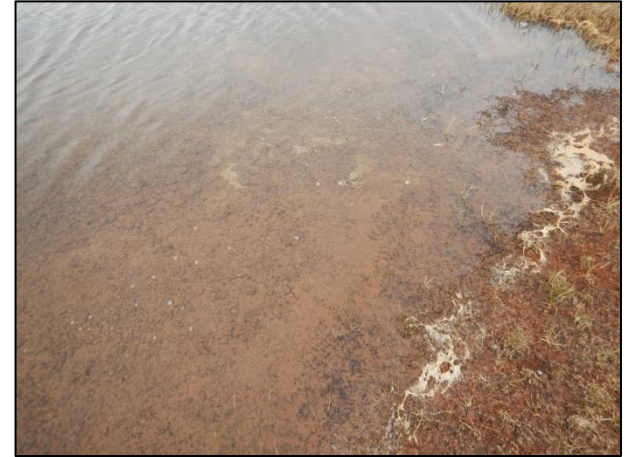
Port area infrastructure includes a pond encroachment and culvert installation at the north end of pond P-Culv-38. The pond is shallow with soft, fine sediment throughout and small amounts of cobble in nearshore habitat. Inflows to the pond are largely diffuse. The outflow is a small stream with multiple subsurface flow barriers that drains the pond north to Phillips Creek.

Photos 1. Photos of the pond in spring: (A) looking north; (B) looking east; and (C) looking at nearshore substrate.
