PORT SITE P-CULV-1

LOCATION AND CROSSING DESCRIPTION

BAFFINLAND IRON MINES
MARY RIVER PROJECT

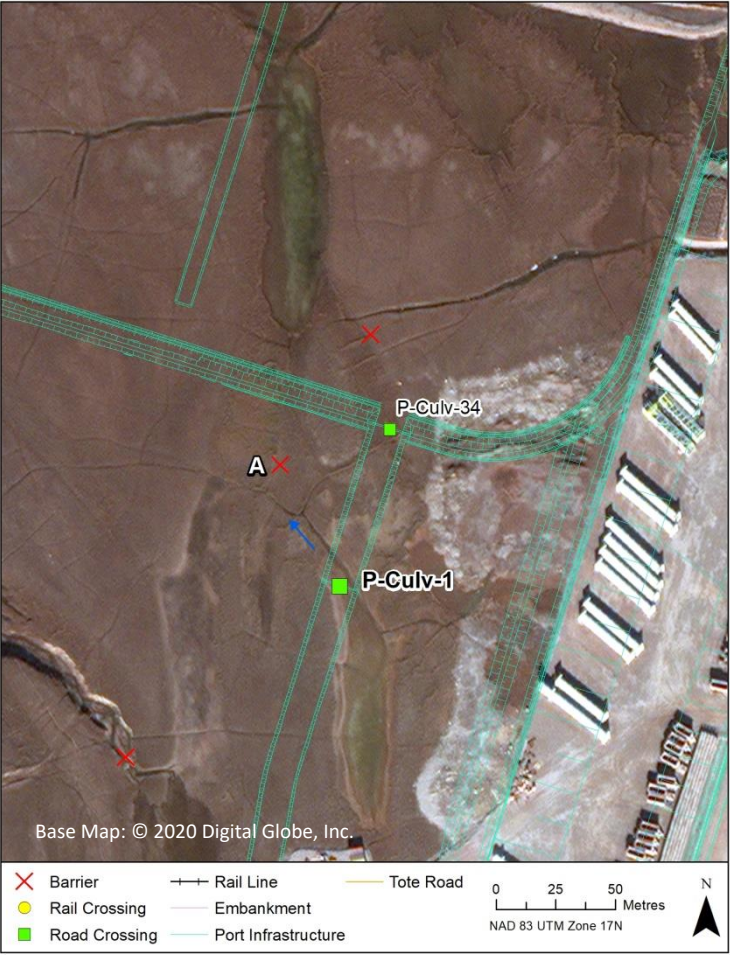
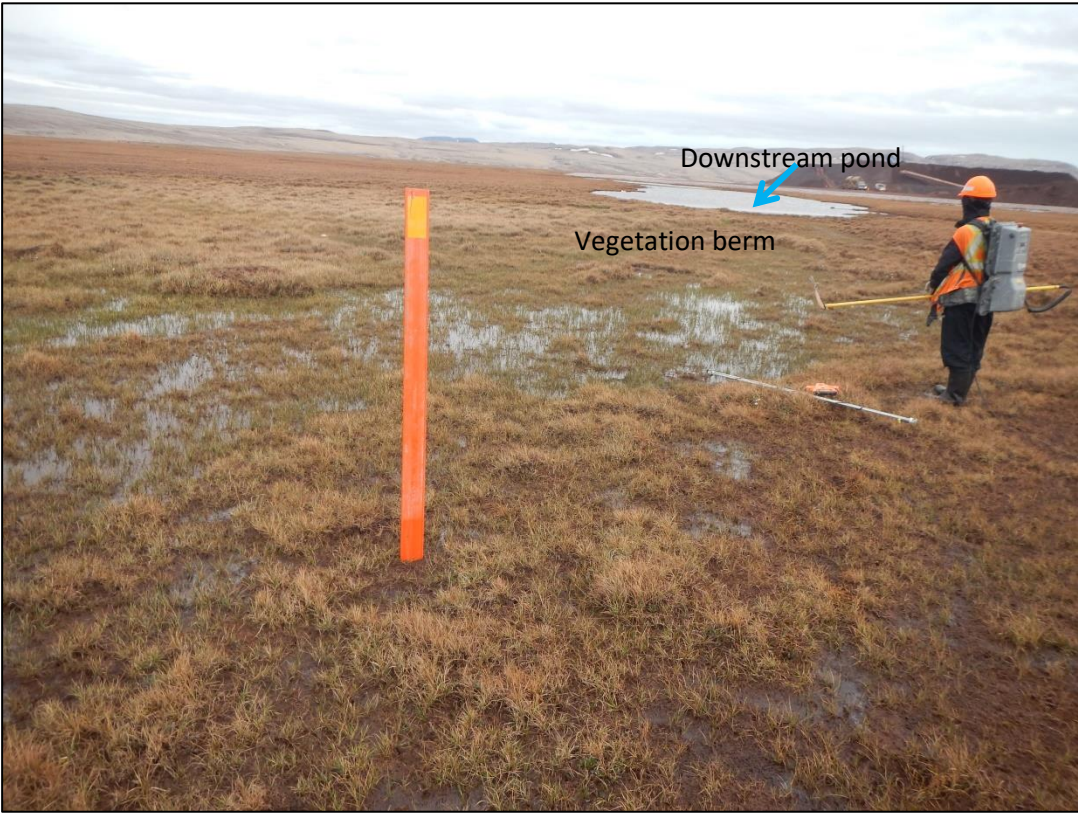
BARRIERS

Upstream/ Downstream	UTM		Barrier Type			Height (m)	Gradient (°)	Description	Site Label
	Easting	Northing	1	2	3				
Downstream	503028	7975464	SSF					Permanent barrier: No surface water connectivity downstream from vegetation berm at this location	A
Upstream	NO INFLOW TO POND

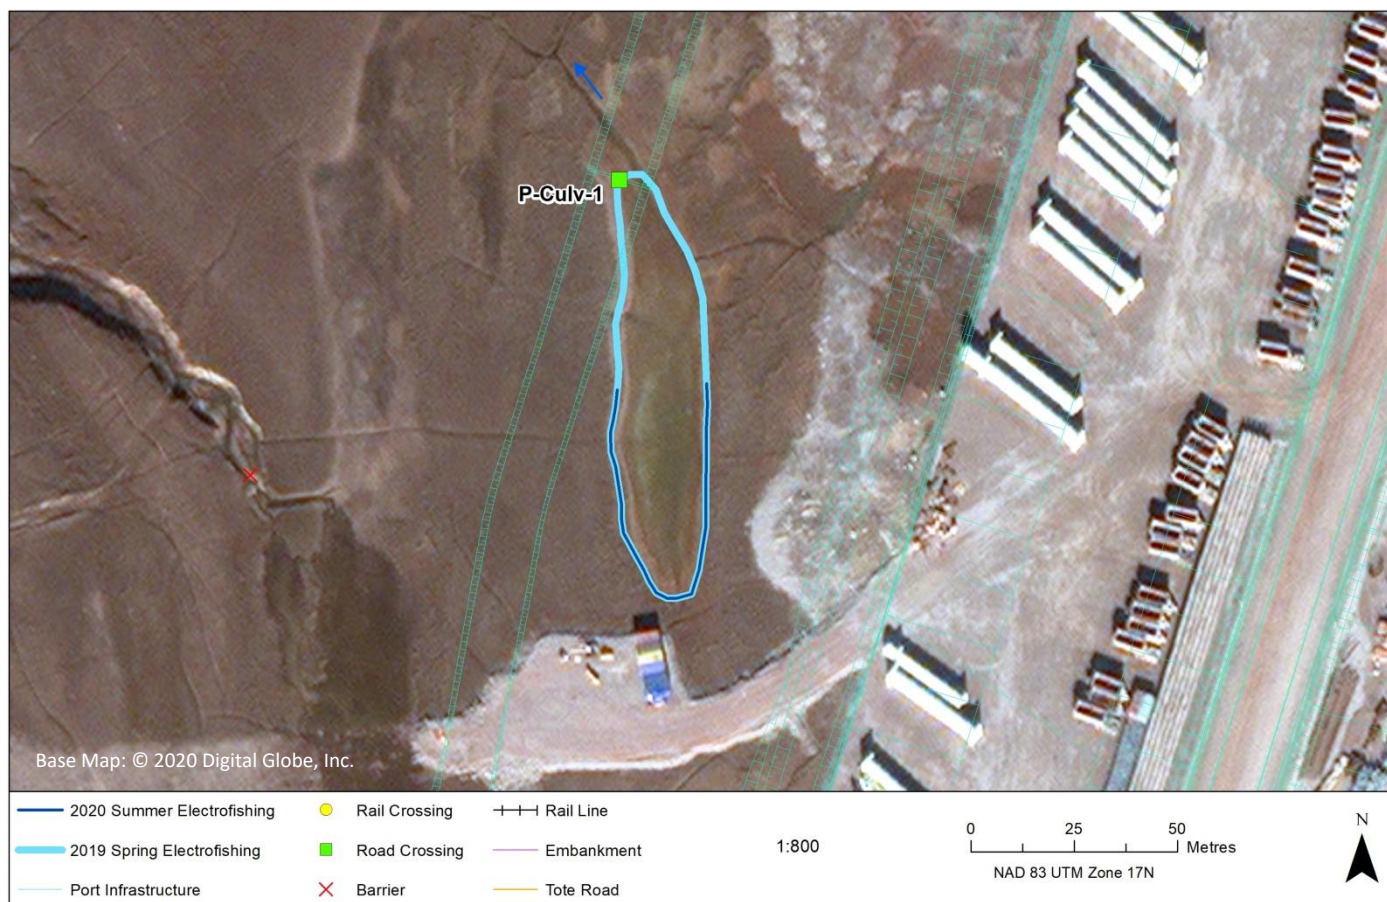
FISHING SITES

No fish were captured via electrofishing or observed in the pond in spring 2019 or fall 2020. Due to its isolation and lack of sufficient depth for overwintering, the pond does not provide fish habitat.

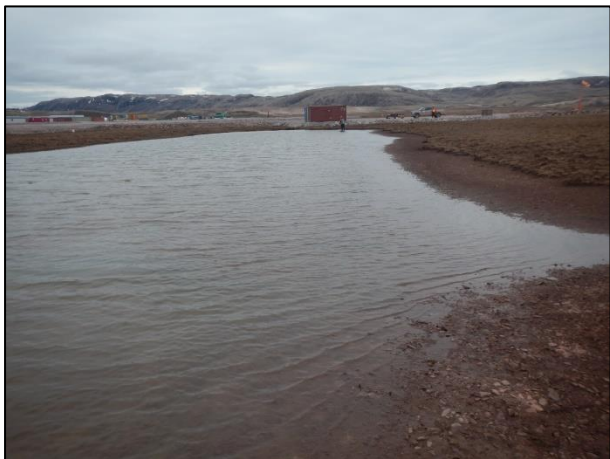
A

Photos 1. Photos at the site in spring 2019 (top) and fall 2020 (bottom): (A,D) looking south; (B,E) looking north; and (C,F) looking at the outflow.

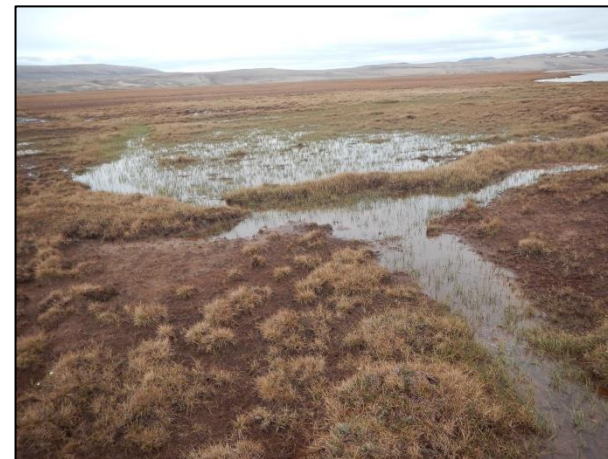
C

There is a permanent barrier, vegetation berm, separating the outflow from habitat farther downstream. The pond is fishless and lacks connectivity to other waterbodies. This pond does not provide fish habitat.
