PORT SITE P-CULV-2

LOCATION AND CROSSING DESCRIPTION

**BAFFINLAND IRON MINES
MARY RIVER PROJECT**

North/South Consultants Inc.
Aquatic Environment Specialists

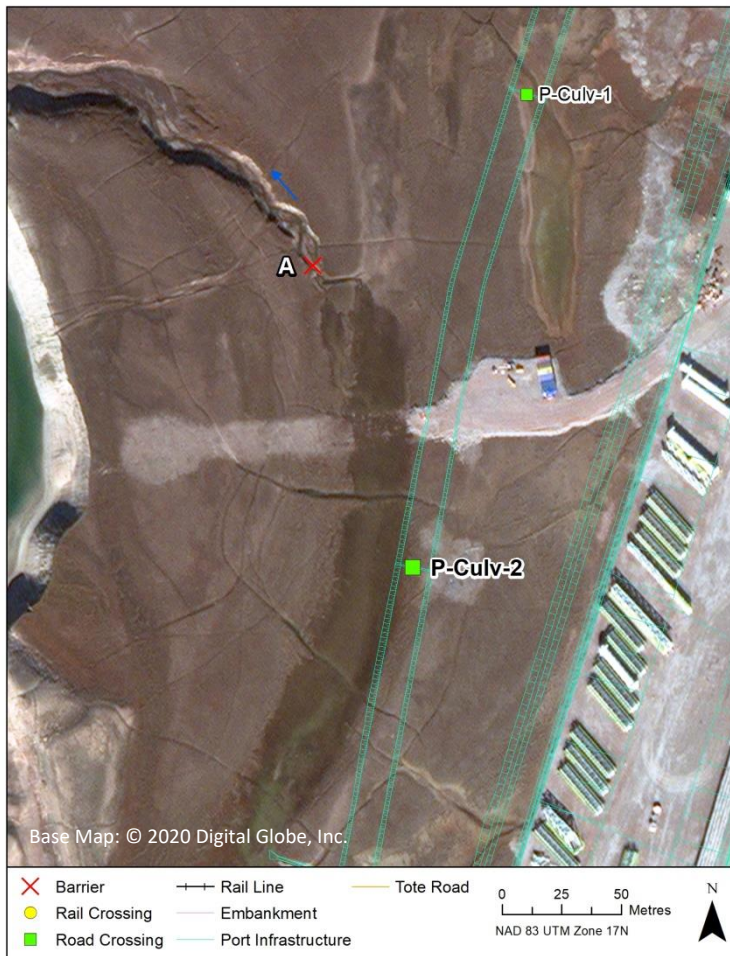
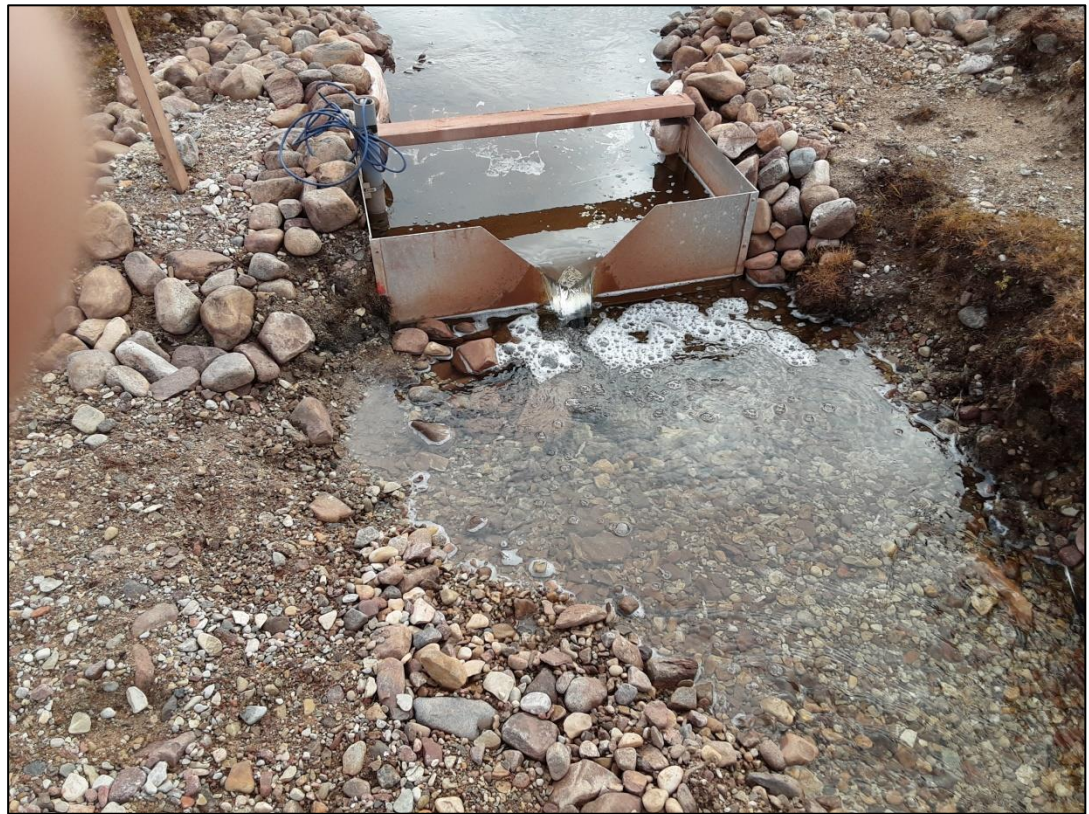
Upstream/ Downstream	UTM		Barrier Type			Height (m)	Gradient (°)	Description	Site Label
	Easting	Northing	1	2	3				
Downstream	502963	7975341	VD					Permanent barrier: Hydrology station downstream prevents fish access to the pond	A
Upstream	INFLOW TO POND AN ARTIFICIAL DIVERSION CHANNEL

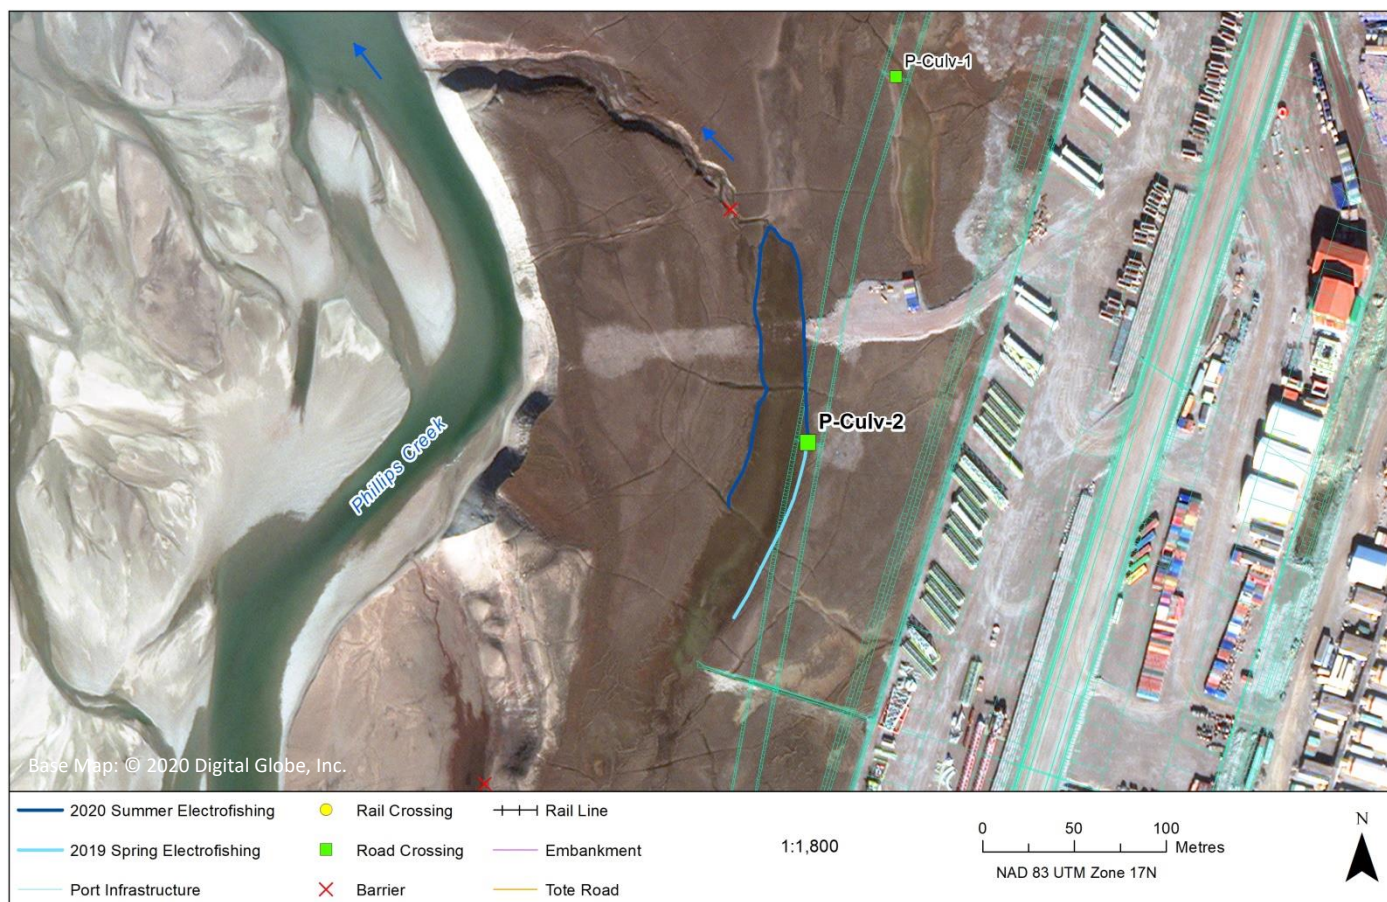
FISHING SITES

No fish were captured via electrofishing or observed in the pond in spring 2019 or fall 2020. Due to the downstream barrier preventing access from Phillips Creek, the pond does not provide fish habitat.

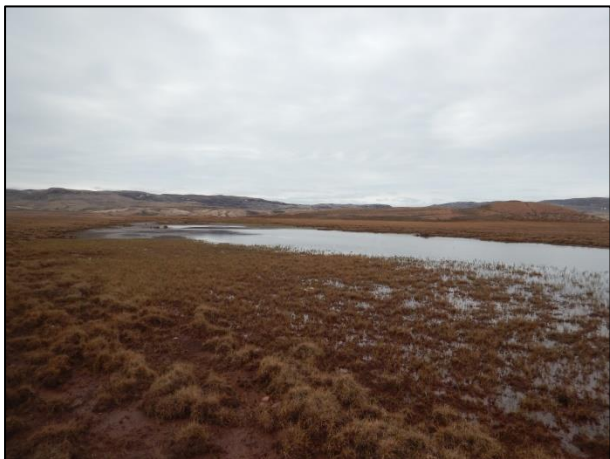
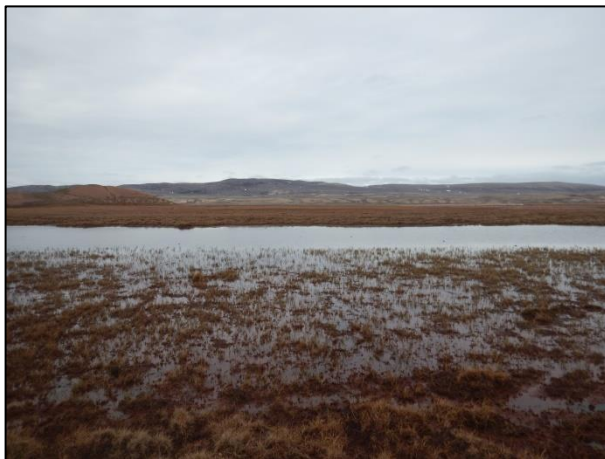
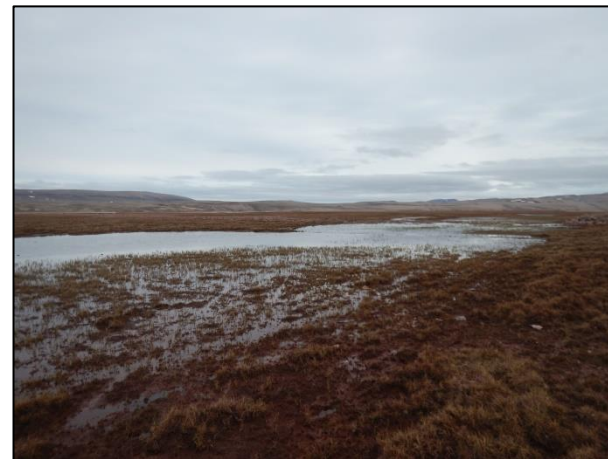
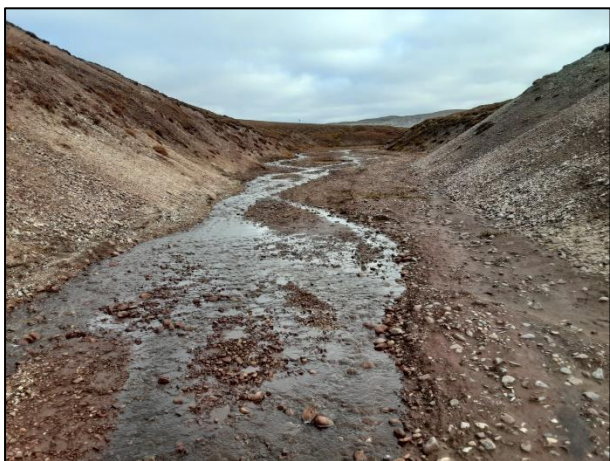
18-JUN-19; 02-SEP-20

Photos 1. Photos at the site in spring 2019 (top) and fall 2020 (bottom): (A) looking south; (B) looking east; (C) looking north; and (D) looking upstream from the outflow's confluence with Phillips Creek.
