RAIL CV-105-3

LOCATION AND CROSSING DESCRIPTION

**BAFFINLAND IRON MINES
MARY RIVER PROJECT**

North/South Consultants Inc.
Aquatic Environment Specialists

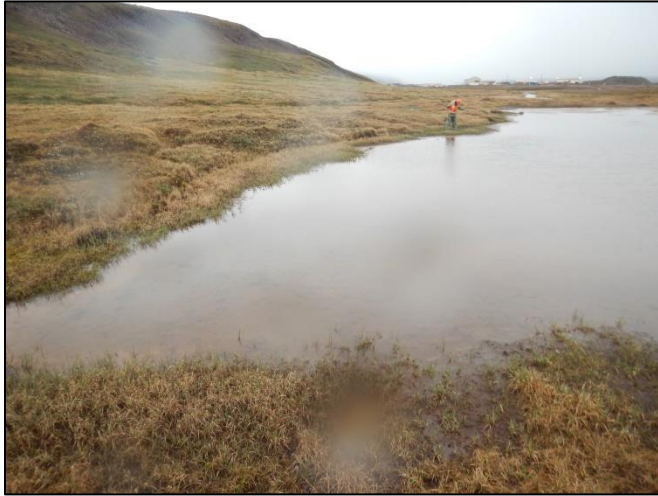
A

Photos 1. Photos taken of: (A) the encroachment area during spring; (B) looking upstream towards inlet during summer/fall; (C) looking downstream towards the outlet during summer/fall; and (D) the encroachment area during summer/fall.
