RAIL CV-105-4

LOCATION AND CROSSING DESCRIPTION

**BAFFINLAND IRON MINES
MARY RIVER PROJECT**

**North/South Consultants Inc.**
Aquatic Environment Specialists

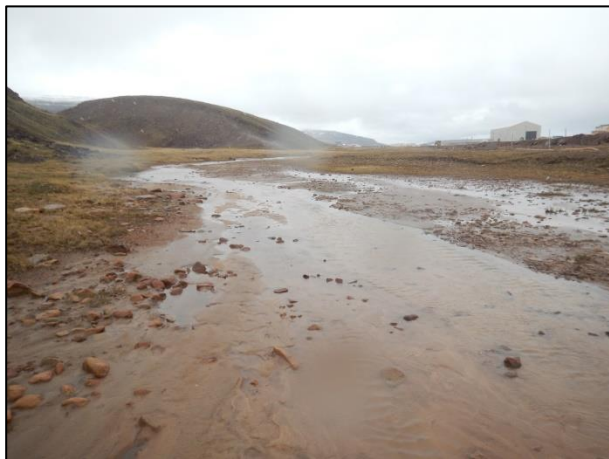
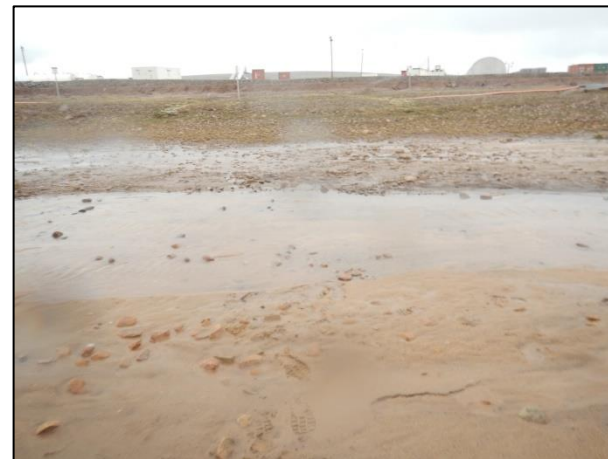
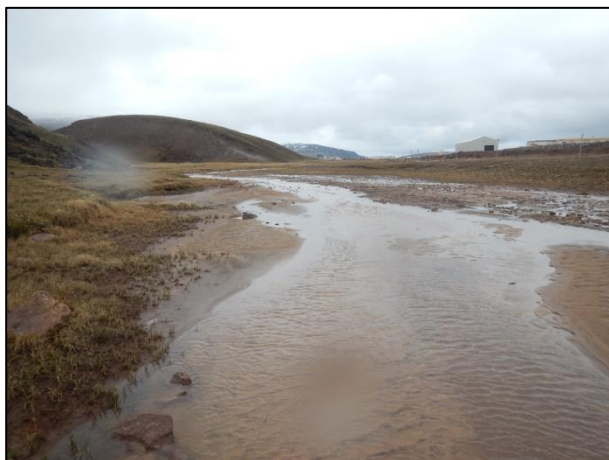
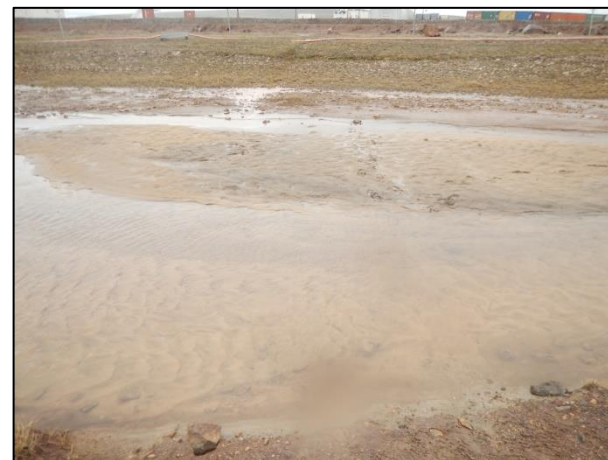
Photos 1. Photos taken at the crossing centreline (top) and 20 m downstream (bottom) in spring: (A,D) facing upstream; (B,E) facing downstream; and (C,F) across (left bank looking at right bank).

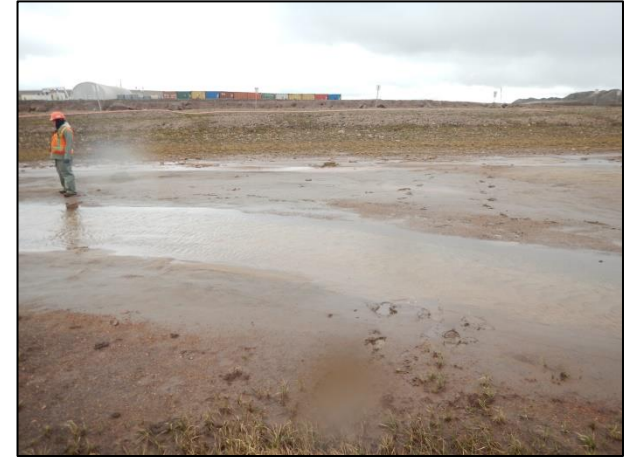
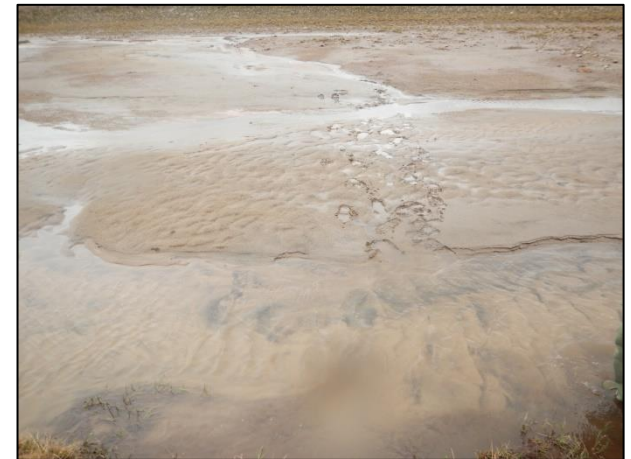
Photos 2. Photos taken 40 m downstream (top) and 60 m downstream (bottom) in spring: (A,D) facing upstream; (B,E) facing downstream; and (C,F) across (left bank looking at right bank).

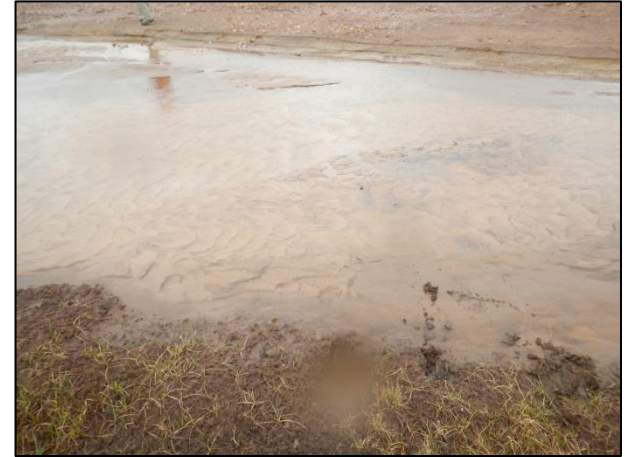
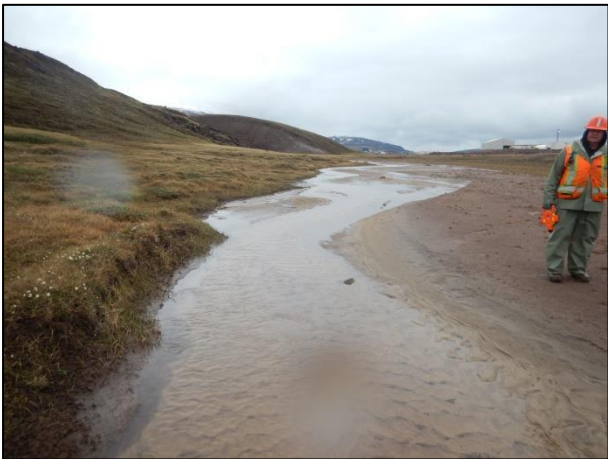
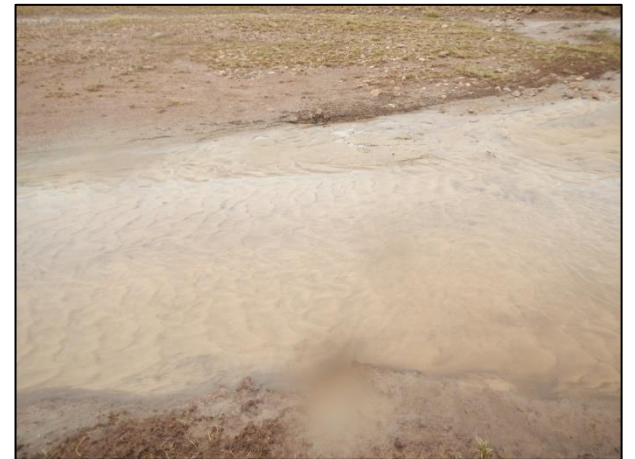
Photos 3. Photos taken 80 m downstream (top) and 100 m downstream (bottom) in spring: (A,D) facing upstream; (B,E) facing downstream; and (C,F) across (left bank looking at right bank).

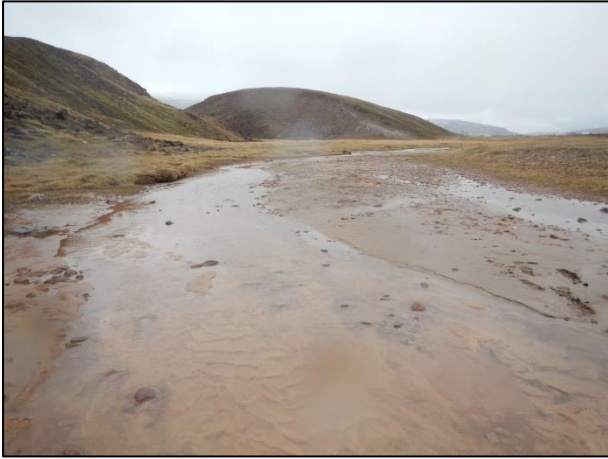
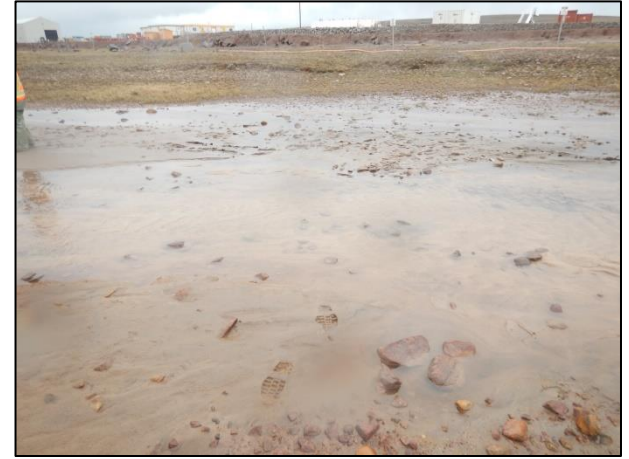
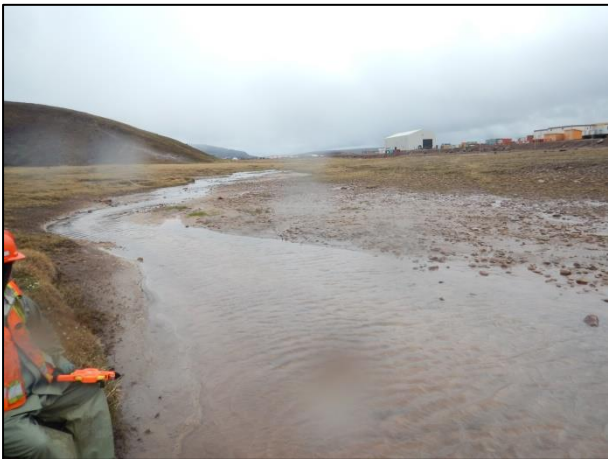
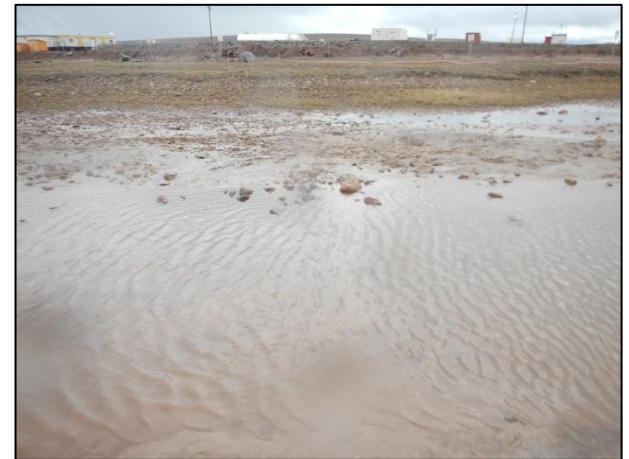
Photos 4. Photos taken 20 m upstream (top) and 40 m upstream (bottom) in spring: (A,D) facing upstream; (B,E) facing downstream; and (C,F) across (left bank looking at right bank).

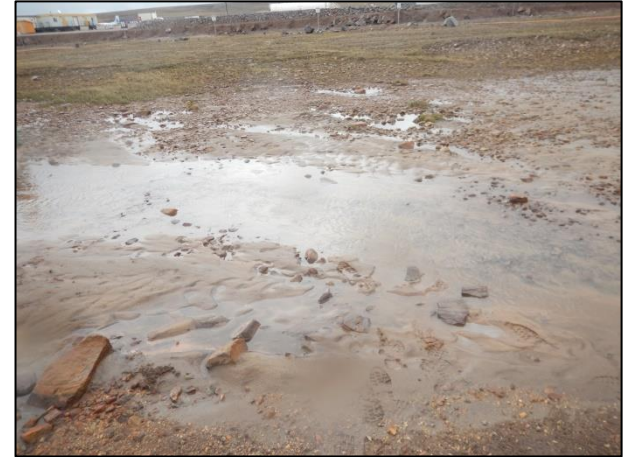
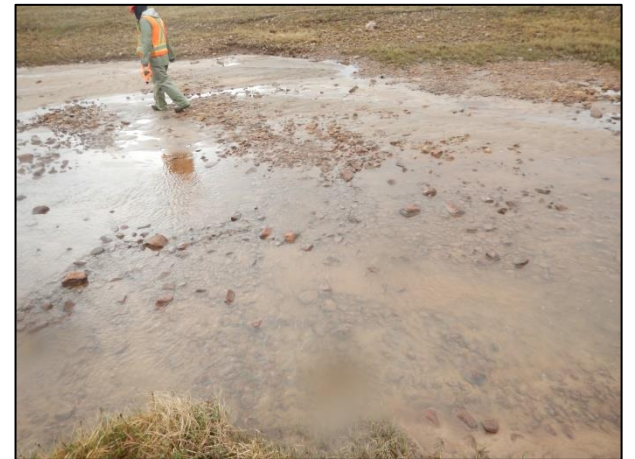
Photos 5. Photos taken 60 m upstream (top) and 80 m upstream (bottom) in spring: (A,D) facing upstream; (B,E) facing downstream; and (C,F) across (left bank looking at right bank).

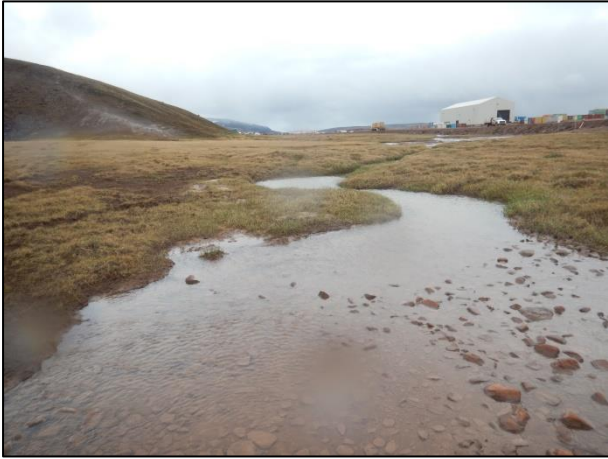
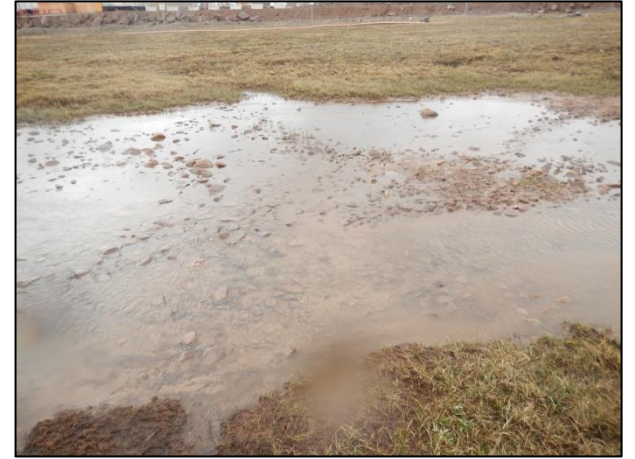
Photos 6. Photos taken 100 m upstream (top) in spring: (A) facing upstream; (B) facing downstream; and (C) across (left bank looking at right bank).

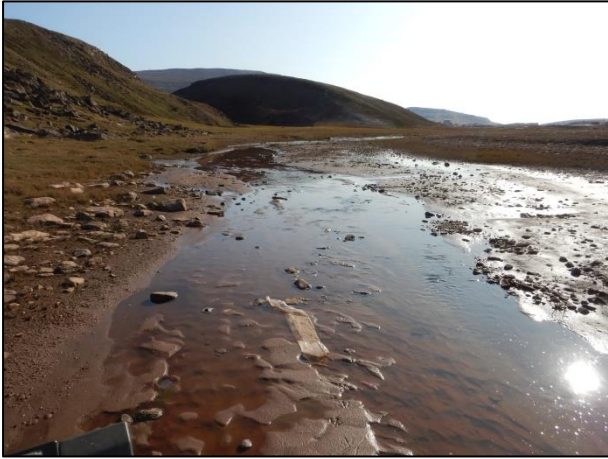
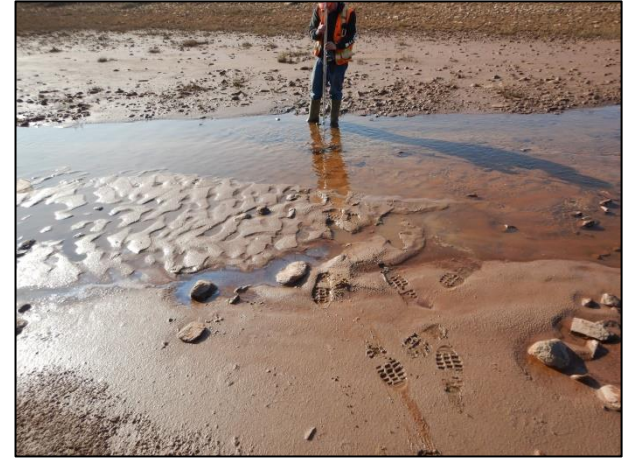
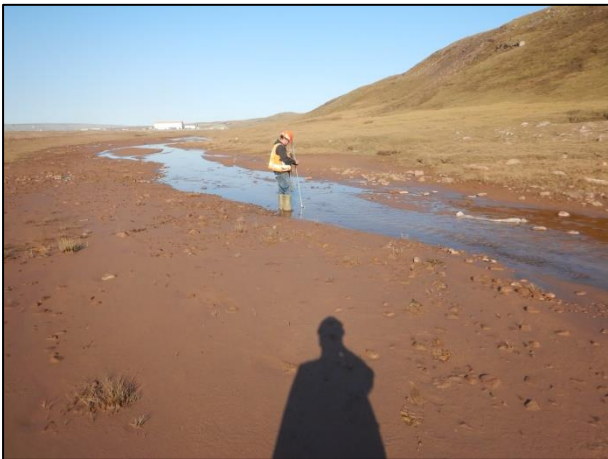
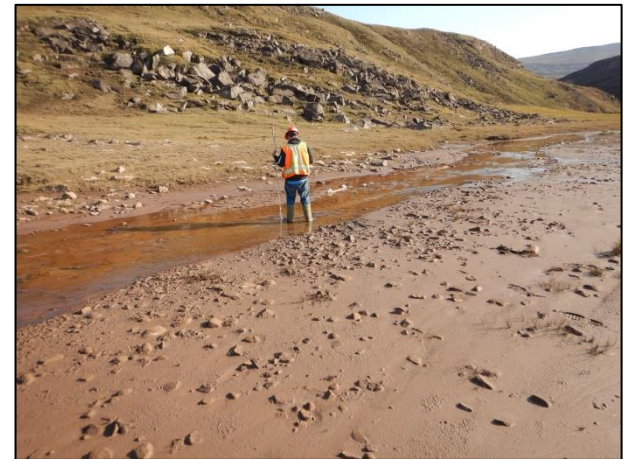
Photos 7. Photos taken at the crossing centerline in summer/fall: (A) facing upstream; (B) facing downstream; (C) across (left bank looking at right bank); (D) diagonal from right bank above the centreline looking downstream; (E) across (right bank looking at left bank); and (F) diagonal from right bank below the centreline looking upstream.

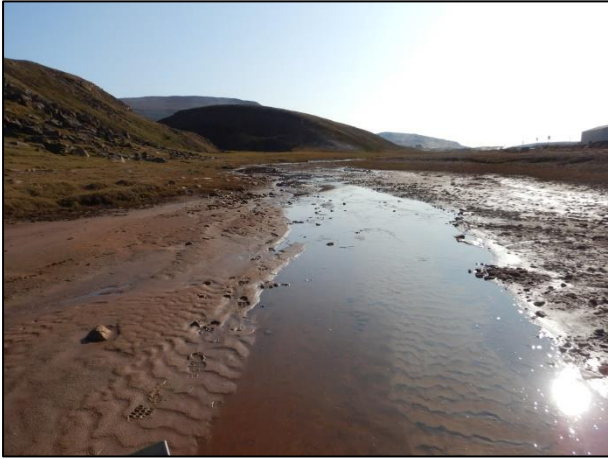
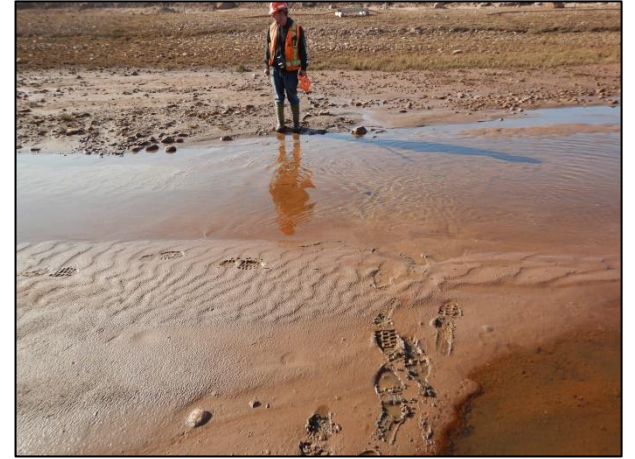
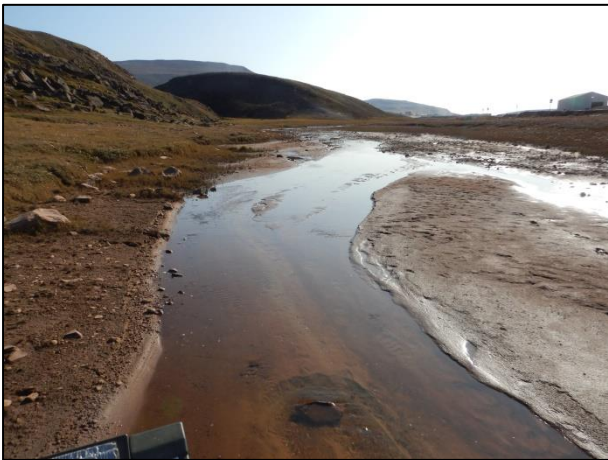
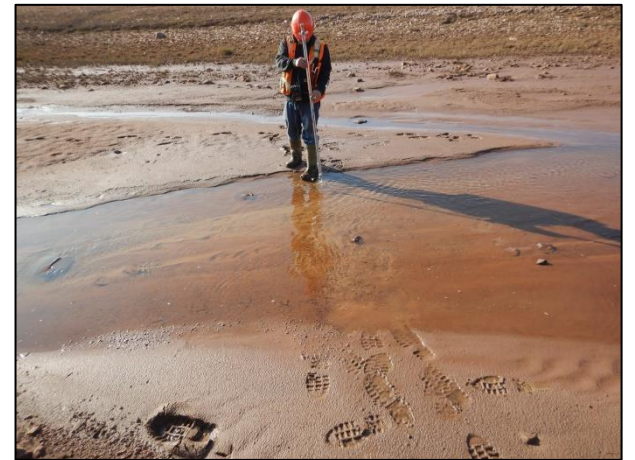
Photos 8. Photos taken 20 m downstream (top) and 40 downstream (bottom) in summer/fall: (A,D) facing upstream; (B,E) facing downstream; and (C,F) across (left bank looking at right bank).

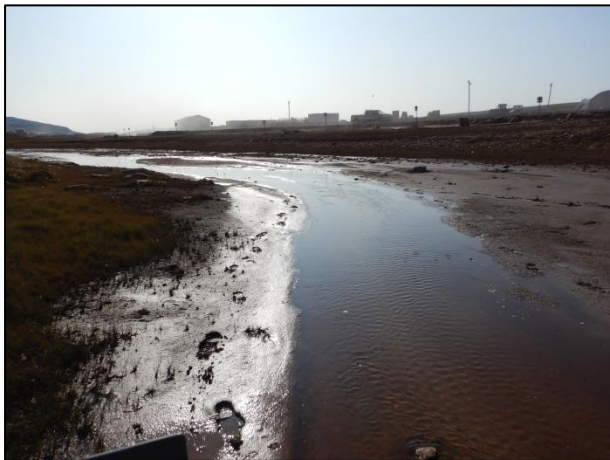
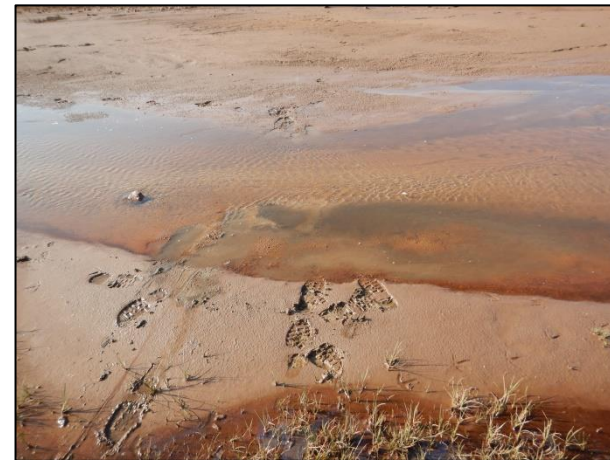
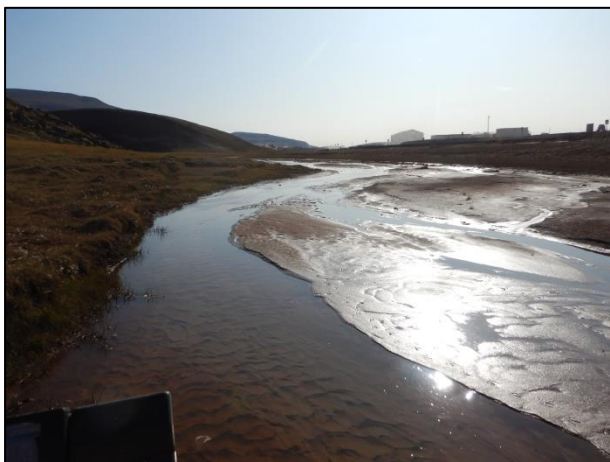
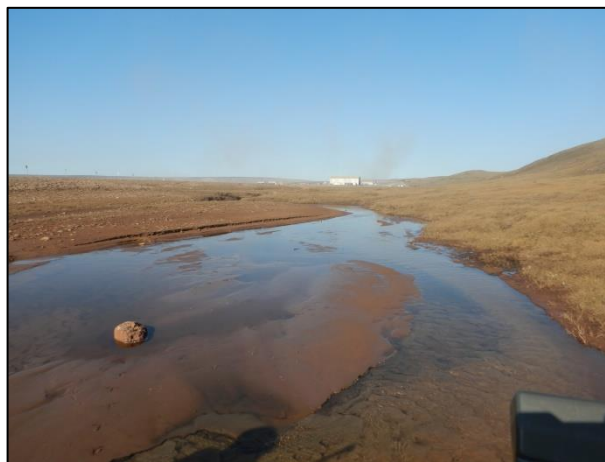
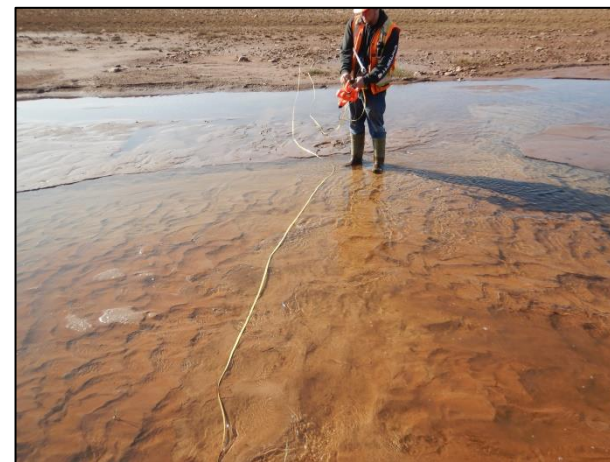
Photos 9. Photos taken 60 m downstream (top) and 80 m downstream (bottom) in summer/fall: (A,D) facing upstream; (B,E) facing downstream; and (C,F) across (left bank looking at right bank).

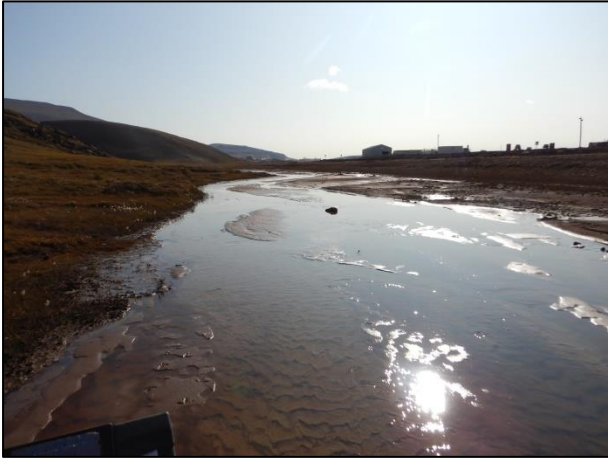
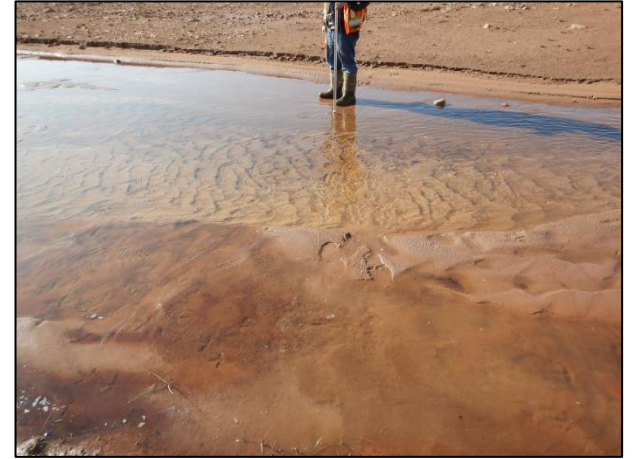
Photos 10. Photos taken 100 m downstream in summer/fall: (A) facing upstream; (B) facing downstream; and (C) across (left bank looking at right bank).

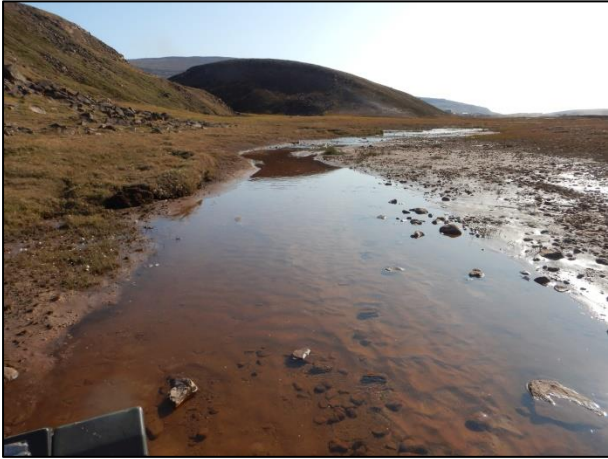
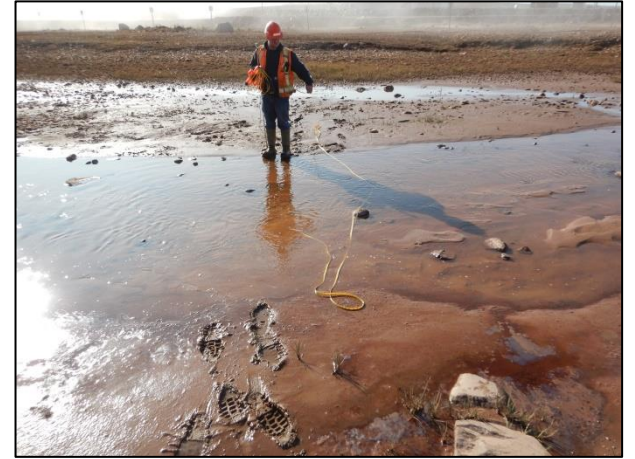
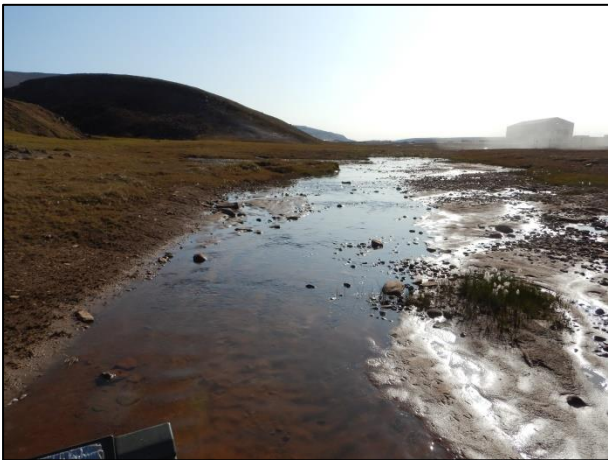
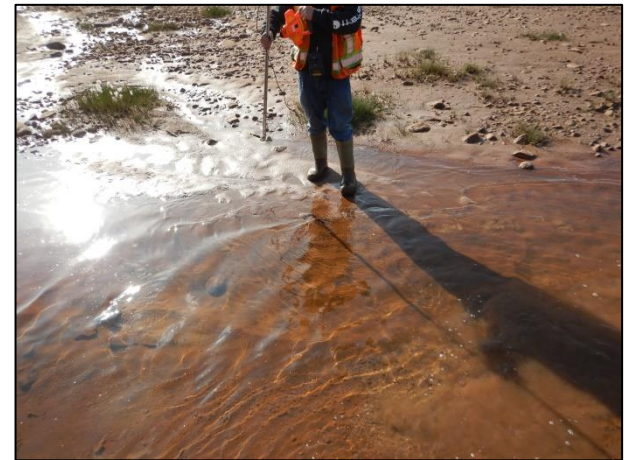
Photos 11. Photos taken 20 m upstream (top) and 40 m upstream (bottom) in summer/fall: (A,D) facing upstream; (B,E) facing downstream; and (C,F) across (left bank looking at right bank).

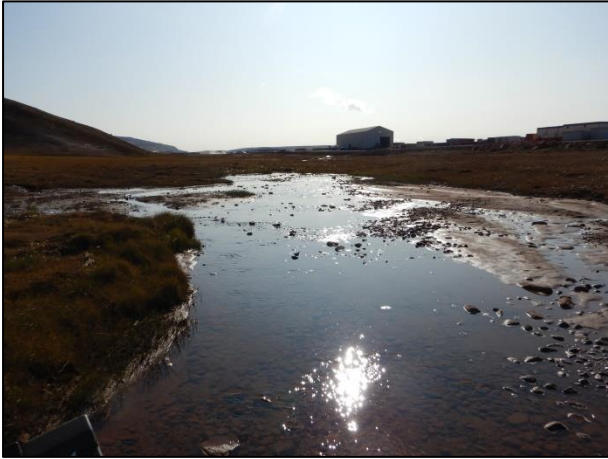
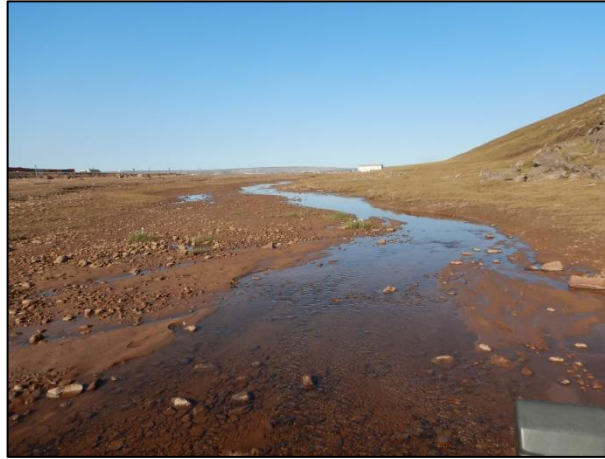
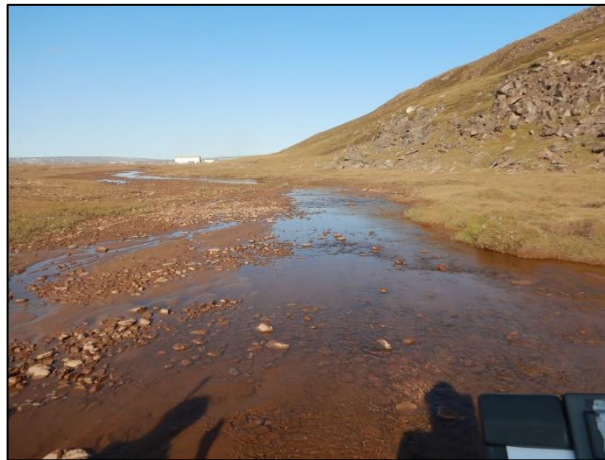
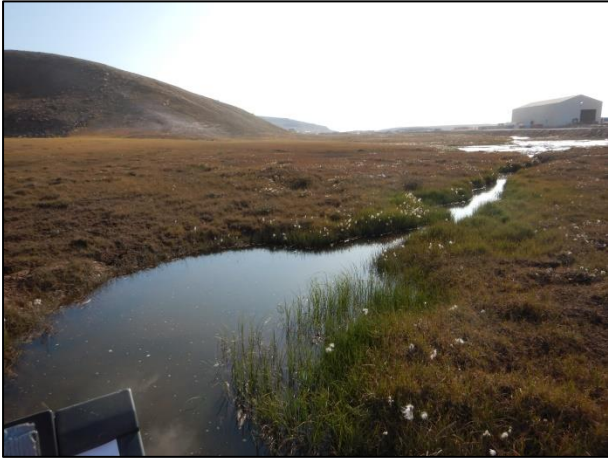
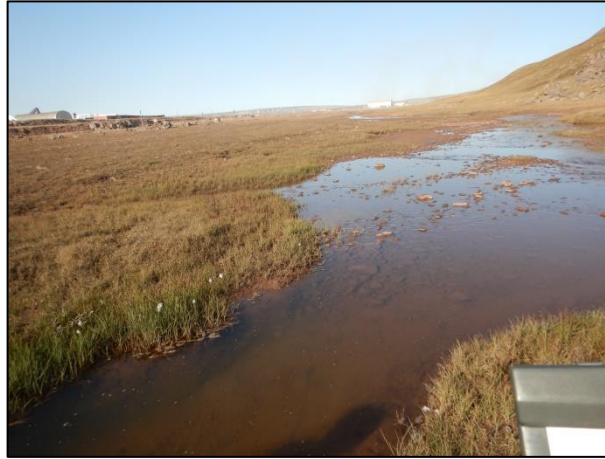
Photos 12. Photos taken 60 m upstream (top) and 80 m upstream (bottom) in summer/fall: (A,D) facing upstream; (B,E) facing downstream; and (C,F) across (left bank looking at right bank).

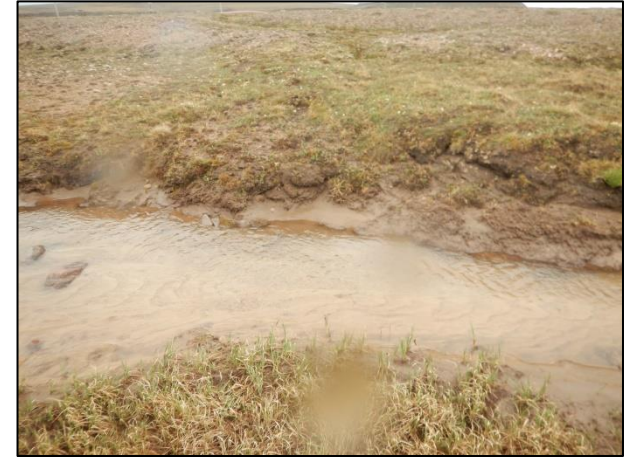
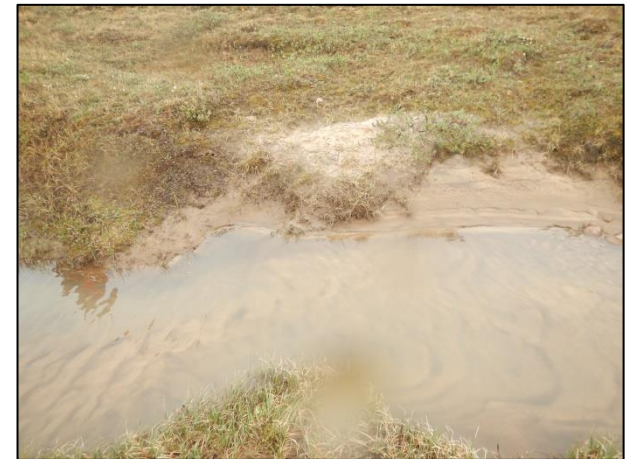
Photos 14. Photos taken 120 m downstream (top) and 140 m downstream (bottom) in spring: (A,D) facing upstream; (B,E) facing downstream; and (C,F) across (left bank looking at right bank).

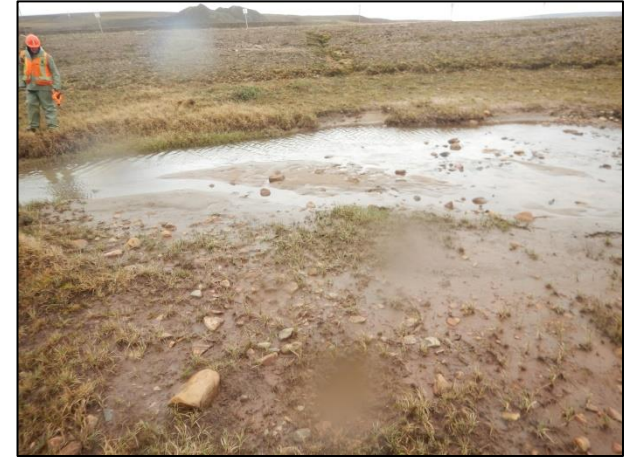
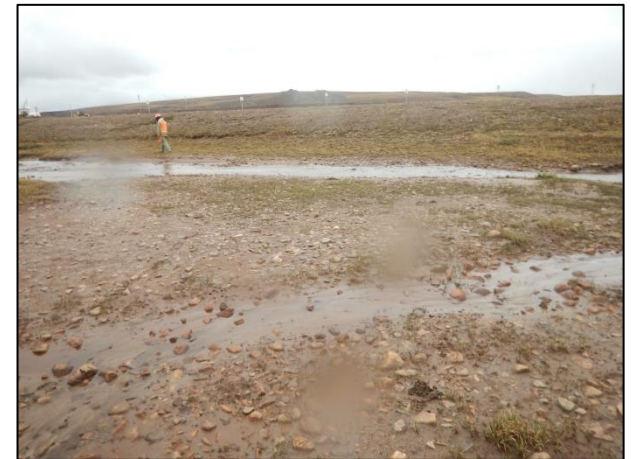
Photos 15. Photos taken 160 m downstream (top) and 180 m downstream (bottom) in spring: (A,D) facing upstream; (B,E) facing downstream; and (C,F) across (left bank looking at right bank).

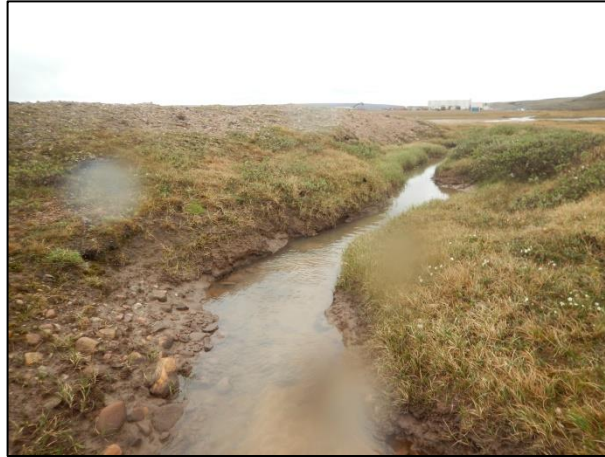
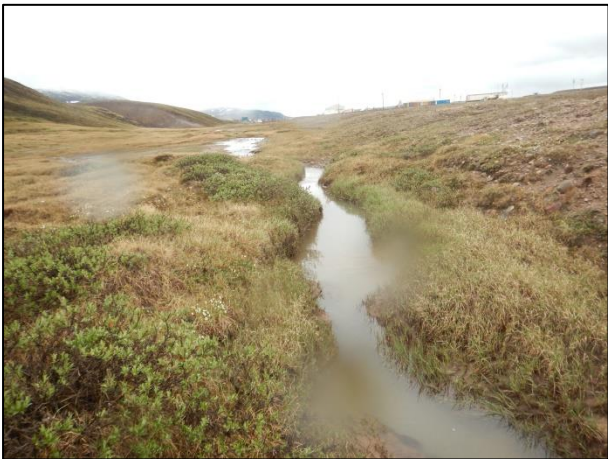
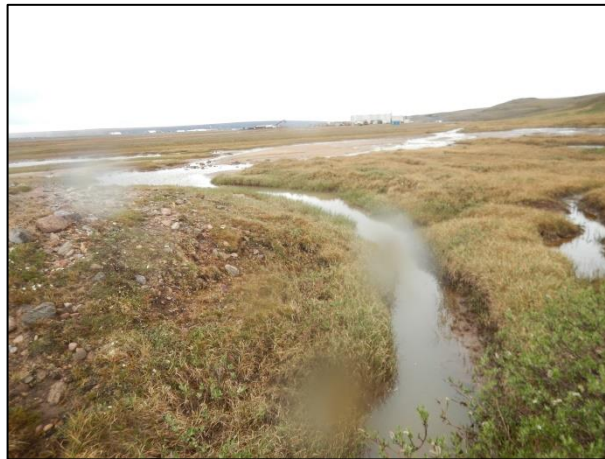
Photos 16. Photos taken 200 m downstream (top) and 220 m downstream (bottom) in spring: (A,D) facing upstream; (B,E) facing downstream; and (C,F) across (left bank looking at right bank).

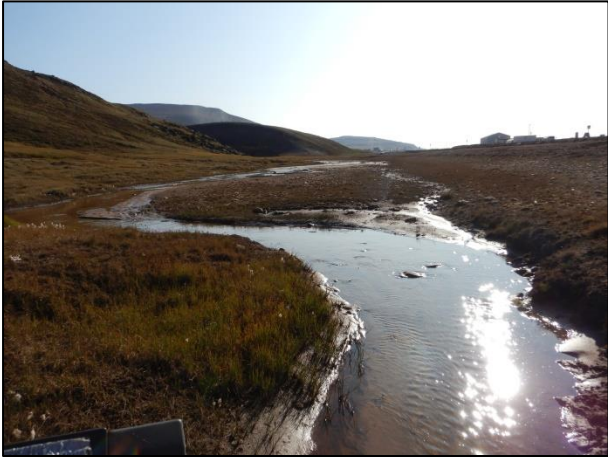
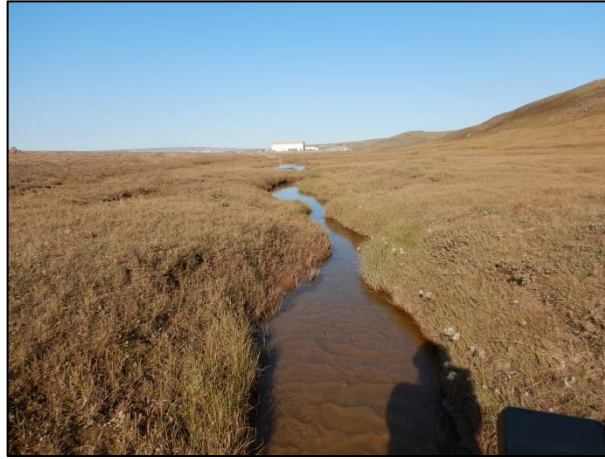
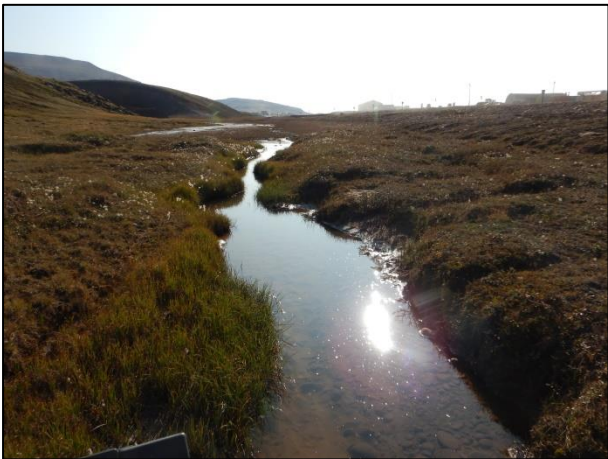
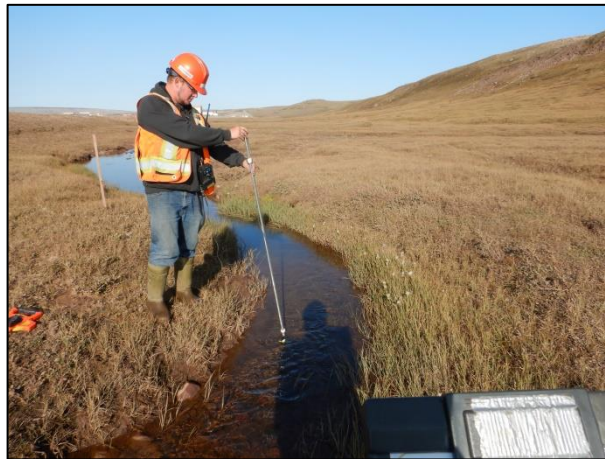
Photos 17. Photos taken 120 m downstream (top) and 140 m downstream (bottom) in summer/fall: (A,D) facing upstream; (B,E) facing downstream; and (C,F) across (left bank looking at right bank).

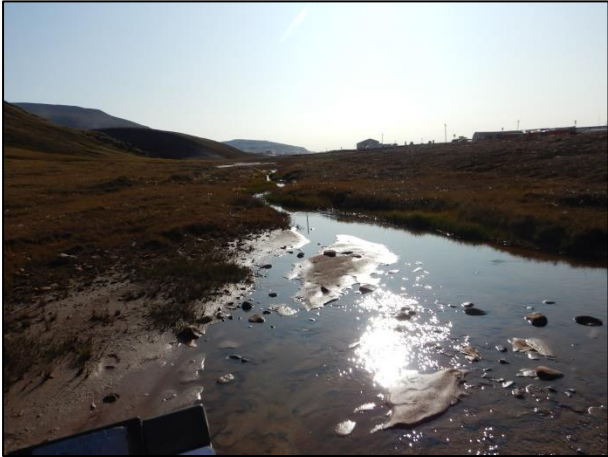
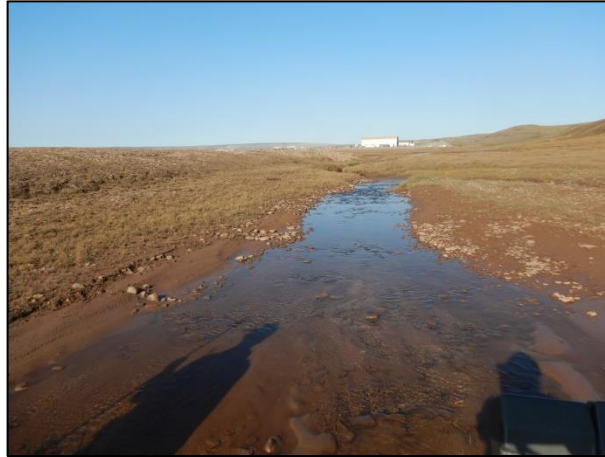
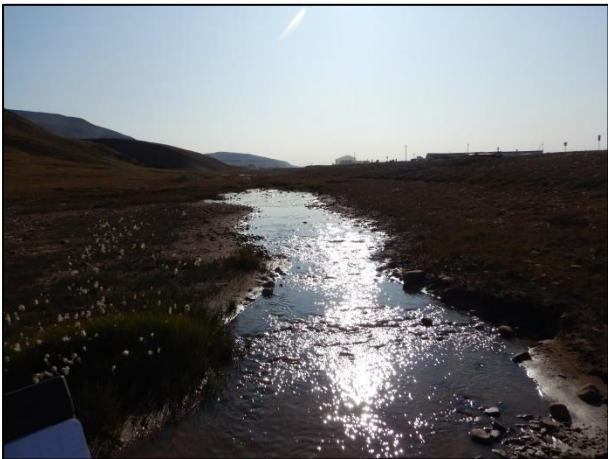
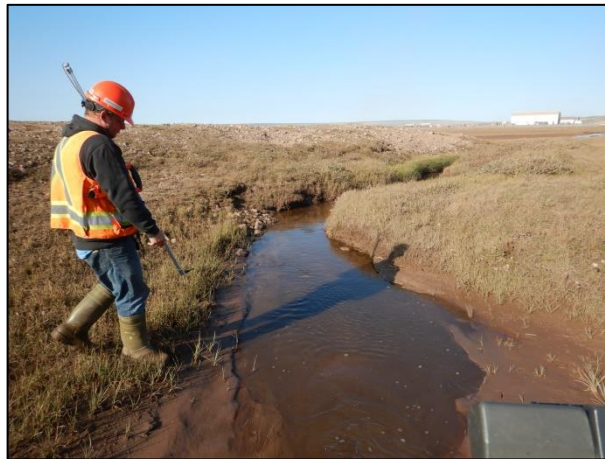
Photos 18. Photos taken 160 m downstream (top) and 180 m downstream (bottom) in summer/fall: (A,D) facing upstream; (B,E) facing downstream; and (C,F) across (left bank looking at right bank).

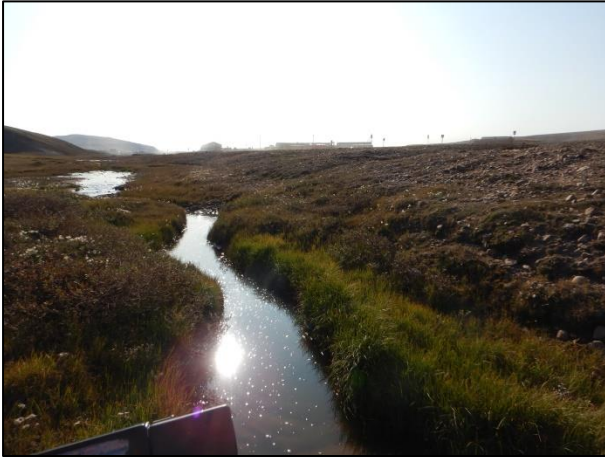
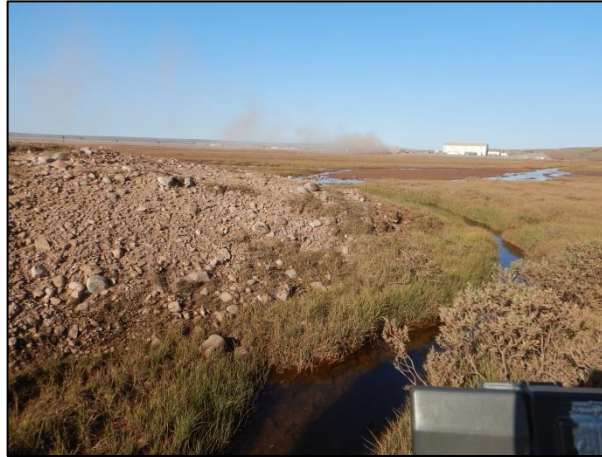
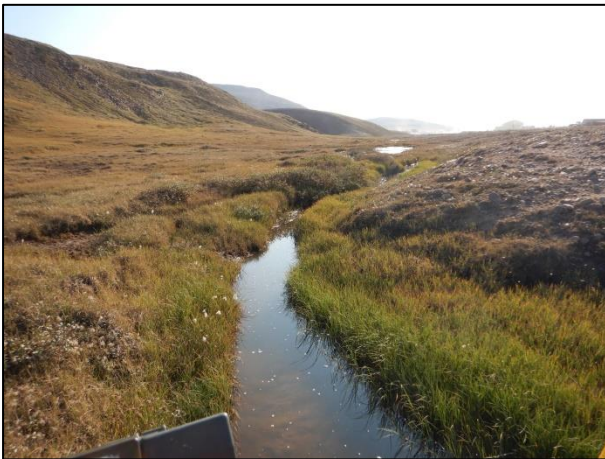
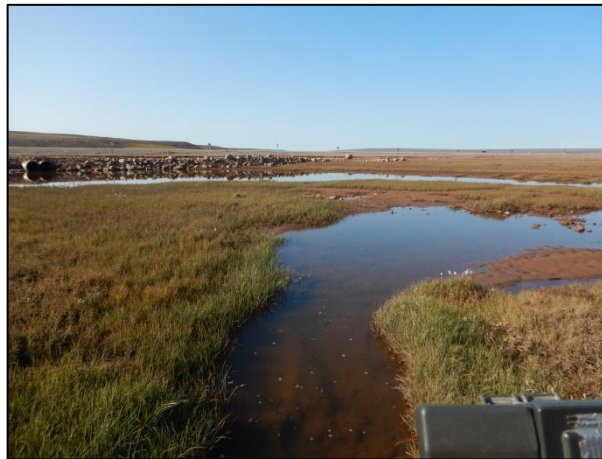
Photos 19. Photos taken 200 m downstream (top) and 220 m downstream (bottom) in summer/fall: (A,D) facing upstream; (B,E) facing downstream; and (C,F) across (left bank looking at right bank).

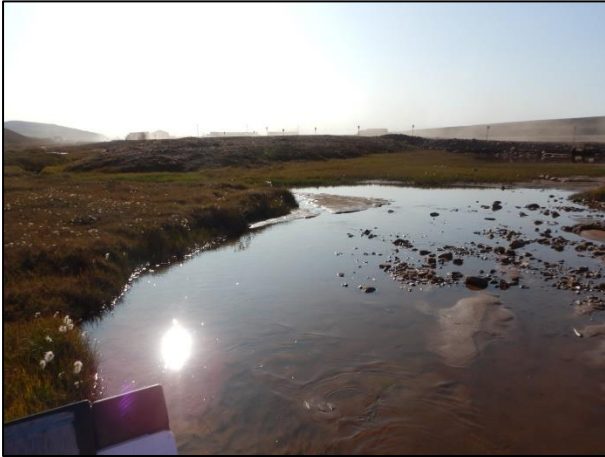
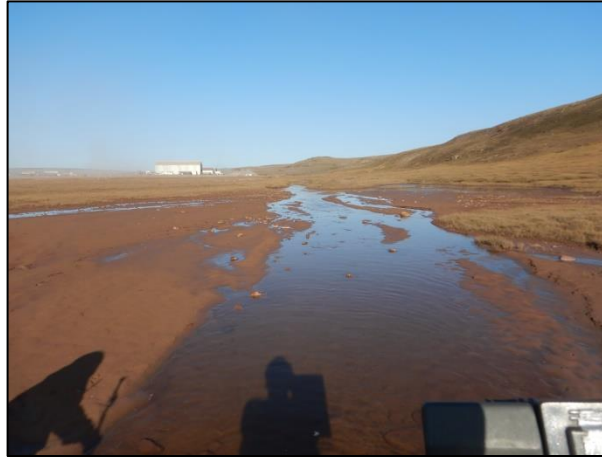
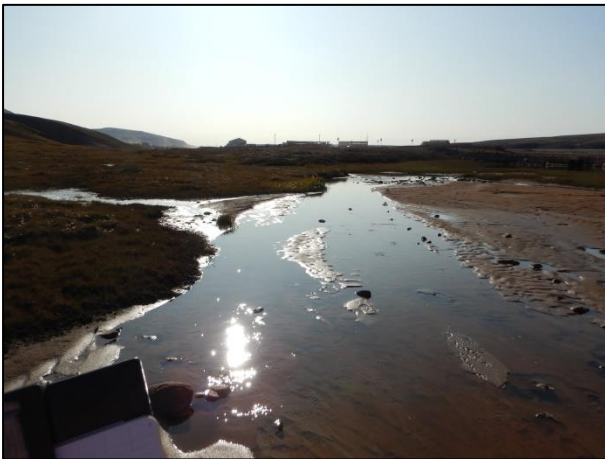
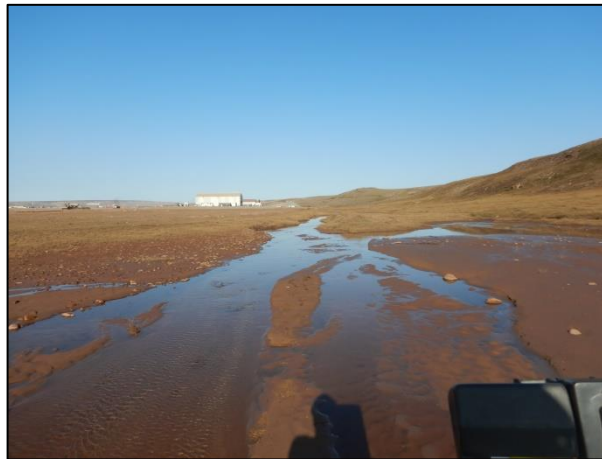
Photos 20. Photos taken 240 m downstream (top) and 260 m downstream (bottom) in summer/fall: (A,D) facing upstream; (B,E) facing downstream; and (C,F) across (left bank looking at right bank).

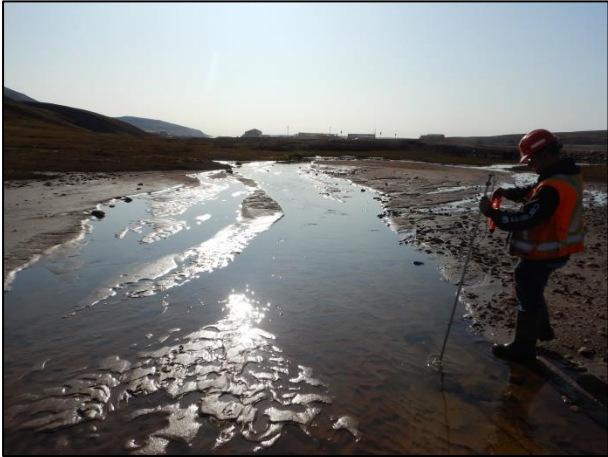
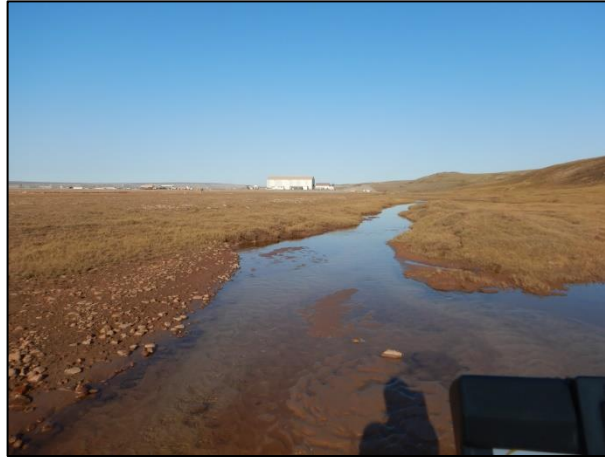
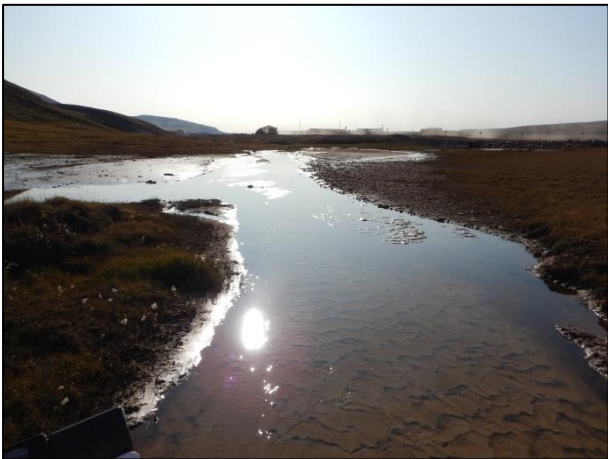
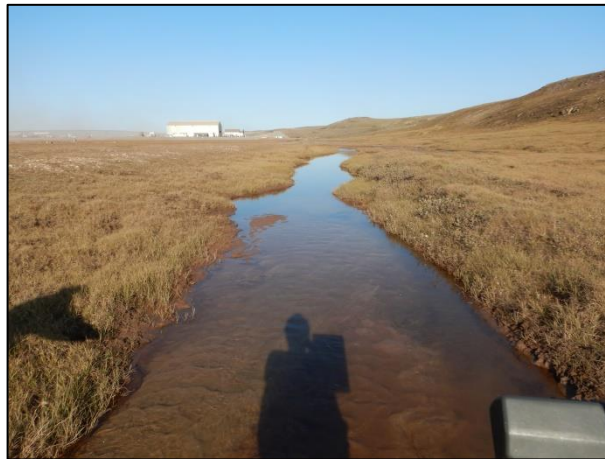
Photos 21. Photos taken 280 m downstream (top) and 300 m downstream (bottom) in summer/fall: (A,D) facing upstream; (B,E) facing downstream; and (C,F) across (left bank looking at right bank).

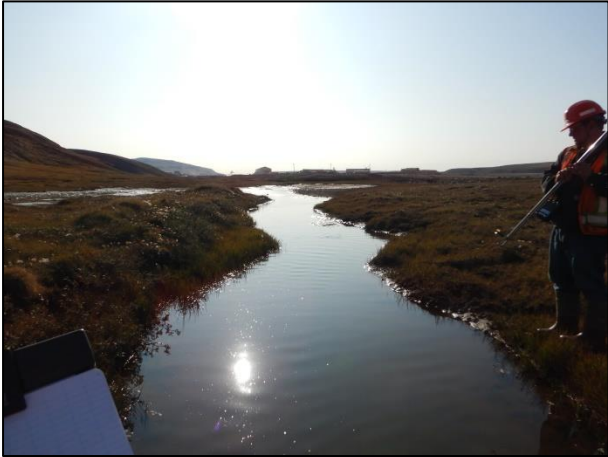
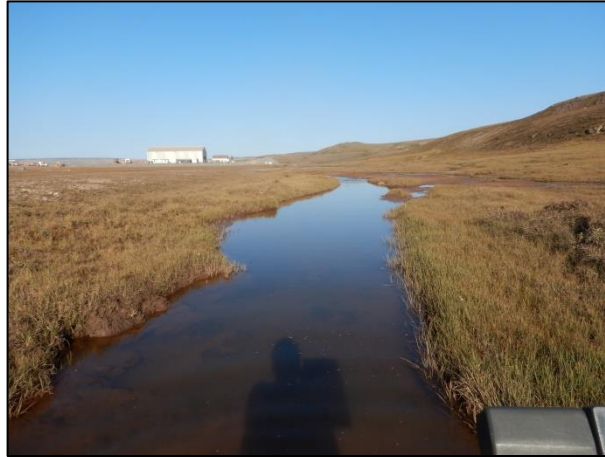
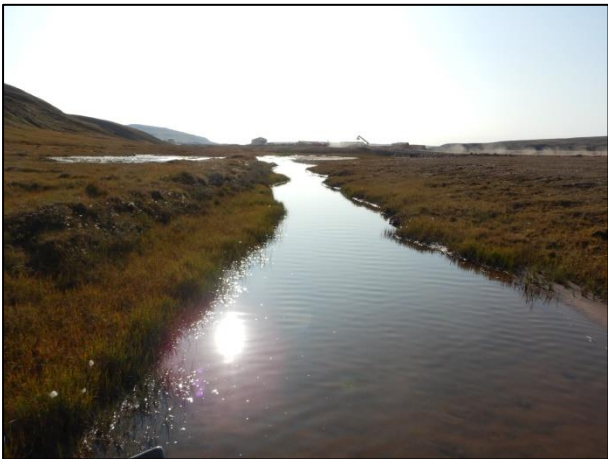
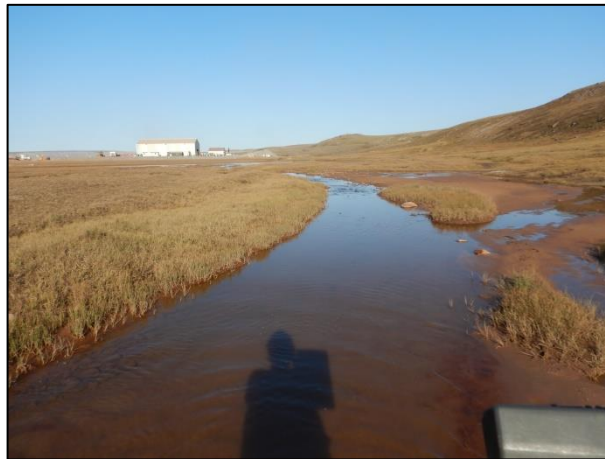
Photos 22. Photos taken 320 m downstream (top) and 340 m downstream (bottom) in summer/fall: (A,D) facing upstream; (B,E) facing downstream; and (C,F) across (left bank looking at right bank).

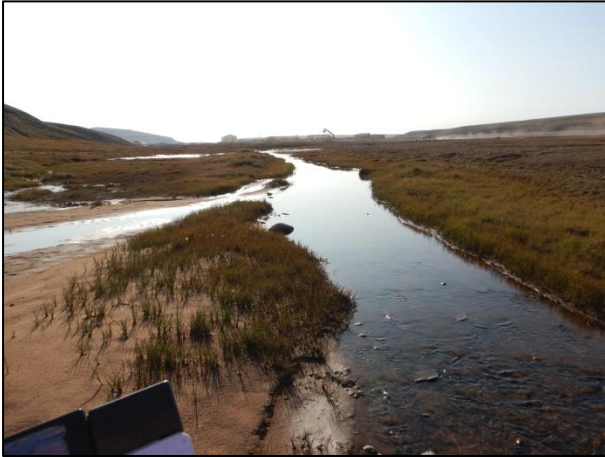
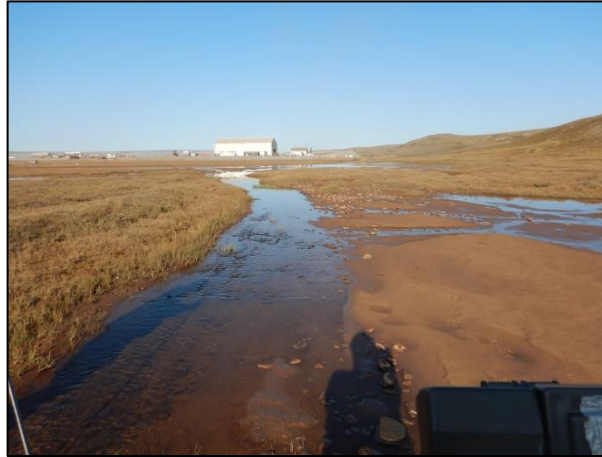
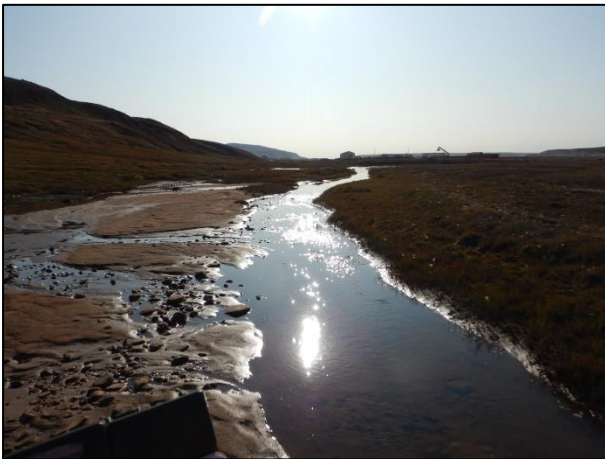
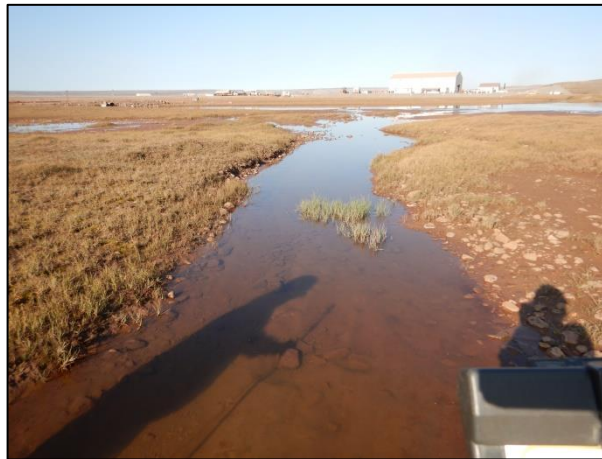
Photos 23. Photos taken 360 m downstream (top) and 380 m downstream (bottom) in summer/fall: (A,D) facing upstream; (B,E) facing downstream; and (C,F) across (left bank looking at right bank).
