RAIL CV-105-4

LOCATION AND CROSSING DESCRIPTION

**BAFFINLAND IRON MINES
MARY RIVER PROJECT**

**North/South Consultants Inc.**
Aquatic Environment Specialists

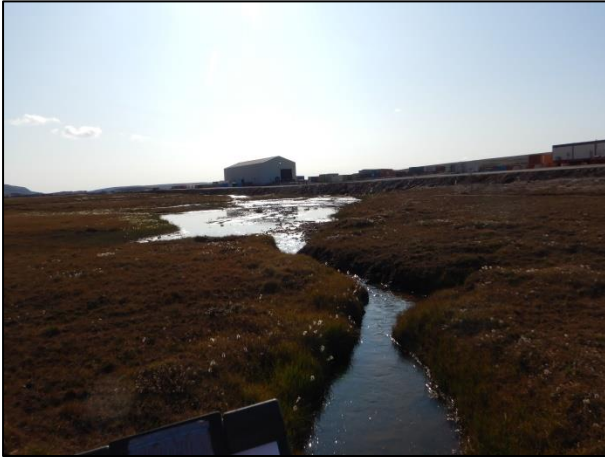
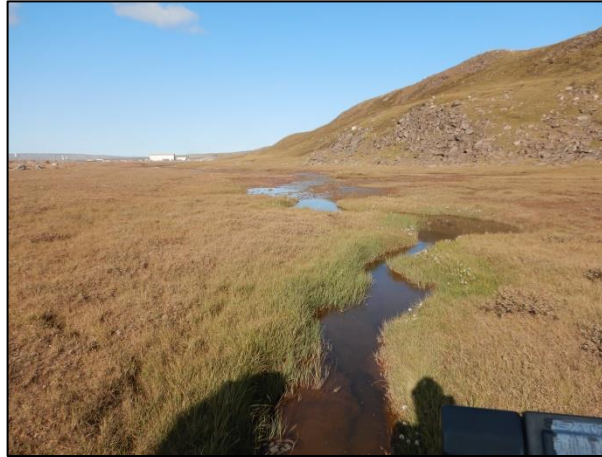
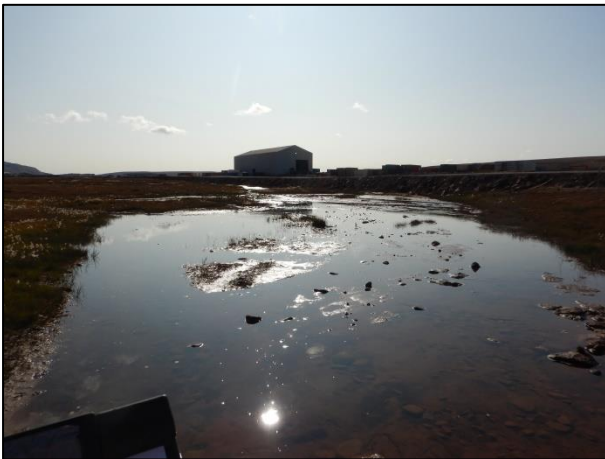
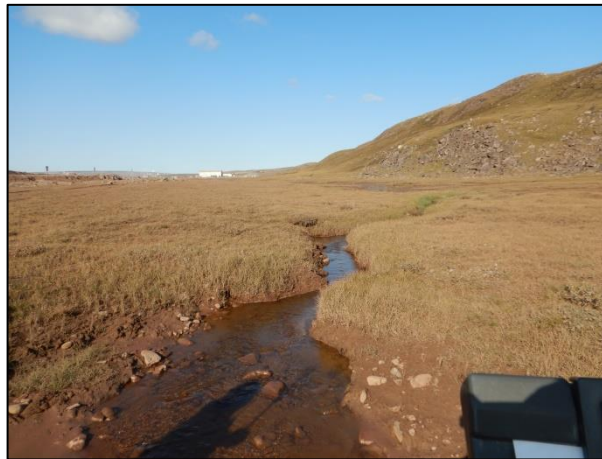
19-AUG-19 - UPSTREAM SURVEY

Upstream habitat (120-200 m upstream) was similar to the crossing area, with narrow, deep runs separated by wide, shallow flats. The transect at 180 m upstream from the CV-105-4 centreline overlaps with the centreline for CV-106-1.

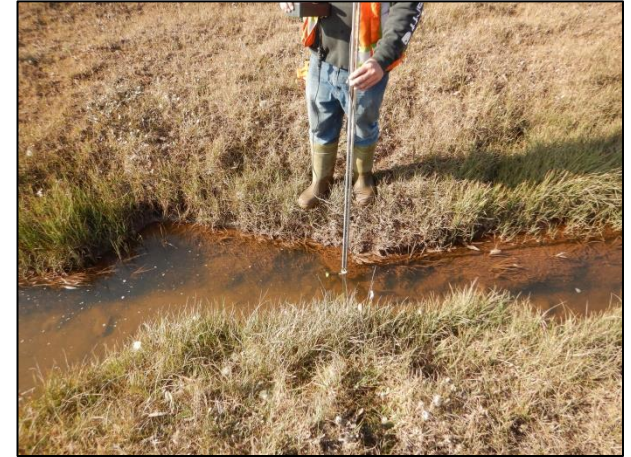
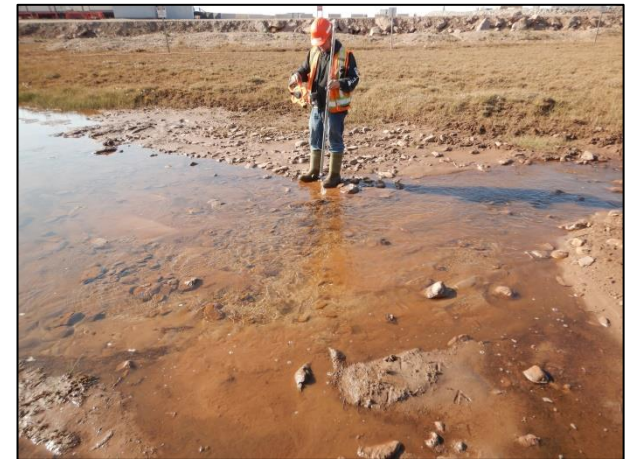
Photos 24. Photos taken 120 m upstream (top) and 140 m upstream (bottom) in summer/fall: (A,D) facing upstream; (B,E) facing downstream; and (C,F) across (left bank looking at right bank).

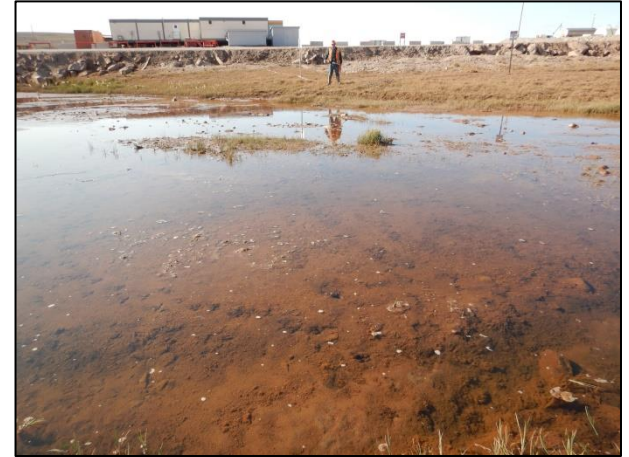
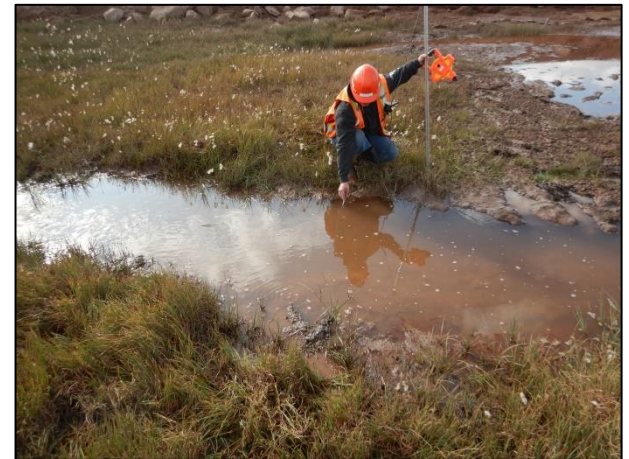
Photos 25. Photos taken 160 m upstream (top) and 180 m upstream (bottom) in summer/fall: (A,D) facing upstream; (B,E) facing downstream; and (C,F) across (left bank looking at right bank).

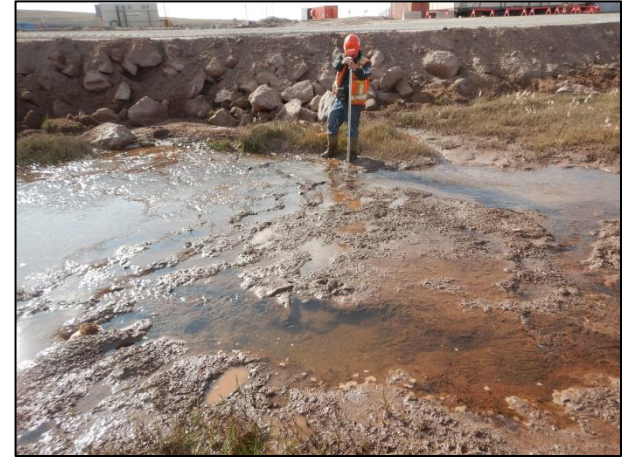
Photos 26. Photos taken 200 m upstream in summer/fall: (A,D) facing upstream; (B,E) facing downstream; and (C,F) across (left bank looking at right bank).
