RAIL CV-106-1

LOCATION AND CROSSING DESCRIPTION

**BAFFINLAND IRON MINES
MARY RIVER PROJECT**

North/South Consultants Inc.
Aquatic Environment Specialists

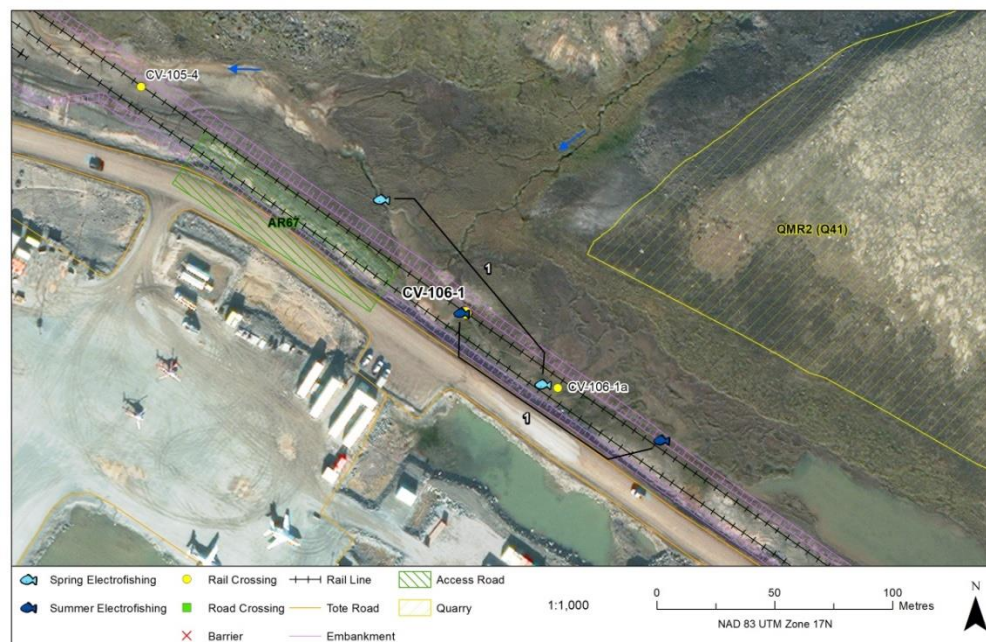
FISHING SITES

Electrofishing in spring and summer/fall included both the pond at 106-1 and some of the stream habitat assessed by the CV-106-1a site. As both habitat types are covered, the data are shared between sites. In both seasons, stickleback were captured exclusively in pond habitat (shallow, silt/sand with vegetation) and char in the narrower, deeper runs upstream from the pond.

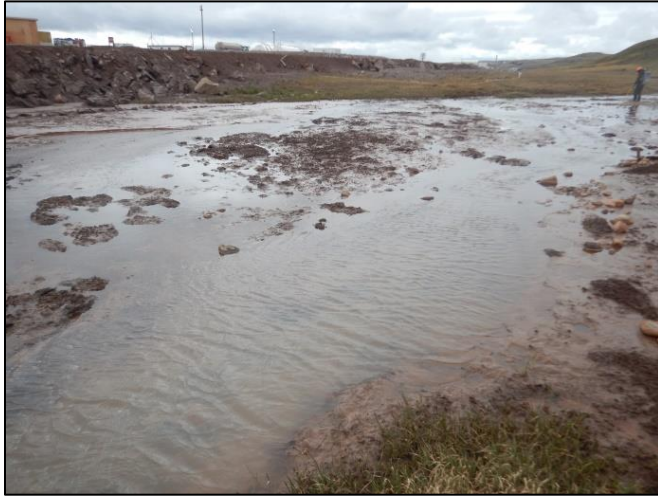
A

Photos 1. Photos taken of: (A) across the pond facing west during spring; (B) across the pond facing southwest during spring; and (C) looking from the inflow towards the northwest during summer/fall; (D) the confluence between pond and inflow facing north during summer/fall.
