RAIL CV-106-2

LOCATION AND CROSSING DESCRIPTION

BAFFINLAND IRON MINES
MARY RIVER PROJECT

**North/South Consultants Inc.**
Aquatic Environment Specialists

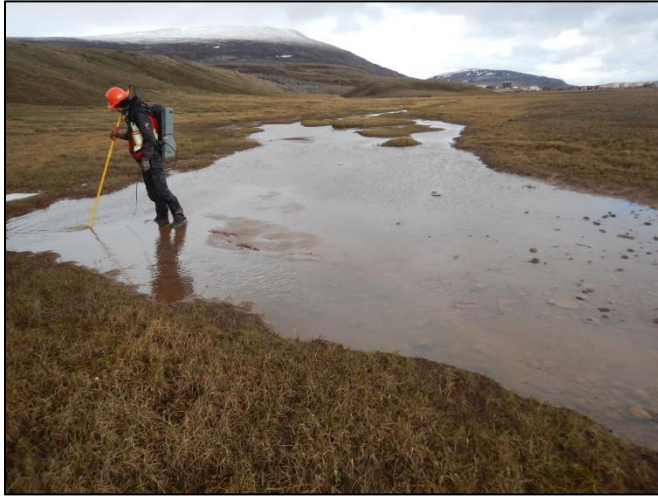
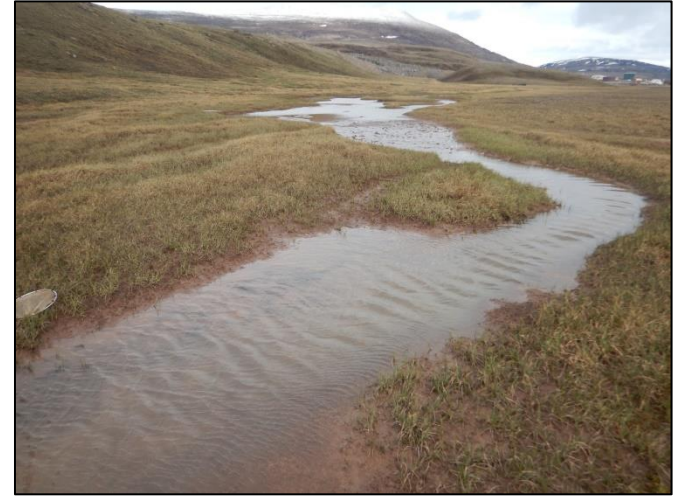
22-JUN-19

This pond provides minimal open-water season rearing habitat for juvenile Arctic Char due mainly to its shallow depth and lack of cover. The pond does not provide overwintering or spawning habitat for char due to insufficient depth in winter. This pond provides open-water season rearing and spawning habitat for Ninespine Stickleback, though it is of insufficient depth to support overwintering for this species.

Photos 1. Photos taken during spring of: (A) the entire pond; and (B) inlet stream habitat.

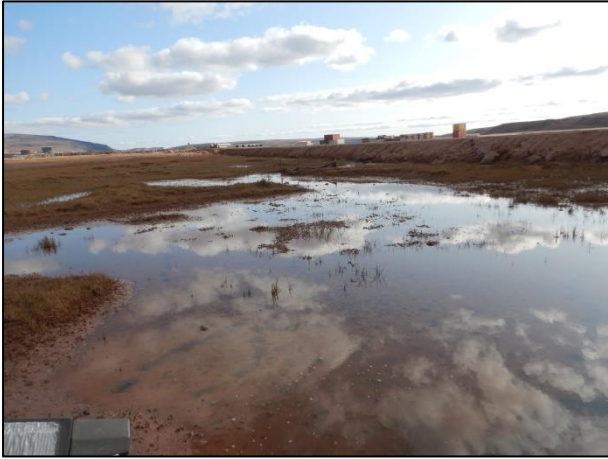
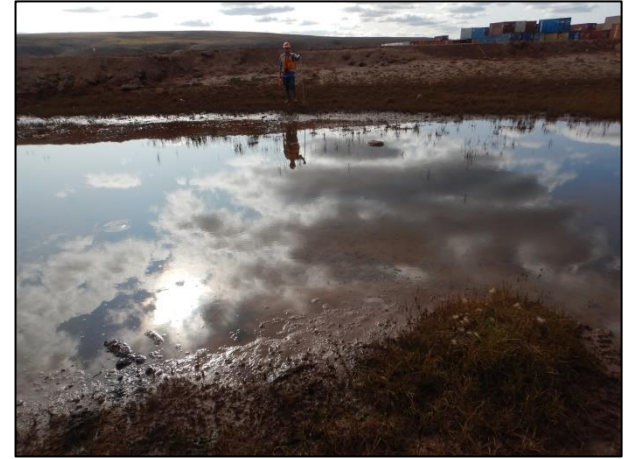
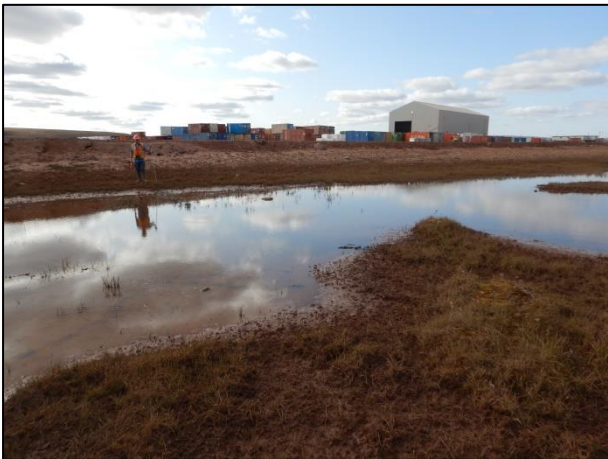
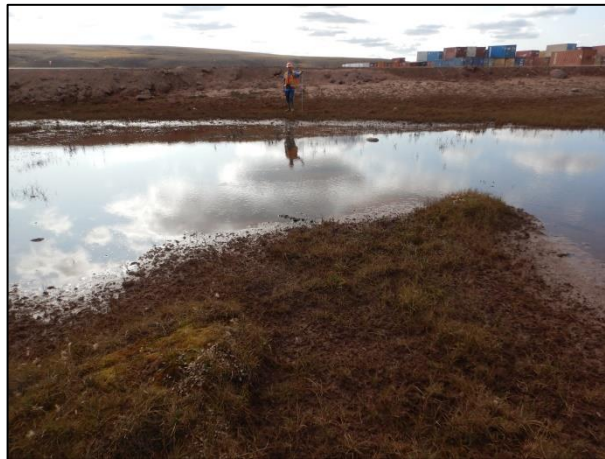
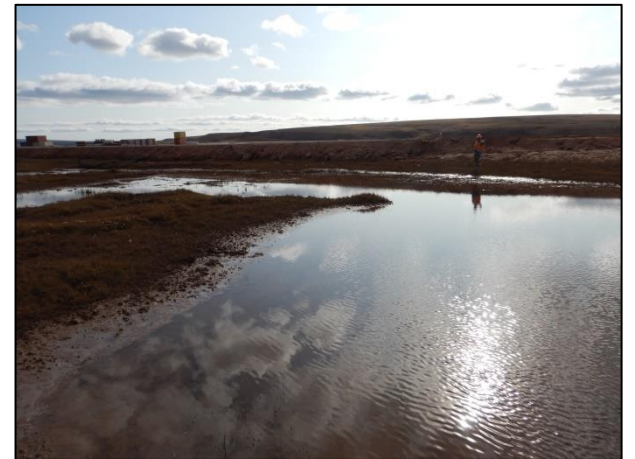
19-AUG-19

Habitat Use – ARCH: Juvenile rearing (minimal) **Habitat Use – NNST:** Rearing; Spawning (probable) **Maximum Water Depth (m):** 0.05

Area	Fines (%)	Gravel (%)	Small Cobble (%)	Large Cobble (%)	Boulders (%)
Nearshore	90	0	10	0	0
Offshore	90	0	10	0	0

Photos 2. Photos taken at the infill site in summer/fall: (A) facing upstream; (B) facing downstream; (C) across (left bank looking at right bank); (D) diagonal from left bank above the centreline looking downstream; (E) across (left bank looking at left bank); and (F) diagonal from left bank below the centreline looking upstream.
