RAIL CV-106-3

LOCATION AND CROSSING DESCRIPTION

BAFFINLAND IRON MINES
MARY RIVER PROJECT

**North/South Consultants Inc.**
Aquatic Environment Specialists

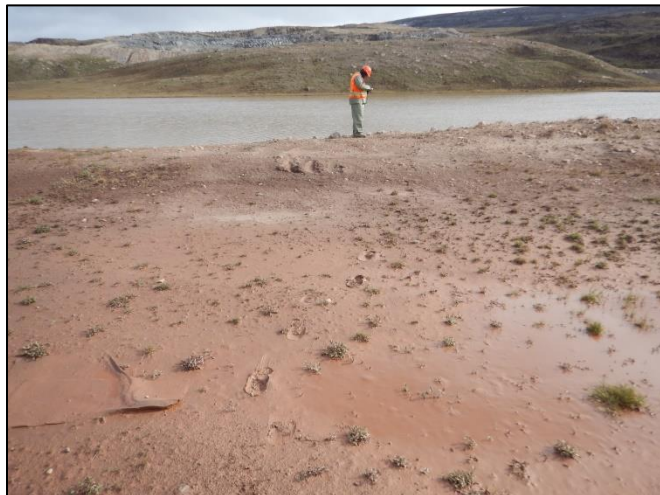
A

Photos 1. Photos taken of: (A) across the pond during spring; (B) encroachment habitat during spring; and (C,D) encroachment habitat during summer/fall.

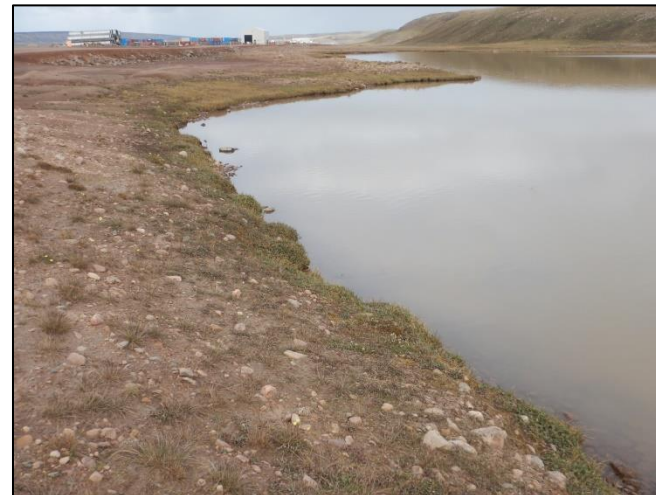
B

This lake has sufficient depth to support overwintering for Ninespine Stickleback and possibly also juvenile char. Habitat at the encroachment footprints is <0.20 m deep, with a mixture of small and large cobble.

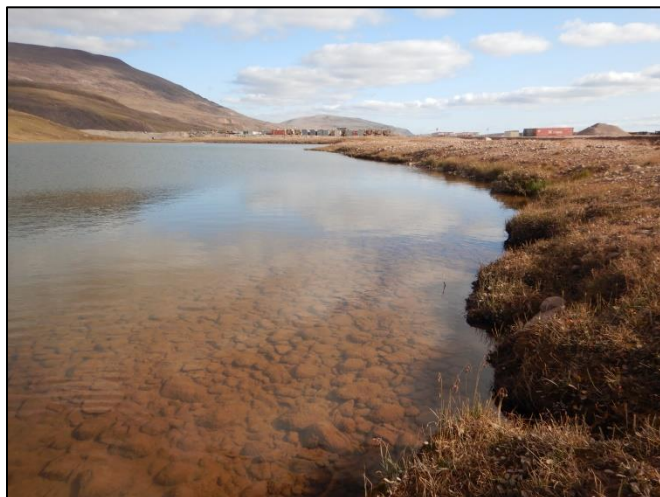
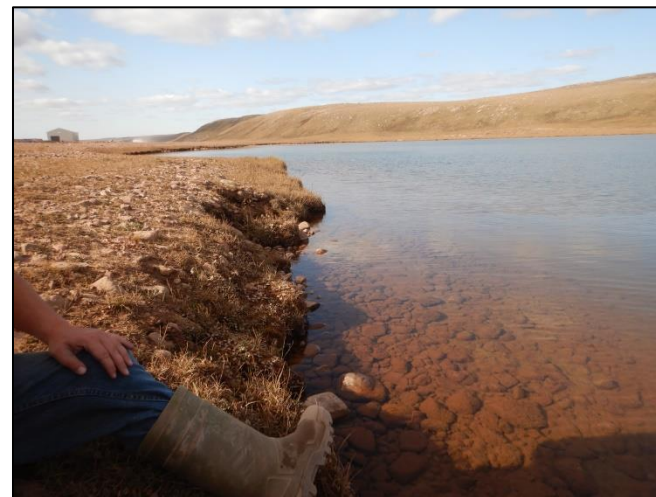
Habitat Use – ARCH: Juvenile rearing & overwintering **Habitat Use – NNST:** Rearing; Spawning; Overwintering **Maximum Water Depth (m):** 0.20

Area	Fines (%)	Gravel (%)	Small Cobble (%)	Large Cobble (%)	Boulders (%)
Nearshore	0	0	80	20	0
Offshore	60	0	30	10	0

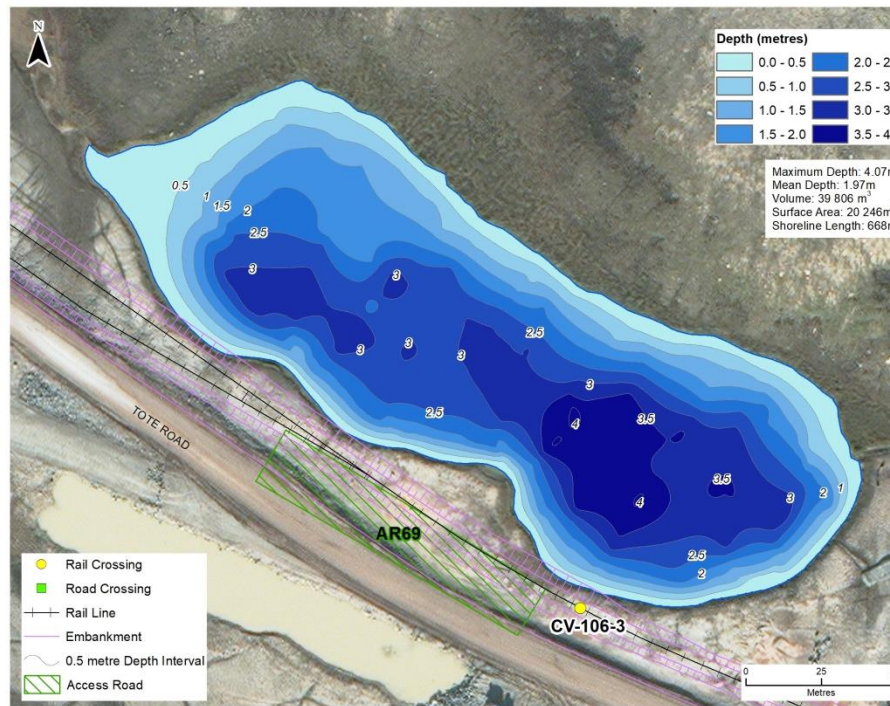
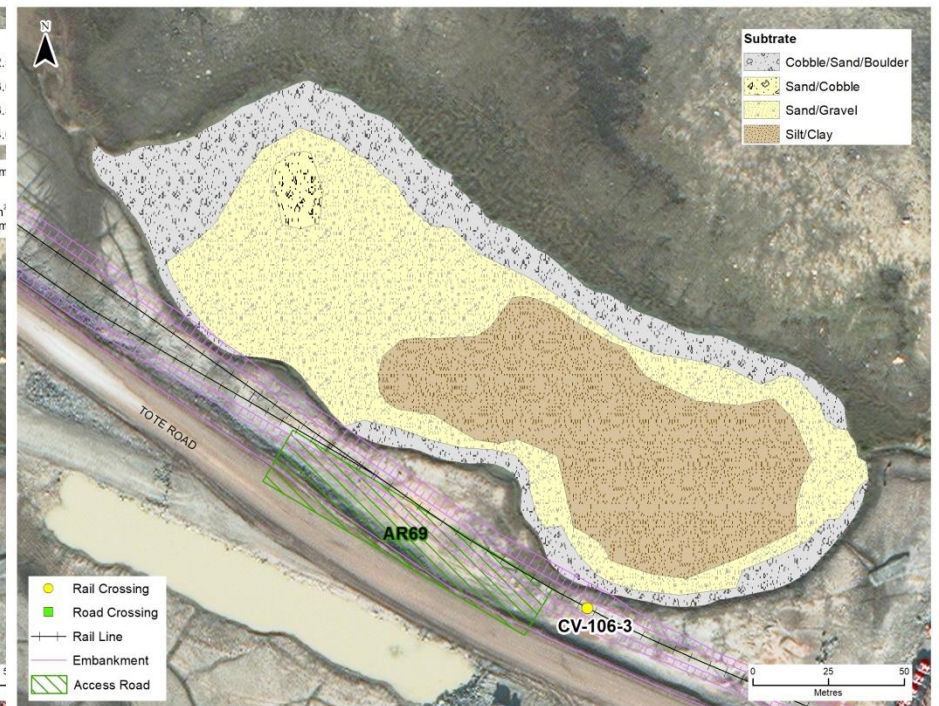
LAKE BATHYMETRY AND SUBSTRATE

Surface Area (m²):	20,246	Shoreline Length (m):	668	Drainage Basin Area (m²):	1.079
Maximum Depth (m):	4.07 (measured)			Mean Depth (m):	1.97

Stickleback were evenly distributed in the surveyed nearshore habitat in 2019 at all encroachment sites. Similar results were noted during the 2018 survey. Only one juvenile char was captured/observed in 2019; none were captured/observed in 2018. Char may primarily move back and forth from Camp Lake downstream. This lake was surveyed for bathymetry and substrate in 2018.
