RAIL CV-107-1

LOCATION AND CROSSING DESCRIPTION

BAFFINLAND IRON MINES
MARY RIVER PROJECT

**North/South Consultants Inc.**
Aquatic Environment Specialists

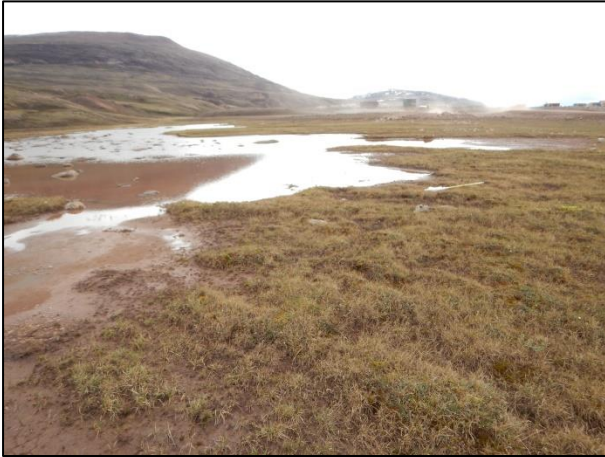
A

Photos 1. Photos taken during spring (top) and summer/fall (bottom): (A) across pond; (B) outflow channel; (C) encroachment area; (D,E) encroachment area; and (F) pond towards outflow.

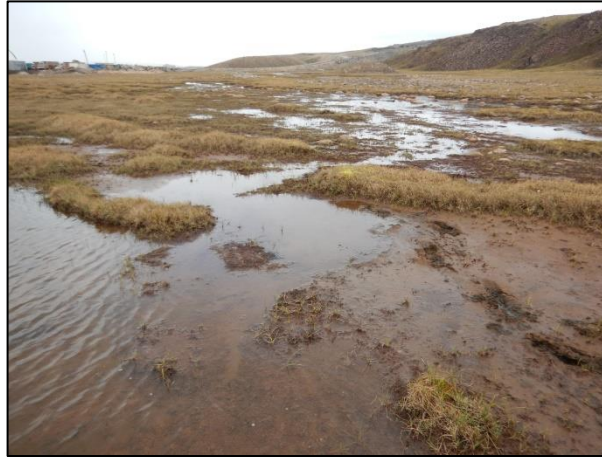
B

Stickleback were observed outside of the rail encroachment area, farther offshore during spring. During summer/fall, stickleback were more evenly distributed in available habitat. Fish were not captured or observed in 2018. A shallow water or subsurface flow barrier has the potential to form in the outlet stream (consistently very shallow, <0.02 m), which could lead to fish stranding and winterkill. Connectivity was maintained during the two 2019 surveys.

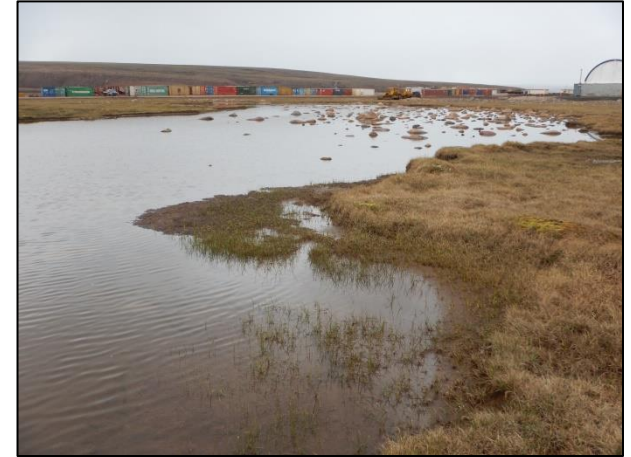
C

This pond, and the encroachment area in particular, provides minimal rearing habitat for both species as evidenced by few fish present in either 2018 or 2019. Stickleback spawning is unlikely due to minimal nest-building materials (i.e., vegetation) present in the pond. Depth is insufficient to support overwintering of either species. Fish likely enter this pond from the downstream lake CV-106-3 under higher flows, but may become stranded and winterkill. The infill area in the pond is shallow (<0.10 m) with primarily fines and the occasional large cobble or boulder.
