RAIL M-CULV-3A

LOCATION AND CROSSING DESCRIPTION

**BAFFINLAND IRON MINES
MARY RIVER PROJECT**

**North/South Consultants Inc.**
Aquatic Environment Specialists

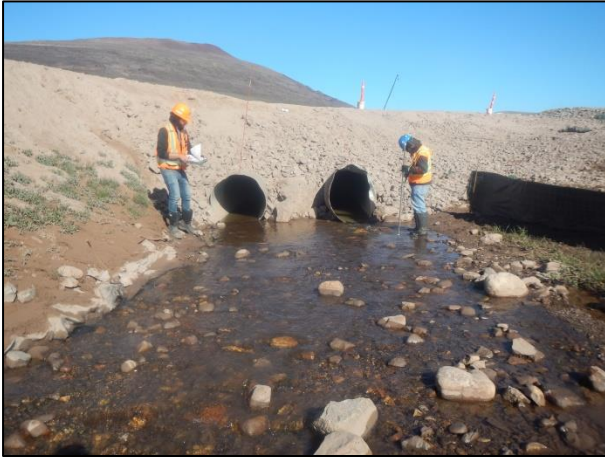
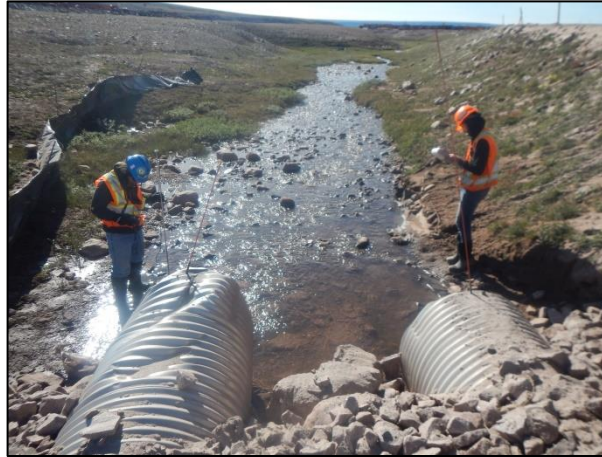
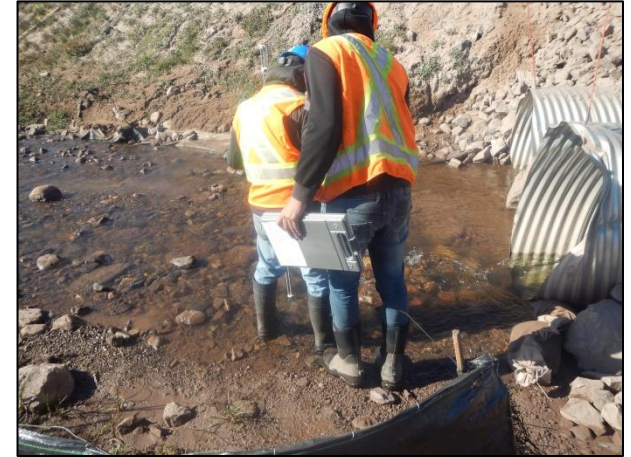
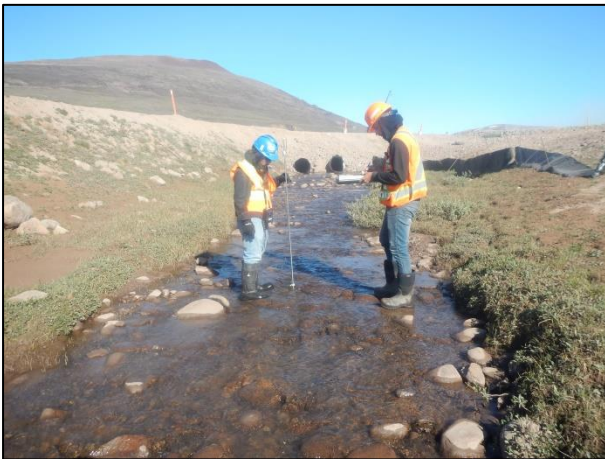
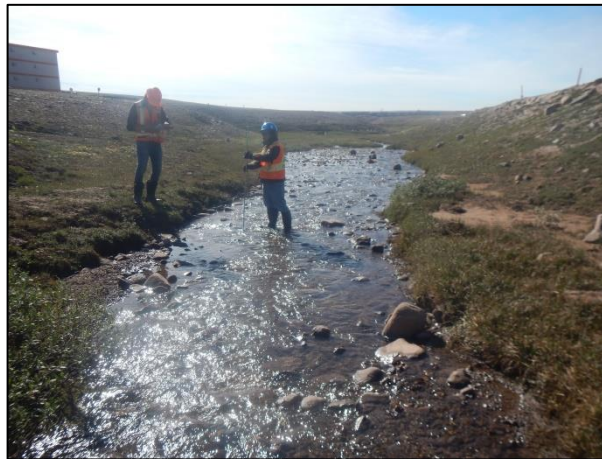
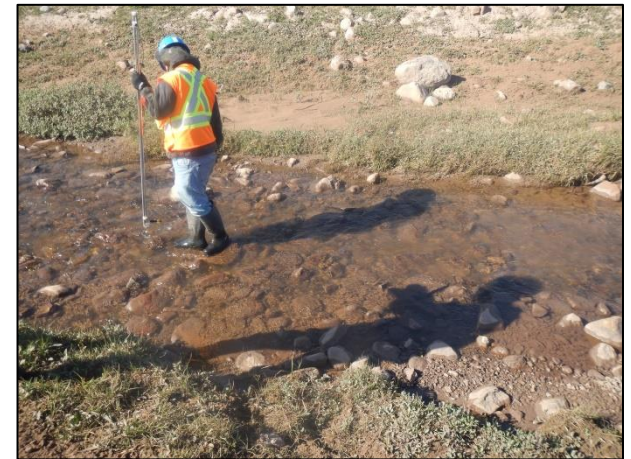
This stream has generally low to moderate depths and velocities, with riffle/pool over cobble substrate. The 40 m downstream transect overlaps with the Tote Road realignment at site M-Culv-3B; the 20m upstream transect overlaps with the 100 m downstream transect for the road crossing at M-Culv-4. Data are shared among sites.

Photos 1. Photos taken 20 m downstream (top) and 40 m downstream (bottom) in spring: (A,D) facing upstream; (B,E) facing downstream; and (C,F) across (right bank looking at left bank). The centreline of the site is the existing Tote Road.

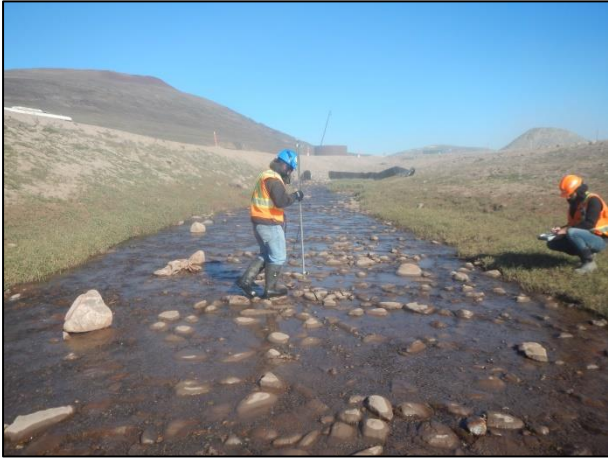
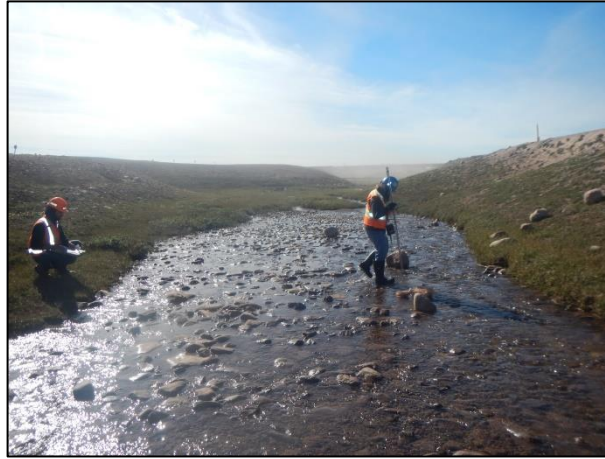
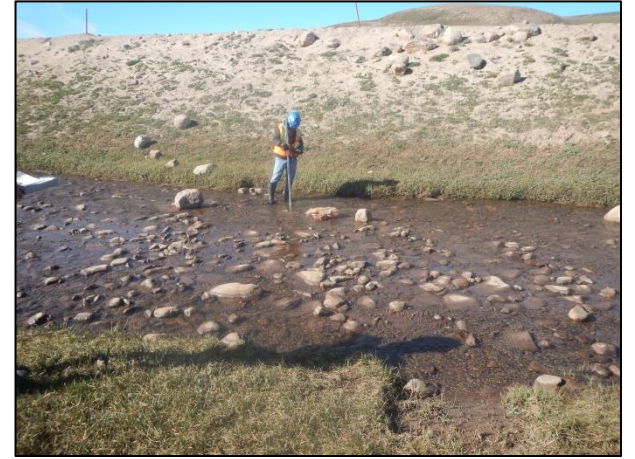
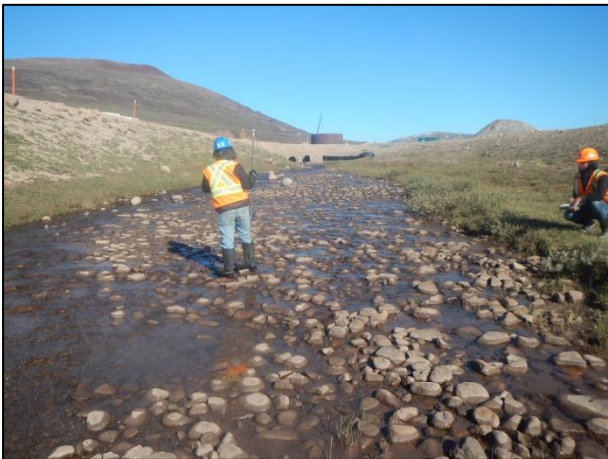
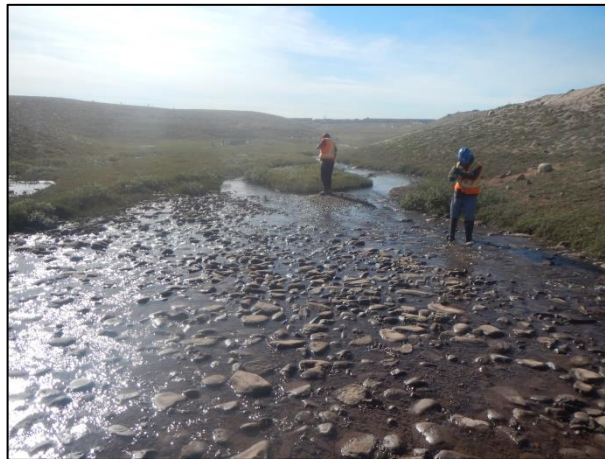
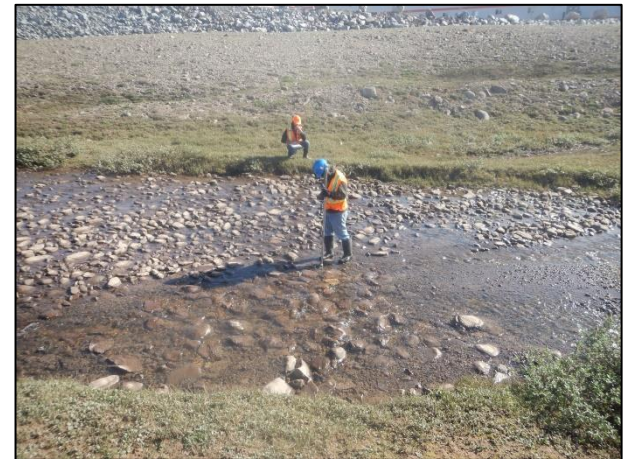
Photos 2. Photos taken 60 m downstream (top) and 80 m downstream (bottom) in spring: (A,D) facing upstream; (B,E) facing downstream; and (C,F) across (right bank looking at left bank).

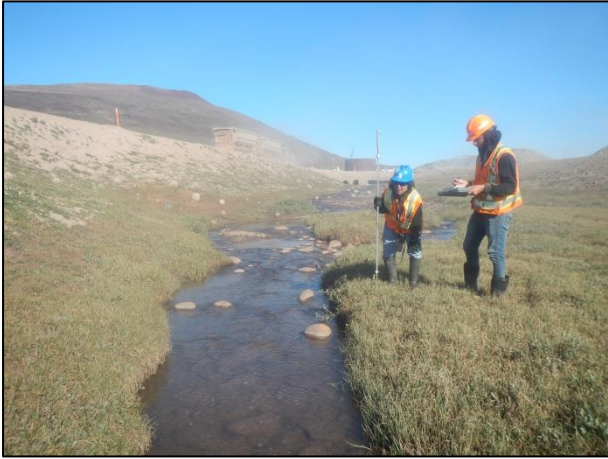
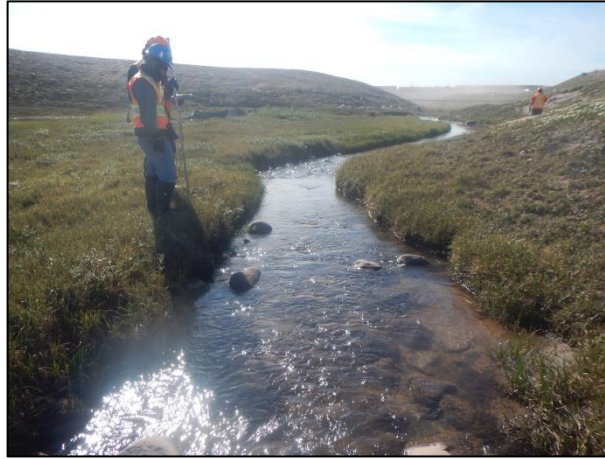
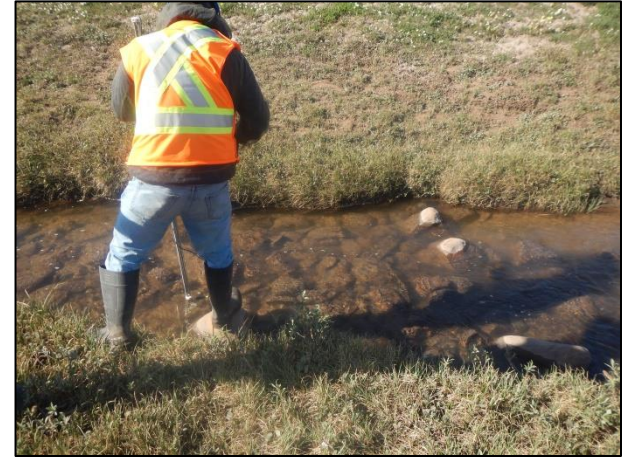
Photos 3. Photos taken 100 m downstream in spring: (A) facing upstream; (B) facing downstream; and (C) across (right bank looking at left bank).

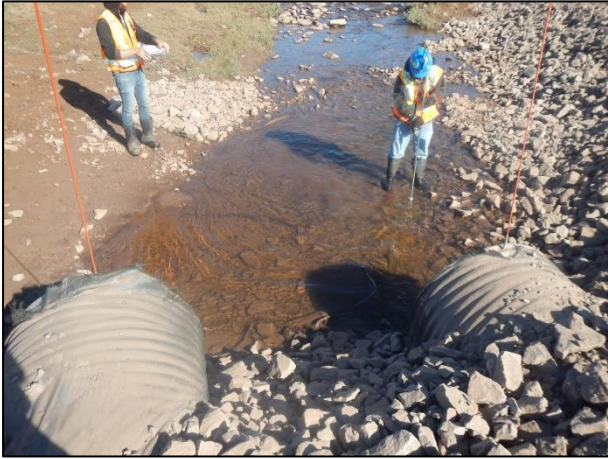
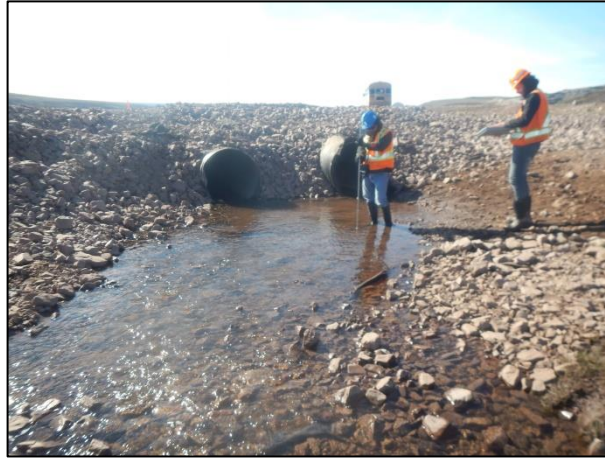
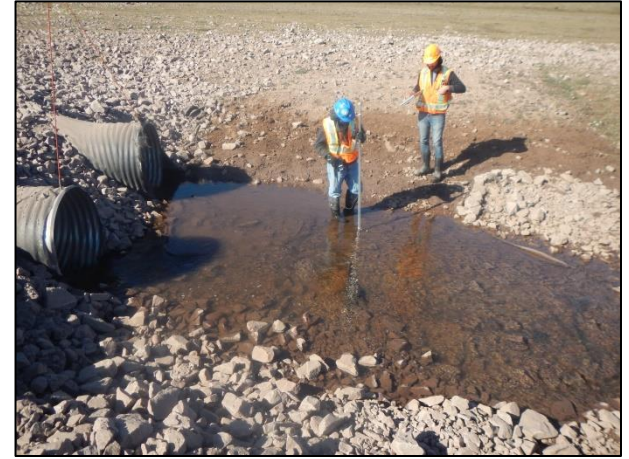
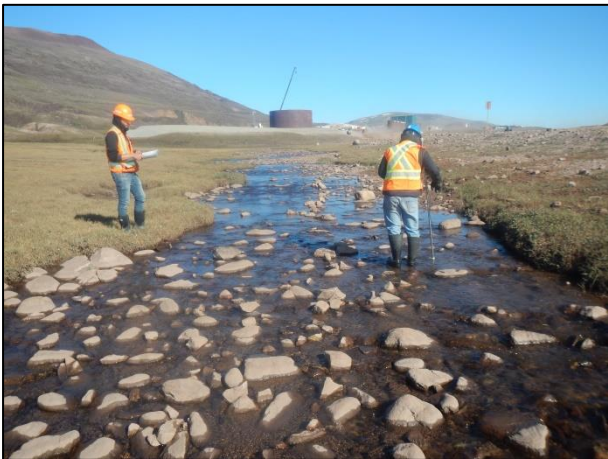
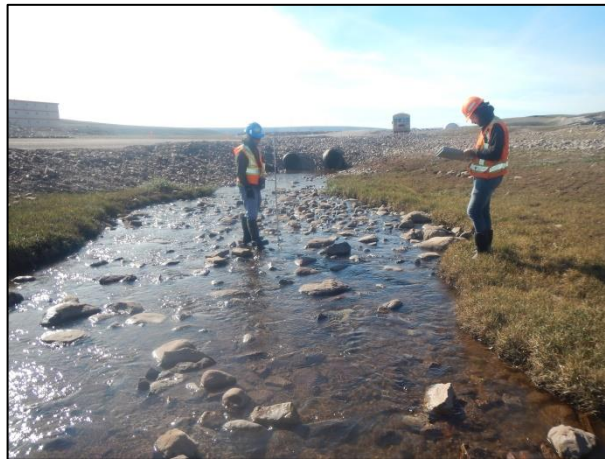
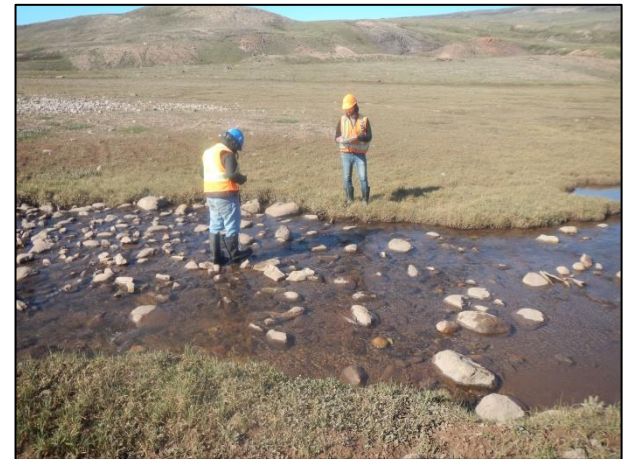
Photos 4. Photos taken 20 m upstream (top) and 40 m upstream (bottom) in spring: (A,D) facing upstream; (B,E) facing downstream; and (C,F) across (right bank looking at left bank).

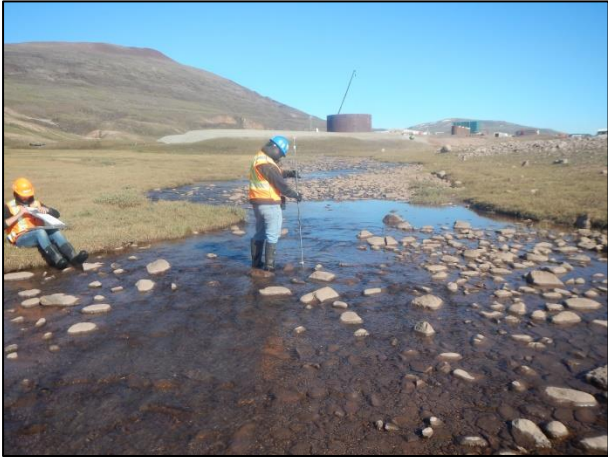
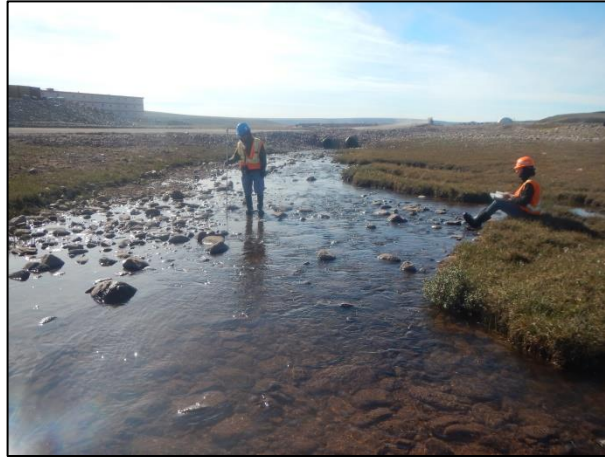
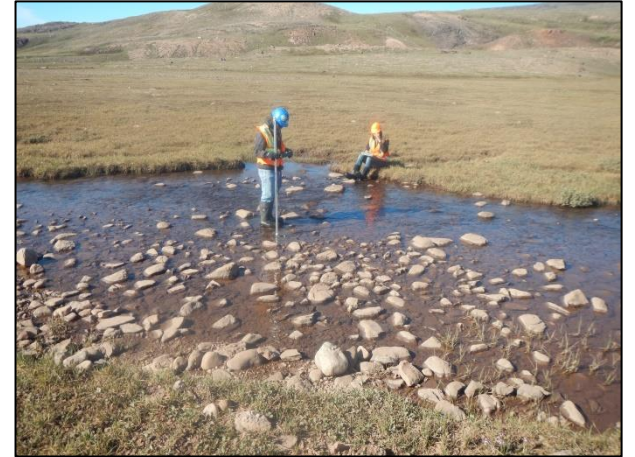
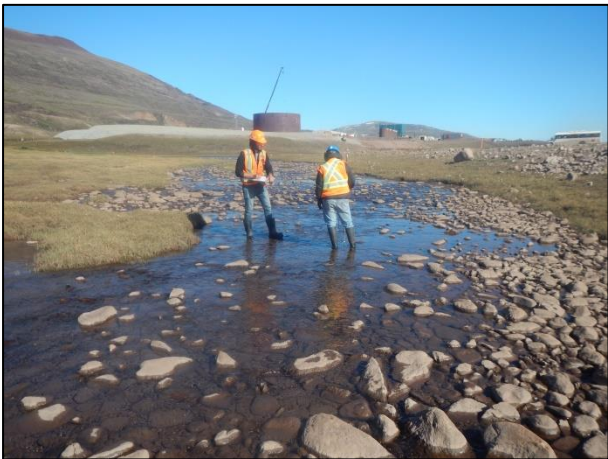
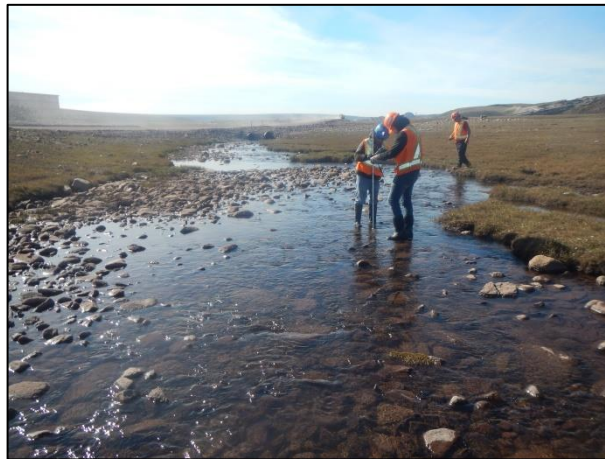
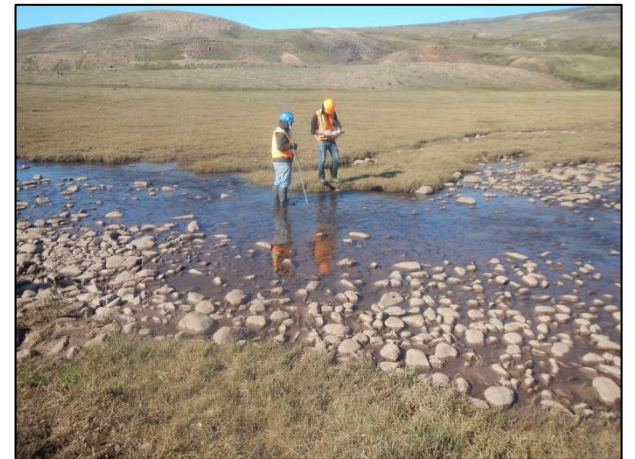
Photos 5. Photos taken 60 m upstream (top) and 80 m upstream (bottom) in spring: (A) facing upstream; (B) facing downstream; and (C) across (right bank looking at left bank).

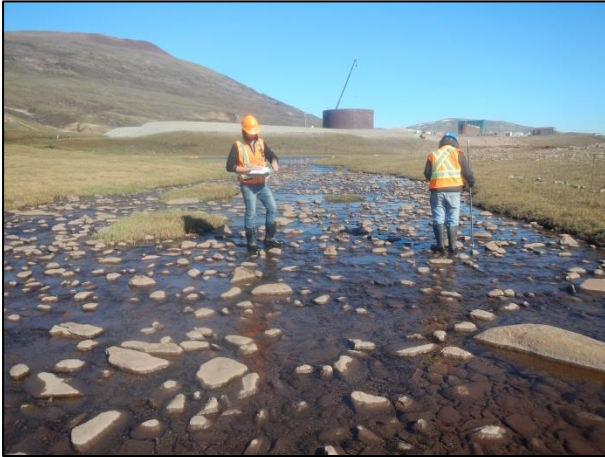
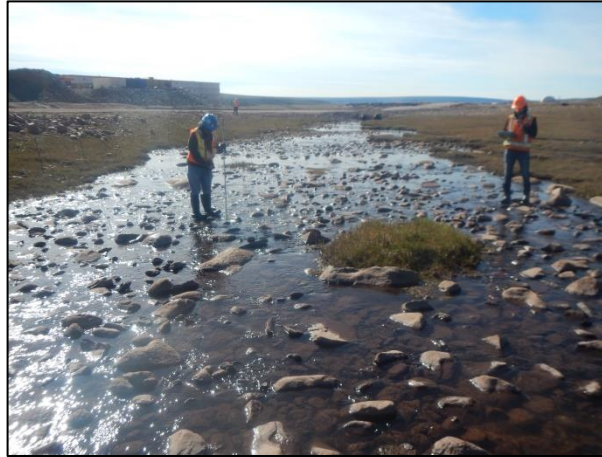
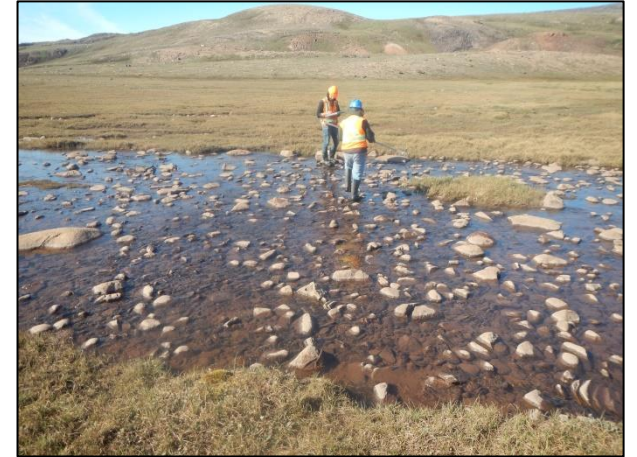
Photos 6. Photos taken 100 m upstream in spring: (A) facing upstream; (B) facing downstream; and (C) across (right bank looking at left bank).

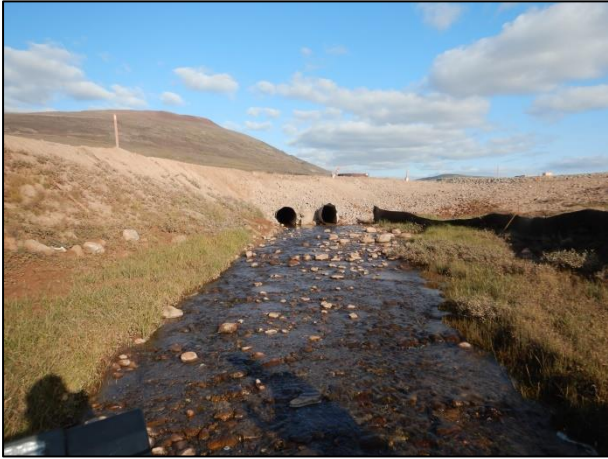
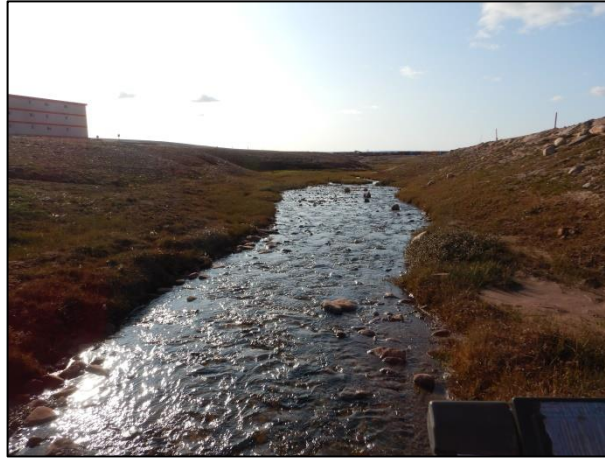
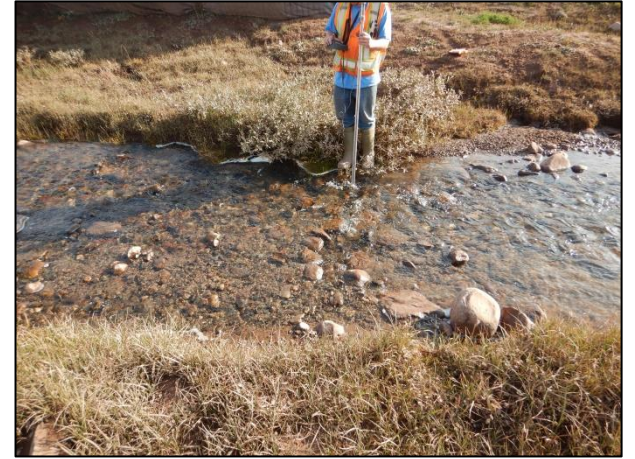
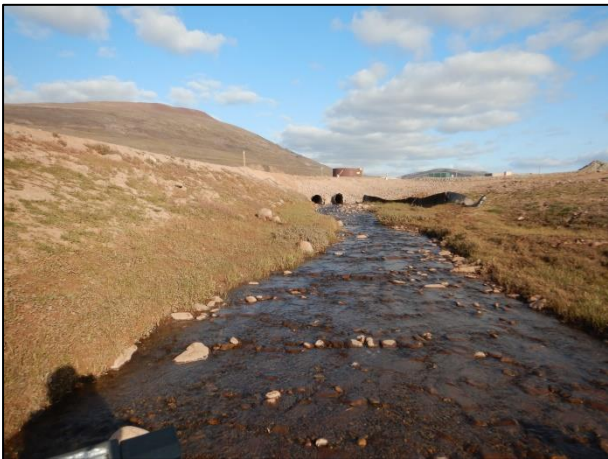
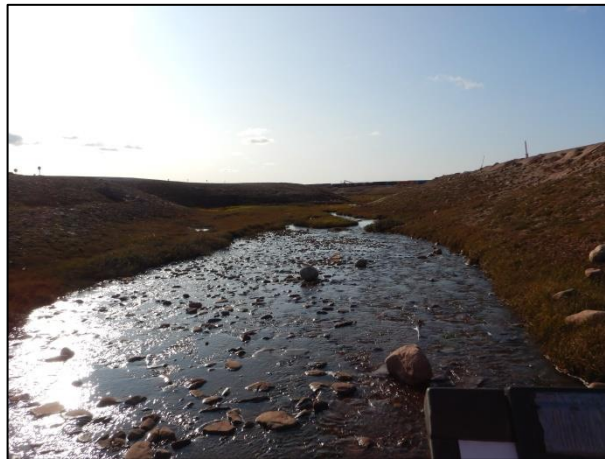
Velocities were marginally higher in summer/fall; habitat was otherwise similar between seasons. As the 20 m downstream transect essentially overlaps with the downstream end of the road culvert, it was not assessed during summer/fall. Habitat was highly influenced by road materials and erosion at this location.

Photos 7. Photos taken 40 m downstream (top) and 60 downstream (bottom) in summer/fall: (A,D) facing upstream; (B,E) facing downstream; and (C,F) across (left bank looking at right bank).

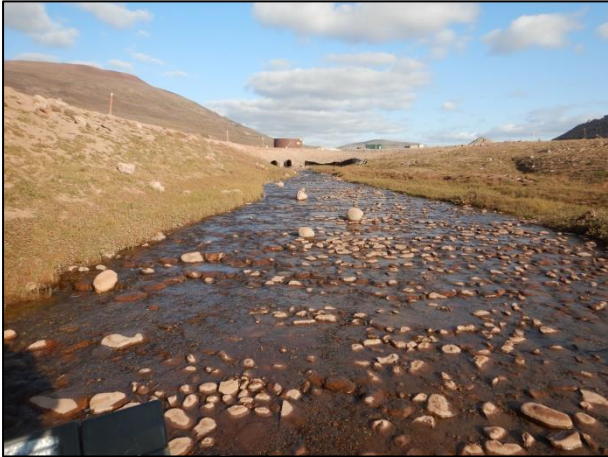
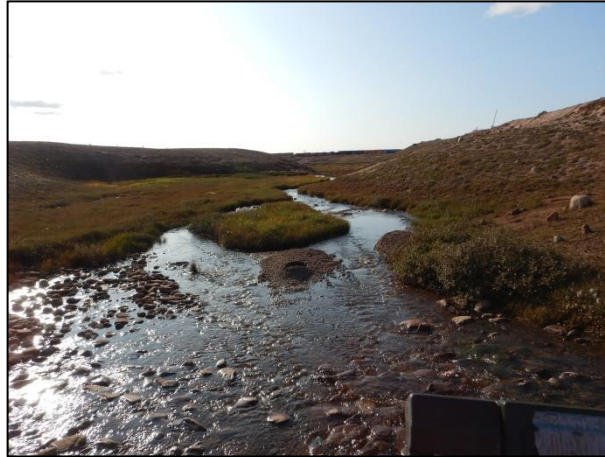
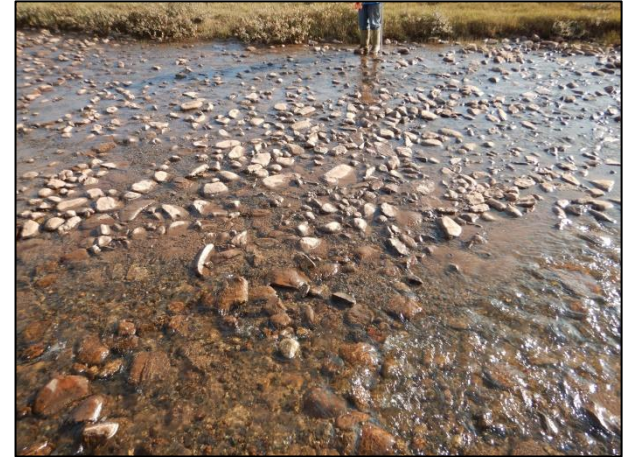
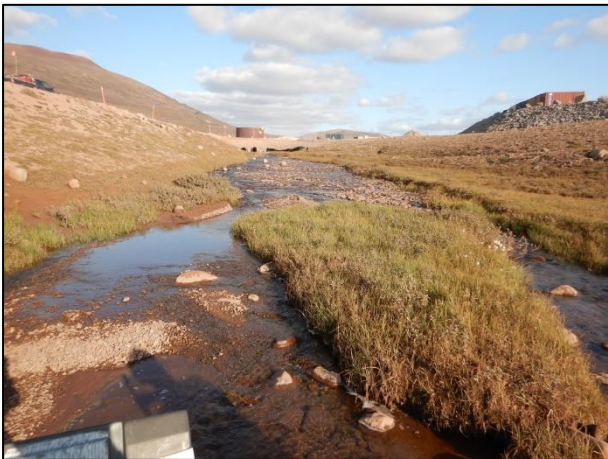
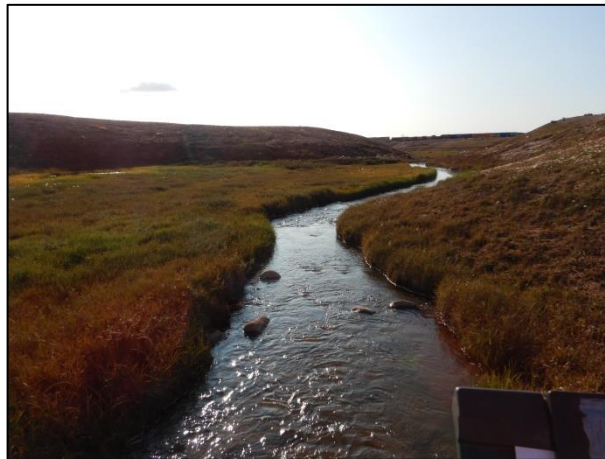
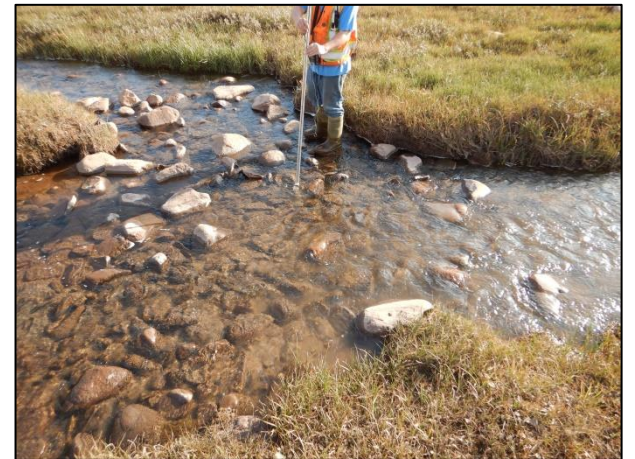
Photos 8. Photos taken 80 m downstream (top) and 100 downstream (bottom) in summer/fall: (A,D) facing upstream; (B,E) facing downstream; and (C,F) across (left bank looking at right bank).

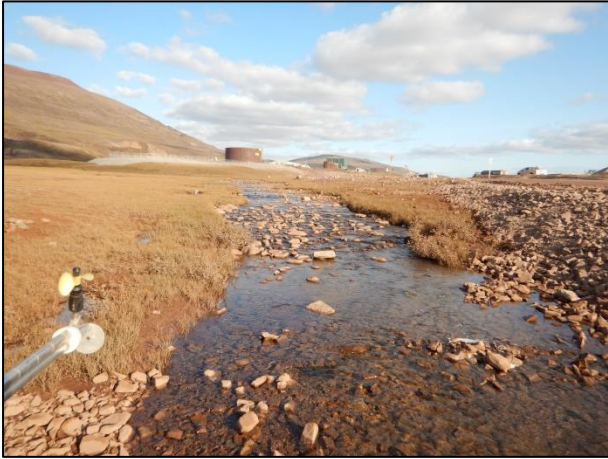
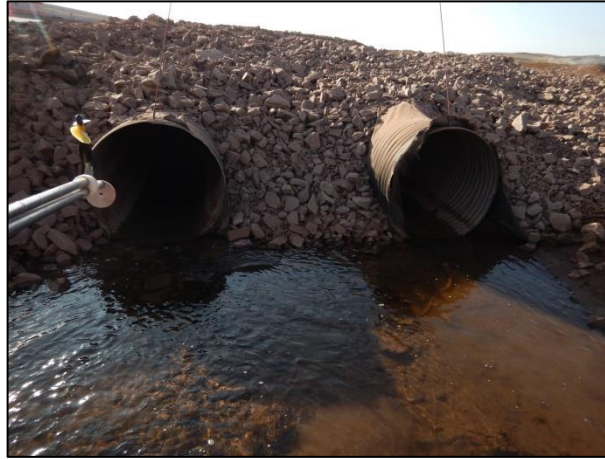
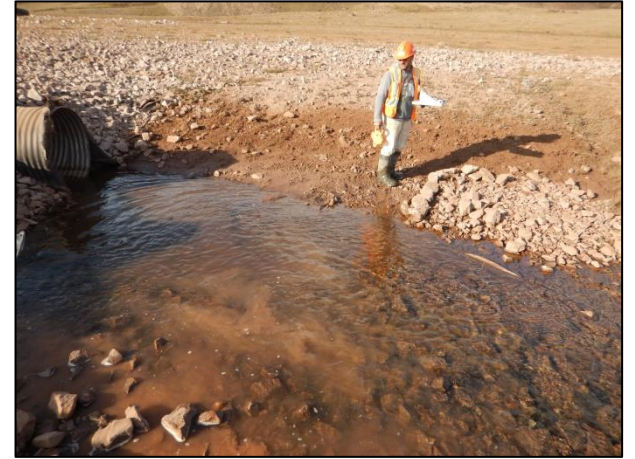
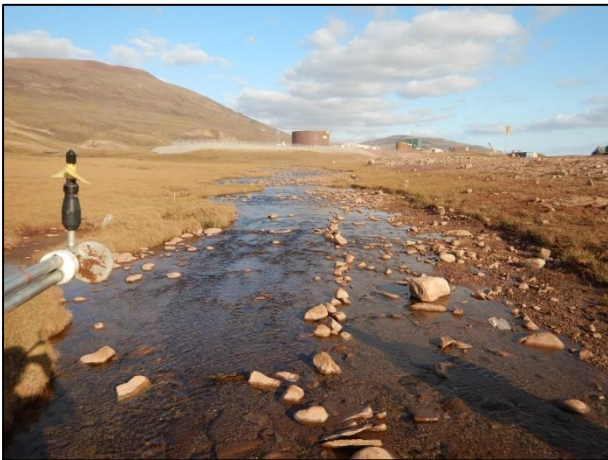
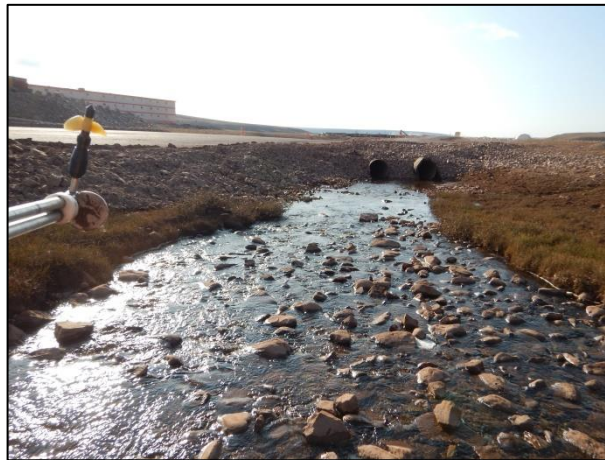
Photos 9. Photos taken 20 m upstream (top) and 40 m upstream (bottom) in summer/fall: (A,D) facing upstream; (B,E) facing downstream; and (C,F) across (left bank looking at right bank).

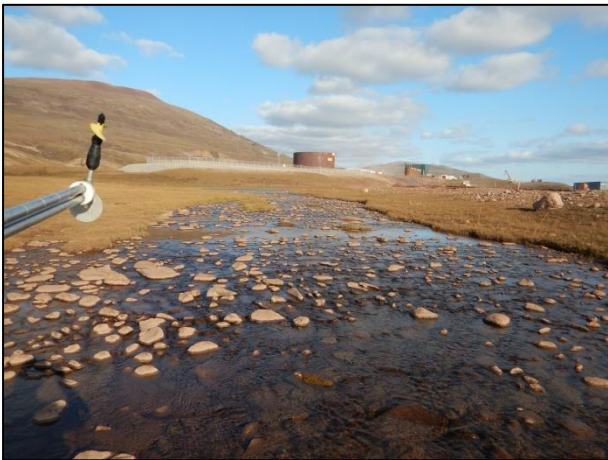
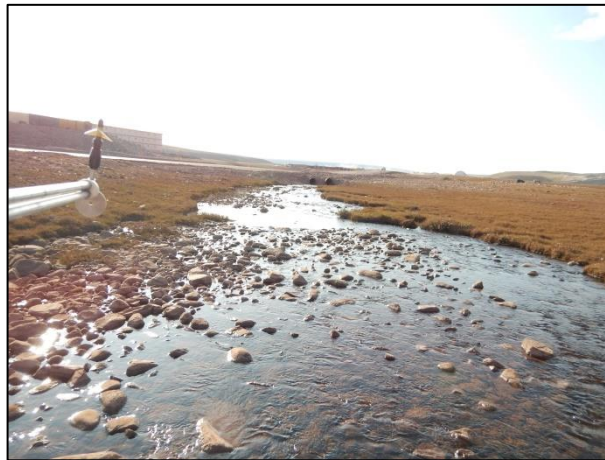
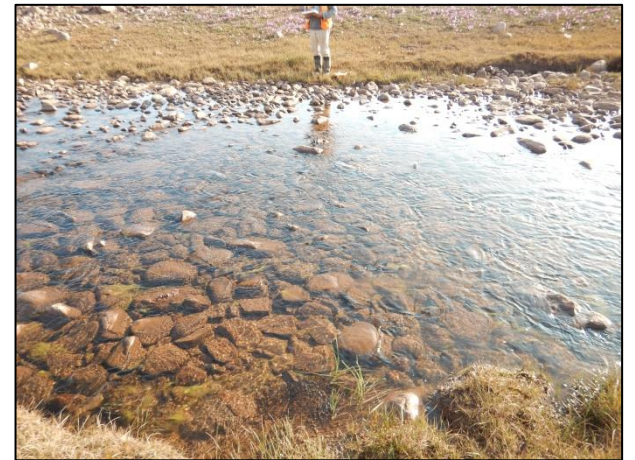
Photos 10. Photos taken 60 m upstream (top) and 80 m upstream (bottom) in summer/fall: (A,D) facing upstream; (B,E) facing downstream; and (C,F) across (left bank looking at right bank).

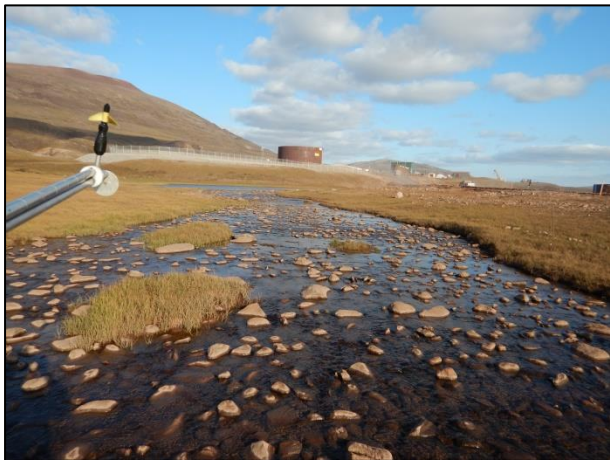
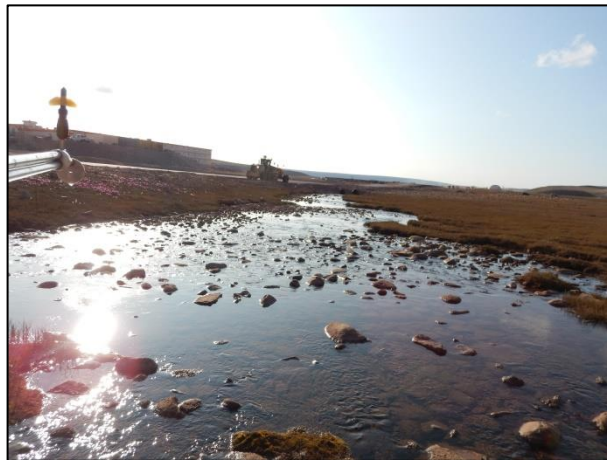
Photos 11. Photos taken 100 m upstream in summer/fall: (A) facing upstream; (B) facing downstream; and (C) across (left bank looking at right bank).
