ROAD M-CULV-3B

LOCATION AND CROSSING DESCRIPTION

**BAFFINLAND IRON MINES
MARY RIVER PROJECT**

North/South Consultants Inc.
Aquatic Environment Specialists

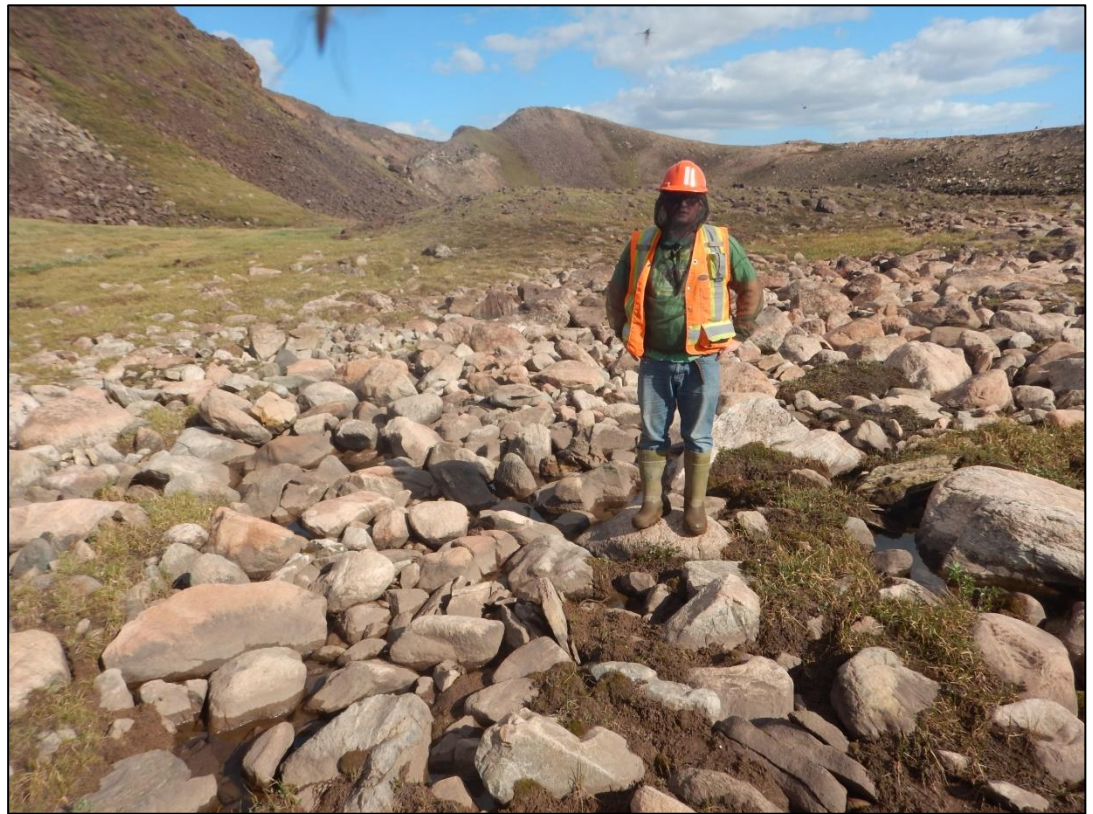
Upstream/ Downstream	UTM		Barrier Type			Height (m)	Gradient (°)	Description	Site Label
	Easting	Northing	1	2	3				
Downstream	NO BARRIERS								
Upstream	561444	7913547	SSF					Permanent Barrier: Subsurface flow under boulders overgrown with vegetation	A

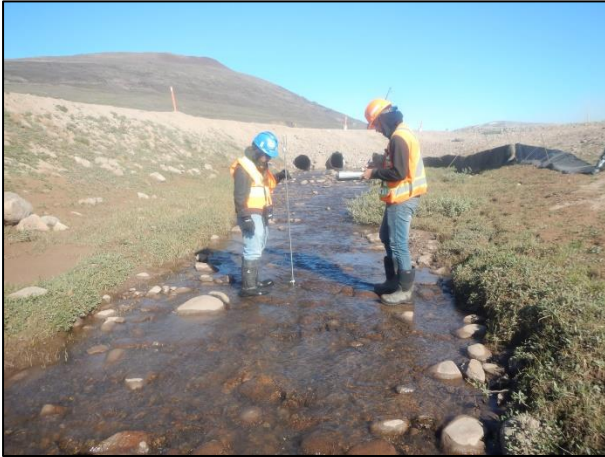
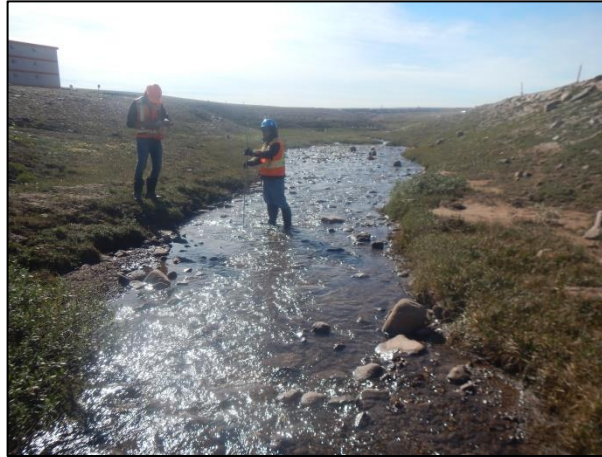
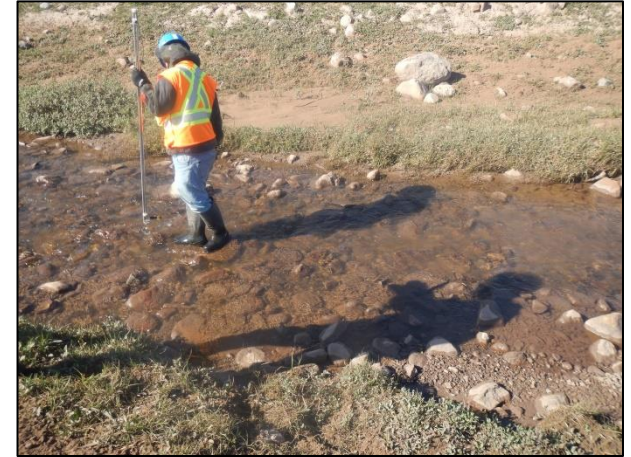
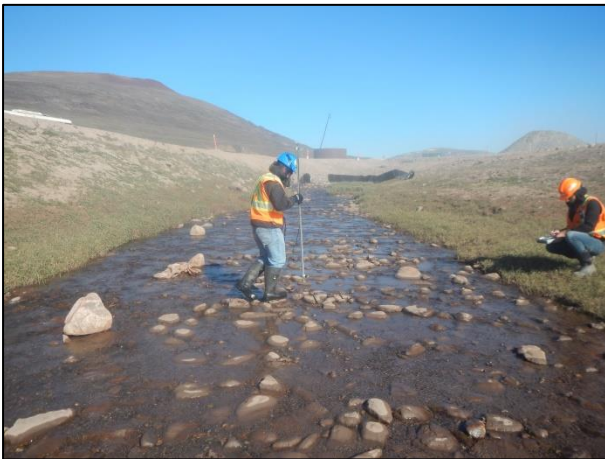
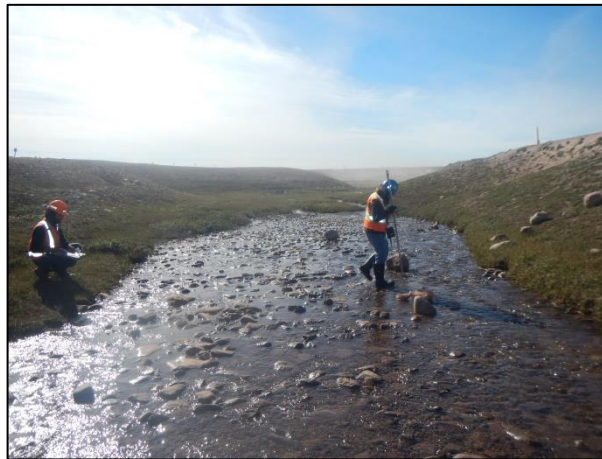
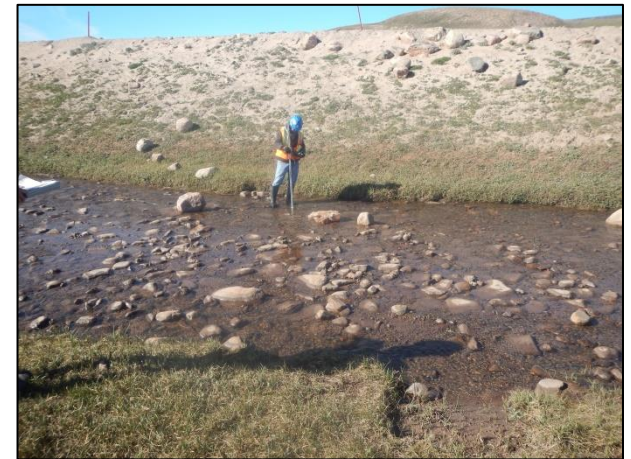
Photos 1. Photos taken at the crossing centreline (top) and 20 m downstream (bottom) in spring: (A,D) facing upstream; (B,E) facing downstream; (C,F) across (right bank looking at left bank).

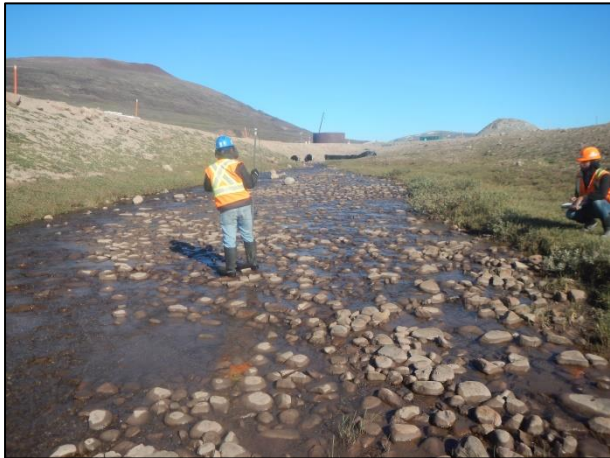
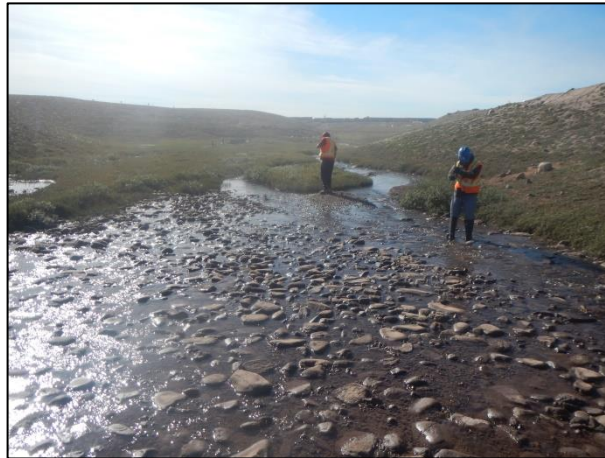
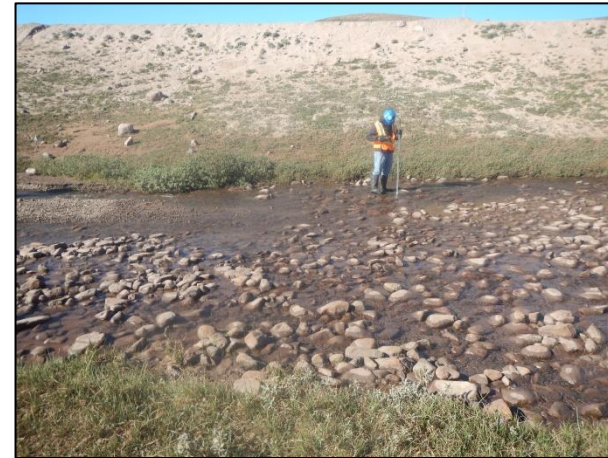
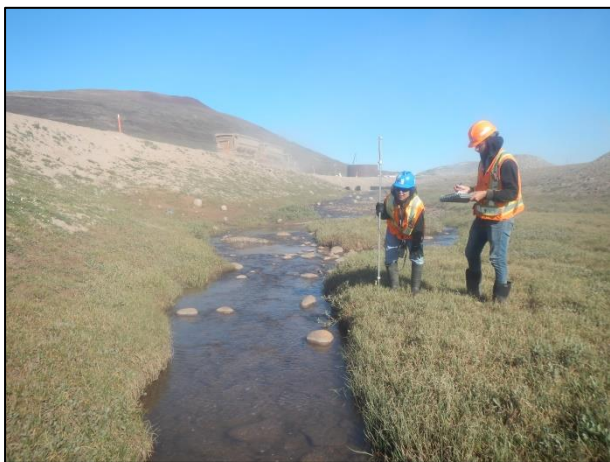
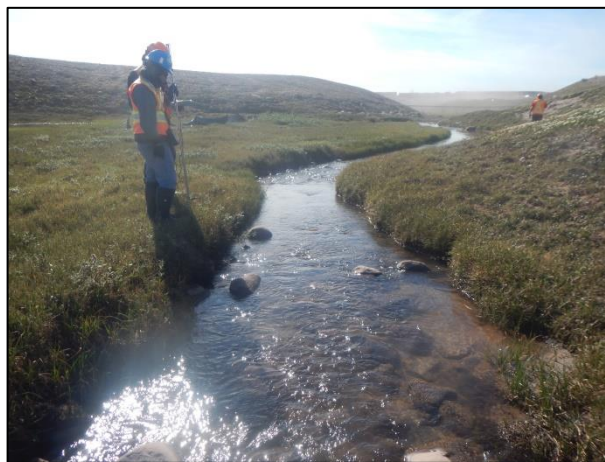
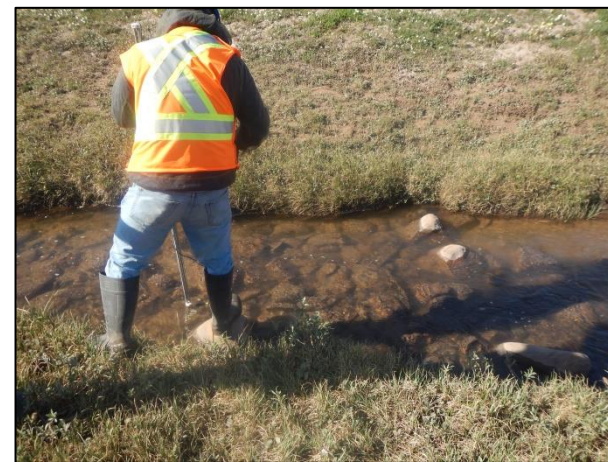
Photos 2. Photos taken 40 m downstream (top) and 60 m downstream (bottom) in spring: (A,D) facing upstream; (B,E) facing downstream; (C,F) across (right bank looking at left bank).

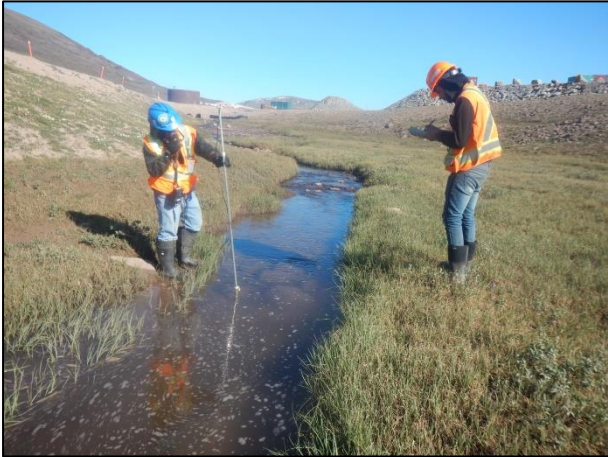
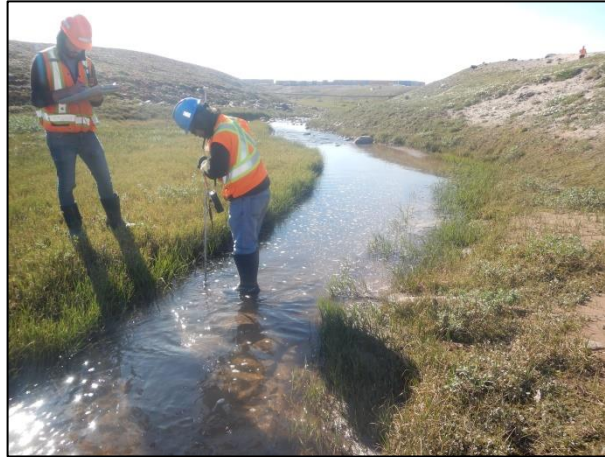
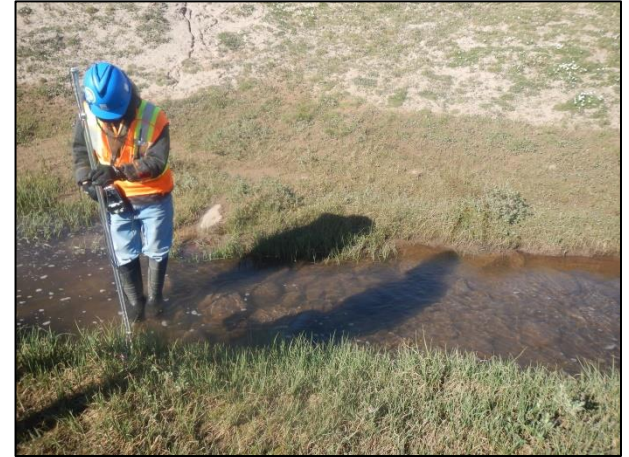
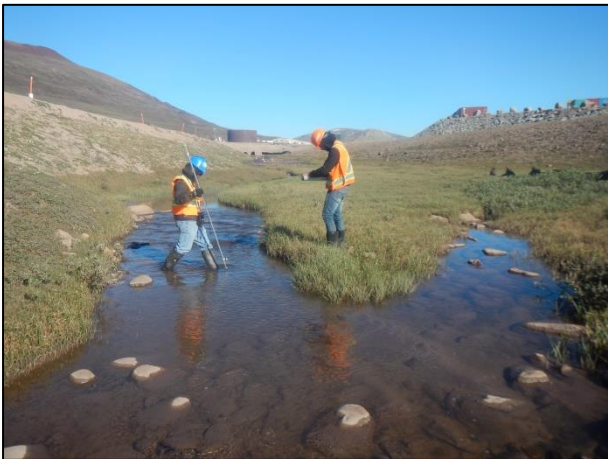
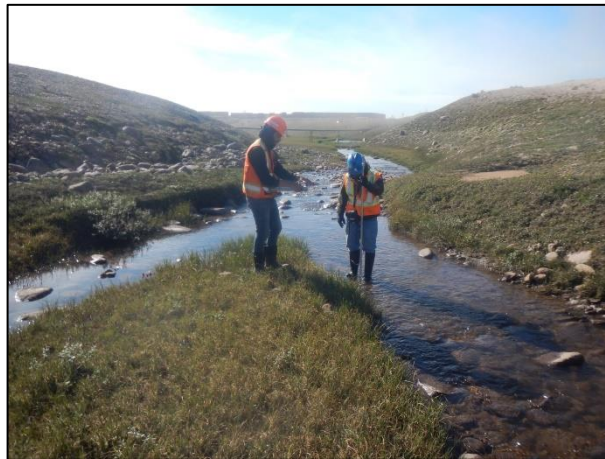
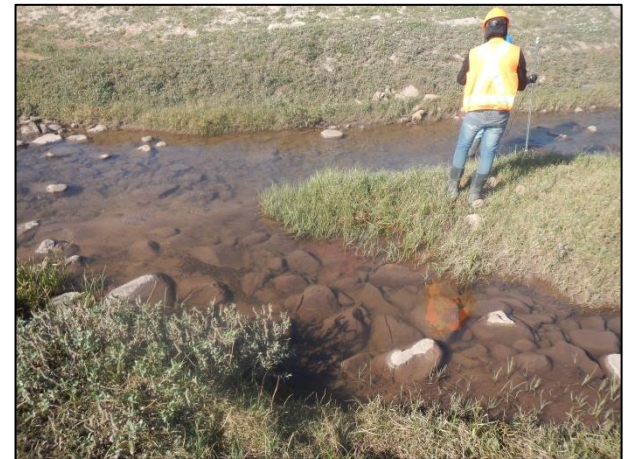
Photos 3. Photos taken 80 m downstream (top) and 100 m downstream (bottom) in spring: (A,D) facing upstream; (B,E) facing downstream; (C,F) across (right bank looking at left bank).

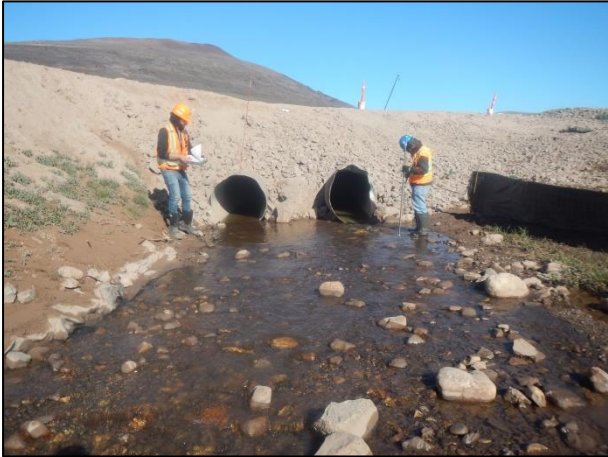
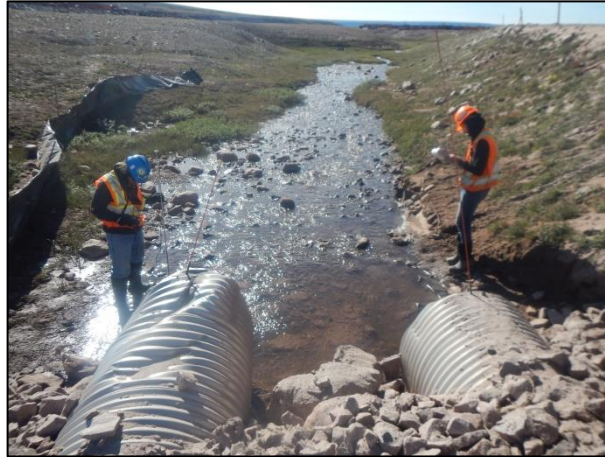
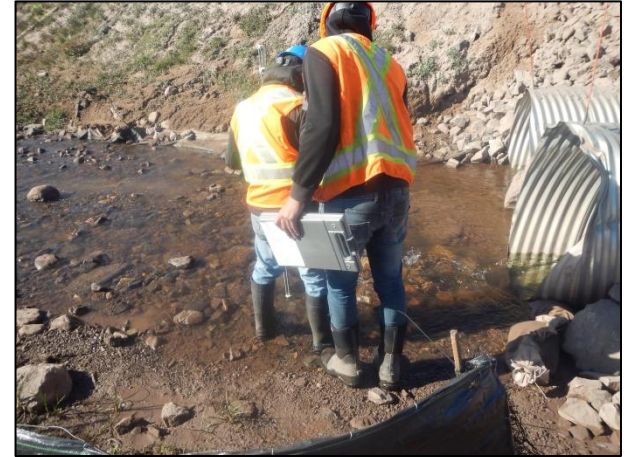
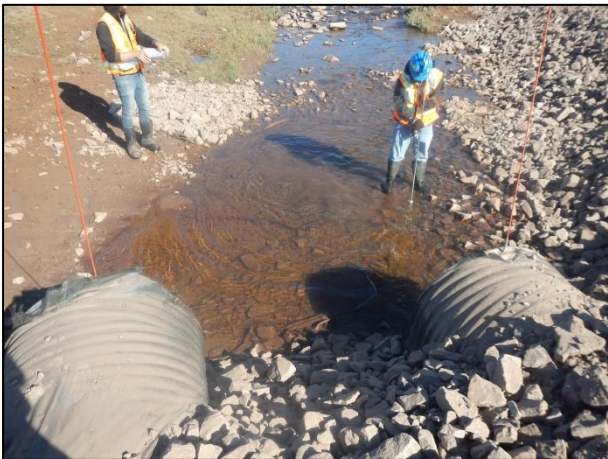
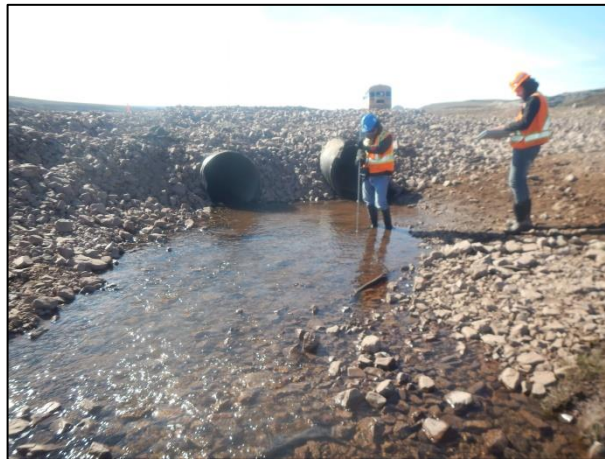
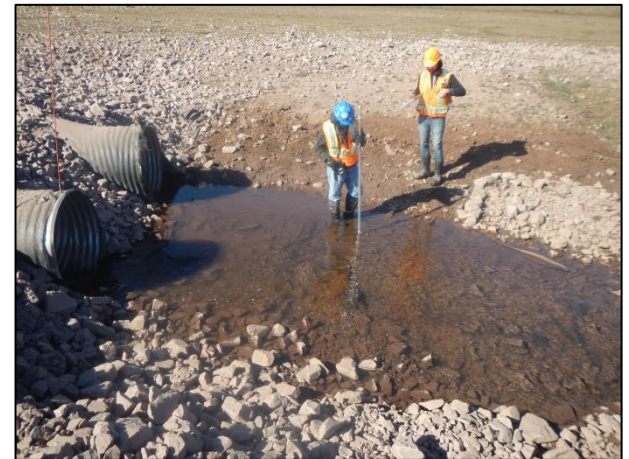
Photos 4. Photos taken 20 m upstream (top) and 60 m upstream (bottom) in spring: (A,D) facing upstream; (B,E) facing downstream; (C,F) across (right bank looking at left bank).

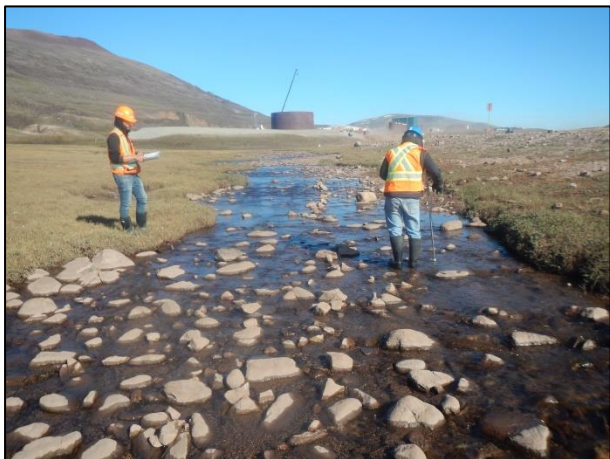
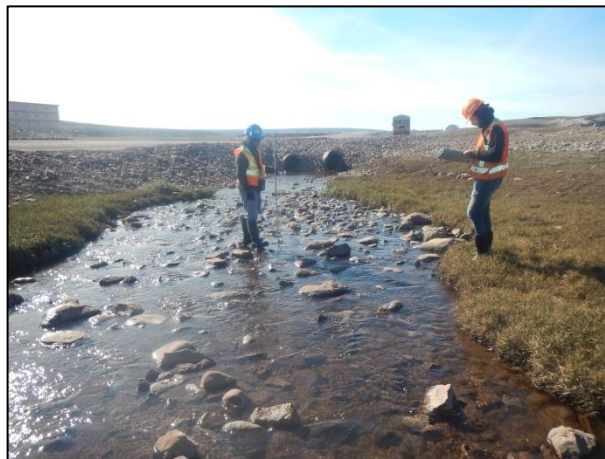
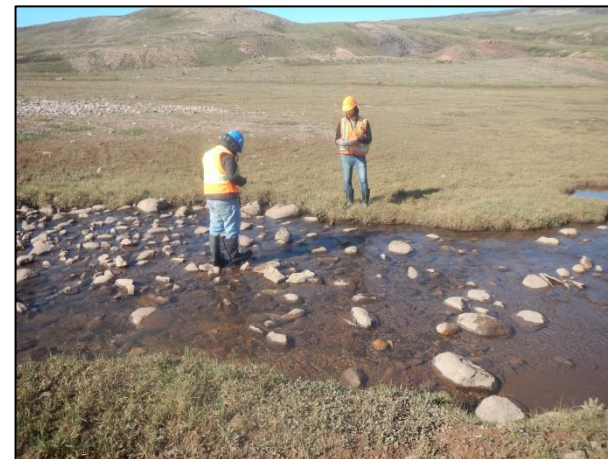
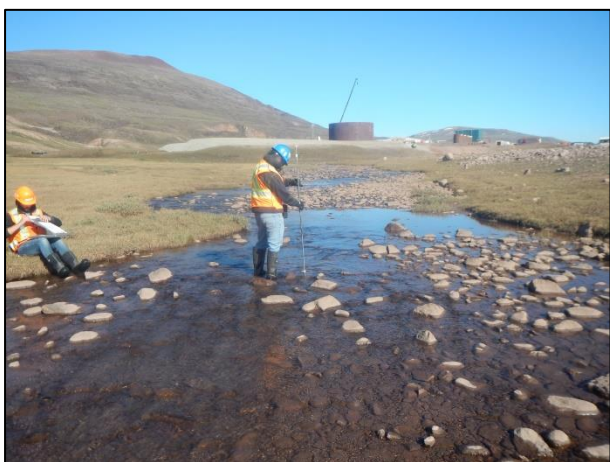
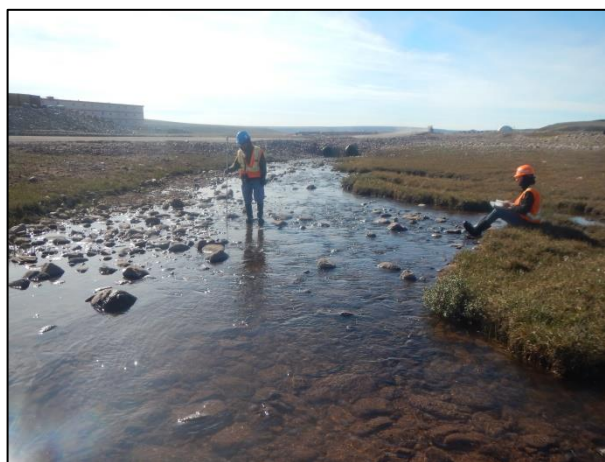
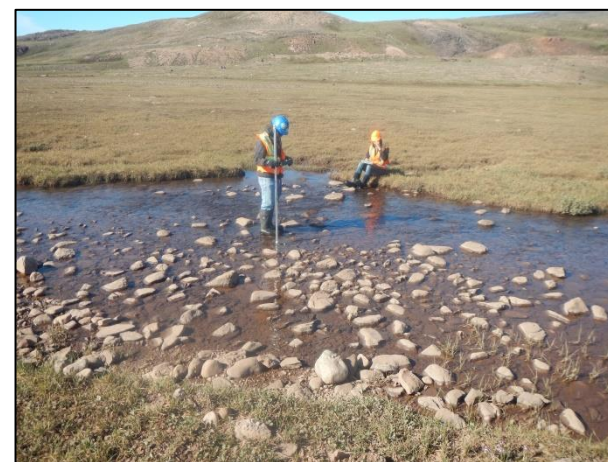
Photos 5. Photos taken 80 m upstream (top) and 100 m upstream (bottom) in spring: (A) facing upstream; (B) facing downstream; (C) across (right bank looking at left bank).

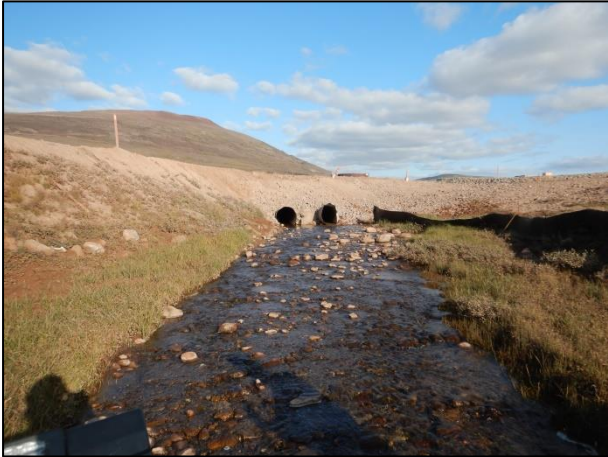
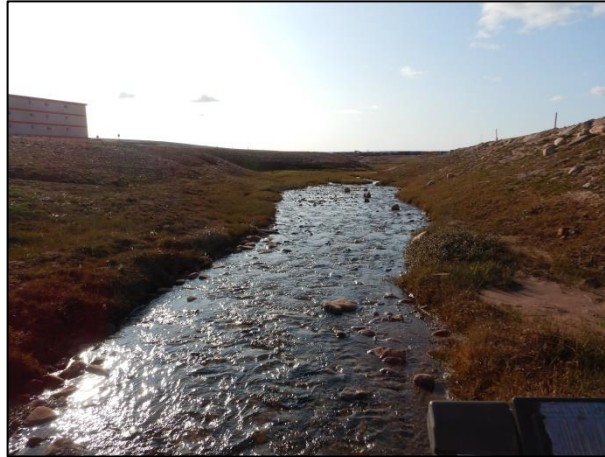
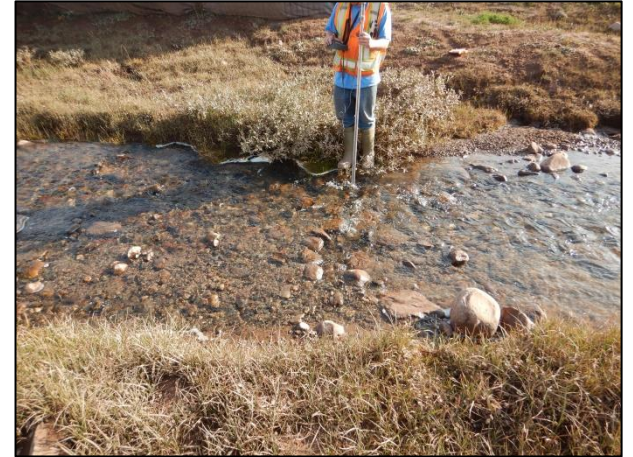
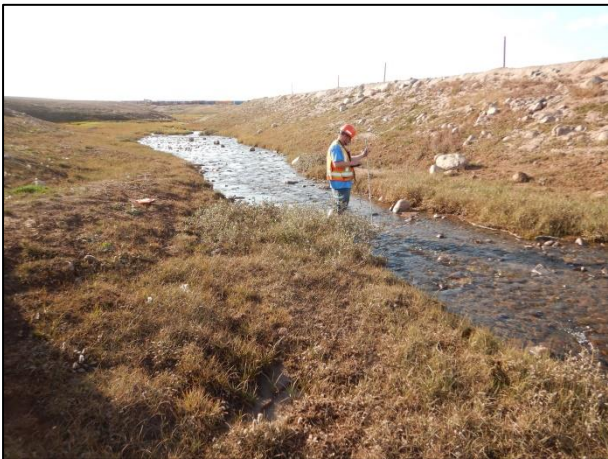
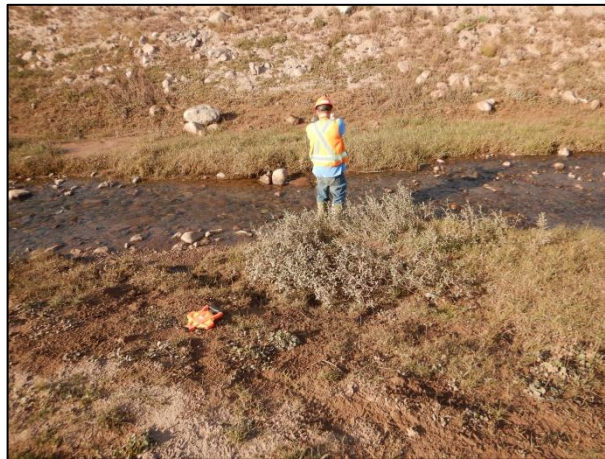
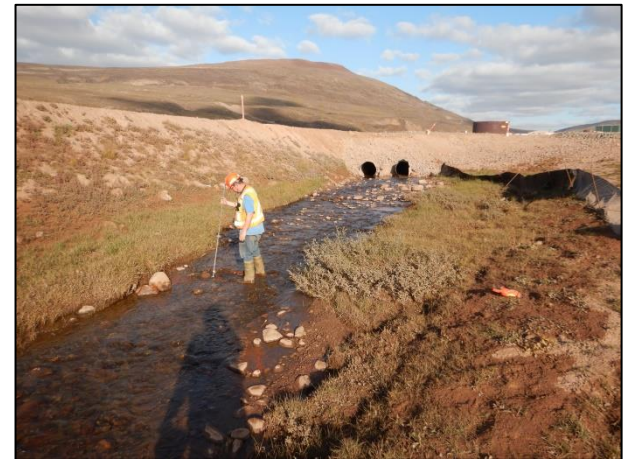
Slightly higher measured velocities during summer/fall, but otherwise similar habitat between seasons. As the 20 m upstream transect essentially overlaps with the downstream end of the road culvert, it was not assessed during summer/fall. Habitat was highly influenced by road materials and erosion at this location.

Photos 6. Photos taken at the crossing centerline in summer/fall: (A) facing upstream; (B) facing downstream; (C) across (left bank looking at right bank); (D) diagonal from right bank above the centreline looking downstream; (E) across (right bank looking at left bank); and (F) diagonal from right bank below the centreline looking upstream.

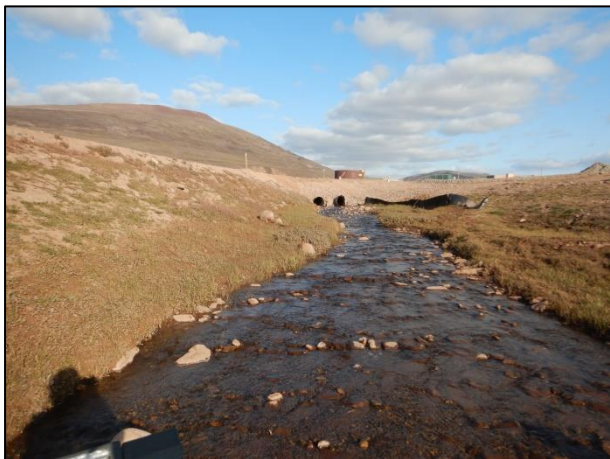
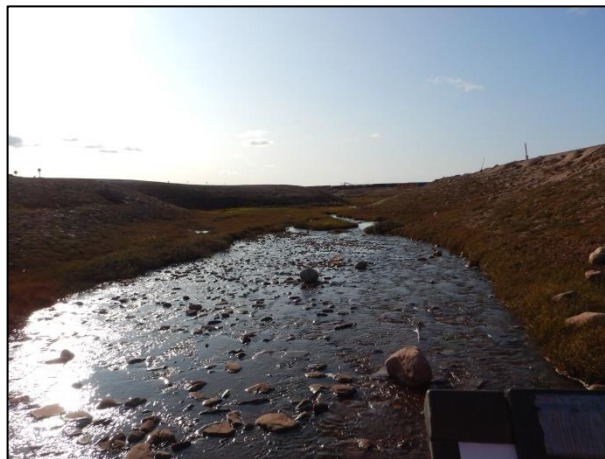
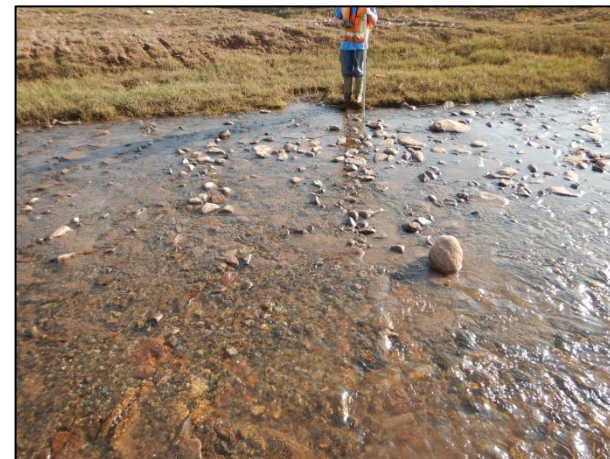
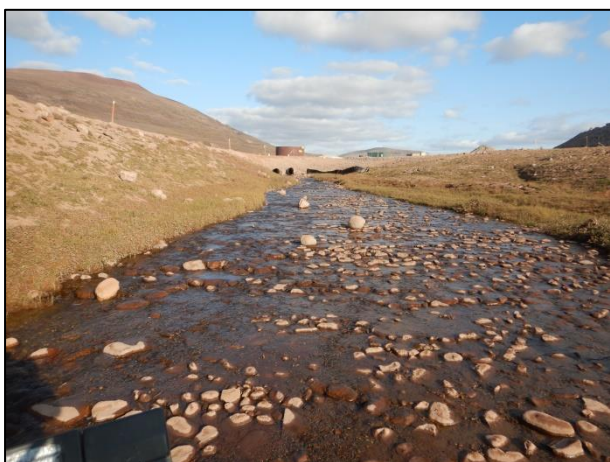
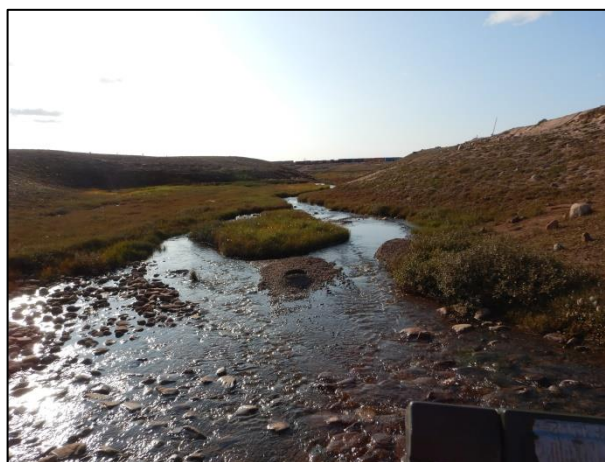
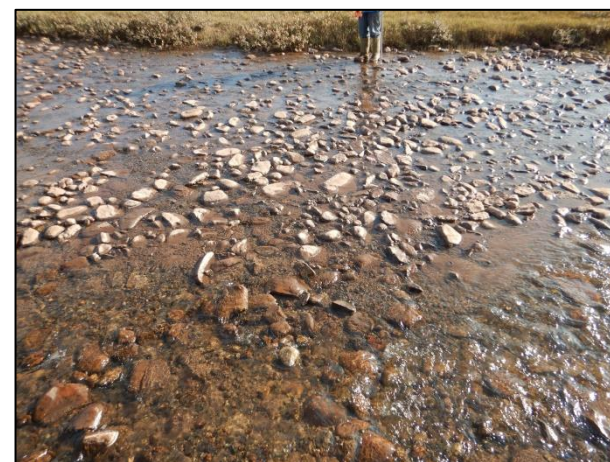
Photos 7. Photos taken 20 m downstream (top) and 40 downstream (bottom) in summer/fall: (A,D) facing upstream; (B,E) facing downstream; and (C,F) across (left bank looking at right bank).

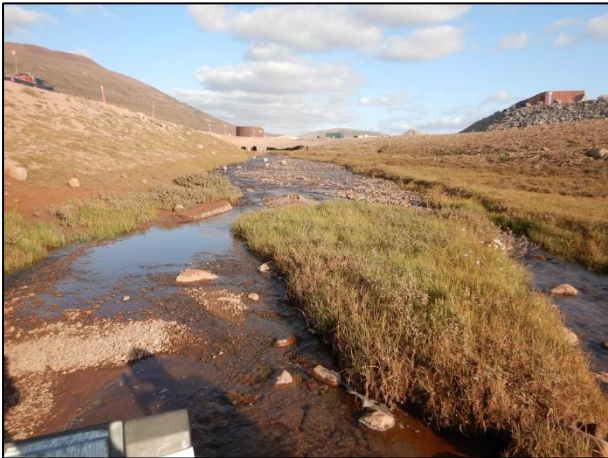
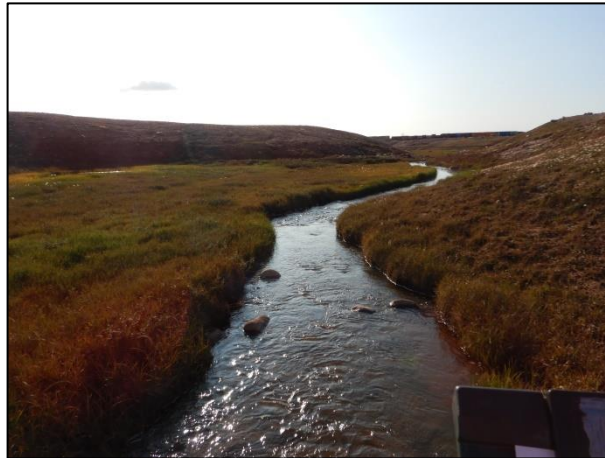
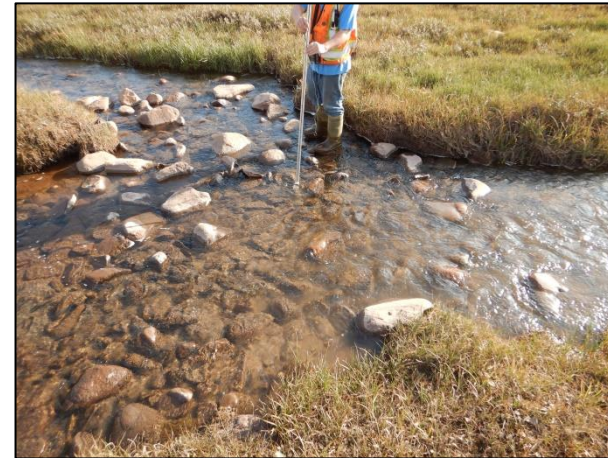
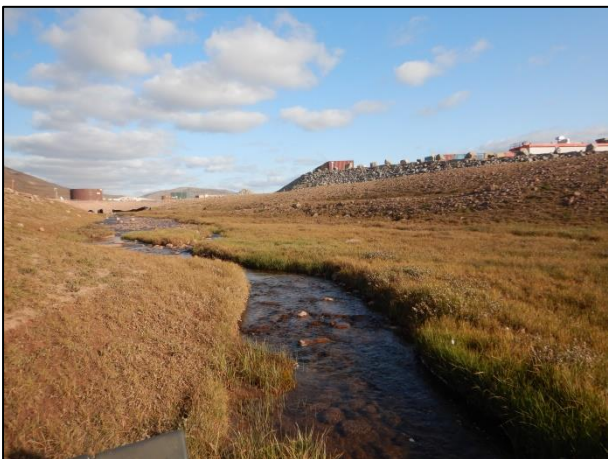
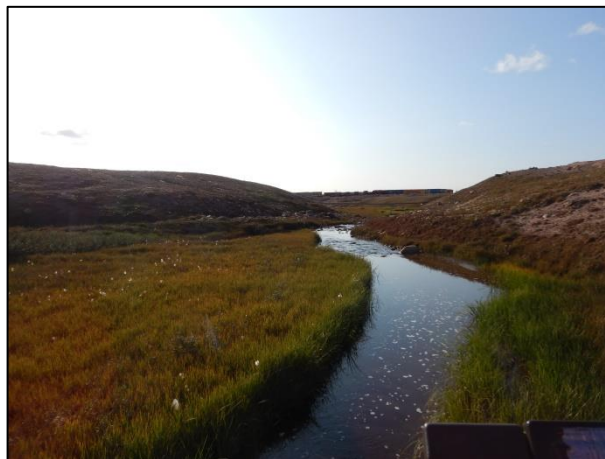
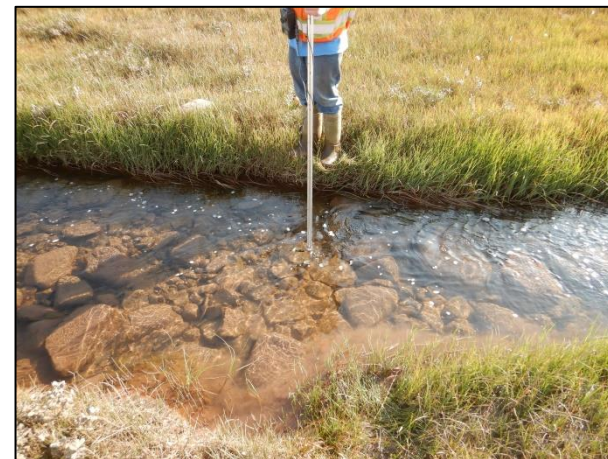
Photos 8. Photos taken 60 m downstream (top) and 80 downstream (bottom) in summer/fall: (A,D) facing upstream; (B,E) facing downstream; and (C,F) across (left bank looking at right bank).

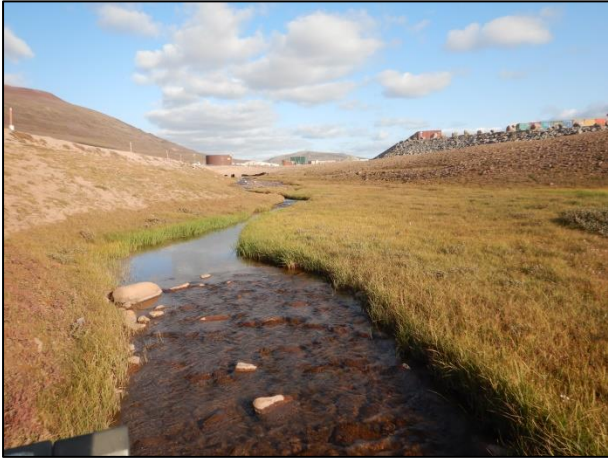
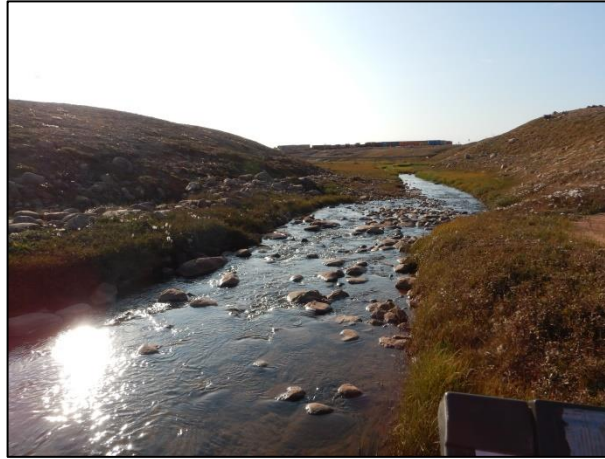
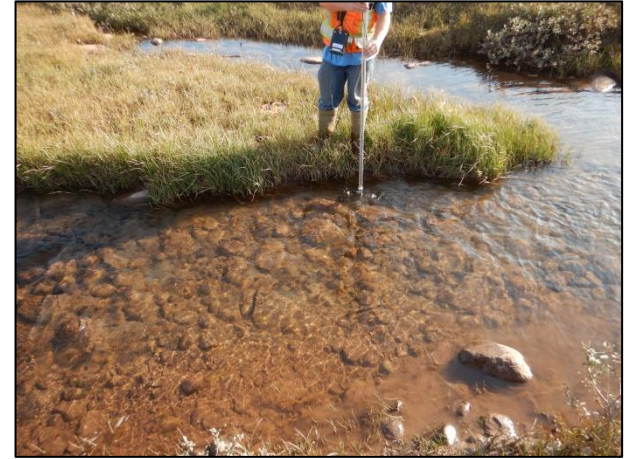
Photos 9. Photos taken 100 m downstream in summer/fall: (A) facing upstream; (B) facing downstream; (C) across (left bank looking at right bank).

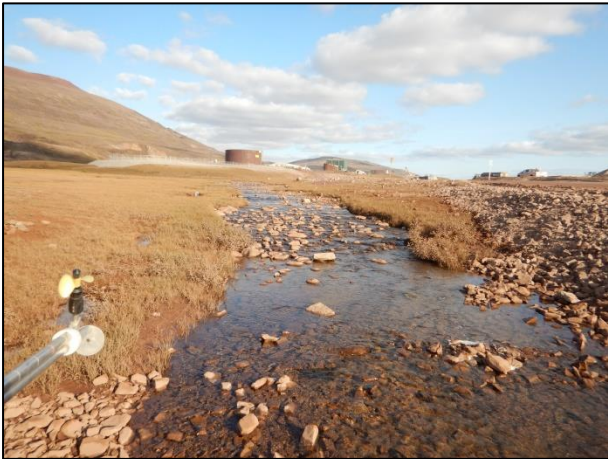
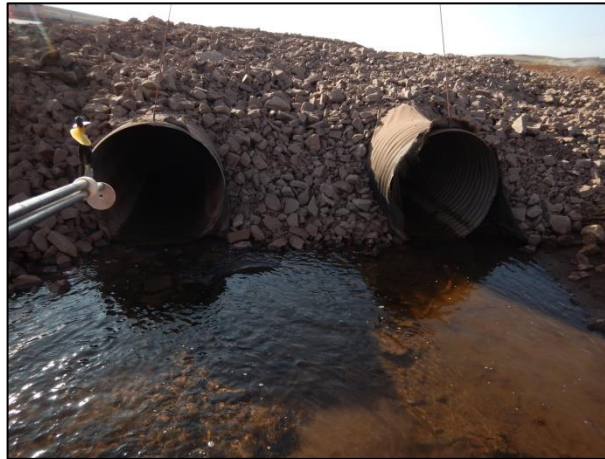
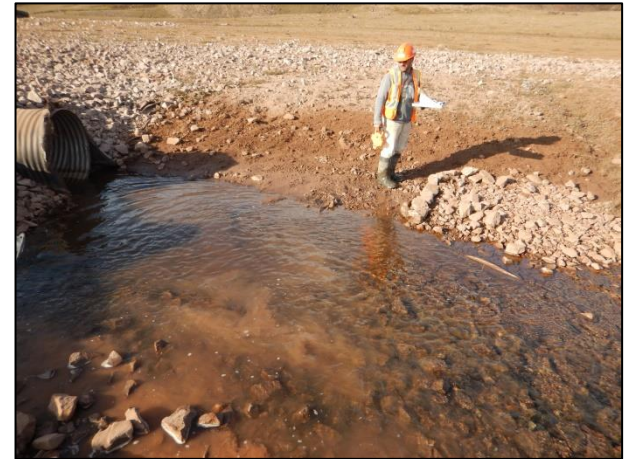
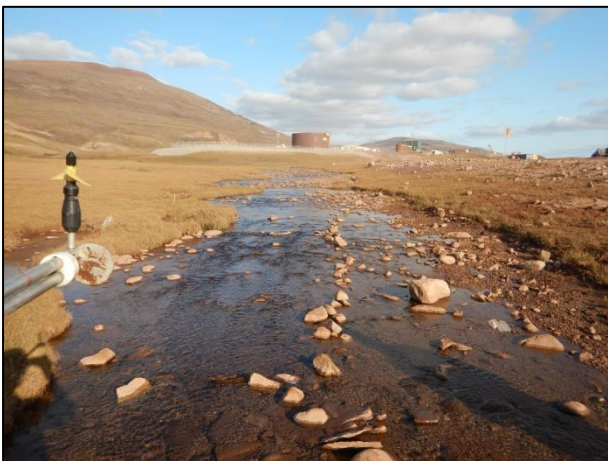
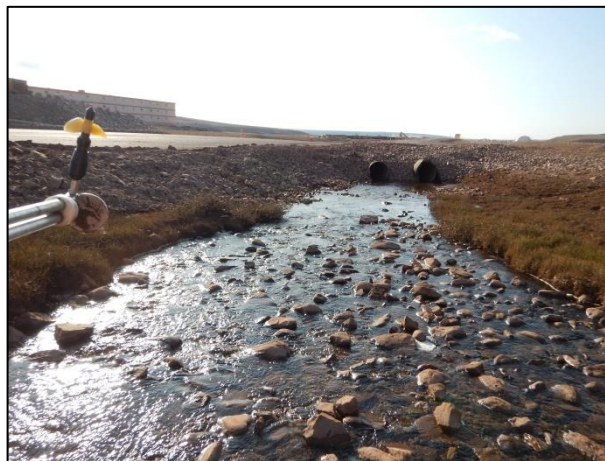
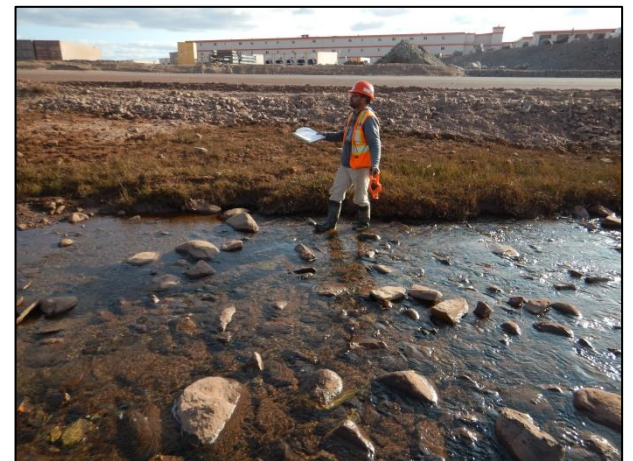
Photos 10. Photos taken 60 m upstream (top) and 80 m upstream (bottom) in summer/fall: (A,D) facing upstream; (B,E) facing downstream; (C,F) across (left bank looking at right bank).

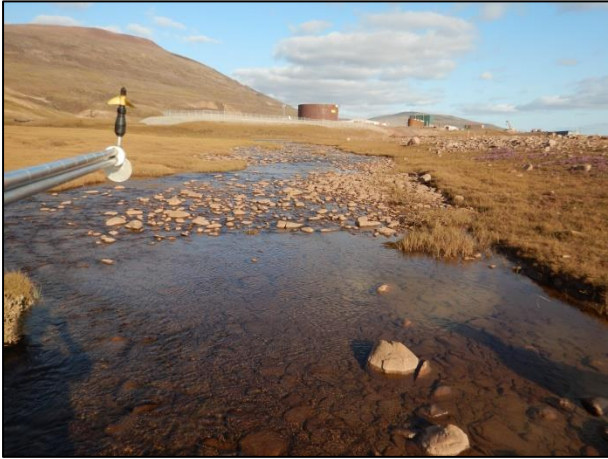
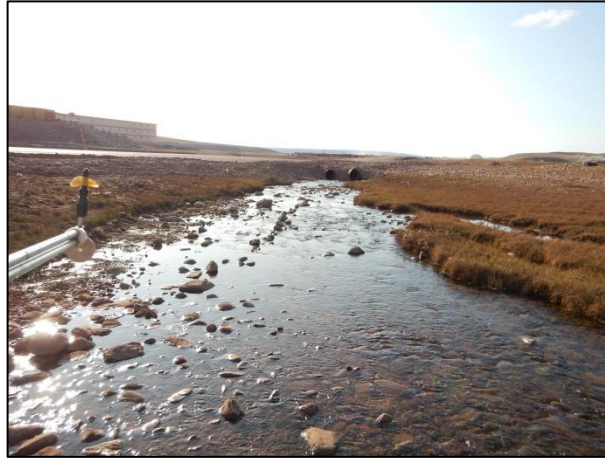
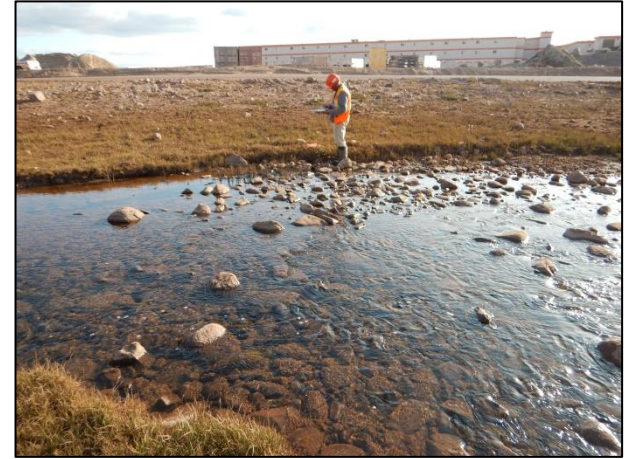
Photos 11. Photos taken 100 m upstream in summer/fall: (A) facing upstream; (B) facing downstream; (C) across (left bank looking at right bank).
