#### LOCATION AND CROSSING DESCRIPTION

Site ID: M-Culv-16 **Dates Surveyed:** 23-Jun-19; 19-Aug-19 Waterbody Type: Pond Pond Infilling + Culvert **Centreline UTM Coordinates:** 17W 560513 E 7913699 N **Project Interaction:** Culvert Length (m): 16.9 Number of Barrels: **Culvert Diameter/Span (mm): Slope (%):** 0

BAFFINLAND IRON MINES MARY RIVER PROIECT

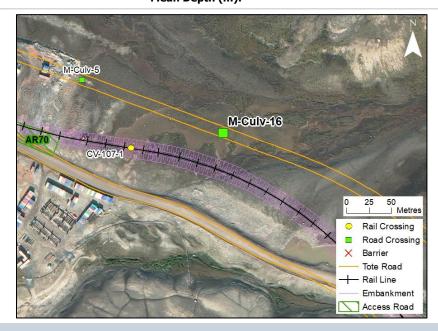
The rail alignment infills the southwest bay of a shallow pond that is intermittently connected via a shallow outflow channel to the lake at CV-106-3. The pond collects meltwater from the hills to the north and northeast; it is the headwaters area of the system that flows to Camp Lake >3 km downstream. The system includes all the fish-bearing rail sites from CV-105-2 to CV-106-3. The pond will also be infilled (the southwest tip) by the rail at site CV-107-1.

This pond, and the encroachment area in particular, provides minimal rearing habitat for both species as evidenced by few fish present in either 2018 or 2019. Stickleback spawning is unlikely due to minimal nest-building materials (i.e., vegetation) present in the pond. Depth is insufficient to support overwintering of either species. Fish likely enter this pond from the downstream lake CV-106-3 under higher flows, but may become stranded and winterkill. The infill area in the pond is shallow (<0.10 m) with primarily fines and the occasional large cobble or boulder.

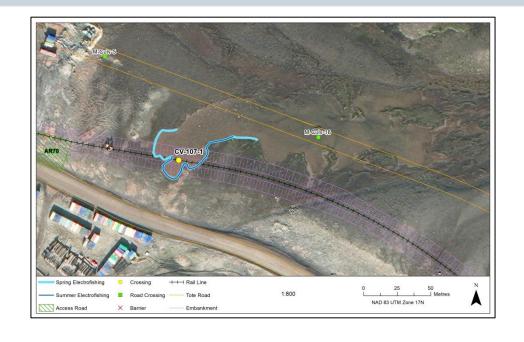
### FISHING SITES

Date: 23-Jun-19 Temperature (°C): NR Gear Used: Backpack Electrofisher/Visual

Distance Fished (m): 180 Duration Fished (seconds): 766

Date: 19-Aug-19 Temperature (°C): NR Gear Used: Backpack Electrofisher/Visual

Distance Fished (m): 100 Duration Fished (seconds): 226

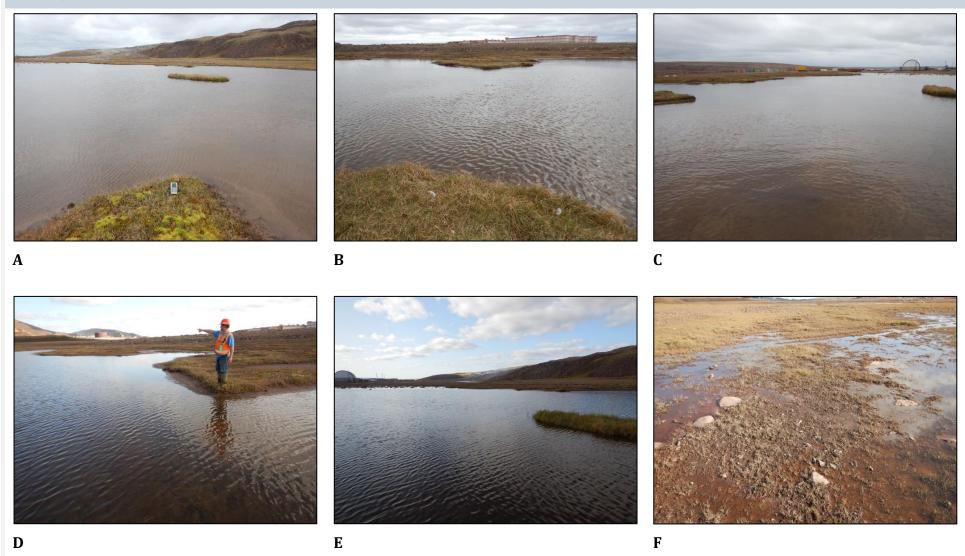
## 23-JUN-19 & 19-AUG-19

Stickleback were observed throughout the infill area during spring. During summer/fall, both species were captured on the west side of the pond. Within the M-Culv-16 infill, stickleback were evenly distributed in available habitat, but char were not observed. Fish were not captured or observed in 2018. A shallow water or subsurface flow barrier has the potential to form in the outlet stream (consistently very shallow, <0.02 m), which could lead to fish stranding and winterkill. Connectivity was maintained during the two 2019 surveys.

Photos 1. Photos taken during spring (top) and summer/fall (bottom): (A) northwest across infill area; (B) southeast across infill area; (C) southwest across infill area; (D) across infill; (E) towards outflow; and (F) possible intermittent barrier area in outflow channel.
