ROAD M-CULV-18

LOCATION AND CROSSING DESCRIPTION

**BAFFINLAND IRON MINES
MARY RIVER PROJECT**

North/South Consultants Inc.
Aquatic Environment Specialists

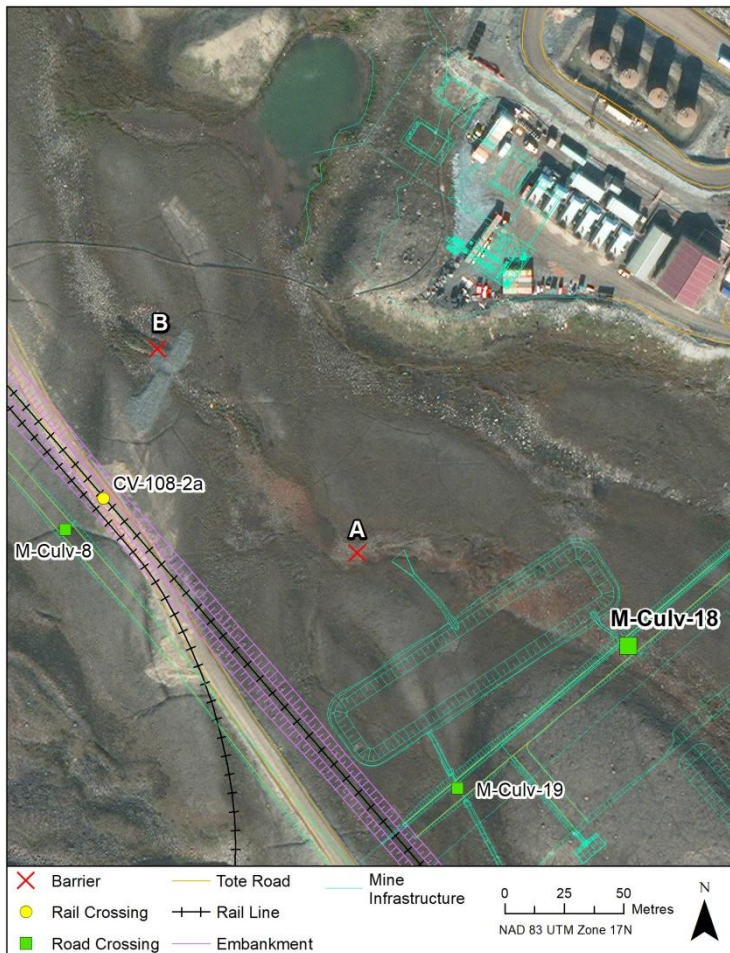
Upstream/ Downstream	UTM		Barrier Type			Height (m)	Gradient (°)	Description	Site Label
	Easting	Northing	1	2	3				
Downstream	561138	7913101	SSF					Permanent Barrier: Water flowing under boulder field	A
Downstream	561054	7913187	SSF					Permanent Barrier: Existing construction footprint, no culvert, subsurface flow	B

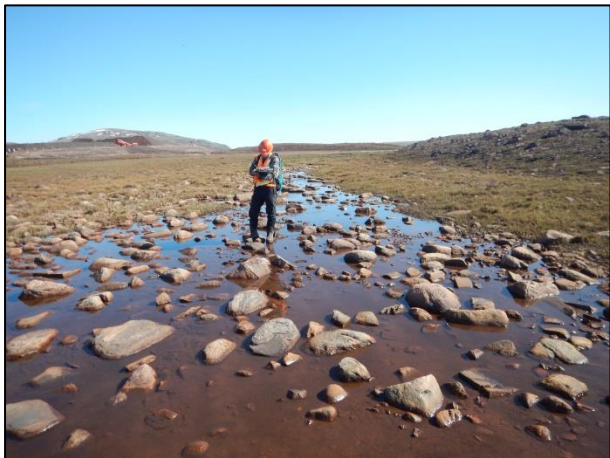
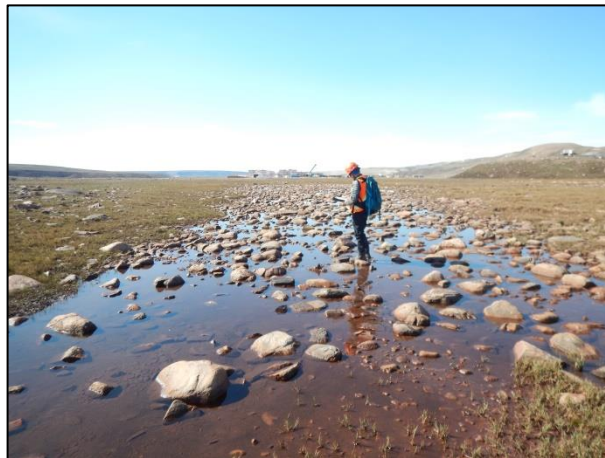
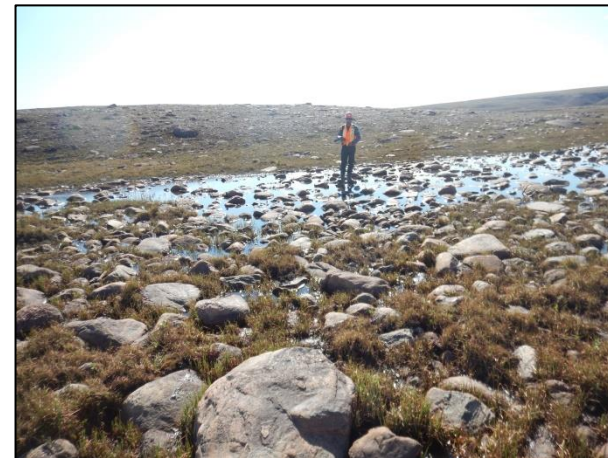
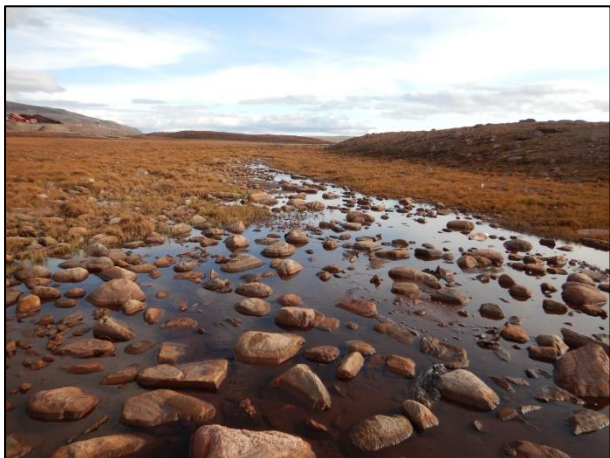
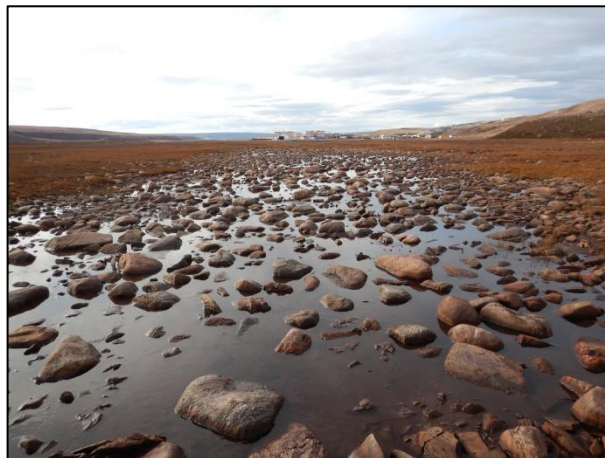
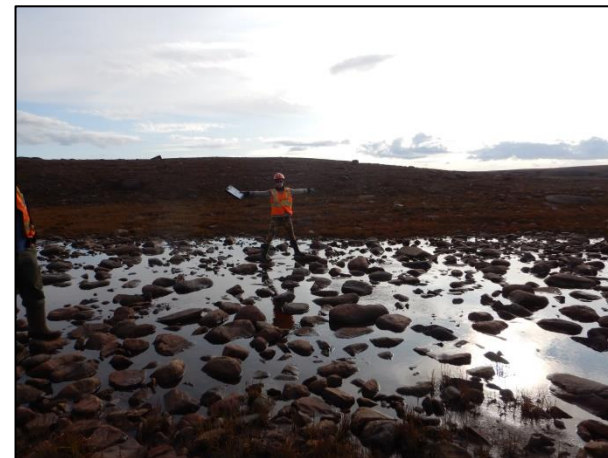
Photos 1. Photos taken at the crossing centreline in spring (top) and summer/fall(bottom): (A,D) facing upstream; (B,E) facing downstream; and (C,F) across (left bank looking at right bank). See habitat assessment sheet SWD-2-Diversion for additional photos and habitat data.
