RAIL CV-102-7B

LOCATION AND CROSSING DESCRIPTION

**BAFFINLAND IRON MINES
MARY RIVER PROJECT**

North/South Consultants Inc.
Aquatic Environment Specialists

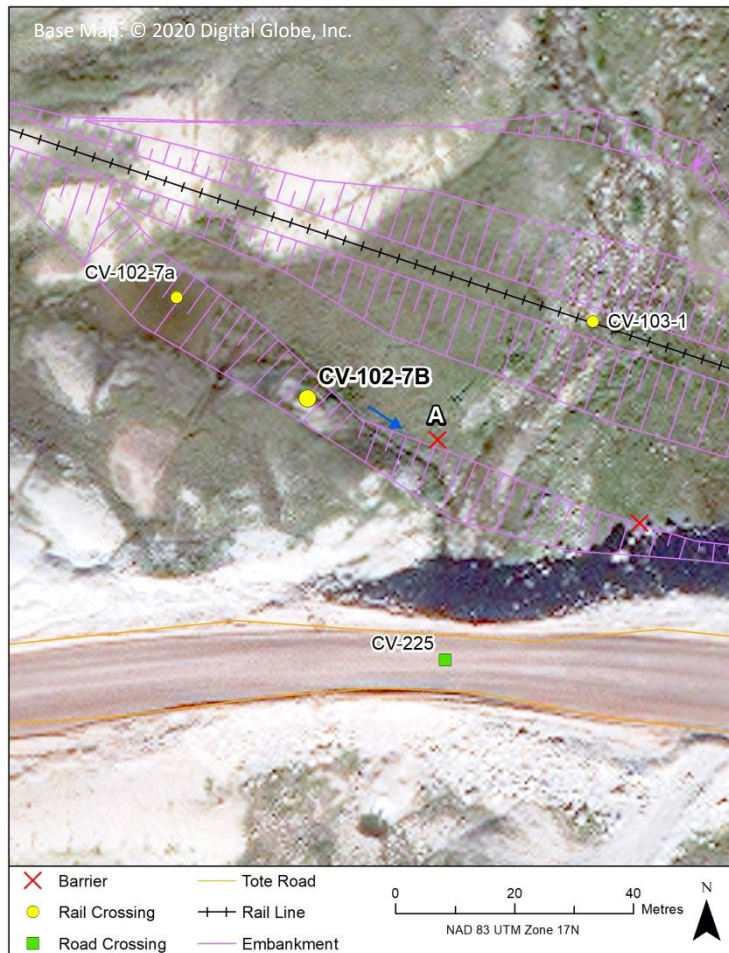
Upstream/ Downstream	UTM		Barrier Type			Height (m)	Gradient (°)	Description	Site Label
	Easting	Northing	1	2	3				
Downstream	557423	7915224	VD	SHALL		0.5	12	Permanent Barrier: Vertical drop at downstream confluence	A

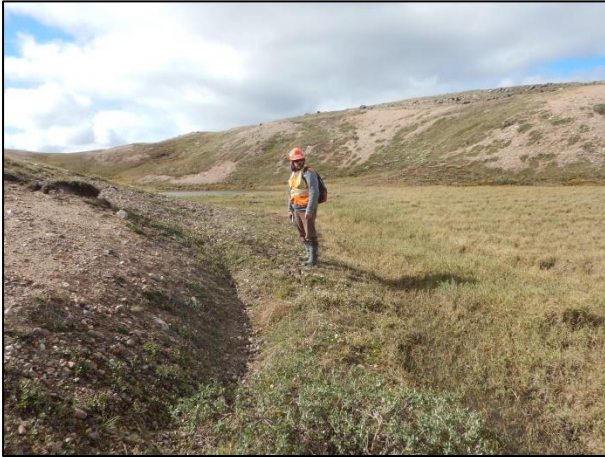
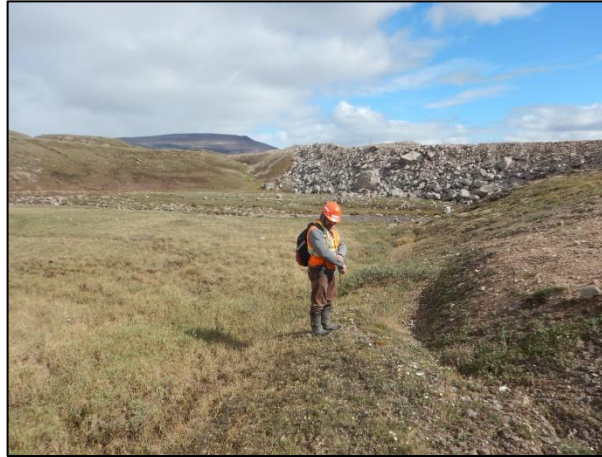
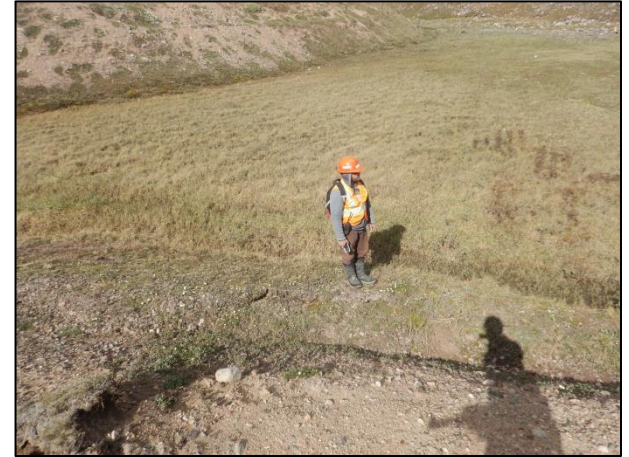
Photos 1. Photos taken at the rail centreline: (A) facing upstream; (B) facing downstream; and (C) across (left bank looking at right bank).

This stream is very shallow, with no defined channel (i.e., water flowing over terrestrial vegetation). Water was frequently subsurface or very shallow downstream of the rail centreline in spring 2019 and there is a permanent vertical drop barrier 5 m upstream from the confluence with the stream crossed at CV-103-1.
