RAIL CV-103-1

LOCATION AND CROSSING DESCRIPTION

**BAFFINLAND IRON MINES
MARY RIVER PROJECT**

North/South Consultants Inc.
Aquatic Environment Specialists

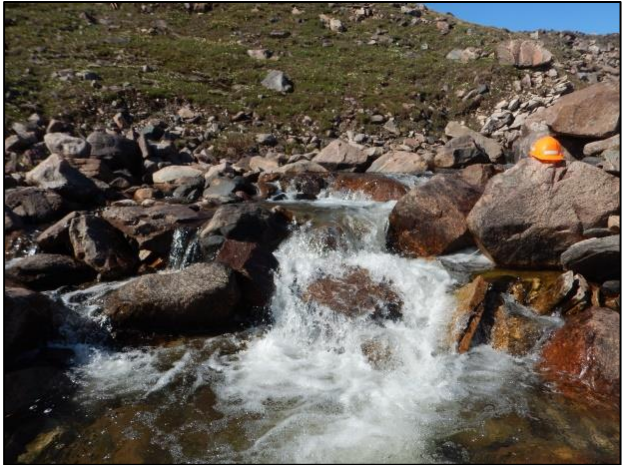
| Upstream/ Downstream | UTM | | Barrier Type | | | Height (m) | Gradient (°) | Description | Site Label |
|---|---|---|---|---|---|---|---|--|---|
| Upstream | 557453 | 7915369 | VD | VALL | | 0.3-0.5 | | Potential Intermittent Barrier: Located at the base of a series of large cascades/falls, some of which may be passable | A |

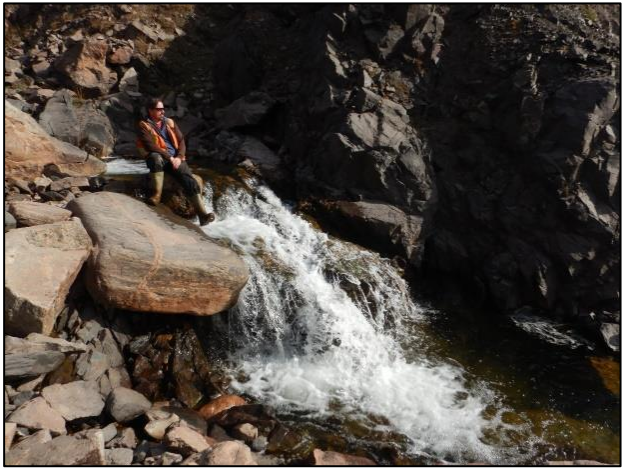
| Upstream/ Downstream | UTM | | Barrier Type | | | Height (m) | Gradient (°) | Description | Site Label |
|---|---|---|---|---|---|---|---|--|---|
| Upstream | 557502 | 7915441 | VD | | | 3-4m | | Permanent Barrier: Large waterfall | B |

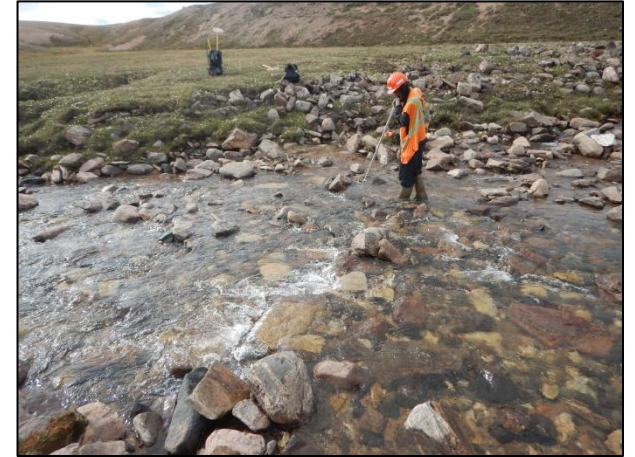
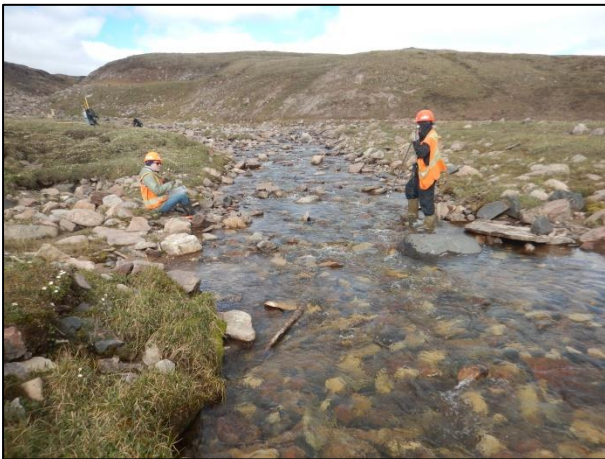
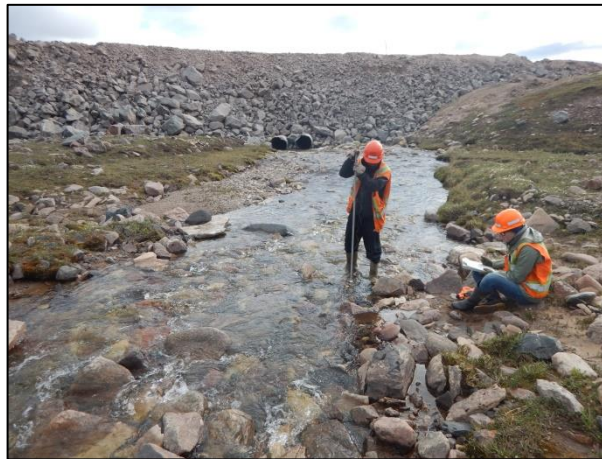
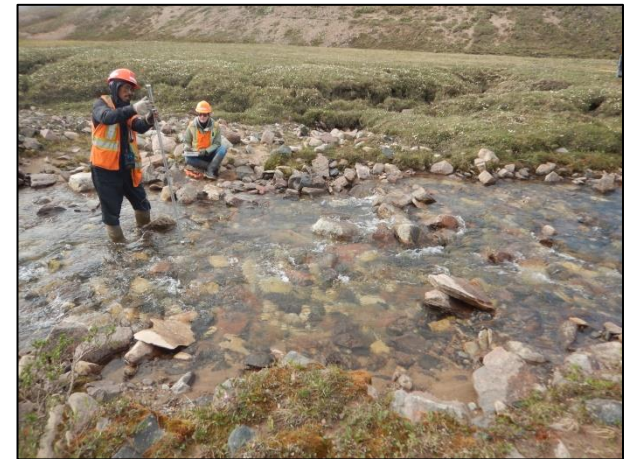
The stream is characterized by riffle/cascade/pool habitat over cobble/boulder substrate, with moderate to high velocities.

Photos 1. Photos taken at the crossing centreline (top) and 20 m downstream (bottom) in spring: (A,D) facing upstream; (B,E) facing downstream; and (C,F) across (right bank looking at left bank).

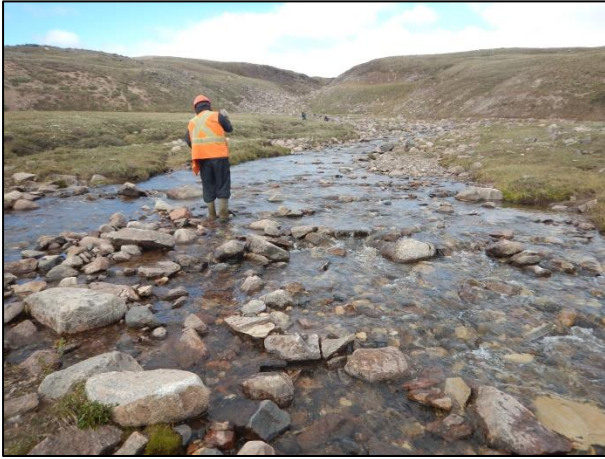
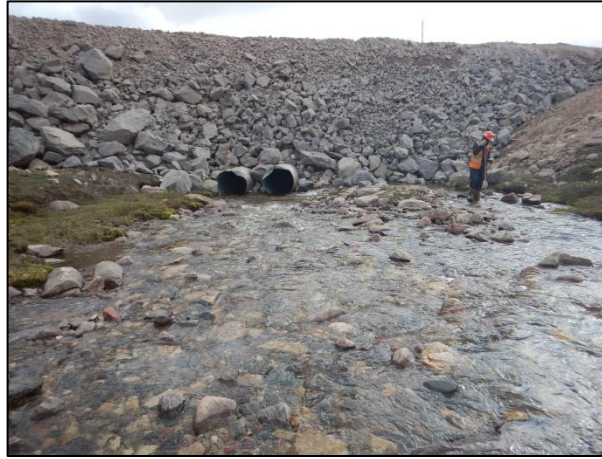
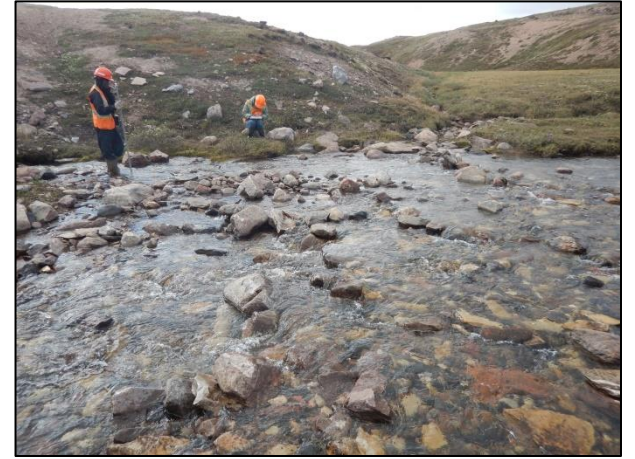
Photos 2. Photos taken 40 m downstream in spring: (A) facing upstream; (B) facing downstream; and (C) across (right bank looking at left bank).

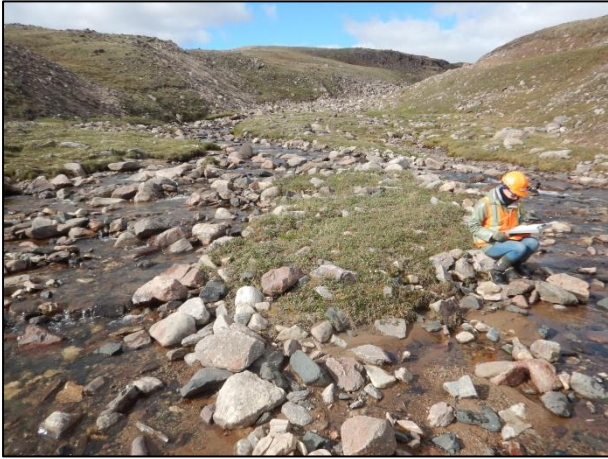
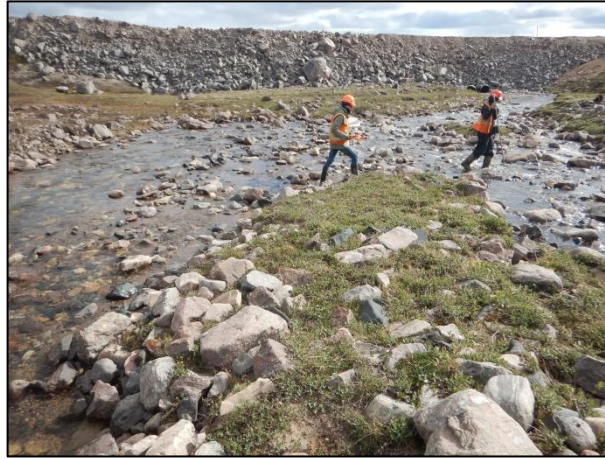
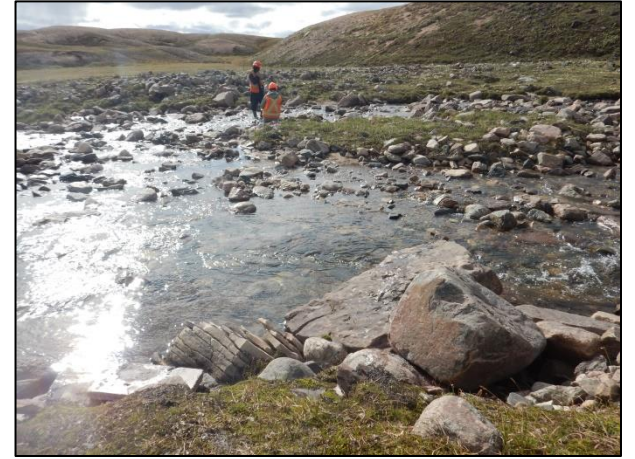
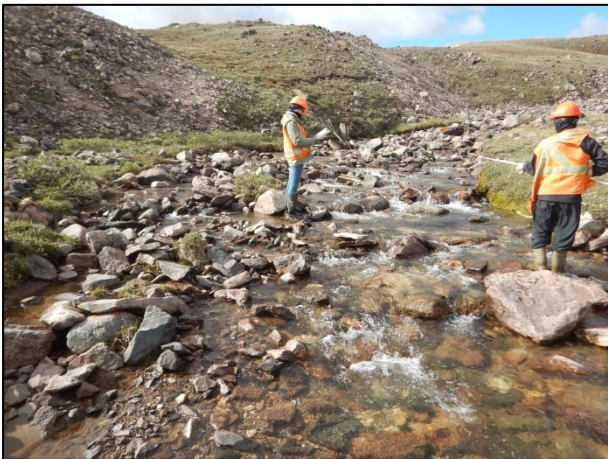
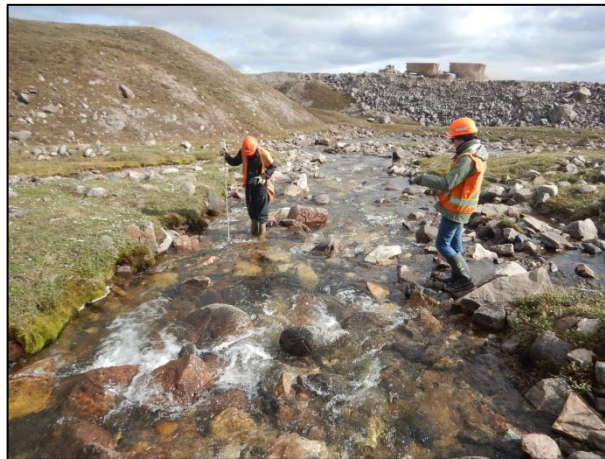
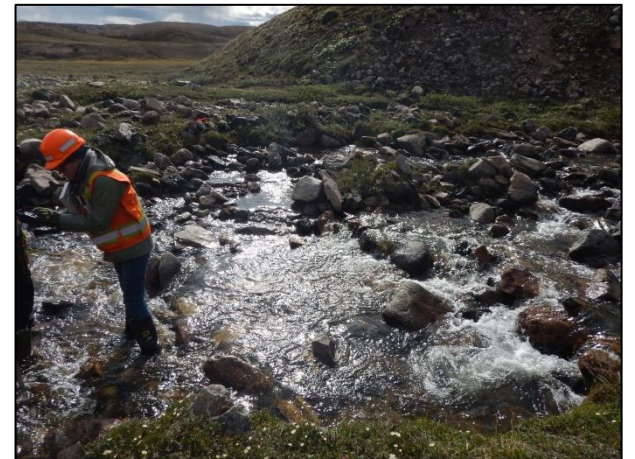
Photos 3. Photos taken 20 m upstream (top) and 40 m upstream (bottom) in spring: (A,D) facing upstream; (B,E) facing downstream; and (C,F) across (right bank looking at left bank).

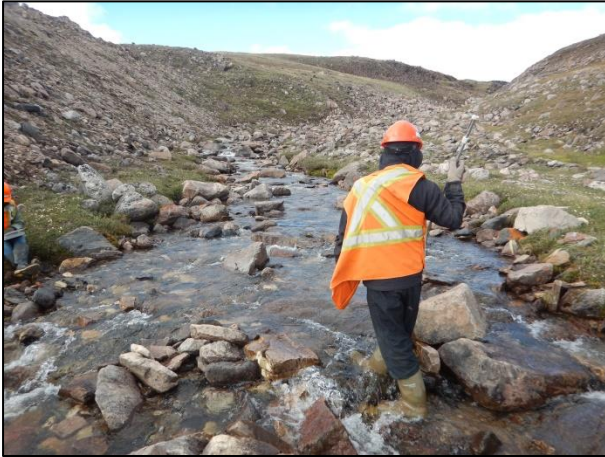
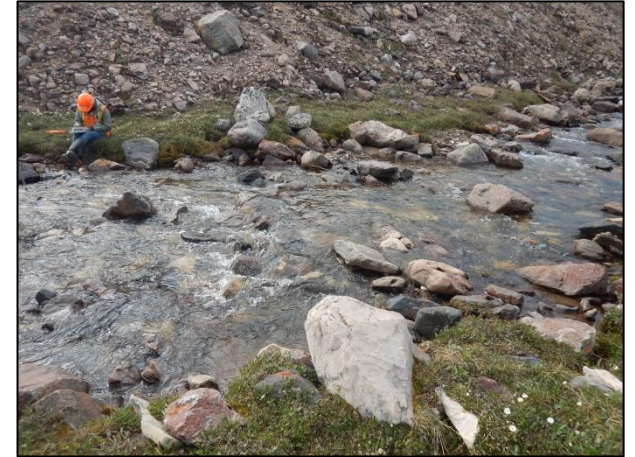
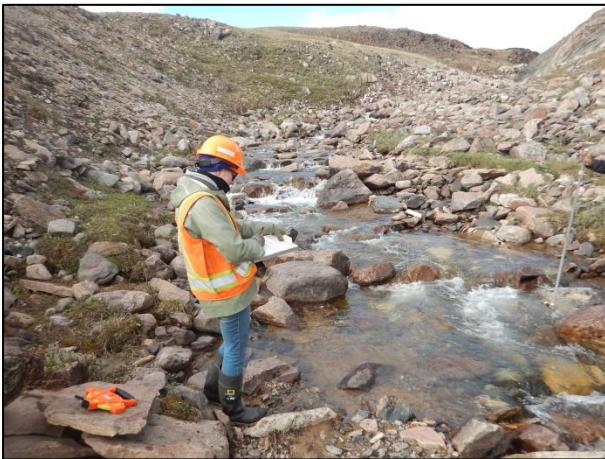
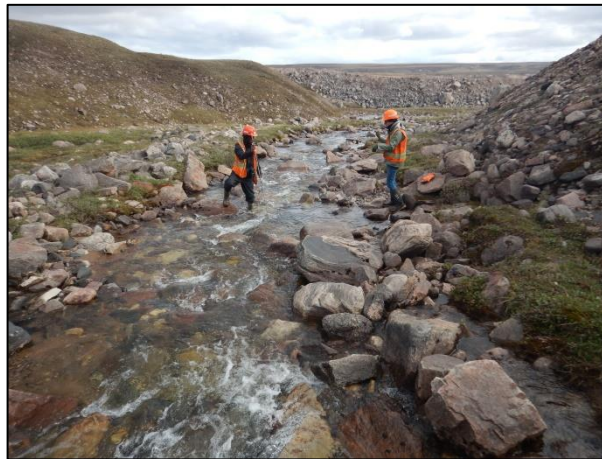
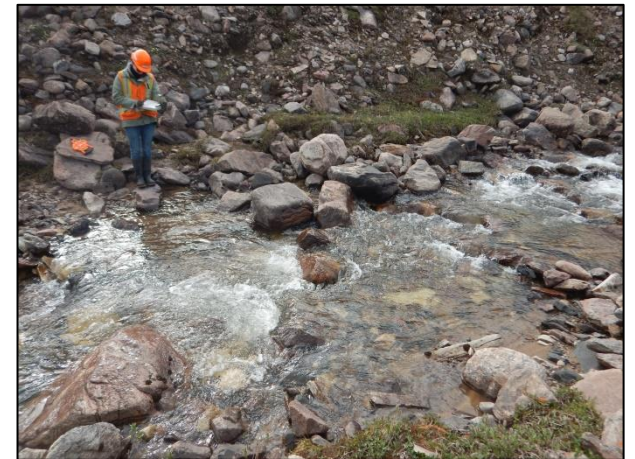
Photos 4. Photos taken 60 m upstream (top) and 80 m upstream (bottom) in spring: (A) facing upstream; (B) facing downstream; and (C) across (right bank looking at left bank).

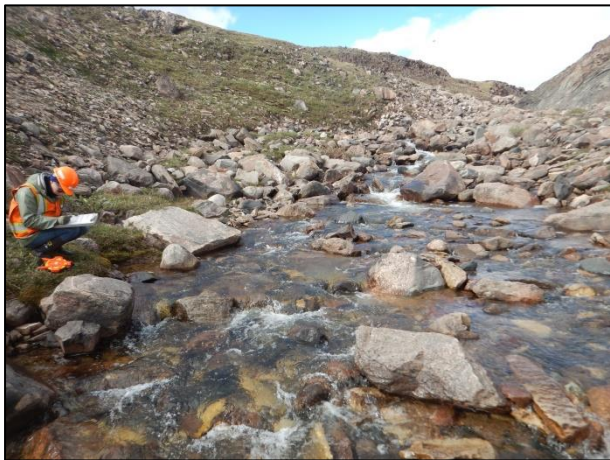
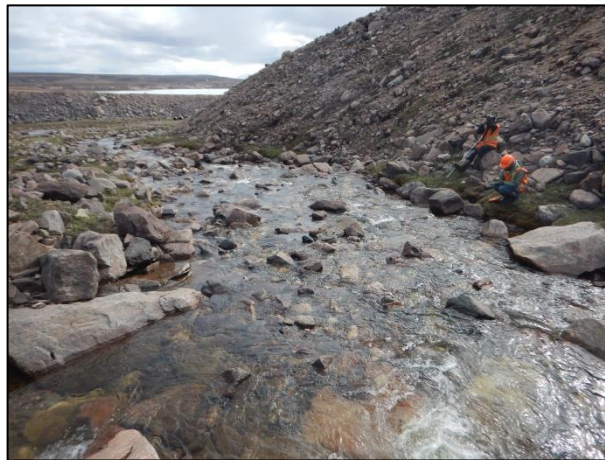
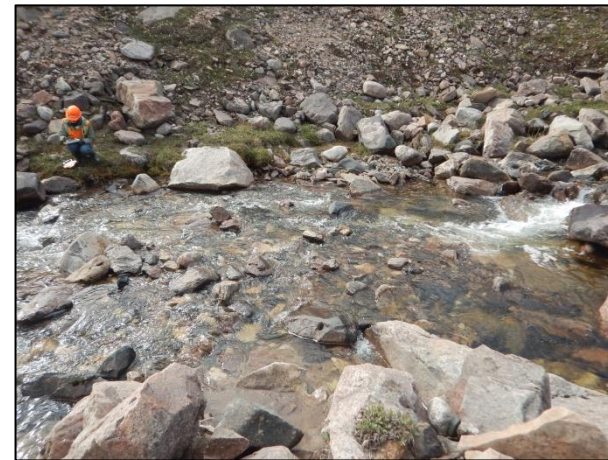
Photos 5. Photos taken 100 m upstream (top) in spring: (A) facing upstream; (B) facing downstream; and (C) across (right bank looking at left bank).

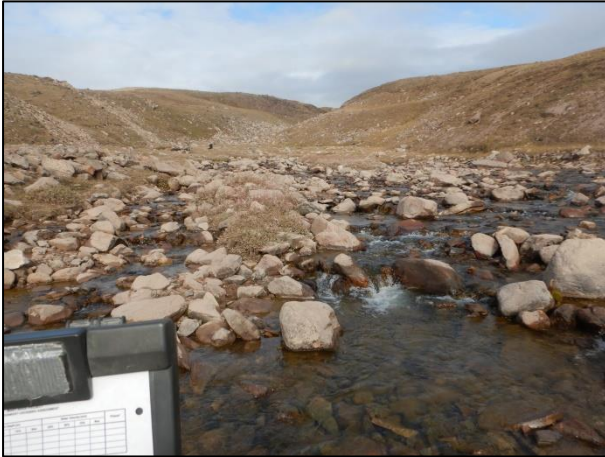
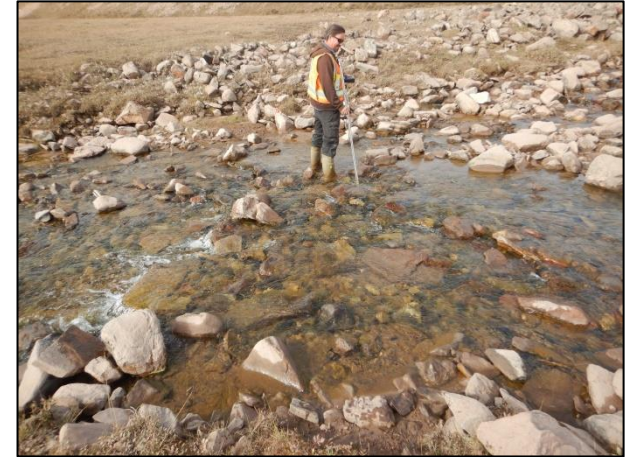
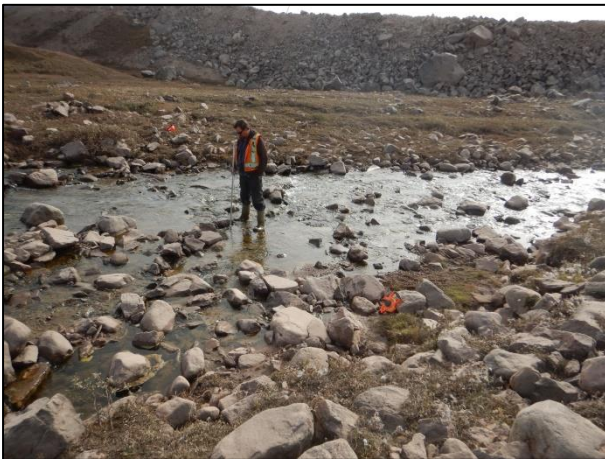
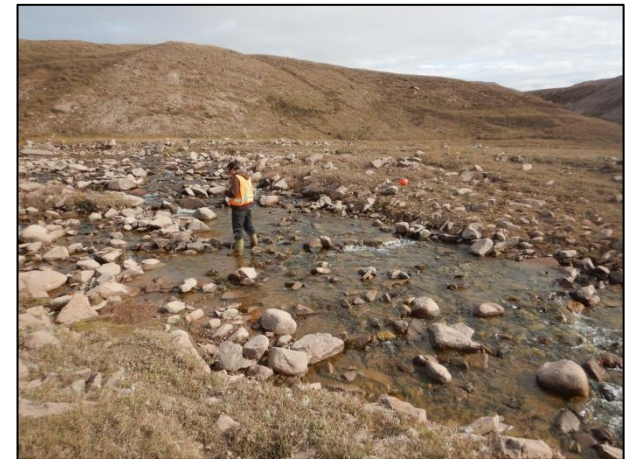
Water levels and velocities were higher in summer/fall than spring.

Photos 6. Photos taken at the crossing centerline in summer/fall: (A) facing upstream; (B) facing downstream; (C) across (right bank looking at left bank); (D) diagonal from left bank above the centreline looking downstream; (E) across (left bank looking at right bank); and (F) diagonal from left bank below the centreline looking upstream.

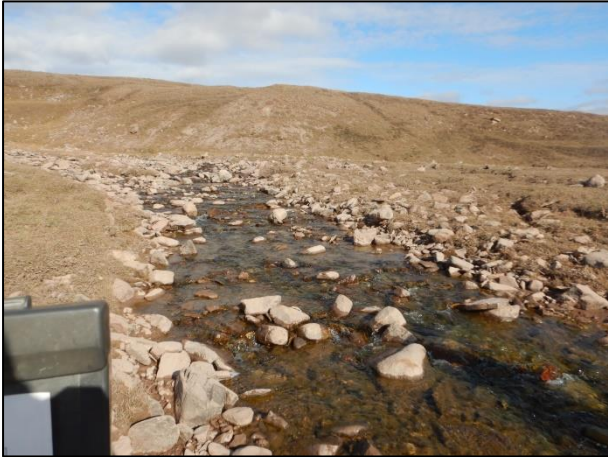
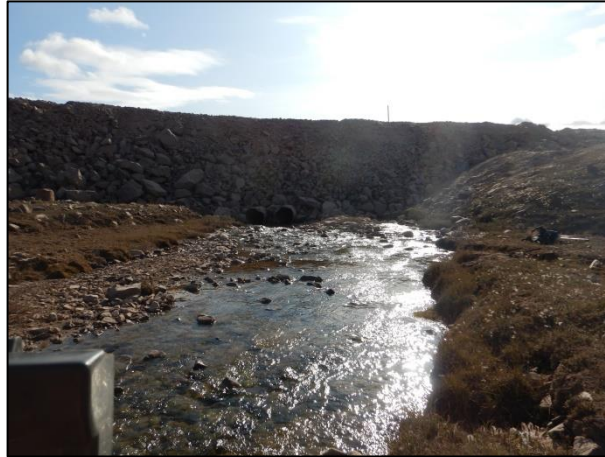
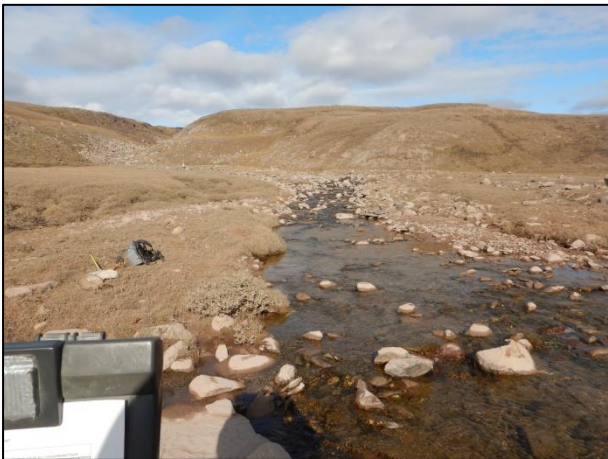
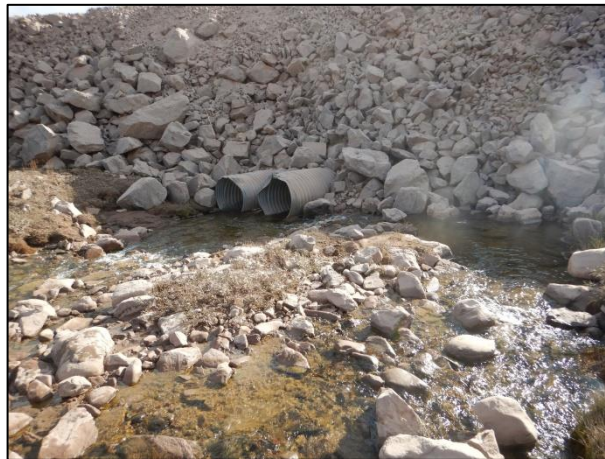
Photos 7. Photos taken 20 m downstream (top) and 40 downstream (bottom) in summer/fall: (A,D) facing upstream; (B,E) facing downstream; and (C,F) across (left bank looking at right bank).

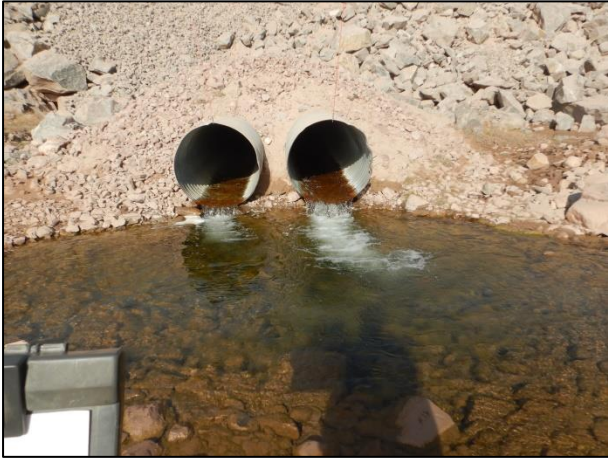
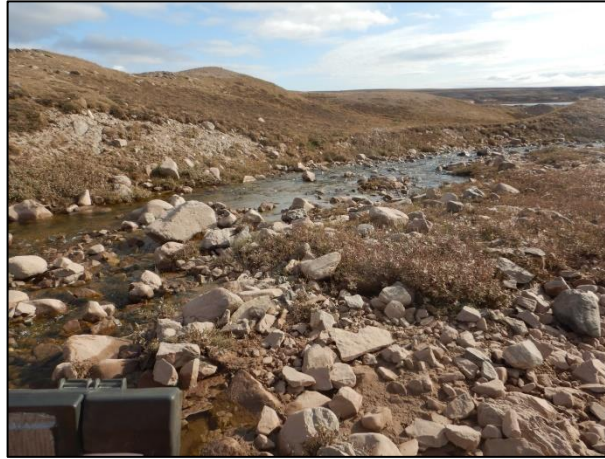
Photos 8. Photos taken 100 m downstream in summer/fall: (A) facing upstream; (B) facing downstream; and (C) across (left bank looking at right bank).

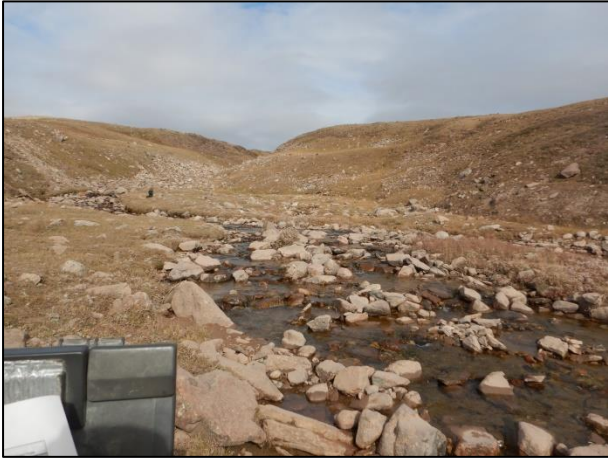
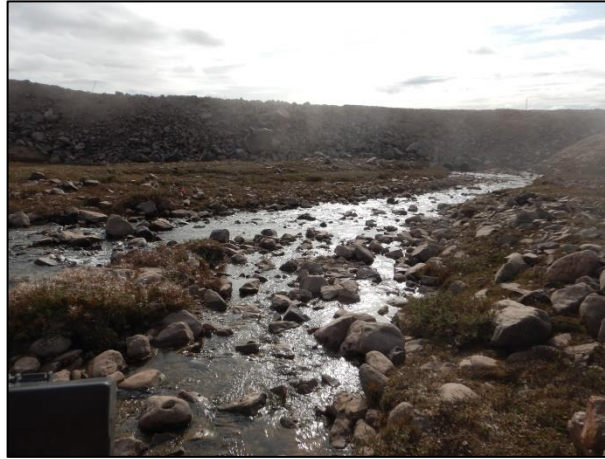
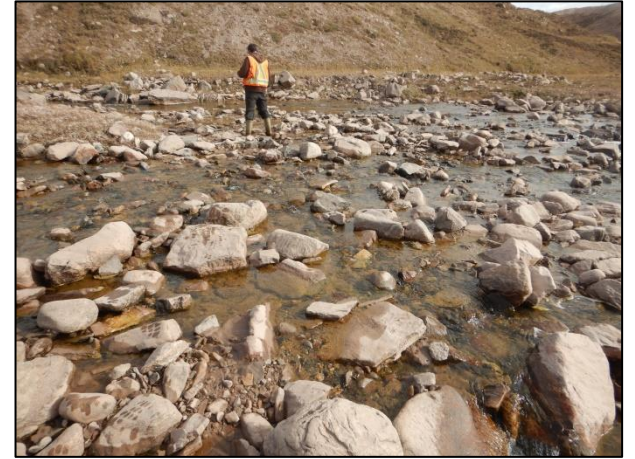
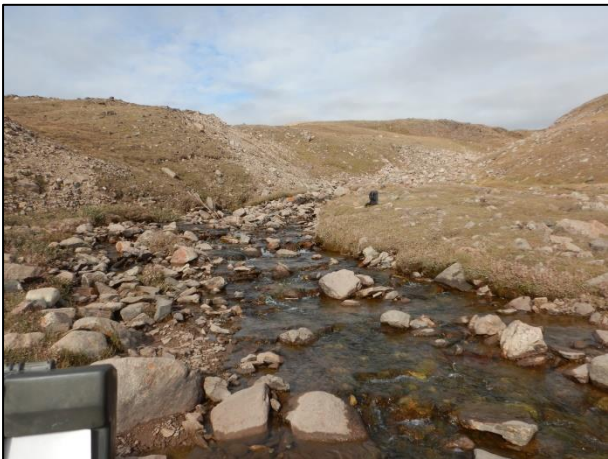
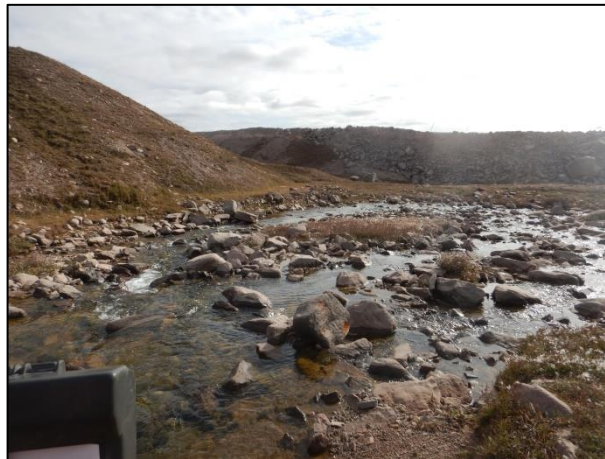
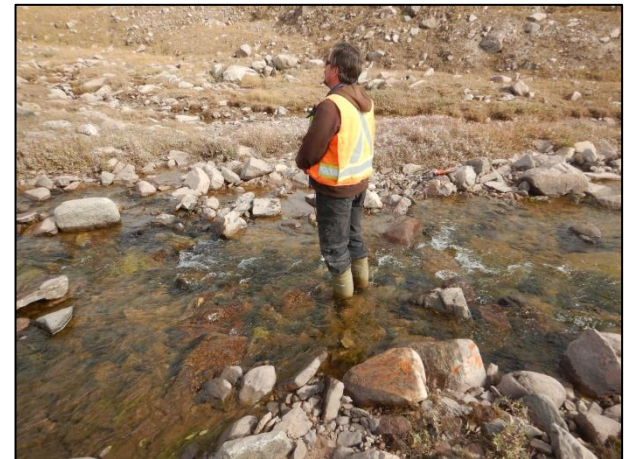
Photos 9. Photos taken 20 m upstream (top) and 40 m upstream (bottom) in summer/fall: (A,D) facing upstream; (B,E) facing downstream; and (C,F) across (left bank looking at right bank).

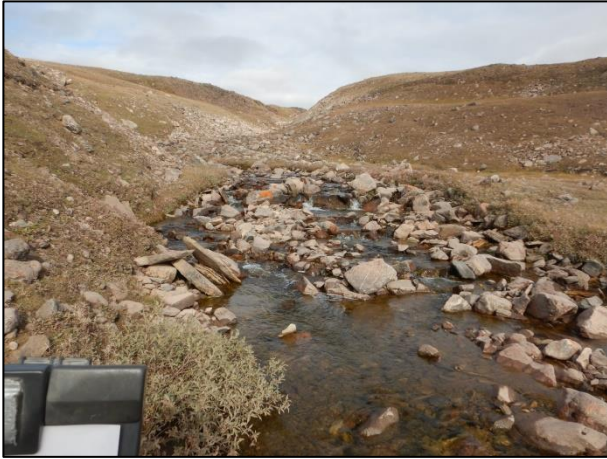
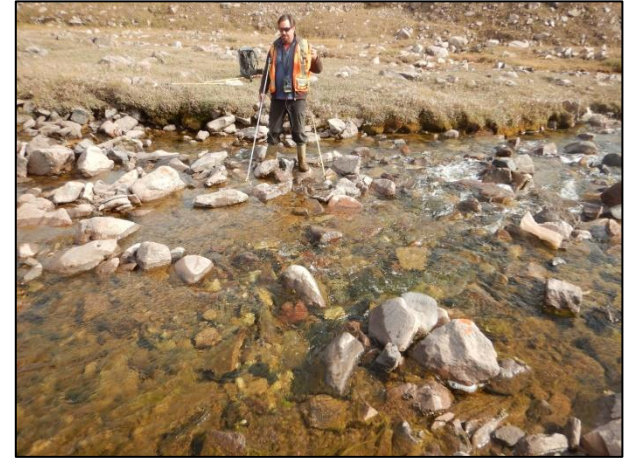
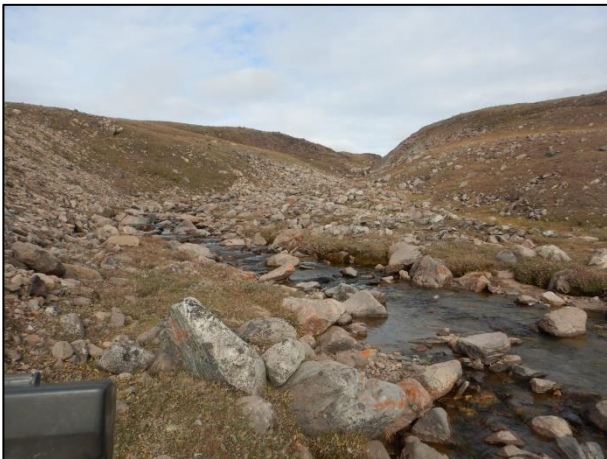
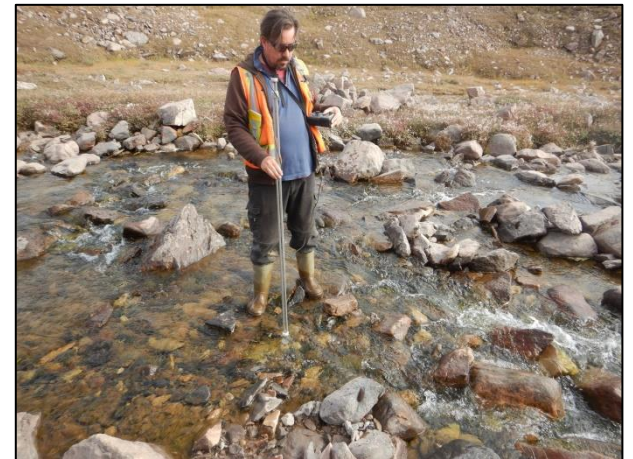
Photos 10. Photos taken 60 m upstream (top) and 80 m upstream (bottom) in summer/fall: (A,D) facing upstream; (B,E) facing downstream; and (C,F) across (left bank looking at right bank).

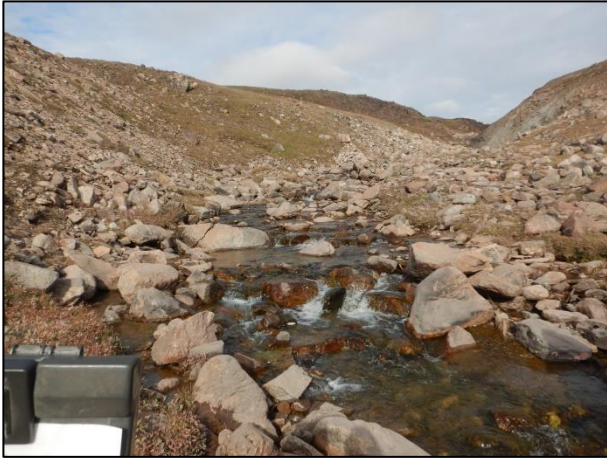
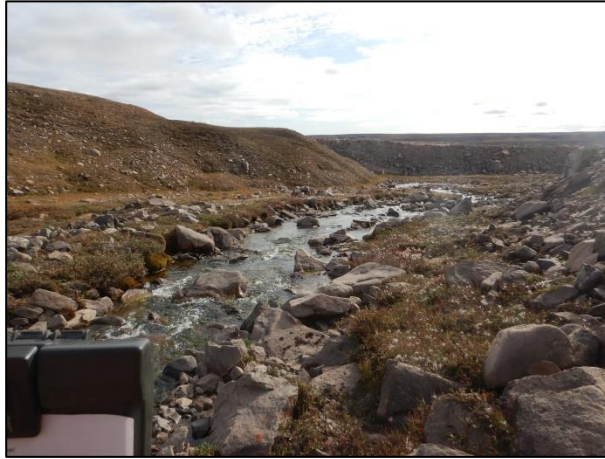
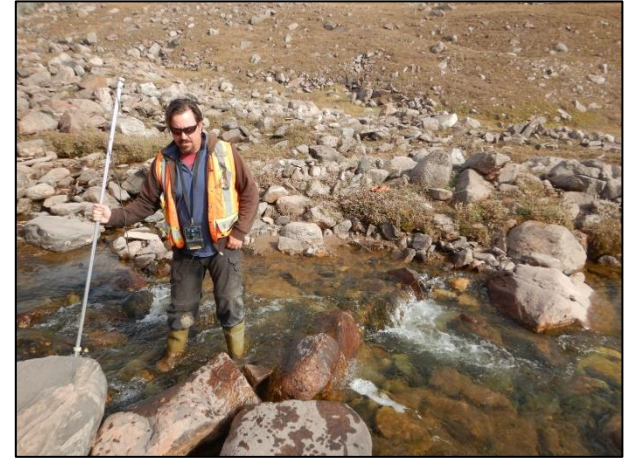
Photos 11. Photos taken 100 m upstream in summer/fall: (A) facing upstream; (B) facing downstream; and (C) across (left bank looking at right bank).

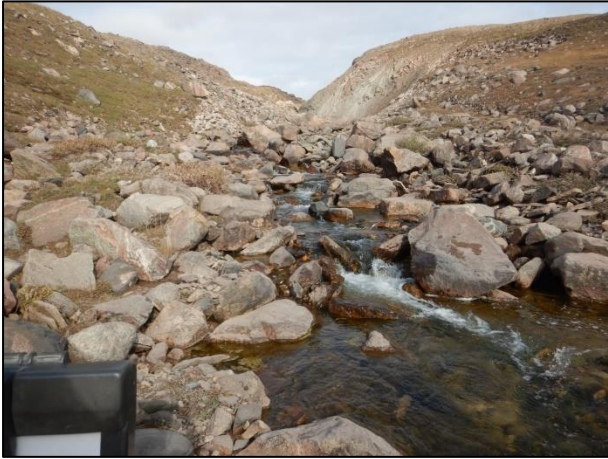
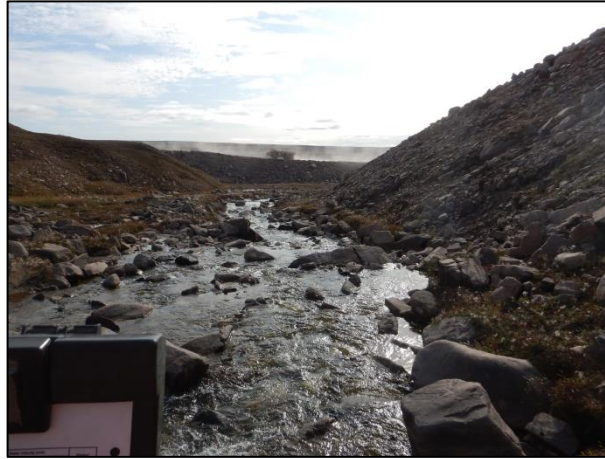
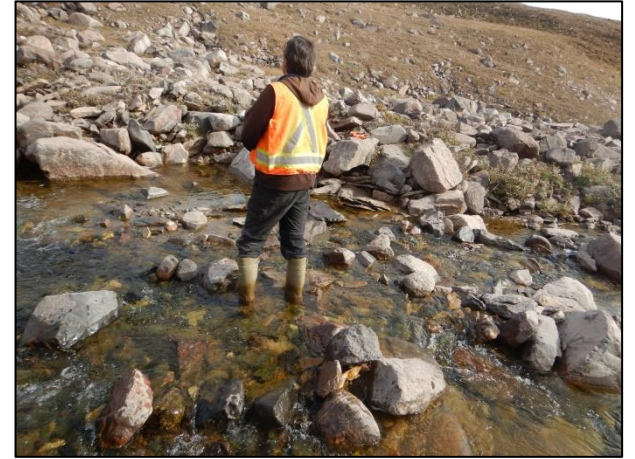
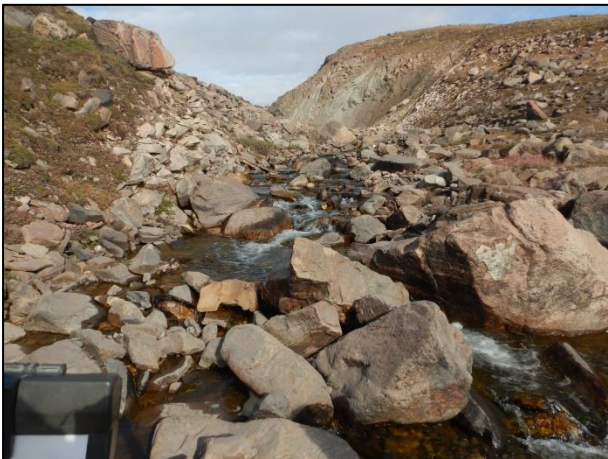
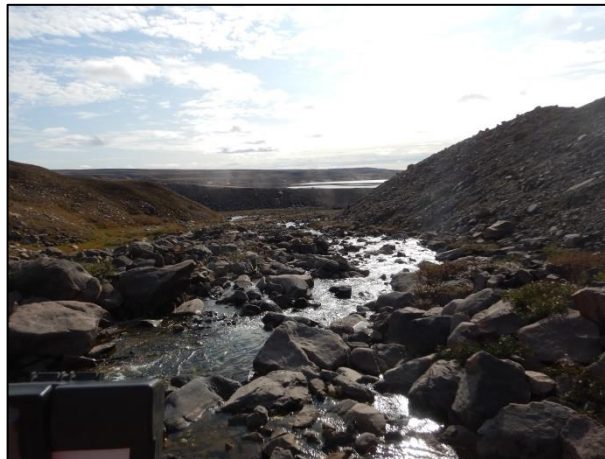
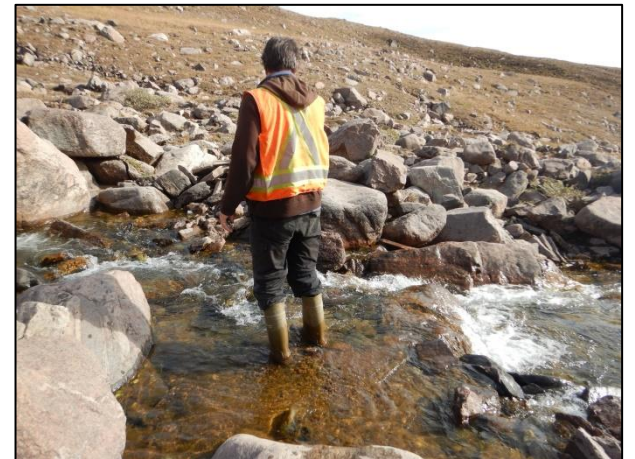
A detailed habitat survey was conducted from 100-200 m upstream in summer/fall. Average velocities and substrate sizes increased upstream of the 100 m upstream transect. The first upstream barrier includes a relatively large drop, but there are side cascades with smaller drops on either side of the 0.5 m drop that may allow the larger juveniles observed in this stream (>150 mm) to access additional upstream habitat depending on water levels (there was minimal water in the side cascades during the summer/fall survey). The permanent barrier (falls) is an additional 20 m upstream from this reach.

Photos 12. Photos taken 120 m upstream (top) and 140 m upstream (bottom) in summer/fall: (A,D) facing upstream; (B,E) facing downstream; and (C,F) across (left bank looking at right bank). Note: all photos taken while standing at the transect centreline.

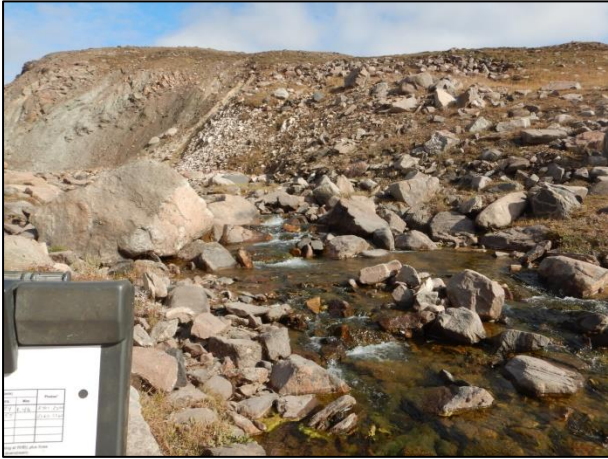
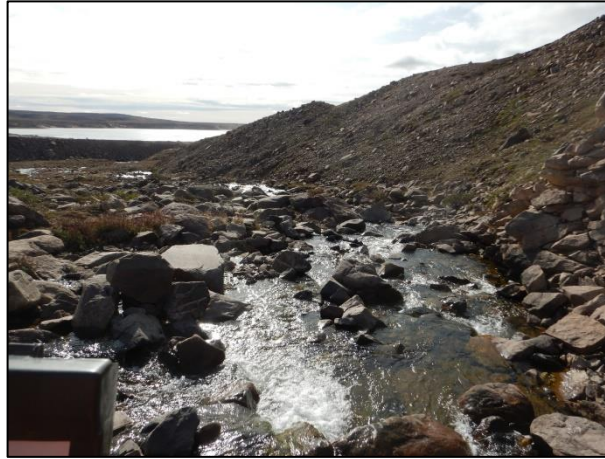
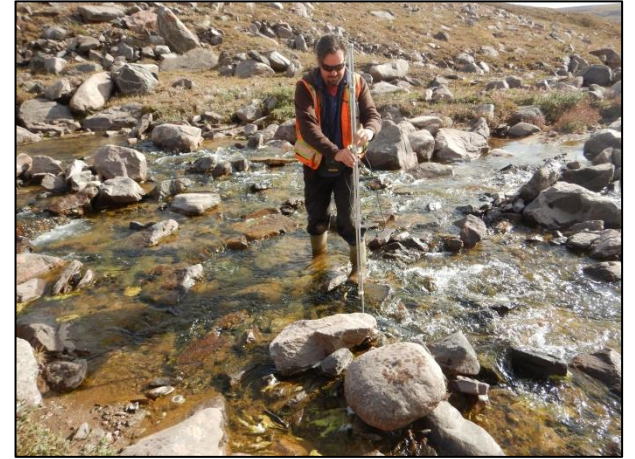
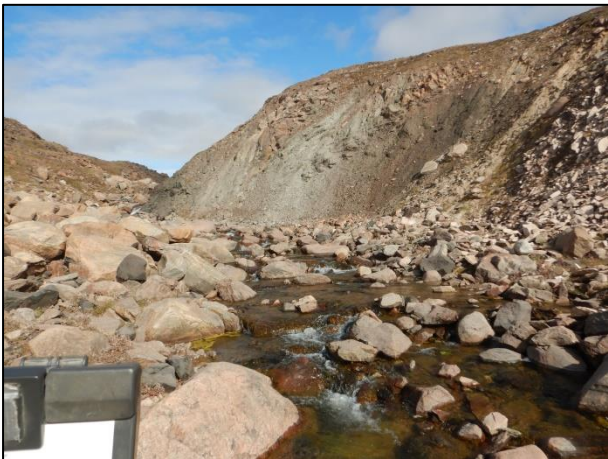
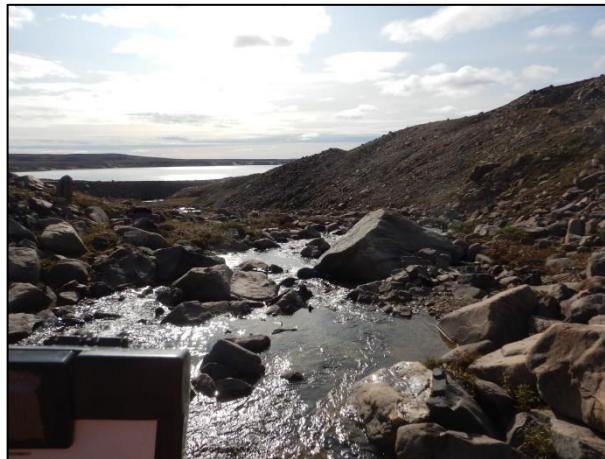
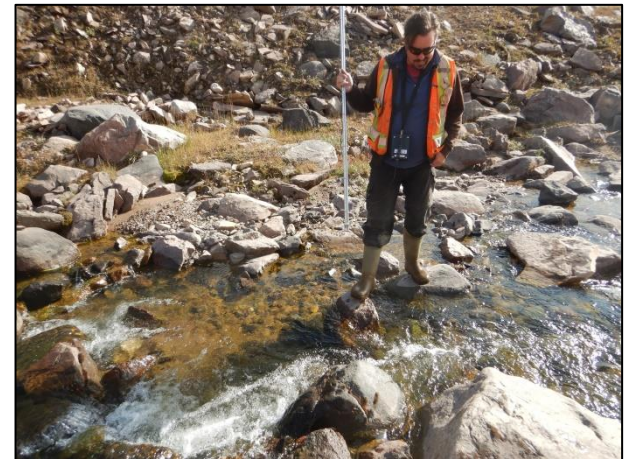
Photos 13. Photos taken 160 m upstream (top) and 180 m upstream (bottom) in summer/fall: (A,D) facing upstream; (B,E) facing downstream; and (C,F) across (left bank looking at right bank). Note: all photos taken while standing at the transect centreline.

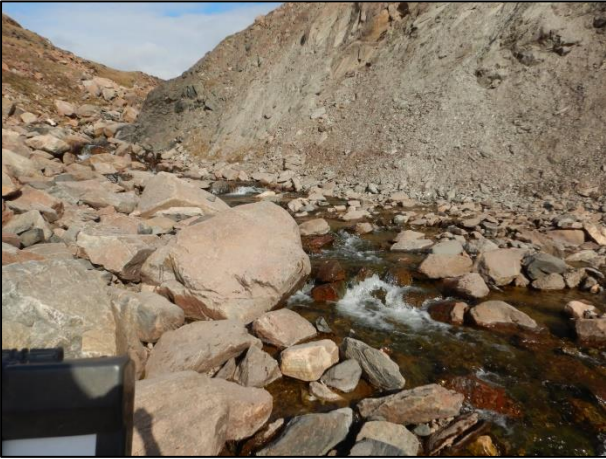
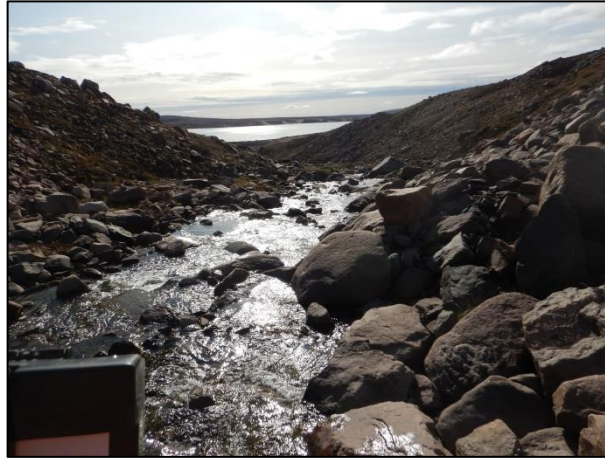
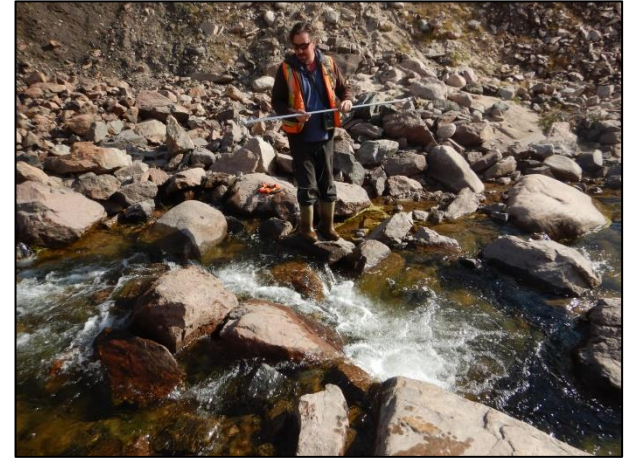
Photos 14. Photos taken 200 m upstream in summer/fall: (A) facing upstream; (B) facing downstream; and (C) across (right bank looking at left bank). Note: all photos taken while standing at the transect centreline.
