# RAIL CV-104-0

<b>Site ID:</b>	CV-104-0	<b>Dates Surveyed:</b>	22-Jun-19	<b>Waterbody Type:</b>	Stream
<b>Project Interaction:</b>	Stream Infilling	<b>Centreline UTM Coordinates:</b>	17W 557514 E 7915207 N	<b>Culvert Length (m):</b>	N/A
<b>Number of Barrels:</b>	N/A	<b>Culvert Diameter/Span (mm):</b>	N/A	<b>Slope (%):</b>	N/A

BAFFINLAND IRON MINES  
MARY RIVER PROJECT

**North/South Consultants Inc.**  
Aquatic Environment Specialists

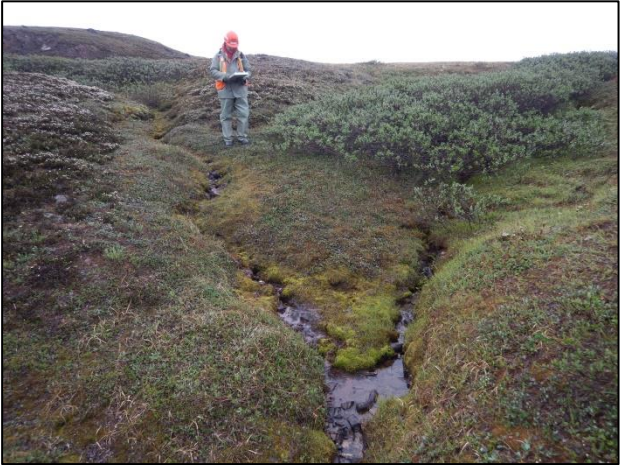
The Tote Road embankment is a permanent barrier located almost immediately downstream from the infilled area. There is no culvert at the site and the stream dissipates under the cobble/boulder embankment. There is no existing surface connectivity with the CV-103-1 stream. A permanent high gradient barrier is located 20 m upstream from the infilled area.

Upstream/ Downstream	UTM		Barrier Type			Height (m)	Gradient (°)	Description	Site Label
	Easting	Northing	1	2	3				
Upstream	557601	7915215	HG	SSF			12	Permanent barrier: Steep gradient with subsurface flow	A
Downstream	557457	7915210	B	SSF				Permanent barrier: Existing Tote Road embankment	B

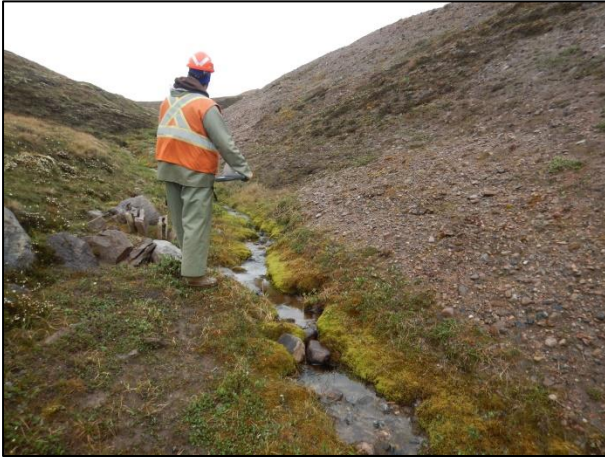
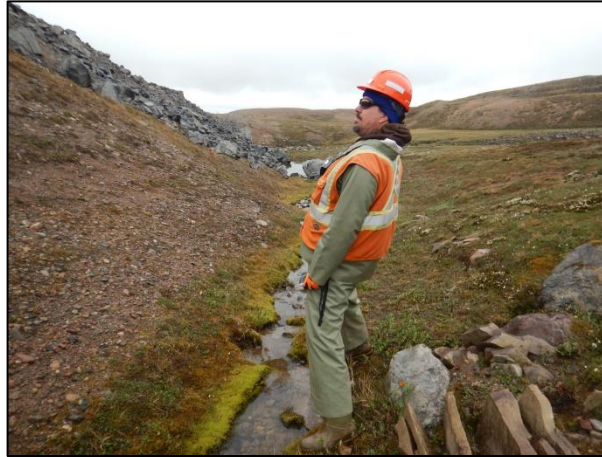
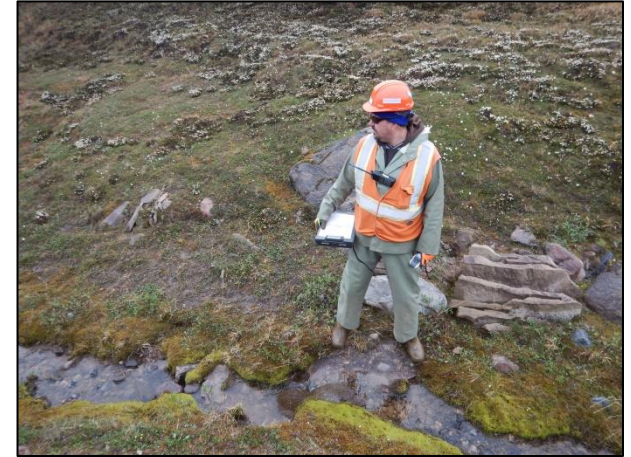
**Photos 1.** Photos taken at centre of the infilled area in spring: (A) facing upstream; (B) facing downstream; and (C) across (left bank looking at right bank).

The rail infills approximately 100 m of an intermittent stream at CV-104-0 that drains west towards and dissipates underneath the Tote Road embankment. The stream also has a rail culvert crossing at CV-104-1, approximately 50 m upstream from the CV-104-0 site.

Depth was insufficient for electrofishing. No fish were observed in this stream and access from downstream is prevented by a permanent barrier.
