# RAIL CV-5-1

## LOCATION AND CROSSING DESCRIPTION

BAFFINLAND IRON MINES  
MARY RIVER PROJECT

**North/South Consultants Inc.**  
Aquatic Environment Specialists

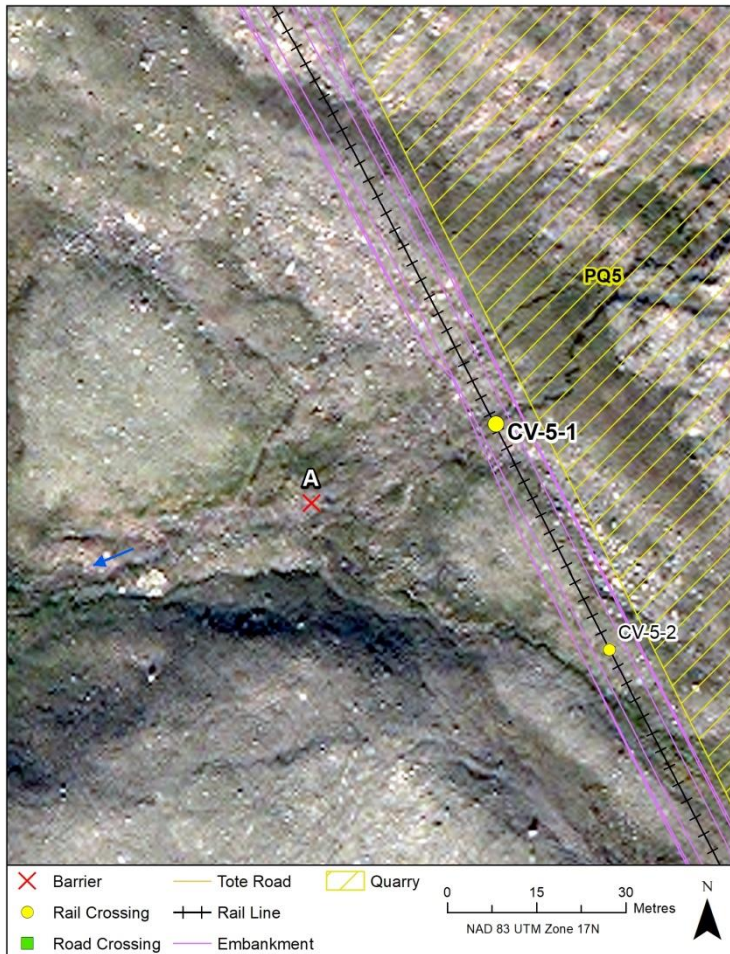
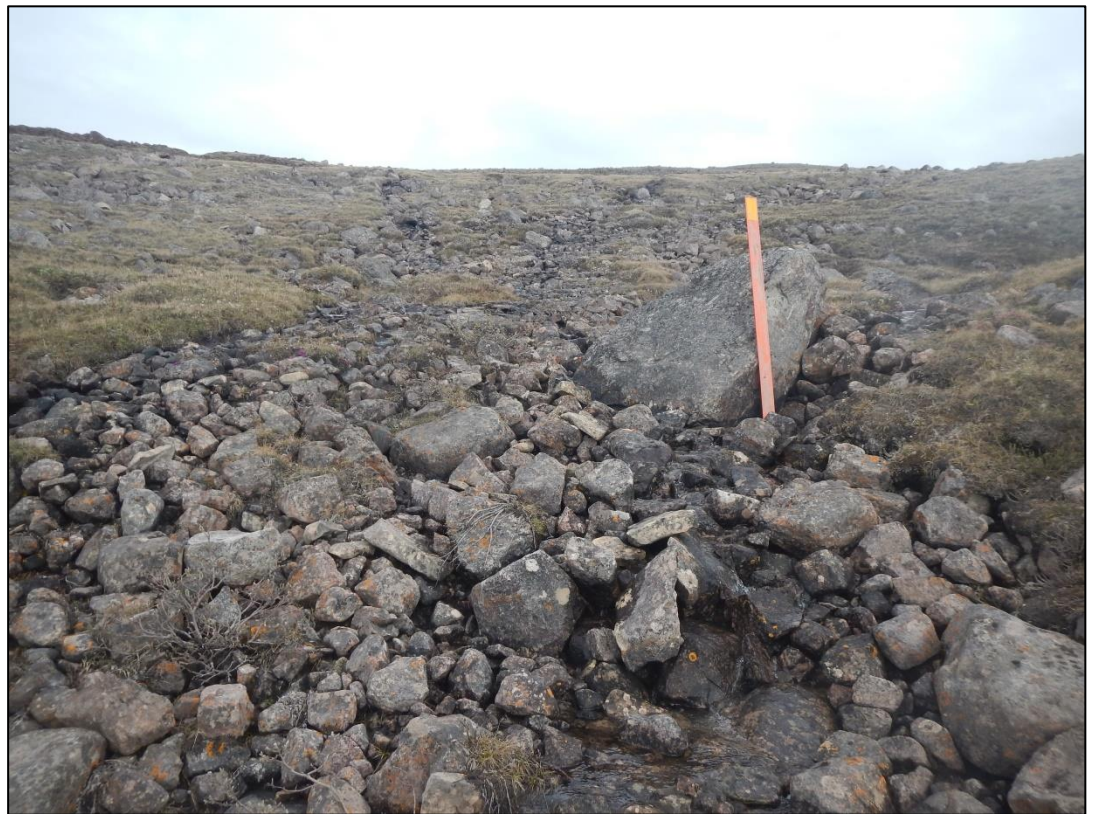
The stream does not provide habitat for Arctic Char or Ninespine Stickleback due to the presence of a permanent barrier (high gradient with vertical drops) extending from the crossing to approximately 100 m downstream (which includes its confluence with CV-5-2). There is no upstream connectivity to overwintering habitat.

Upstream/ Downstream	UTM		Barrier Type			Height (m)	Gradient (°)	Description	Site Label
	Easting	Northing	1	2	3				
At Crossing and Downstream	506135	7972022	HG	VD		>0.5	15	Permanent Barrier: High gradient with several vertical drops; shared with CV-5-2	A

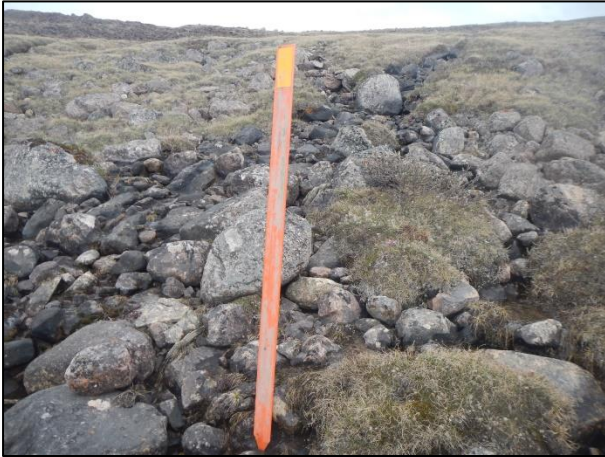
**A**

**Photos 1.** Photos taken at the crossing centreline in spring (A) facing upstream; (B) facing downstream; and (C) across (left bank looking at right bank).
