#### LOCATION AND CROSSING DESCRIPTION

Site ID: CV-5-4 **Dates Surveyed:** 15-Jun-19 Waterbody Type: Stream **Centreline UTM Coordinates: Project Interaction:** Rail Daylight + Culvert 17W 506541 E 7971623 N Culvert Length (m): 12 Number of Barrels: Culvert Diameter/Span (mm): 900 **Slope (%):**

BAFFINLAND IRON MINES MARY RIVER PROJECT

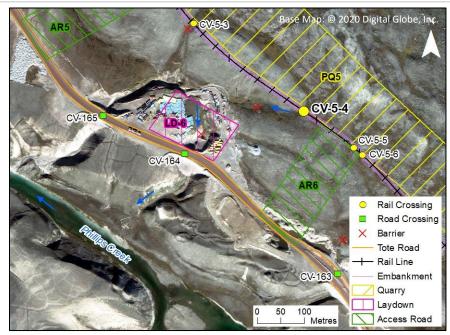
The North Rail crosses an unnamed intermittent stream at CV-5-4 located approximately 480 m upstream of Tote Road Crossing CV-164. The stream flows west to existing laydown LD-06 and then south through the laydown to a Tote Road culvert at CV-164 and then ultimately discharging to Phillips Creek approximately 280 m southwest of the Tote Road. There was little water in the channel when surveyed in spring 2019.

There is a steep vertical gradient and subsurface flow through boulders approximately 100 m downstream of the rail crossing that represents a permanent barrier to upstream fish passage from Phillips Creek.

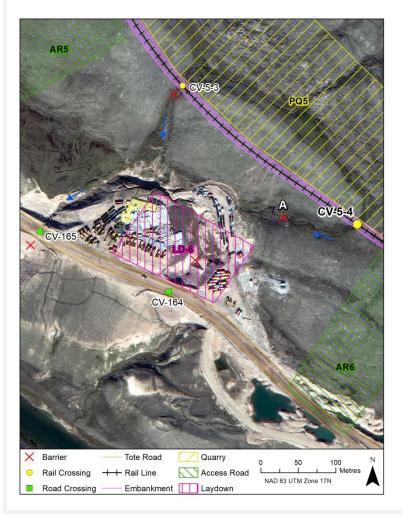
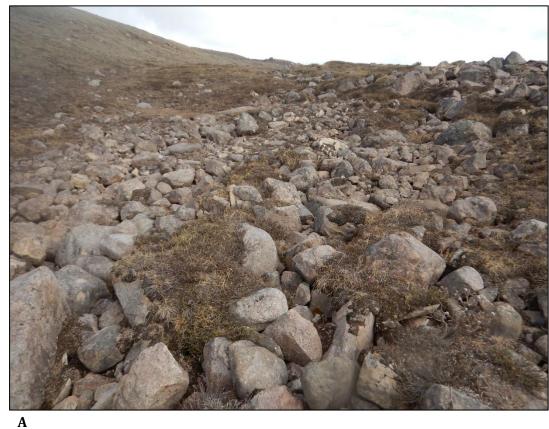
Upstream/	UTM		Barrier Type			Height	Gradient	Description	
Downstream	Easting	Northing	1	2	3	(m)	(°)	Description	
Downstream	506442	7971632	HG	SSF			14	Permanent Barrier: High gradient with subsurface flow under boulder cover	Α

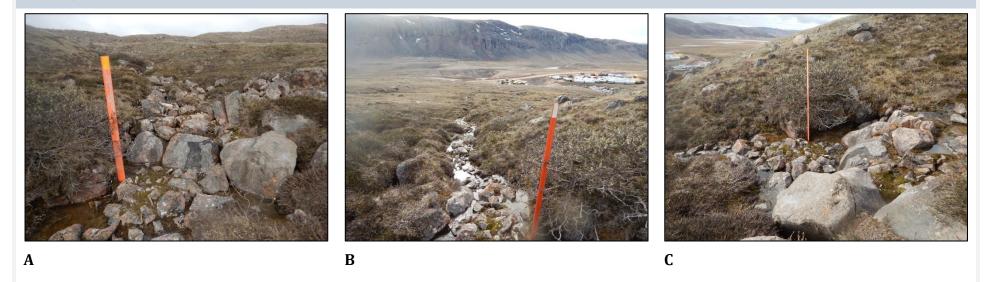
## 15-JUN-19

There was little flow at the crossing in spring 2019. Upstream passage from Phillips Creek is blocked by a high gradient/subsurface flow barrier downstream of the rail crossing.

**Photos 1.** Photos taken at the crossing centreline in spring (A) facing upstream; (B) facing downstream; and (C) across (left bank looking at right bank).
