#### LOCATION AND CROSSING DESCRIPTION

Site ID:	CV-5-5	Dates Surveyed:	15-Jun-19	Waterbody Type:	Stream
Project Interaction:	Rail Cut	Centreline UTM Coordinates:	17W 506647 E 7971545 N	Culvert Length (m):	N/A
Number of Barrels:	N/A	Culvert Diameter/Span (mm):	N/A	Slope (%):	N/A

BAFFINLAND IRON MINES MARY RIVER PROJECT

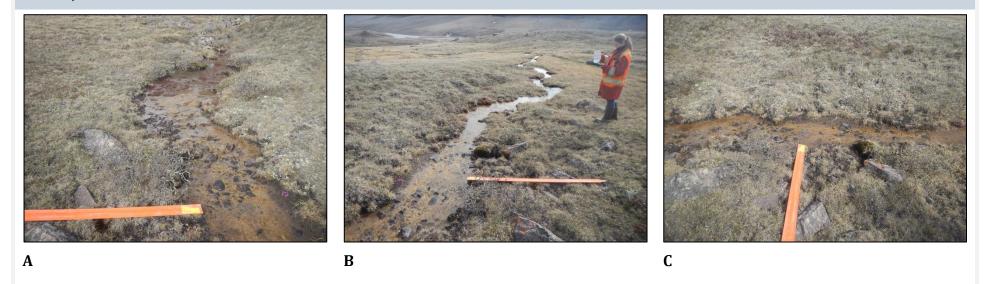
There was little water at the crossing, and a permanent downstream barrier of high gradient combined with subsurface flow in spring 2019.

**Photos 1.** Photos taken at the crossing centreline in spring (A) facing upstream; (B) facing downstream; and (C) across (left bank looking at right bank).
